**WMSC Commissioner Brief: W-0267 – Derailment – Greenbelt Station – August 11, 2023**

FINAL REPORT OF INVESTIGATION A&I E23556

Greenbelt Station – Derailment

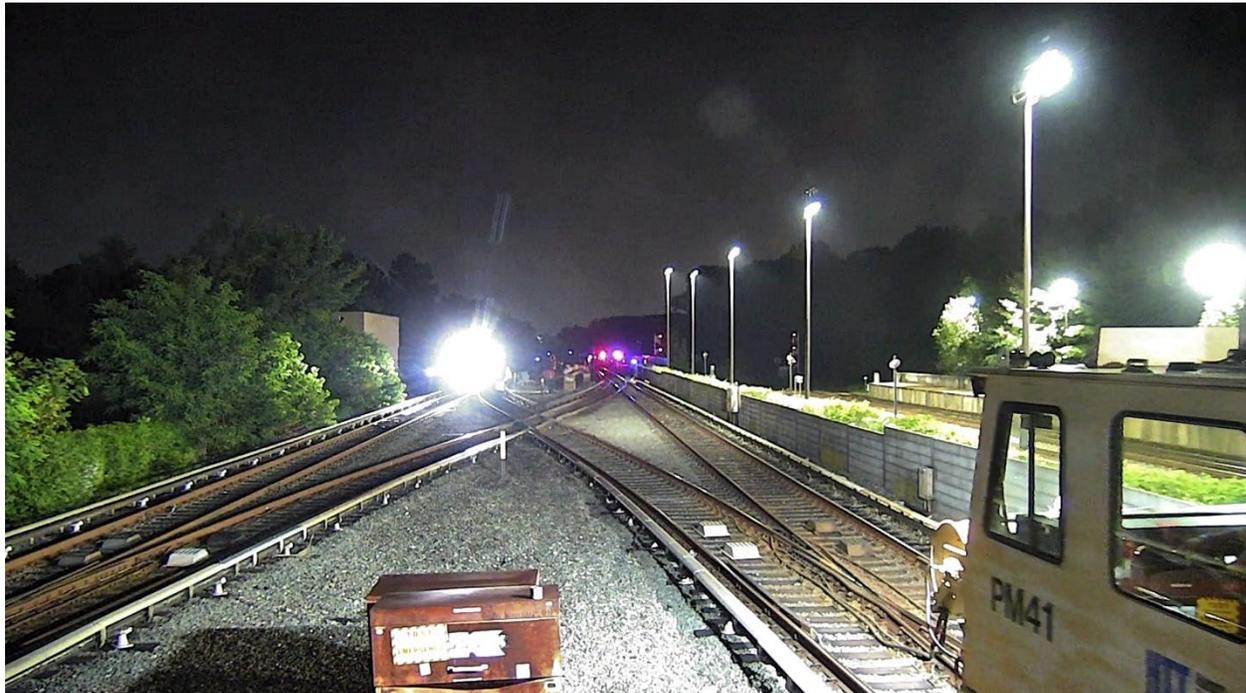
Figure 1 – Equipment Operator of PM-41 entering the Greenbelt interlocking from Track 2 at CM 661+37 at approximately 23:54 hours.

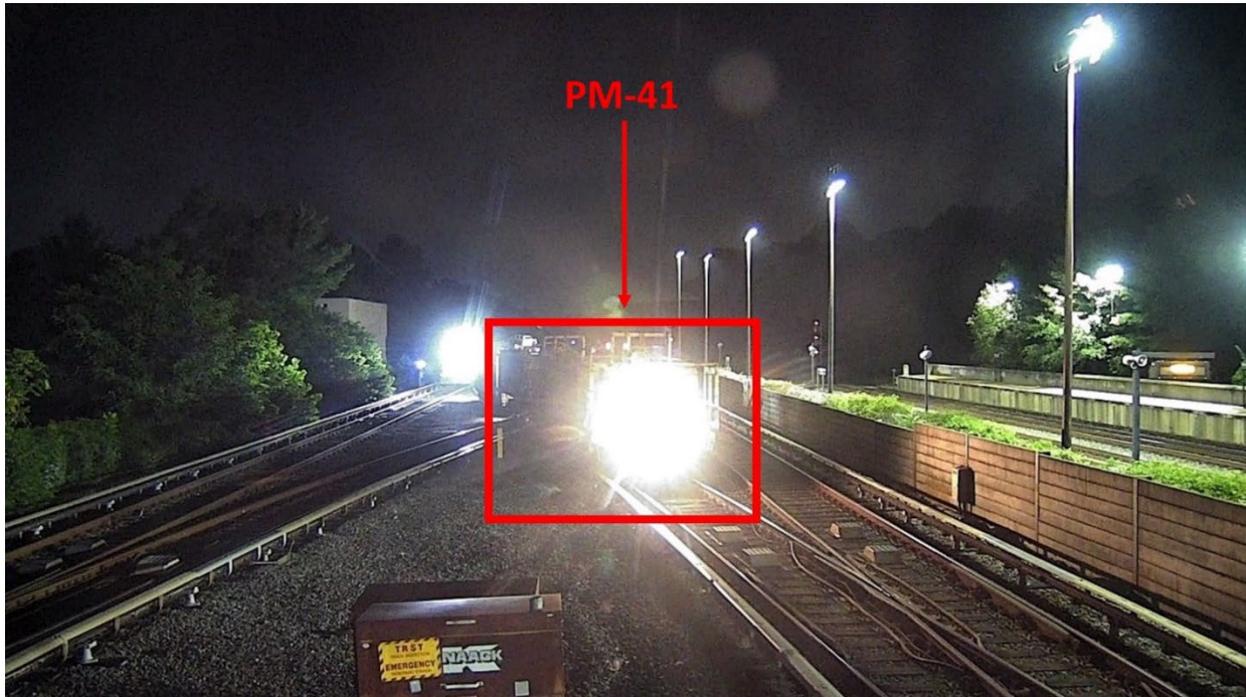
Figure 2 – Equipment Operator of PM-41 stopped momentarily as another RMM exits the interlocking on Track 1 in the direction of College Park Station at approximately 23:55 hours.

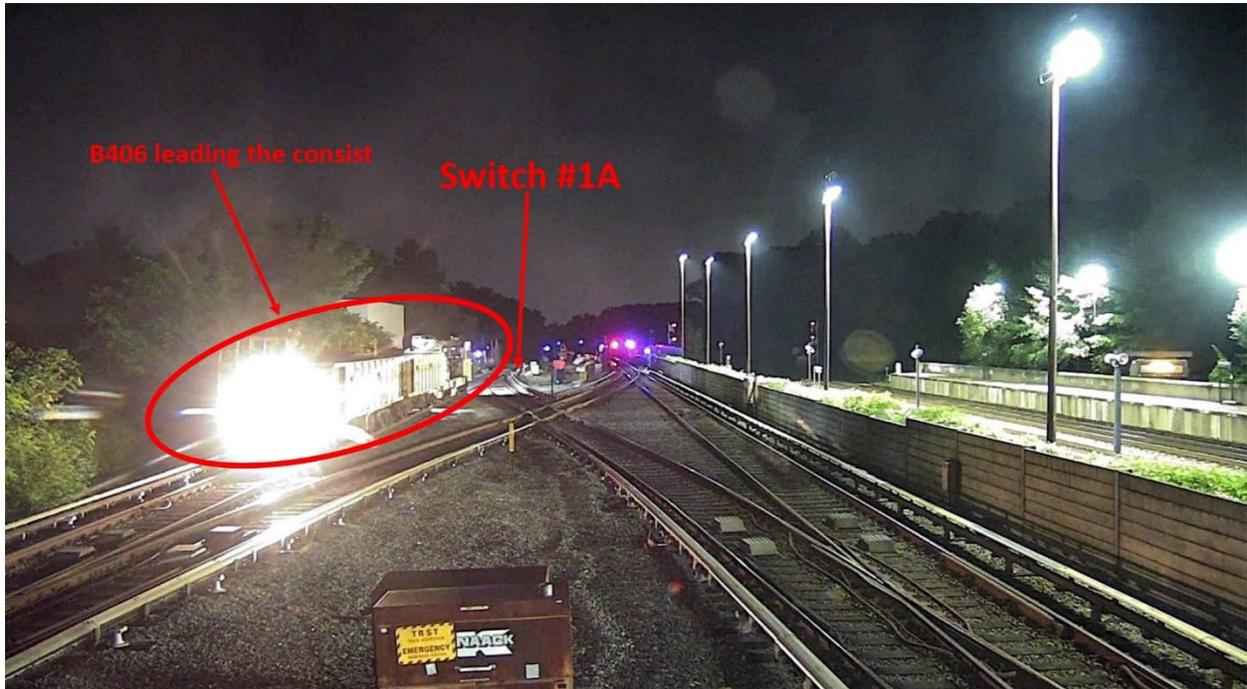
Figure 3 – Equipment Operator of PM-41 moved through Switch #1A on Track 1 in the direction of Greenbelt Station at approximately 00:30 hours.

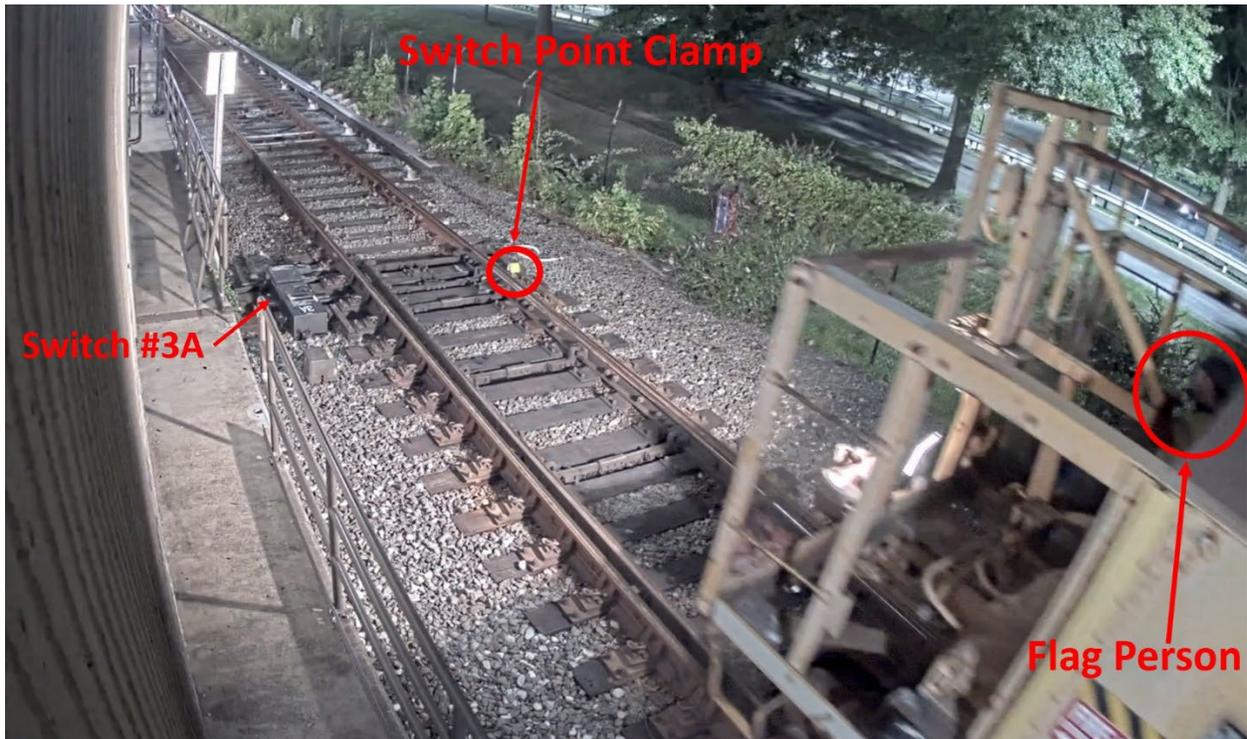
Figure 4 – Flag Person on B406 approaching Switch #3A on Track 1 near CM 661+37 at approximately 00:30:34 hours.

00:30:34 hours	<u>Equipment Operator</u> : The Equipment Operator operating PM-41 approached Switch #3A on Track 1 in the direction of Greenbelt Station, with the Flag Person on the leading vehicle. [CCTV]

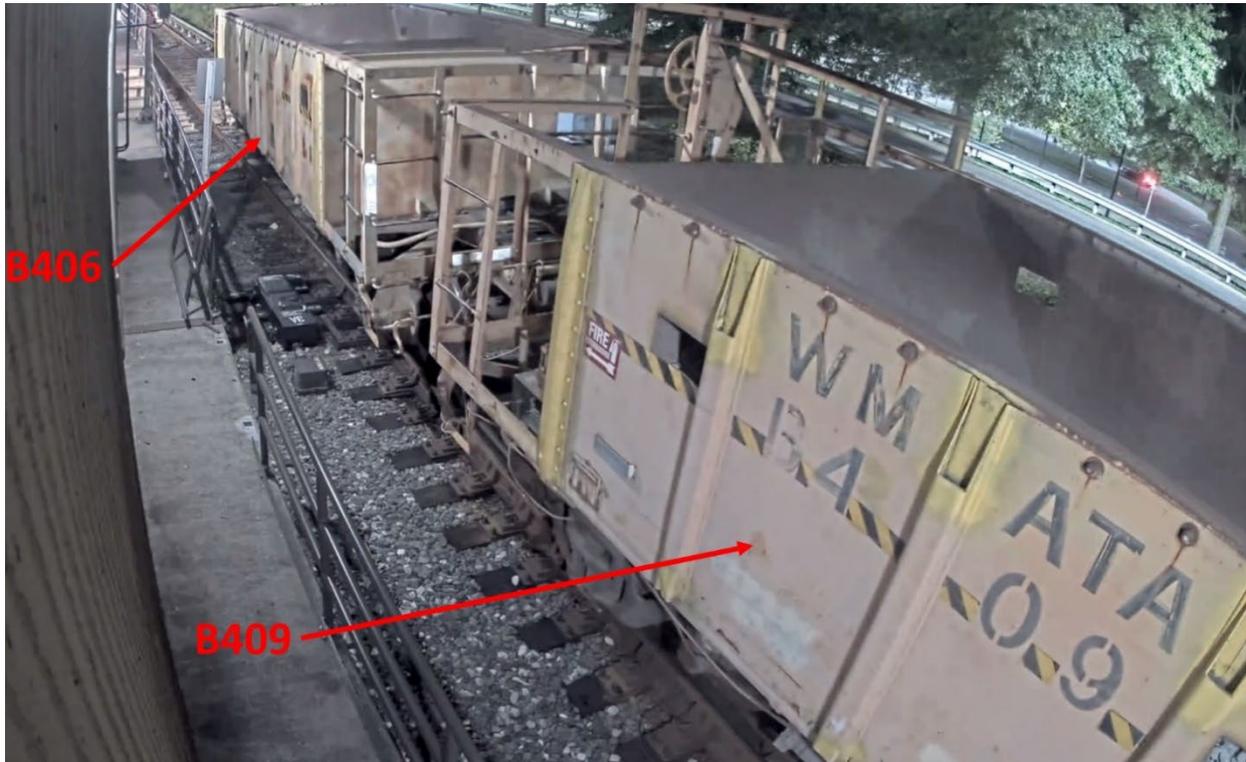
Figure 5 – Flatcar B406 with front and rear axles derailed at Switch #3A on Track 1 at approximately 00:30:39 hours.

00:30:39 hours	<u>Equipment Operator</u> : The front axle of B406 derailed on Track 1. [CCTV]
00:40:00 hours	<u>RWIC</u> : The RWIC contacted MCC and reported that Ballast Flat car B406 derailed in the interlocking at Switch #3A. No reported injuries. [Incident Statement]

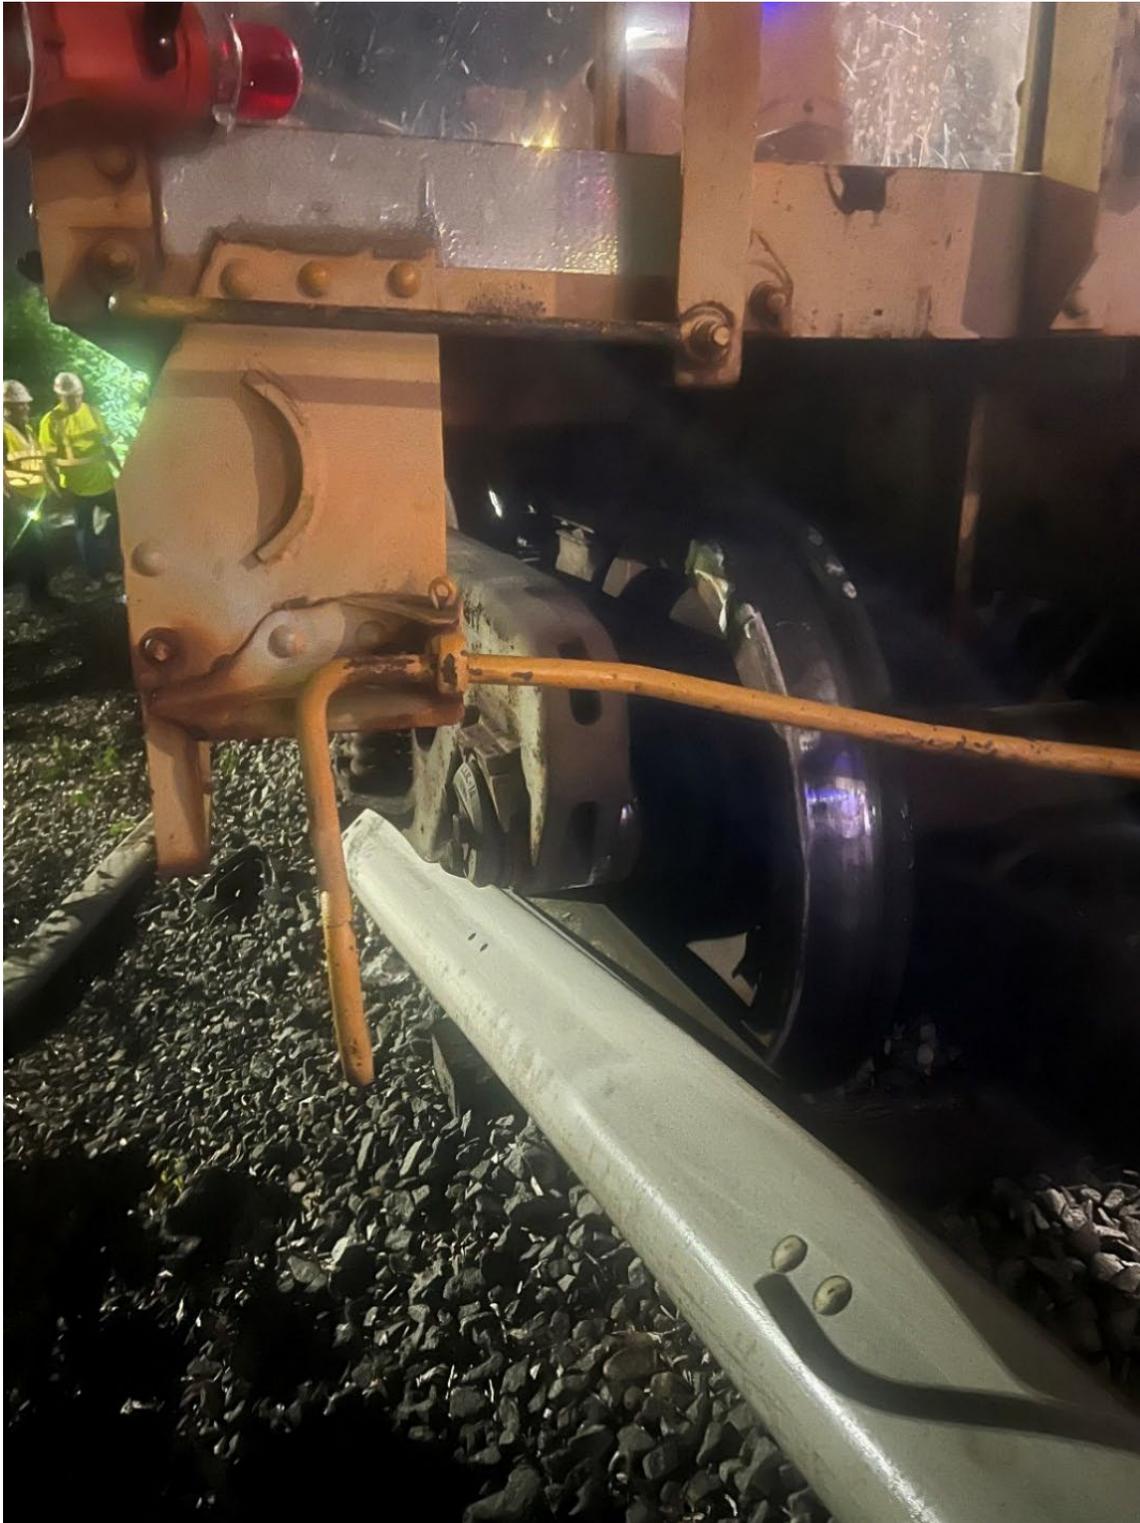
Photograph 1 – Right axle of B406 came in contact and damaged the un-energized third rail. (Front view).

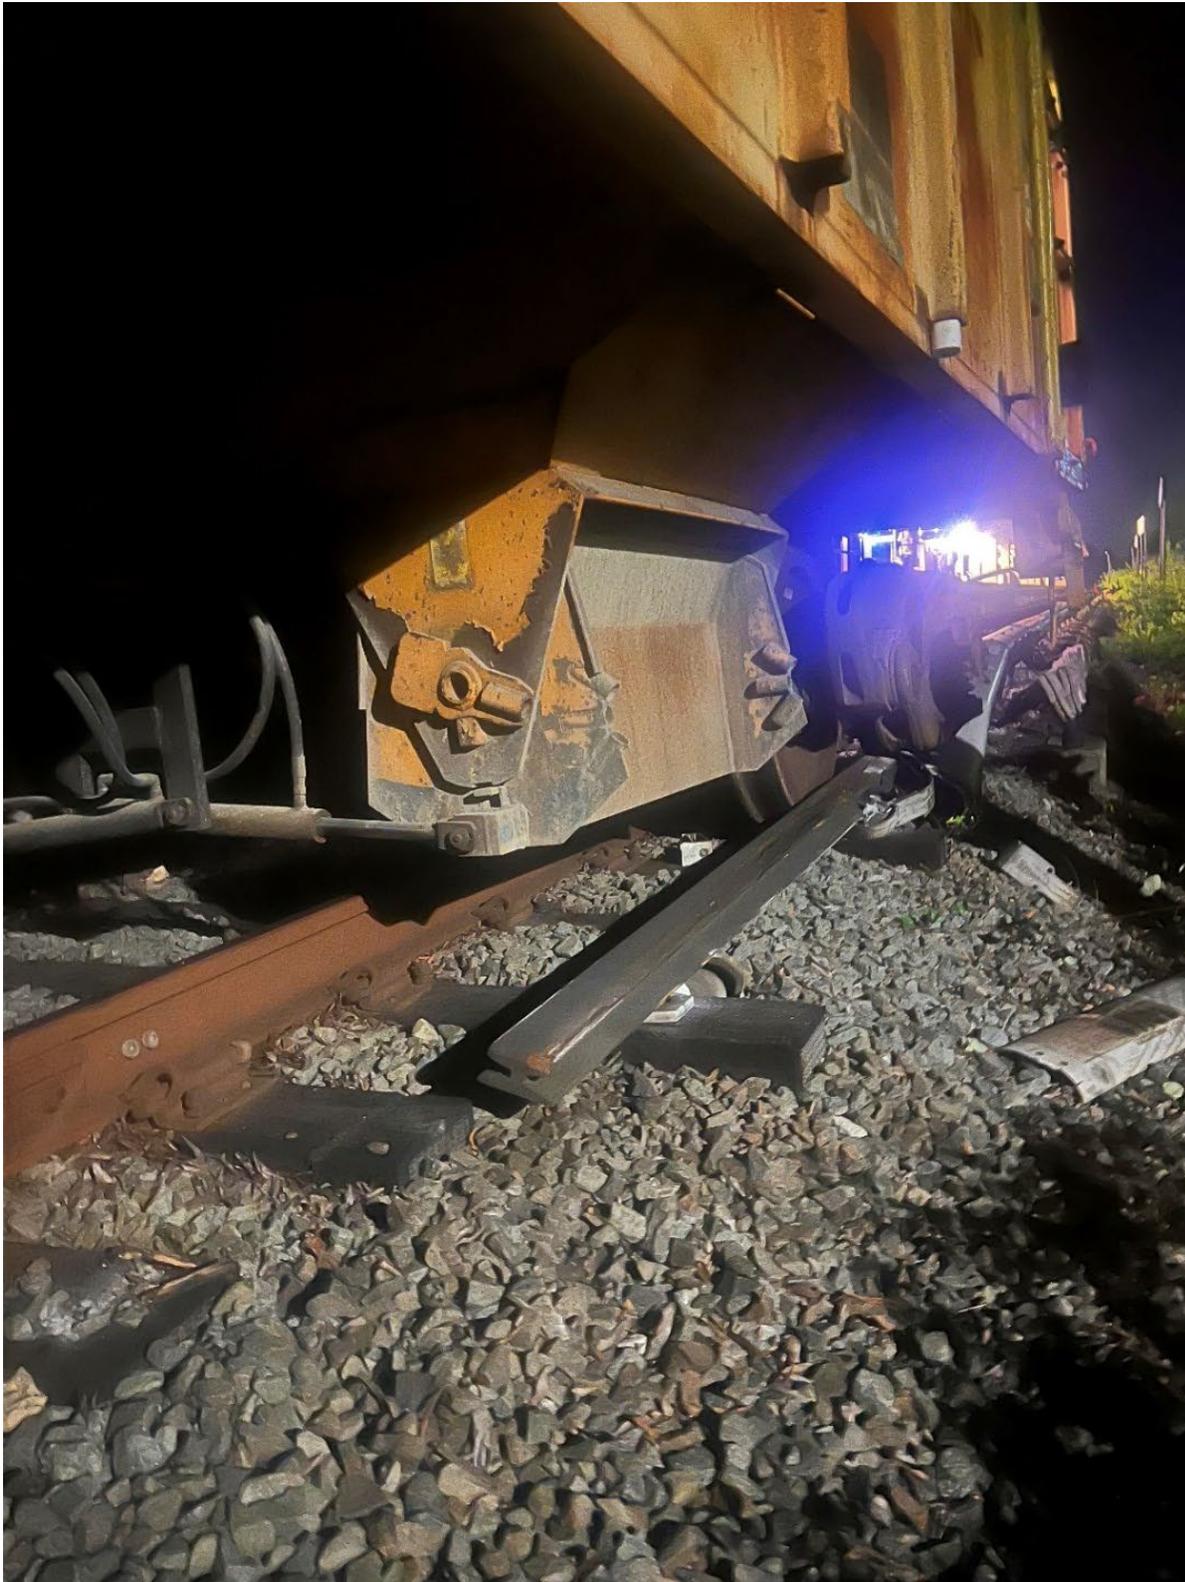
Photograph 2 – Right axle of B406 came in contact and damaged the un-energized third rail. (Rear view)

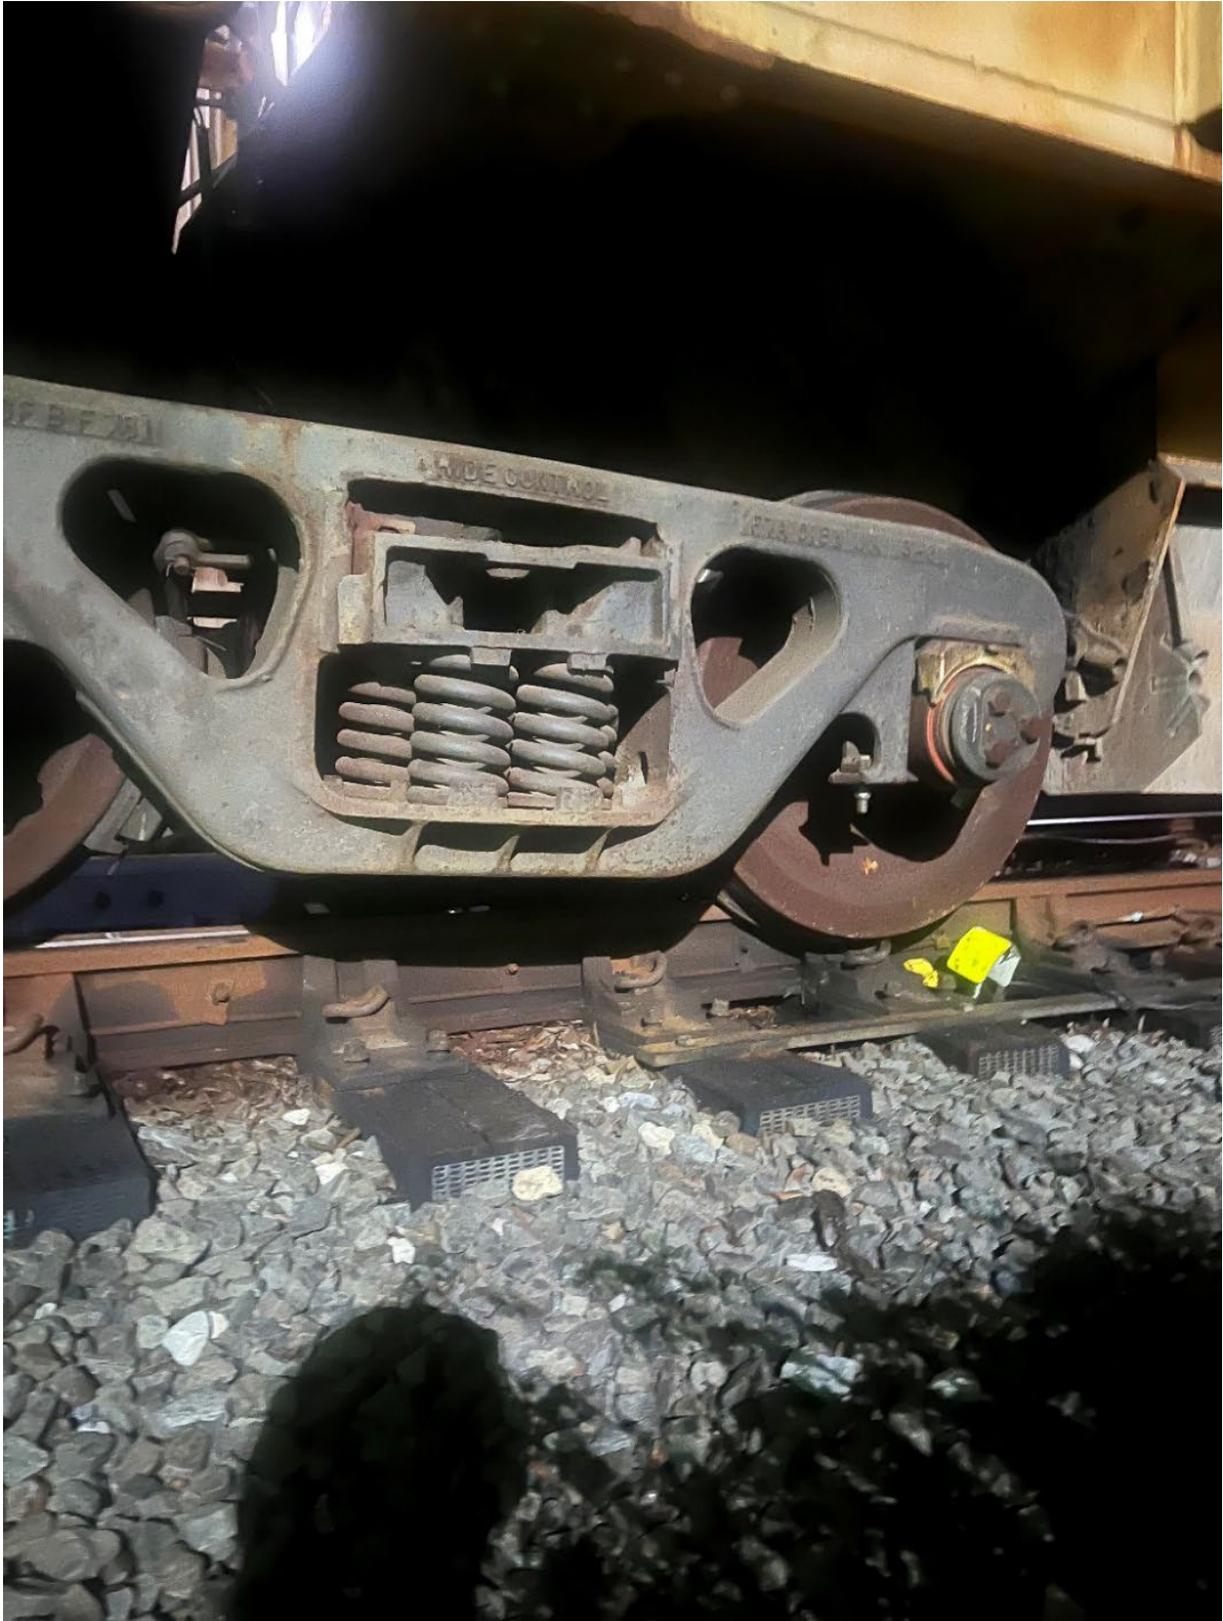
Photograph 3 – Right axle of B406 derailed near Switch #3. Switch Point Clamp Indicator was present.

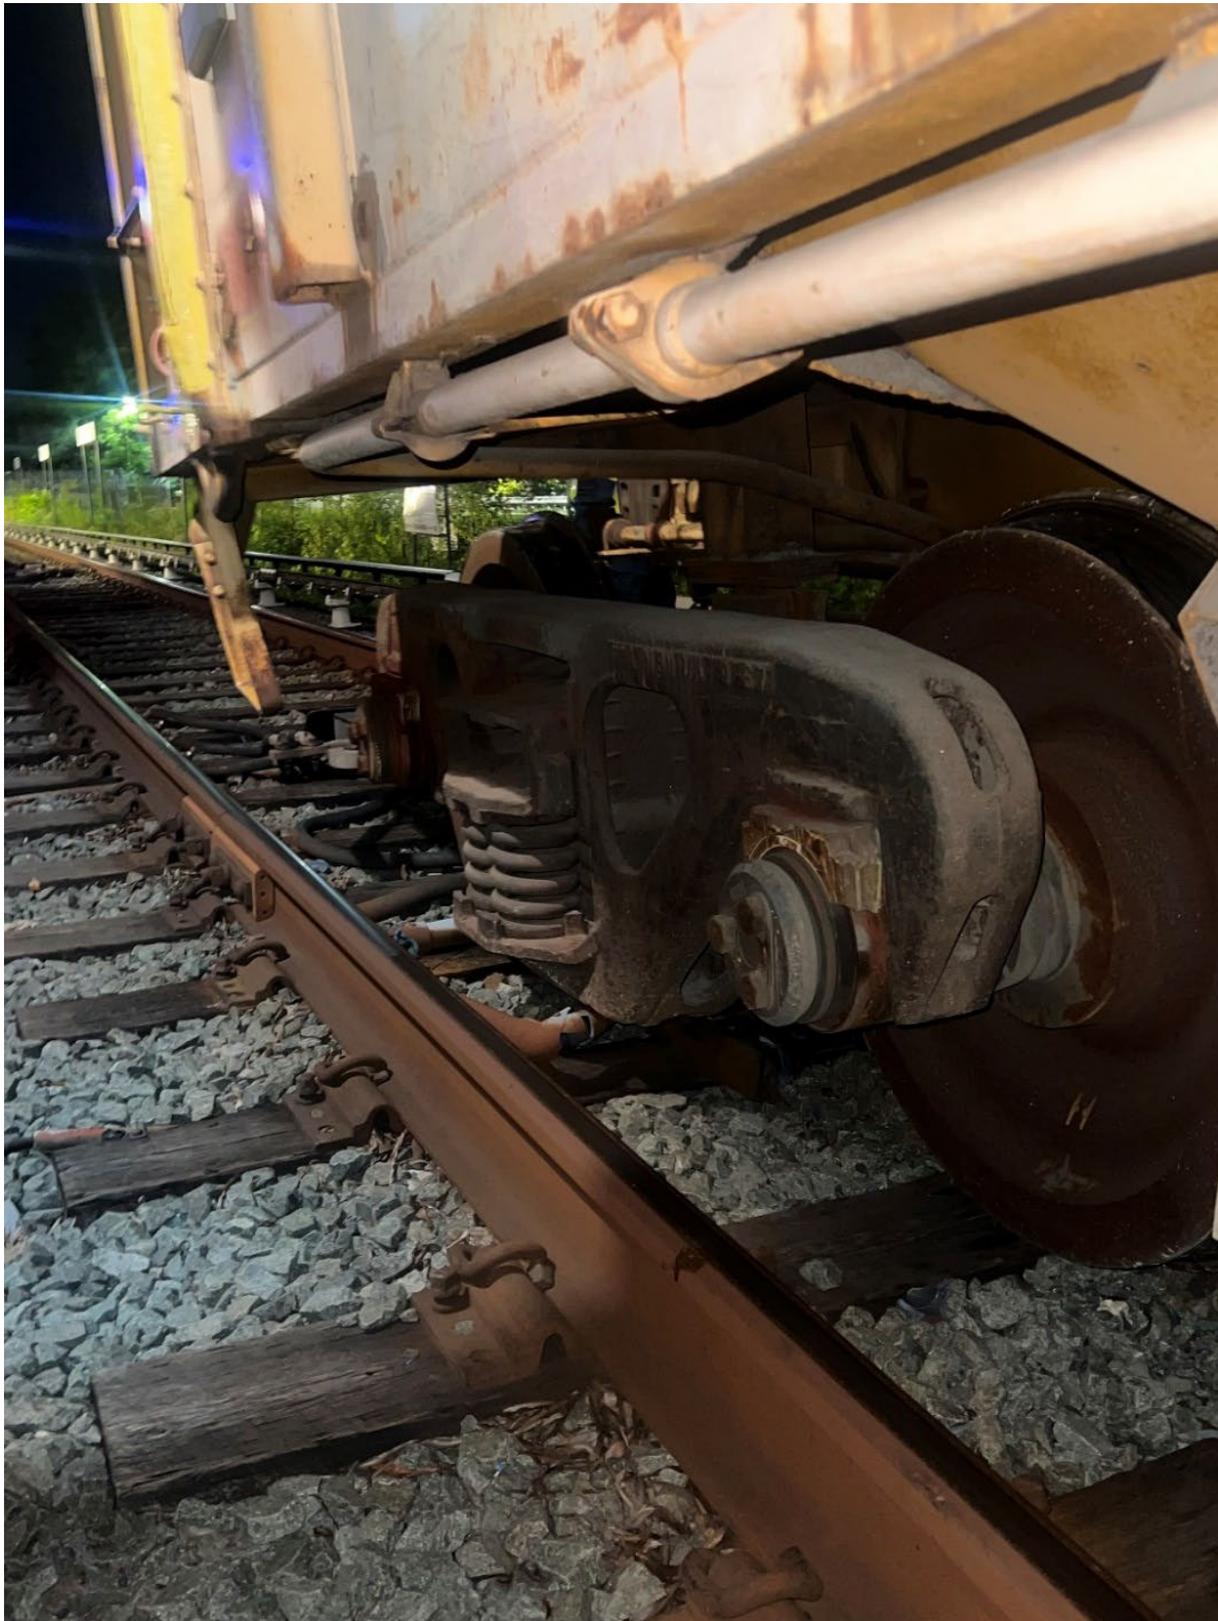
Photograph 4 – Front left axle of B406 derailed past Switch #3.
