WMSC Commissioner Brief: W-0268 – Improper Rail Vehicle Movement – Federal Triangle Station – January 6, 2023

Washington Metropolitan Area Transit Authority Department of Safety (SAFE) Office of Safety Investigations (OSI) FINAL REPORT OF INVESTIGATION A&I E23016

Federal Triangle Station – Improper Rail Vehicle Movement January 6, 2023

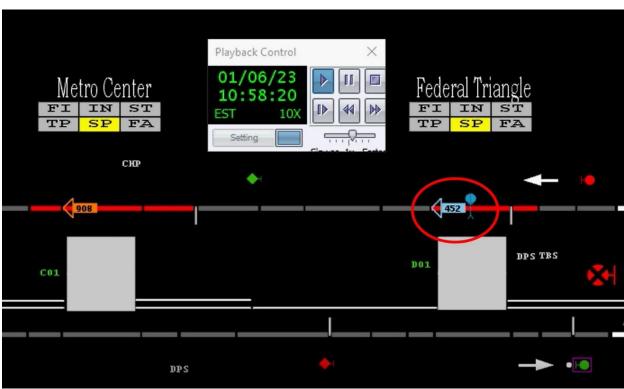
Image 1 - Train ID 452 arrived at Federal Triangle Station Track 2 platform at 10:58 hours.

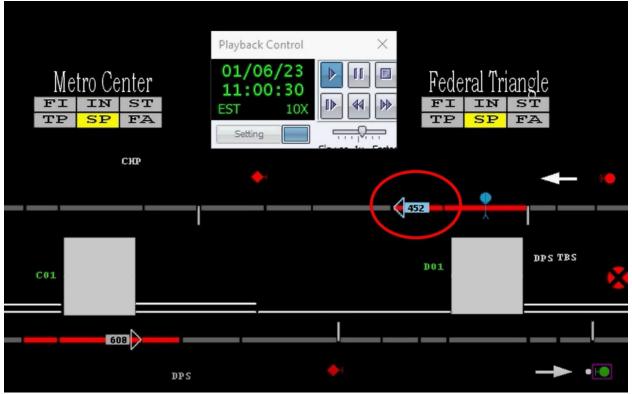
Image 2 - Train ID 452 departed the Federal Triangle Station Track 2 platform at approximately 11:00 hours without speed commands.

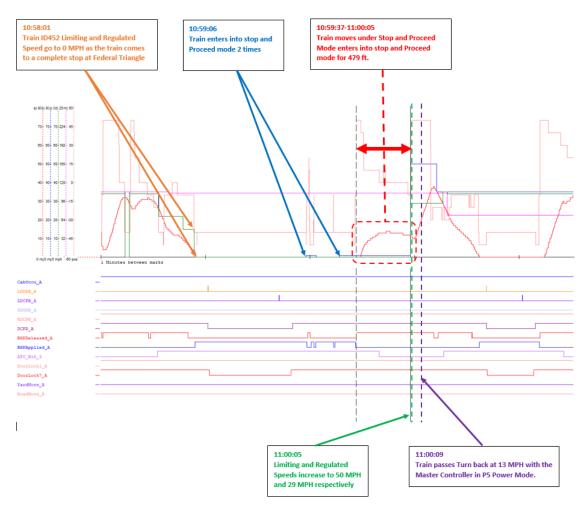
"Based on the VMS data, Train ID 452 Speed Commands dropped to 0 MPH as the train was coming to a stop onto Federal Triangle Station's platform on Track 2. After servicing the station by cycling the doors, Train ID [452's] Stop and Proceed Mode was activated. The Master Controller was moved, but the train did not move. Stop and Proceed Mode was terminated. The train entered Stop and Proceed Mode again and moved while under Stop and Proceed Mode for 479 feet before the Limiting and Regulated Speed limits increased to 50 MPH and 29 MPH, respectively. The Master Controller was moved to P5 Power Mode, and the train increased speed and continued to Metro Center Station, passing the turnback at 13 MPH. Based on VMS data, CMOR IIT did not identify any faults with the train that contributed to the cause of this incident. The train performed and designed and commanded." See the timeline of events below:

Figure 1 – IIT analysis of the Train Operator actions of Train ID 452.

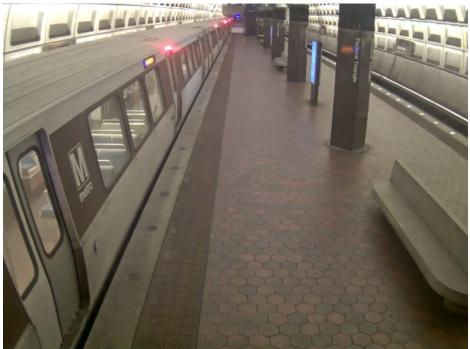
Image 8 – Train ID 452 serviced the Federal Triangle Station, Track 2 platform, and doors closed at 10:59:33 hours.

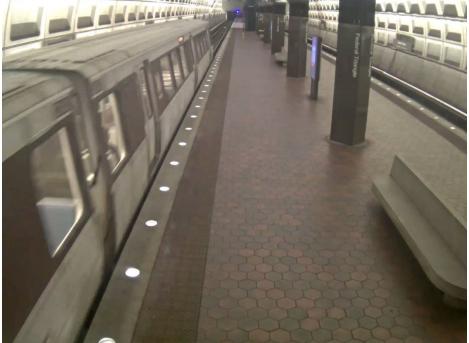
Image 9 – Train ID 452 departed Federal Triangle Station, Track 2, at 11:00:12 hours.

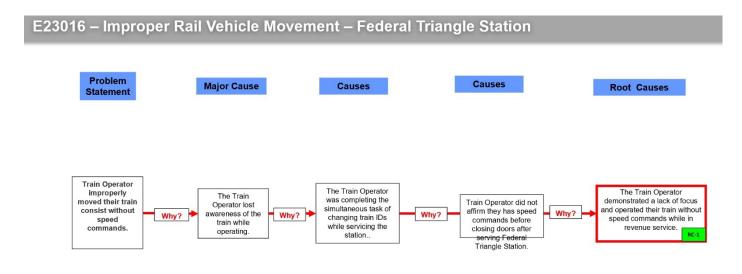
Appendix E – Root Cause Analysis

The probable cause of the event was a human factors error of inattention that resulted in the Train Operator bringing the train to a point of power without having speed commands and excluding permission from ROCC.
