## **WMSC Commissioner Brief: W-0269 – Red Signal Overrun – Mount Vernon Sq. Station – July 11, 2023**

**FINAL REPORT OF INVESTIGATION A&I E23474**

<b>Date of Event:</b>	July 11, 2023
<b>Type of Event:</b>	O-8: Red Signal Overrun
<b>Incident Time:</b>	06:51 hours
<b>Location:</b>	Mount Vernon Square Station, Track 1
<b>Time and How received by SAFE:</b>	06:56 hours MAC Desk
<b>WMSC Notification Time:</b>	07:26 hours
<b>Responding Safety Officers:</b>	SAFE OSI
<b>Rail Vehicle:</b>	Train ID 307 (L 3052-3053X3046-3047X3094-3095 T)
<b>Injuries:</b>	None
<b>Damage:</b>	None
<b>Emergency Responders:</b>	ATCM, RTRA, ERT
<b>SMS I/A Number</b>	20230711#109841

# Mount Vernon Square Station – Red Signal Overrun

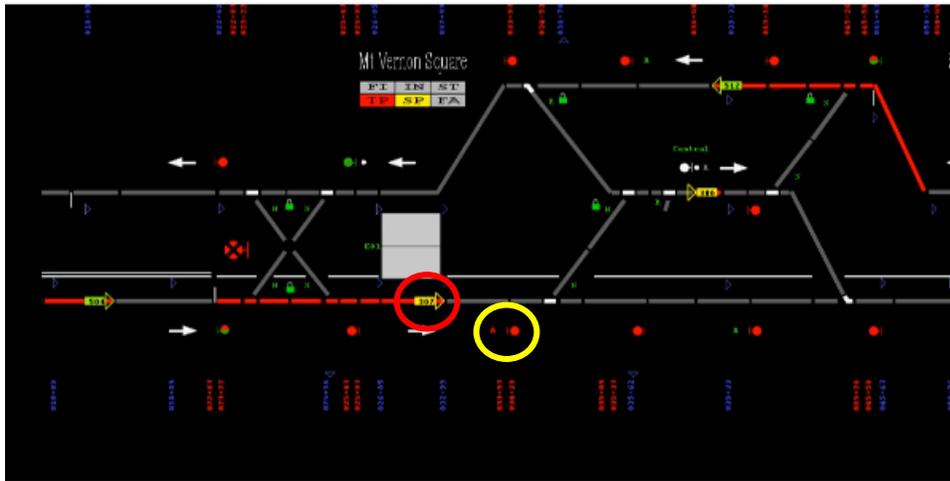
Figure 1: This image shows at 06:48 hours there was a red signal when Train ID 307 arrived at Mt. Vernon Square Station.

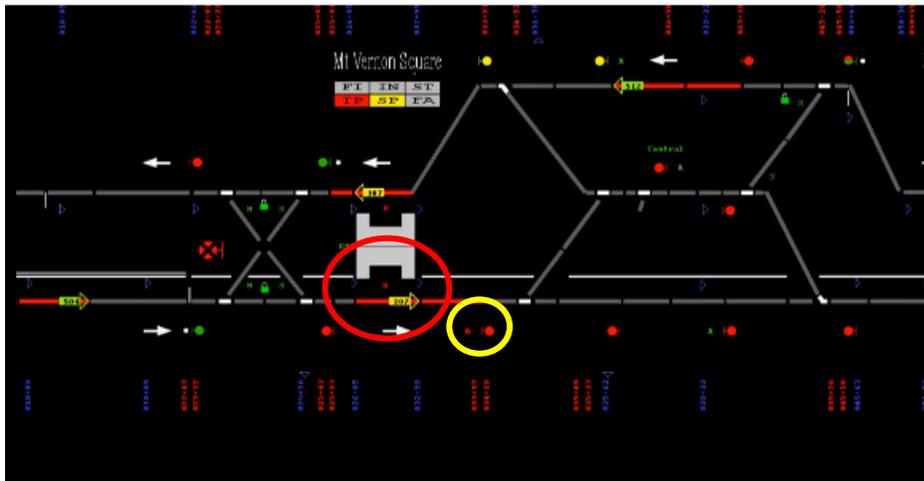
Figure 2: This image shows that at 06:50 hours the signal was still red as Train ID 307 serviced the station.

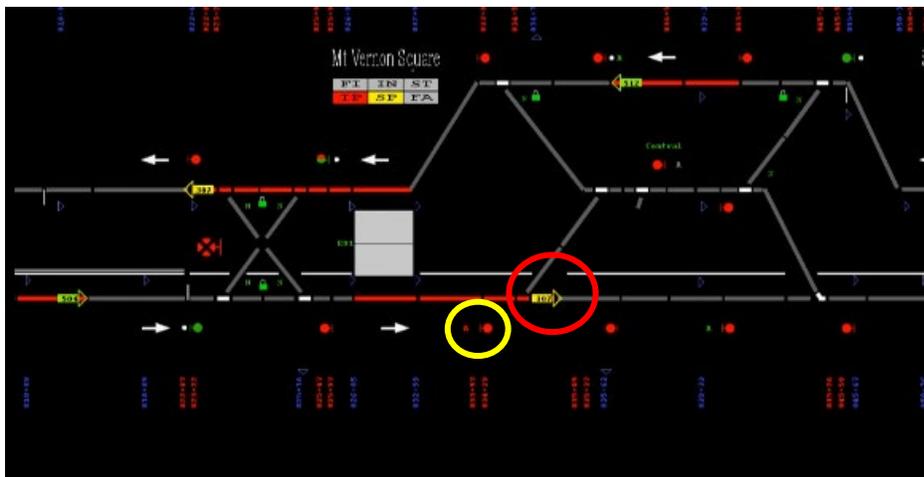
The probable cause for this Red Signal Overrun was that the Train Operator failed to follow established procedures for servicing a station and moving without speed commands. The ineffective functionality of stop and proceed mode was a contributing factor to the event.

Figure 3: This image shows that at 06:51 hours Train ID 307 departed Mt. Vernon Square Station with a red signal.

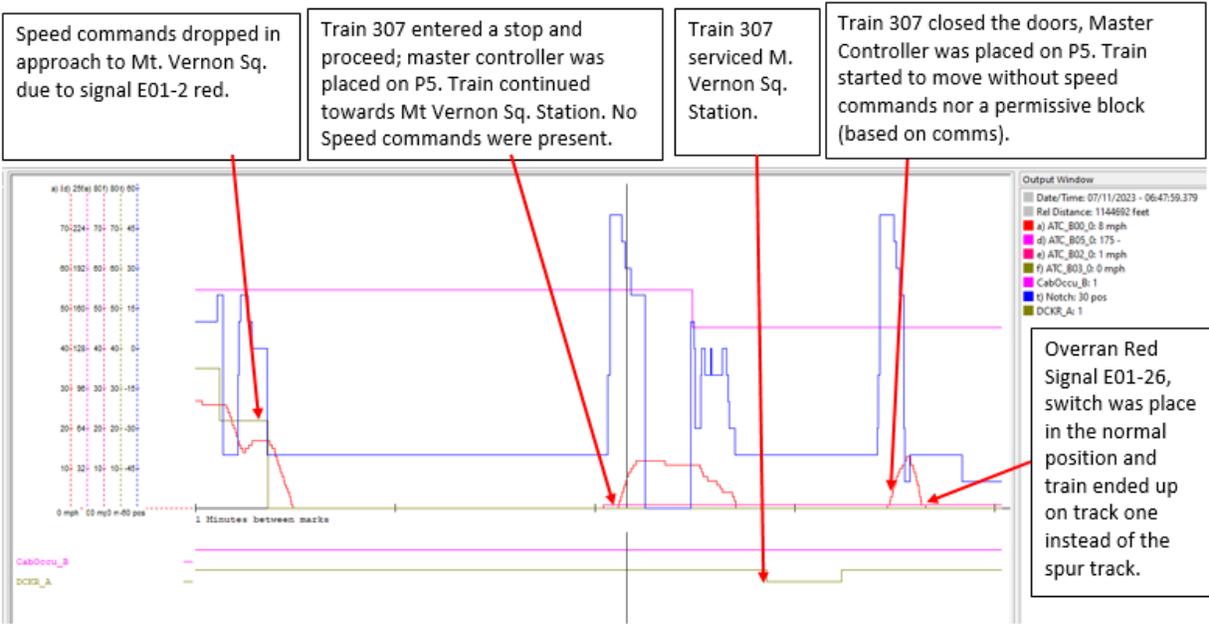
Based on the VMS and ER data, there was no fault with the train that contributed to the cause of this incident. The train performed as designed, responding to the Brake/Power Commands entered through the Master Controller. Please note that speed commands were removed as train 307 approached Mount Vernon Square Station since signal E01-26 was red at the time of the incident. Train 307 stopped due to the loss of speed commands. Later, train 307 was given a permissive block to continue to move and berth the train at the station. Train 307 serviced Mount Vernon Square, doors were closed, master controller was placed on P5 and train moved without speed commands nor a confirmation of a clear block."

Time	Description of Events
6:46:11	Train ID307, lost speed commands and eventually stopped.
6:47:52	Stop and proceed was initiated.
06:47:54	Master Controller was place in P5 and train 307 continued towards Mount Vernon Sq. Station(Central gave a permissive block for this purpose).
06:48:32	Train stopped at Mount Vernon Sq. and service the Station.
06:49:17	Doors were closed, Master Controller was placed in P5 and train 307 started to move without speed commands nor a permissive block.
06:49:27	Overran Red Signal E01-26, switch was place in the normal position and train ended up on track one instead of the spur track.

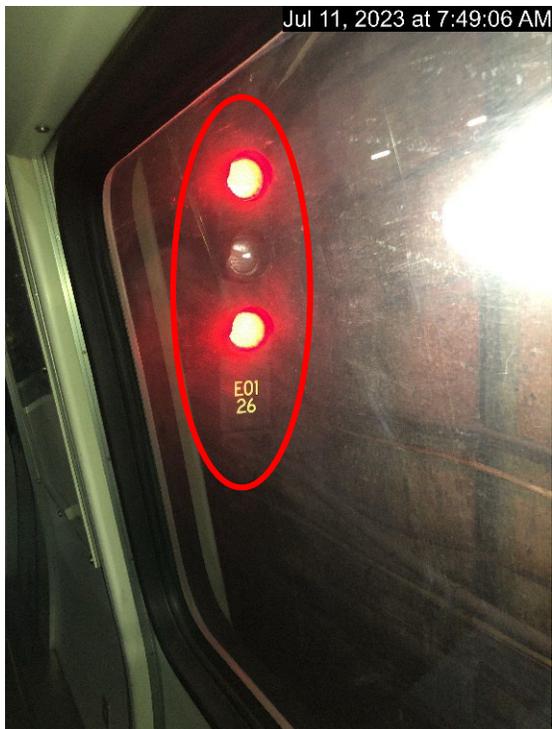
As the train started moving, the Train Operator noticed signal E01-26 had a red aspect and stopped the train. By the time the train stopped, it was approximately 12 feet past the signal but short of the switch point. The Radio Rail Traffic Controller (RTC) observed a red signal overrun alarm on their screen and contacted the Train Operator. The Train Operator reported that they were beyond the signal. The Radio RTC notified appropriate personnel and resources were dispatched to the scene. This included personnel from the Office of Rail Transportation (RTRA), Automatic Train Control Maintenance (ATCM), the Emergency Response Team (ERT), and Office of Safety Investigations (OSI).

Figure 5: This image was taken from the passenger compartment of the lead car. It shows E01-26 signal.

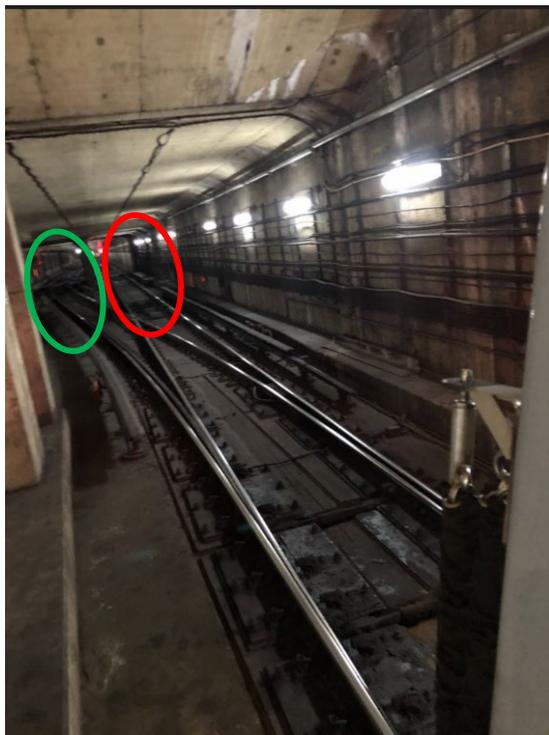
The Train Operator was able to stop the train without fouling the switch point. Switch 5 was misaligned for the intended route and would have taken the train on a straight-through move, instead of the intended diverging route into the pocket track. Signal E01-26 was red on Train ID 307's arrival due to a previous movement of a train into the pocket track, returning on track 2. The Train Operator on track 2 had to clamp the switch so they could proceed with the customers on board.

Figure 6: The green circle is where the Train Operator was supposed to go, and the red circle shows where the train was aligned for before it stopped.

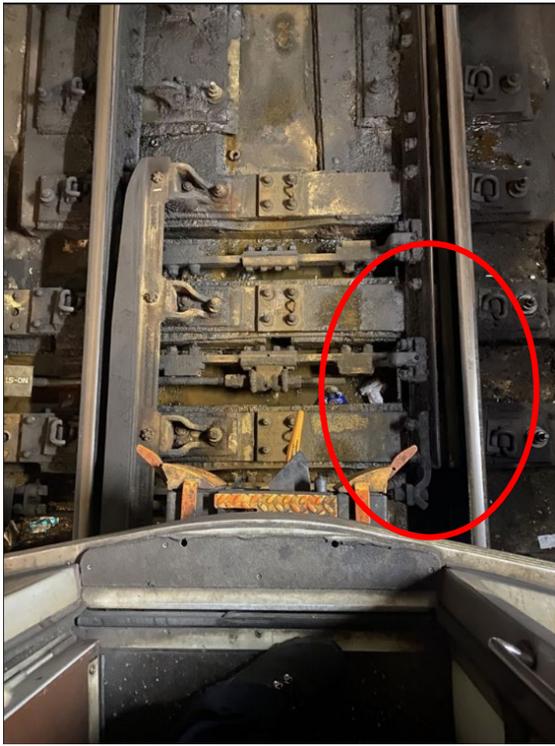
Figure 7: This image shows the switch point from the Operator's cab bulkhead door.

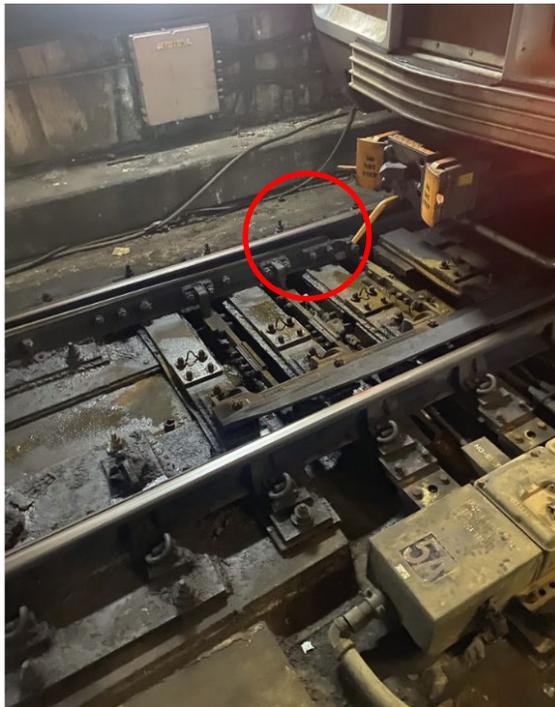
Figure 8: This image shows the train stopped before the switch point of switch 5A.

08:12:40 hours	<u>ERT Unit:</u> Informed the Radio RTC that ATC Unit clamped 5A & 5B switch, all personnel were standing clear on the platform, and moving the train back to the platform was safe. <u>Radio RTC:</u> Gave a 100% repeat back. [Ops. 3]
