WMSC Commissioner Brief: W-0270 – Improper Door Operation – Green Line between U St. And Columbia Heights stations – March 26, 2023

Washington Metropolitan Area Transit Authority
Department of Safety (SAFE)
Office of Safety Investigations (OSI)
FINAL REPORT OF INVESTIGATION A&I E23201

Date of Event:	March 26, 2023
Type of Event:	Uncommanded Train Door
Incident Time:	08:24 Hours
Location:	Between U Street and Columbia Heights Stations, track 1
Time and How received by SAFE:	08:25 Hours – SAFE/MAC
WMSC Notification Time:	09:11 Hours
Responding Safety Officers:	None
Rail Vehicle:	Train ID 507-L3129-3128, 3030-3031, 3117-3116T
Injuries:	None
Damage:	None
Emergency Responders:	None
SMS I/A Incident Number:	20230404#107412

Columbia Heights Station - Uncommanded Train Door

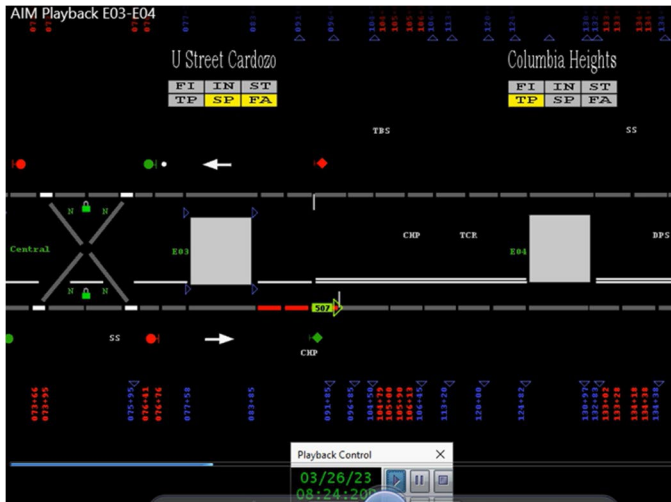
The Audio Recording System (ARS) revealed that at 08:24 hours, the Train Operator reported to ROCC that the train stopped in the tunnel and “All Doors Closed” was not illuminated on the train console.

Figure 1 – AIMS Playback depicting Train ID 507 located between U Street and Columbia Heights Stations when the Train Operator reported the no all doors, non-illuminated.

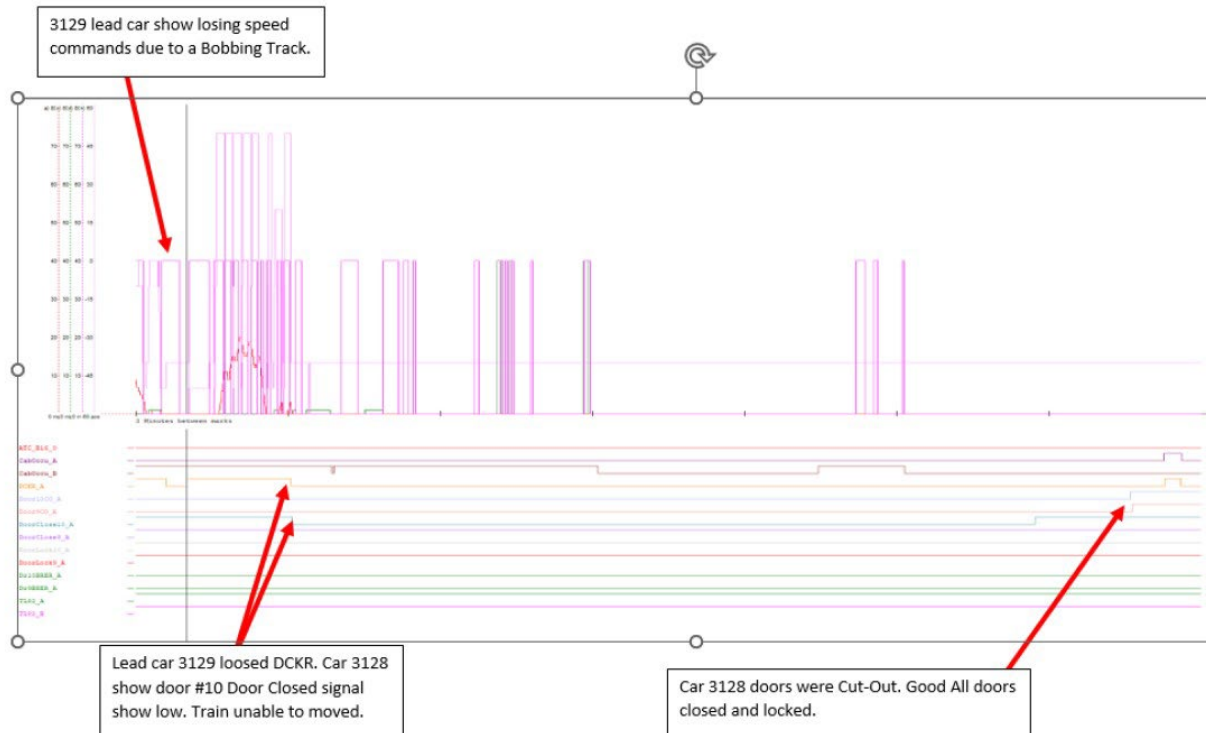
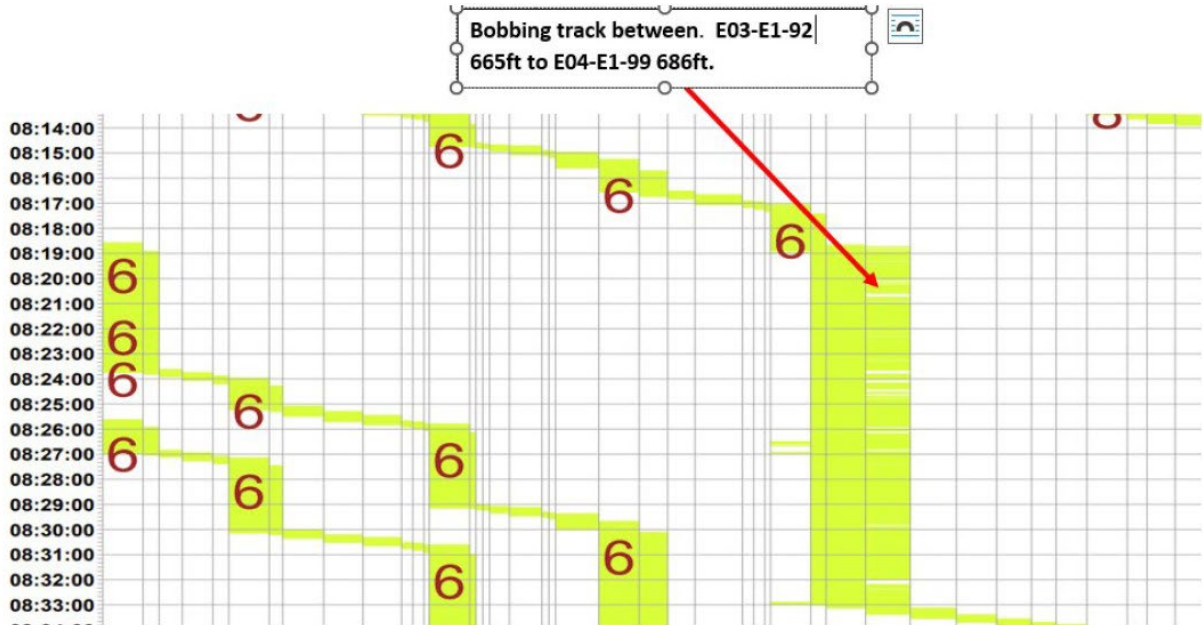
"Based on the VMS data, Lead car 3129 showed losing speed commands [intermittently] causing the train to come to a complete stop after [traveling] **672 Feet** from platform limits of "E03" U Street. The root cause of the intermittent speed commands was a Bobbing track circuit between, E03-E1-92 665 feet to E04-E1-99 686 feet. After coming to a complete stop and when attempting to move, the DCKR on lead car 3128 de-energized. VMS data shows Door #10 on car 3128 lose Door Closed signal preventing train from moving. Door #10 did not show any failure during the incident time. Doors 9&10 were Cut-Out, DCKR energized, and train continued to the next station. NOTE: DCKR on lead car 3129 remain energized while train was moving during the incident."

08:18:00.111	3129. DCKR de-energized after few moving attempts. Train was stop when DCKR de-energized. 3128 Door#10 loss Door closed(S4) switch signal.	"B4"	0Mph	679ft

08:27:45.520	3128 Door #10 closed signal show high. Door is closed.			
08:29:01.803	Both doors 9 and 10 are Cut-Out.			
08:22:01.327	Car 3129 is keyed down. DCKR show de-energized. Door shows not closed or locked.

Figure 2 - Cars 3129 and 3128 ER Data Analysis

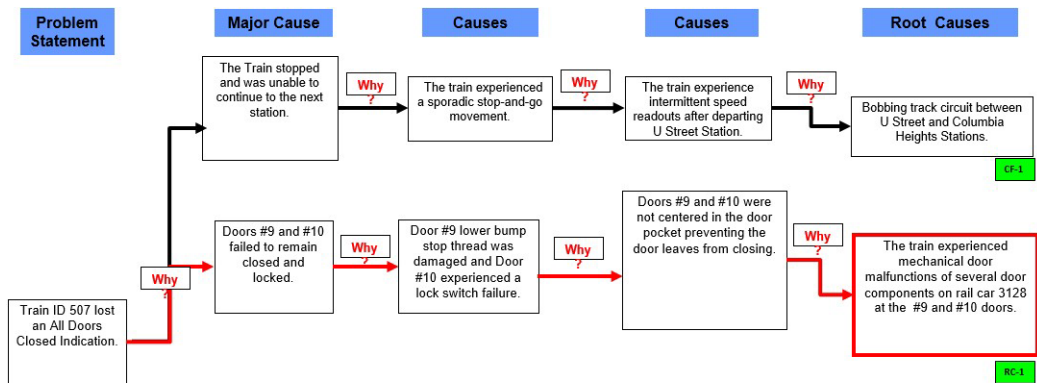
Appendix C – Why-Tree Analysis

The probable cause of the Uncommanded Train Door event between U Street Station and Columbia Heights Station, track 1 on March 26, 2023, was a mechanical defect with rail car 3128 that led to the train losing an All Doors Closed indication.

Corrective Action Code	Description	Responsible Party	Estimated Completion Date
107412_SAFE CAPS_CMNT_ 001	Repair/Replace failed components in car 3128 and evaluate frequency of failure type.	CMNT/REPA	Completed
