WMSC Commissioner Brief: W-0271 – Collision – Alexandria Rail Yard – July 21, 2023

FINAL REPORT OF INVESTIGATION A&I E23505

Alexandria Yard – Collision

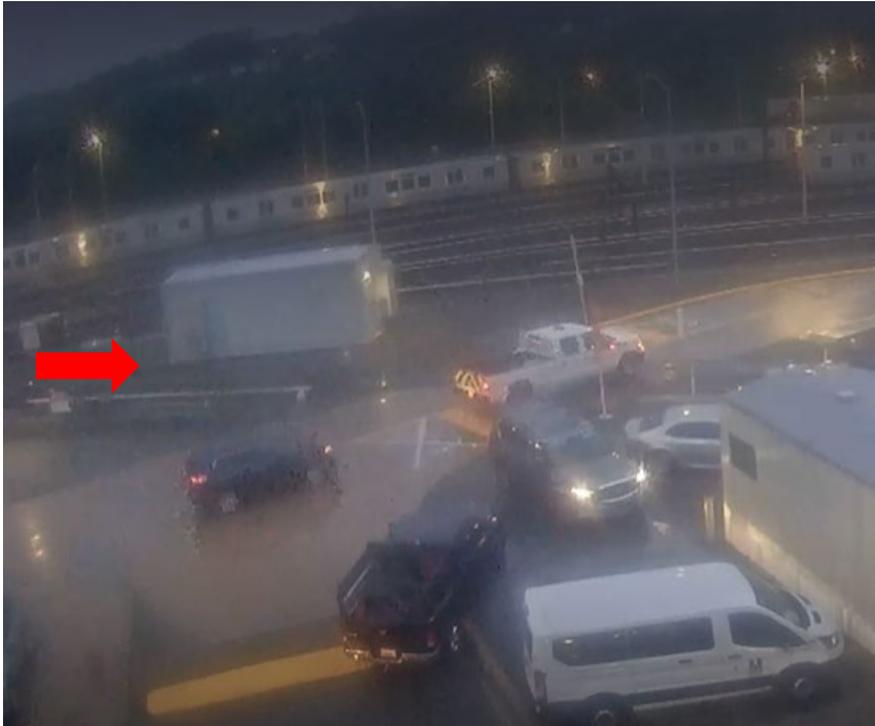
Figure 1: This image shows cars leaving the Yard after a shift change as PM37 was stopped. The red arrow shows the direction PMM37 was approaching.

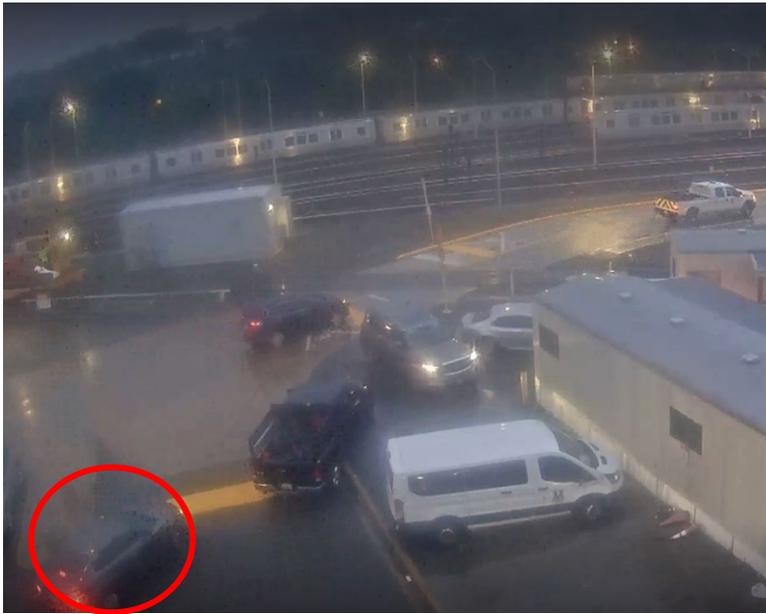
Figure 2: This image shows PM37 moving towards the grade crossing as the two vehicles cleared the crossing. The circled vehicle is the vehicle involved in the collision.

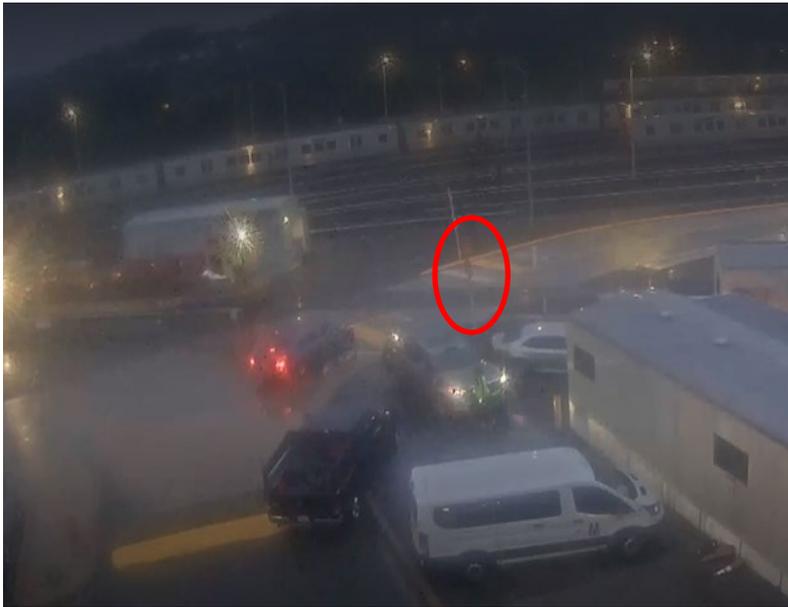
Figure 3: This image shows PM37 beginning to traverse the grade crossing when the vehicle approached the stop sign. The red circle shows where the stop sign is located.

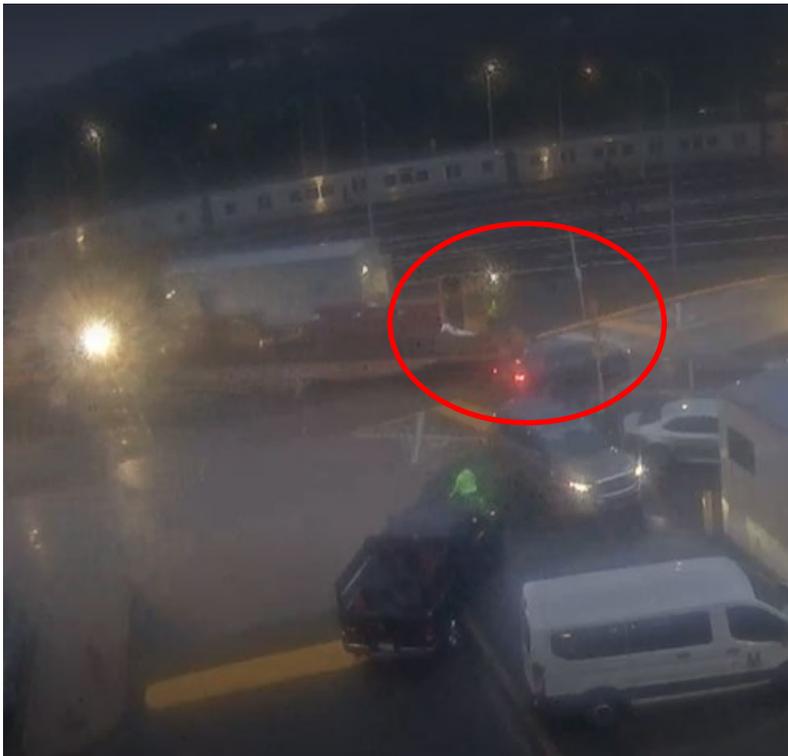
Figure 4: The vehicle appeared to stop directly in the path of PM37 and never made a complete stop at the stop sign.

The probable cause for the Collision at Alexandria Yard on July 21, 2023, was the employee's failure to adhere to signage and pavement markings regulating the grade crossing. The employee did not come to a stop before entering the crossing and failed to yield to the rail vehicle, resulting in their vehicle being positioned directly in front of PM37, which was already in motion.

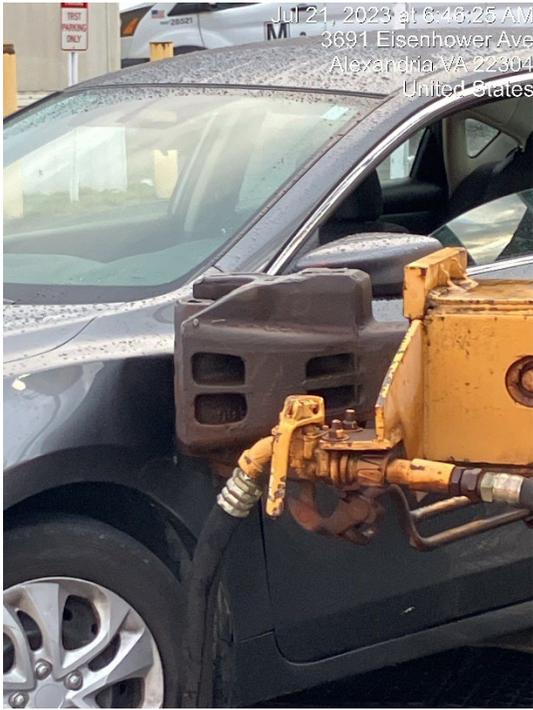
Figure 5: This image shows the point of contact.

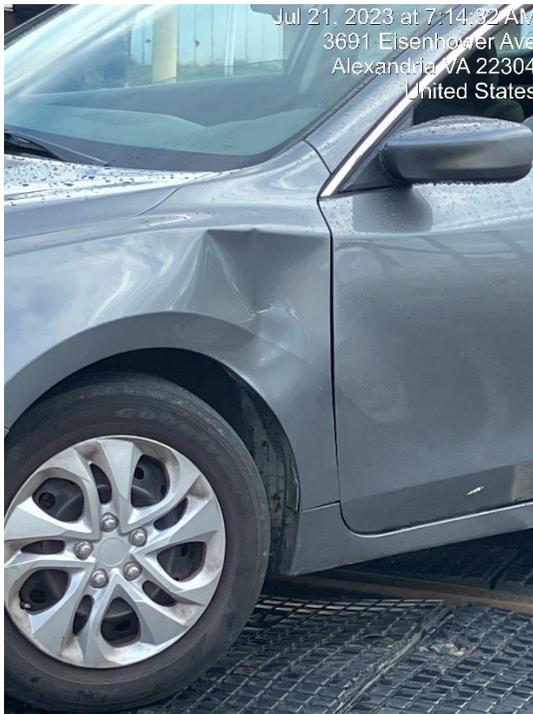
Figure 6: This image shows the damage caused from the impact.

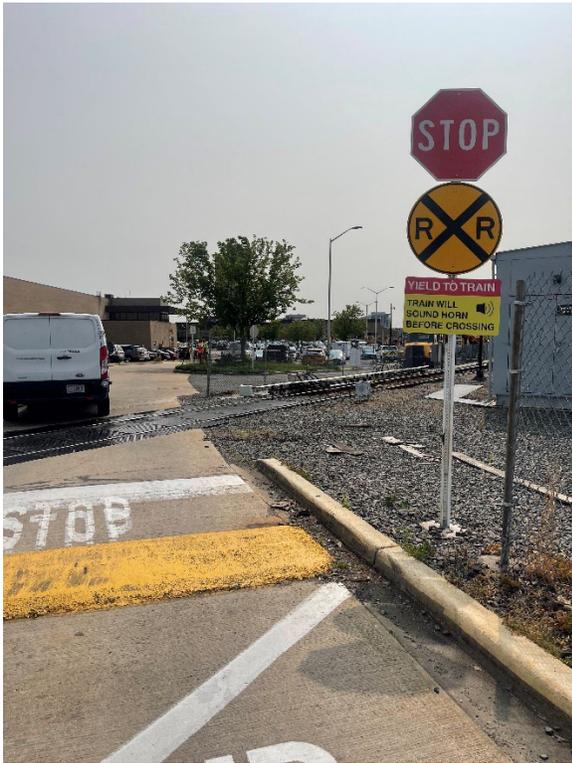
Figure 7: This image shows the updated signage as you enter Alexandria Yard outside of the S & I Shop.

Metrorail is improving signage at its rail yard grade crossings (Metrorail does not have mainline grade crossings) that reminds drivers to yield to trains, and identifies that a horn can indicate vehicle movement.

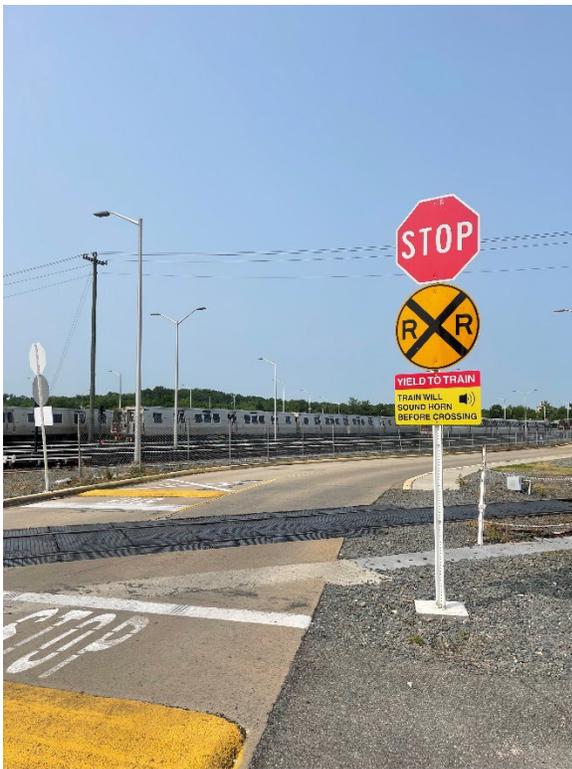
Figure 8: This image shows the updated signage and pavement markings as you exit the Alexandria Yard, which was the direction of travel during this event.
