WMSC Commissioner Brief: W-0272 – Derailment – near Farragut North Station – December 18, 2023

FINAL REPORT OF INVESTIGATION A&I E23894

Farragut North Station – Derailment

December 18, 2023

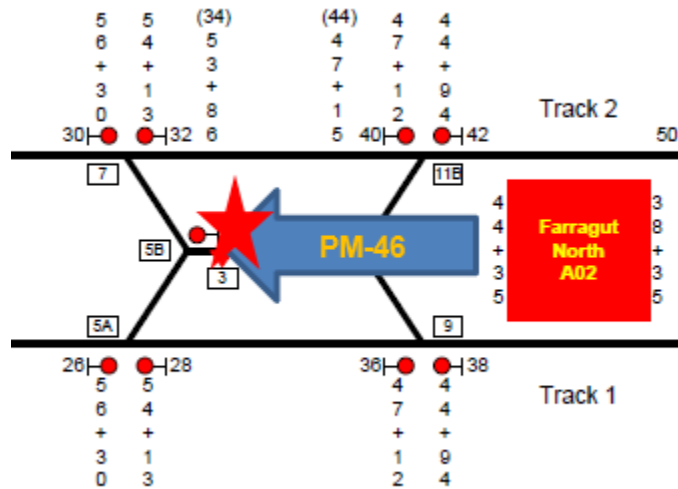
Field Sketch/Schematics

Approximate incident site and location of derailment marked with a "red star". Diagram not to scale.

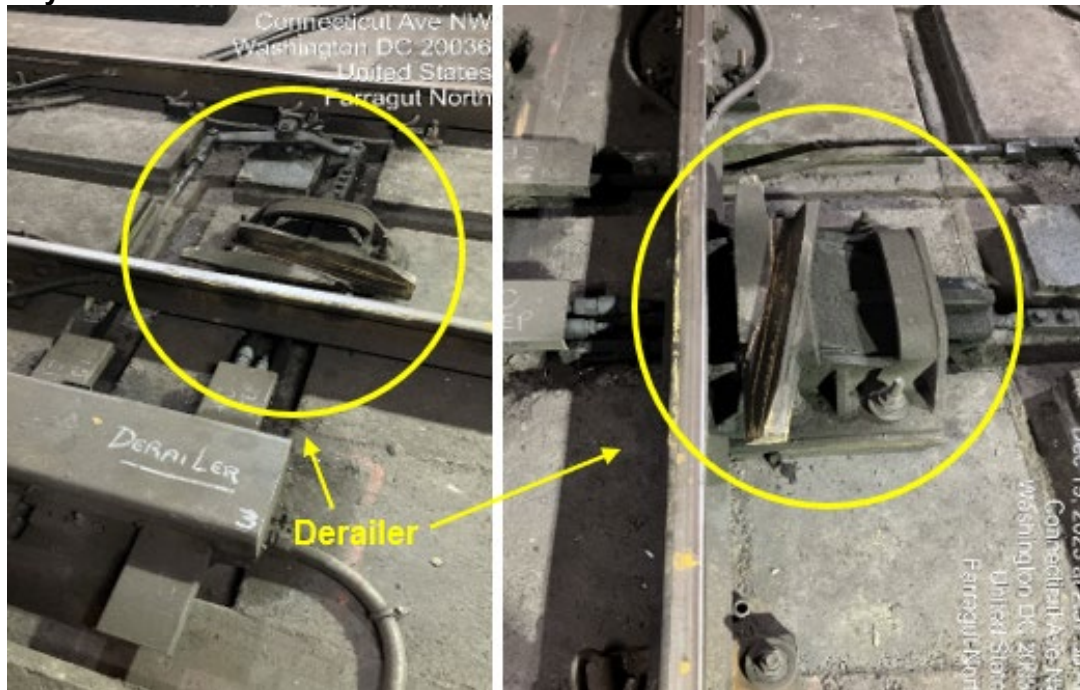
Image 1- depicts two views of the derailer.

- It was apparent that the derailment occurred because a fixed derailer on the pocket track was set in the "normal" position rather than "reverse."

•According to the flagman’s statements, they were not aware that there was a permanent derailer installed on this pocket track and that he had not seen the device upon approach as it was covered in dirt and grease.

- The derailer on track 3 was permanent; signage was posted and visible. However, the derailer did not have high visibility.¹
- PM-46 was moved at a slow and regulated speed.
- Switch 5B was damaged, as was the front truck of the flatcar.
- The Winter Shutdown MCC Map shows a derailer on the legend but not on the map. However, the proposed map shows the derailer on the map and not the legend.

Metrorail inspected the derailleurs in the Farragut North pocket track and ensured it has the intended high-visibility paint and is free of grease. Metrorail inspected the other mainline derailleurs to ensure the visibility of the yellow paint and to be sure they are free of compounded grease.

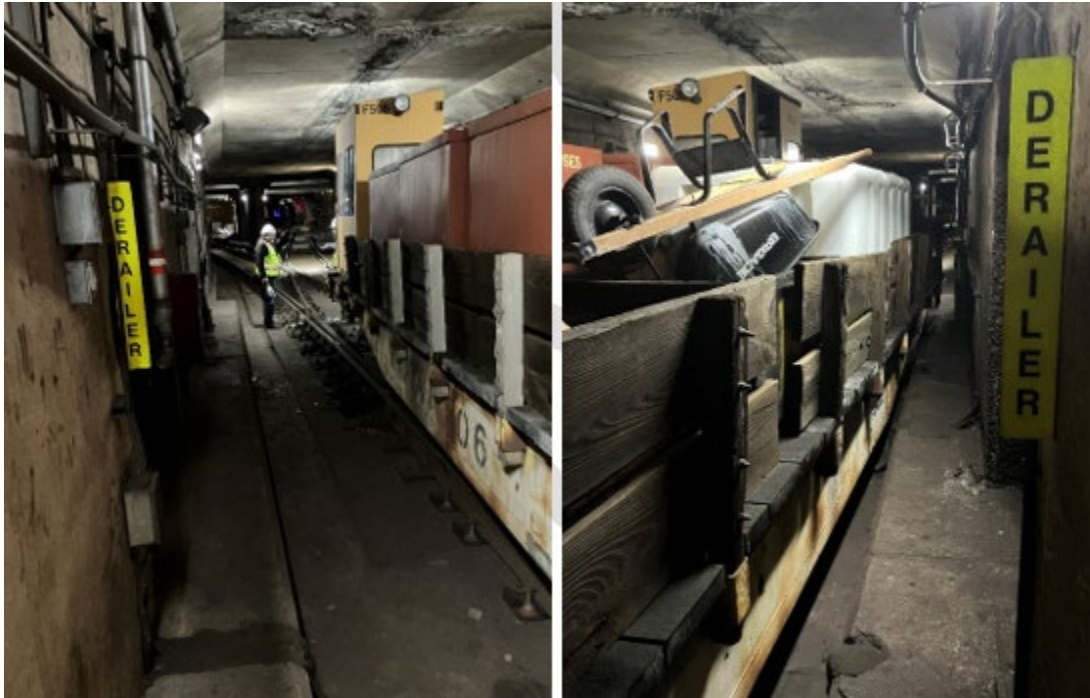
Image 2 - depicts a clear view of the derailer signage located at A02-36 signal.

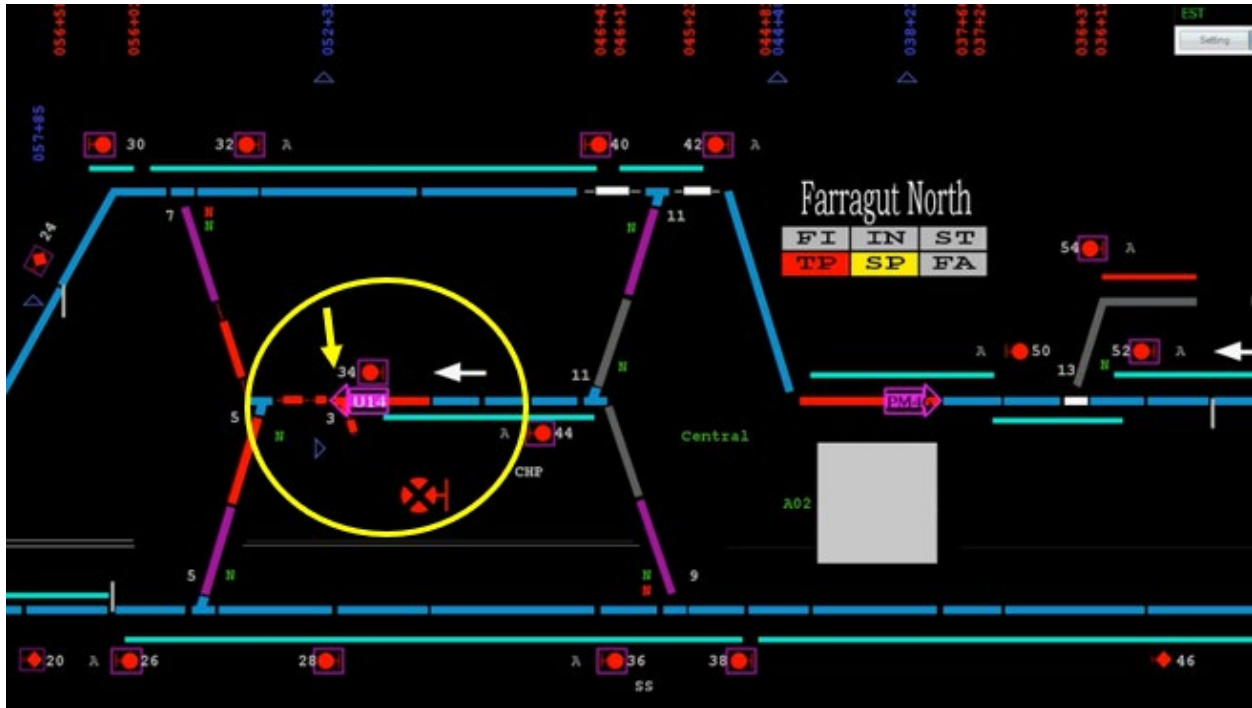
At 05:11 hours, PM-46 reported to the MCC that a flatcar had collided with a fixed derailer, resulting in the derailment of the front truck of the flatcar and impacting switch 5B. Measures were implemented to secure PM-46.

Image 3 - depicts PM-46 derailed at A02-34 signal.

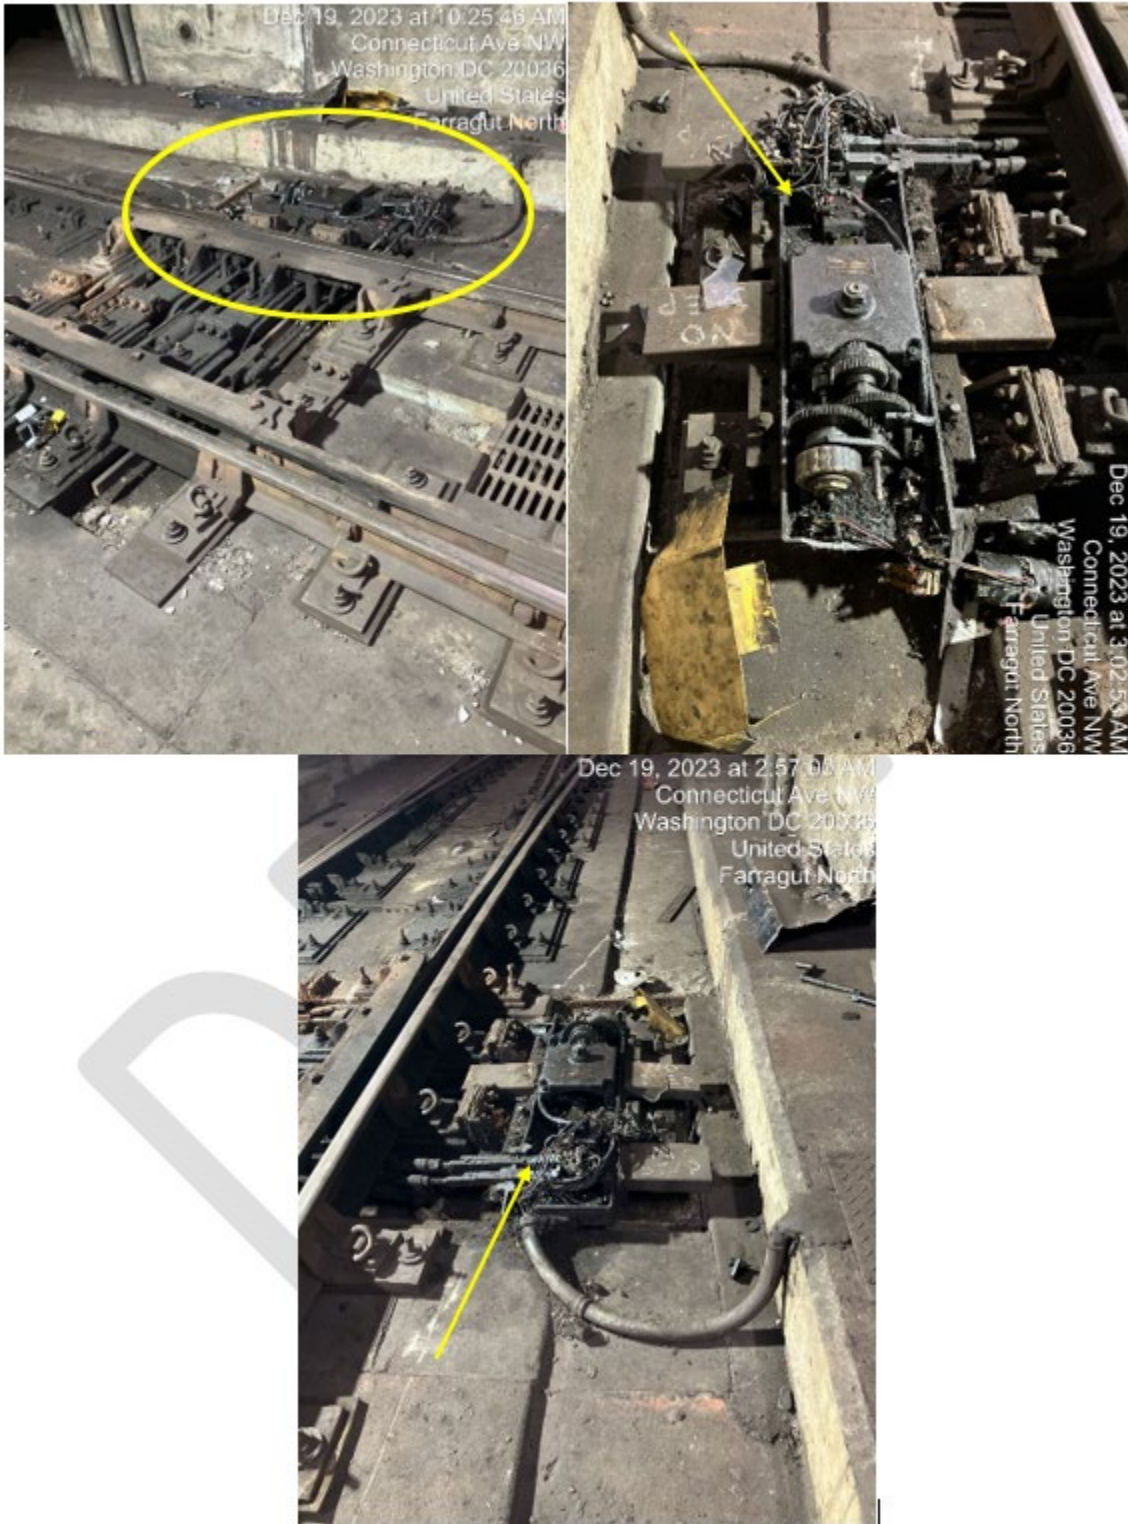
Figures 4 is different views of the switch 5 motor damage.

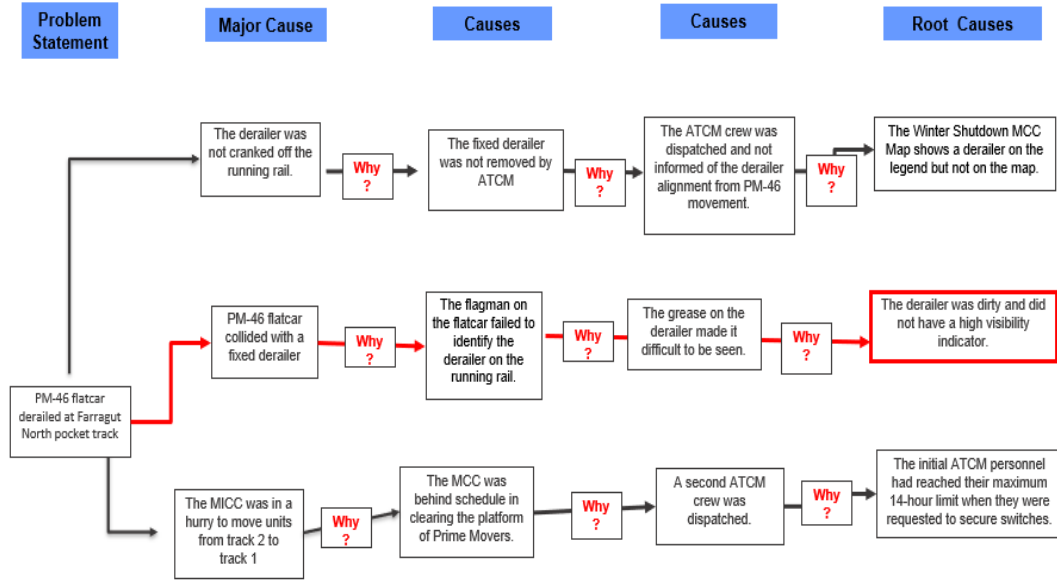
Figure 5 - Root Cause Analysis

The probable cause of the Derailment event on December 18, 2023, at Farragut North, track 3, was a fixed derailer designed to prevent reverse interlocking moves. The failure occurred when the ATCM did not move the derailer to the reverse position after adjusting the switch into a reverse position. Additionally, The Visio map used by the MCC did not depict a derailer in the track area, although it was included in the legend. The proposed Visio map, dated November 16, 2023, does illustrate a derailer at CM 53+86 A02-34 signal, but it is not listed in the legend. This discrepancy in representation suggests a potential inconsistency or oversight in the mapping information.
