**WMSC Commissioner Brief: W-0273 – Improper Rail Vehicle Movement – D&G Junction (Blue, Orange, Silver Lines)
– May 28, 2023**

Prepared for Washington Metrorail Safety Commission meeting on May 14, 2024

FINAL REPORT OF INVESTIGATION A&I E23360

D&G Junction – Improper Rail Vehicle Movement

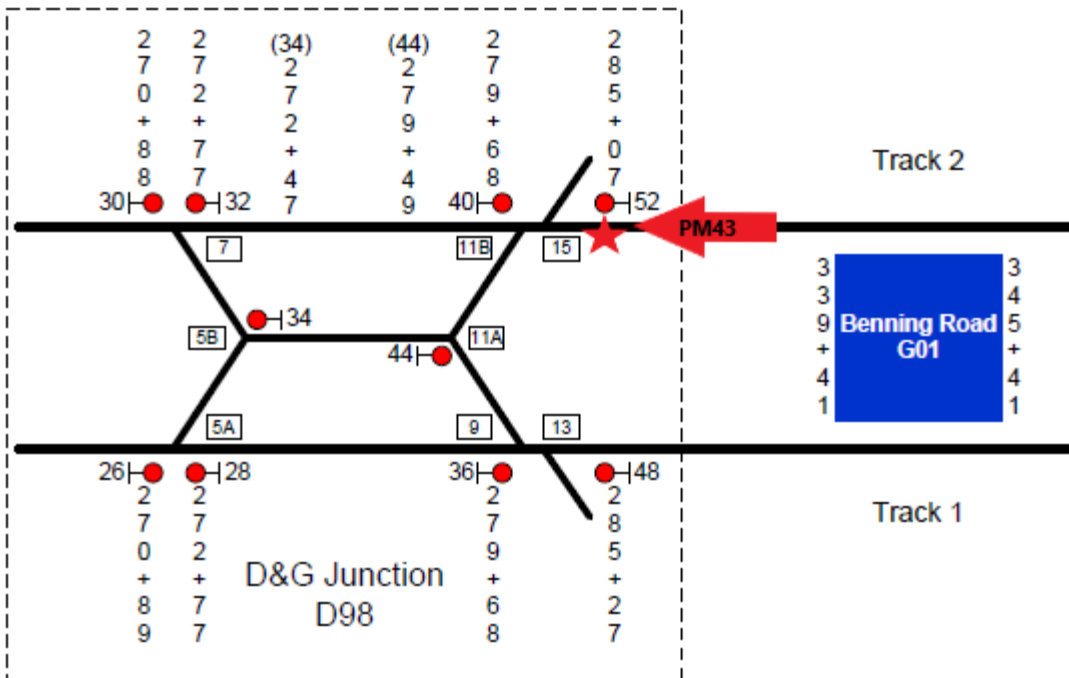
Field Sketch/Schematics

D&G Junction, Track 2
CM D2 285+07
Red Signal D98-52

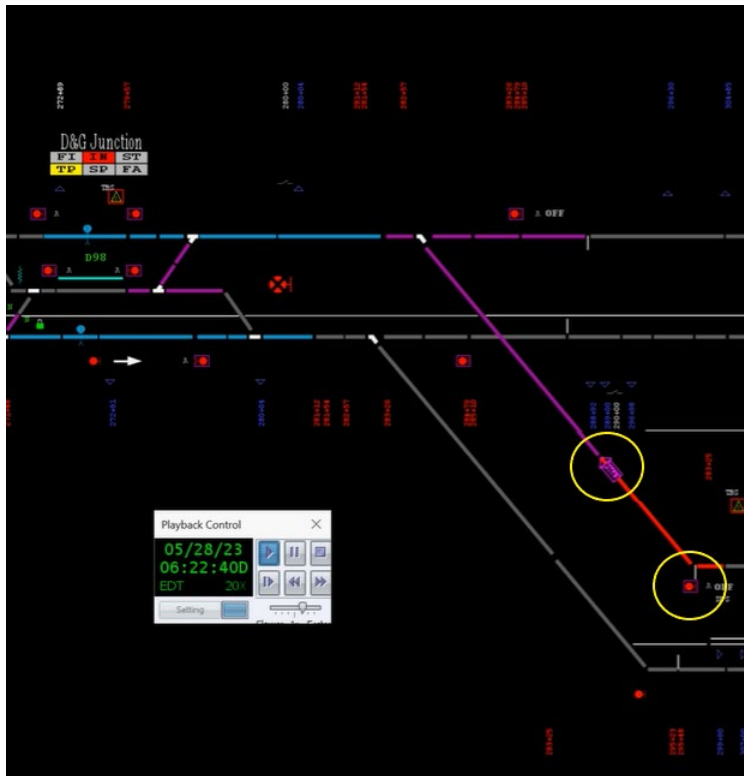
At 06:15 hours, the Equipment Operator of PM-43 advised the Radio RTC that all personnel were clear, and it was safe to move towards CM D2 280+00. The Radio RTC acknowledged and advised the Equipment Operator that they had an absolute block to CM D2 280+00, D98-52 signal was red, and that they had permission to pass after verifying switch position and at speeds no

Figure 1 - AIMS depicting PM-43 passing the D98-52 Signal at the D&G Junction, track 2.

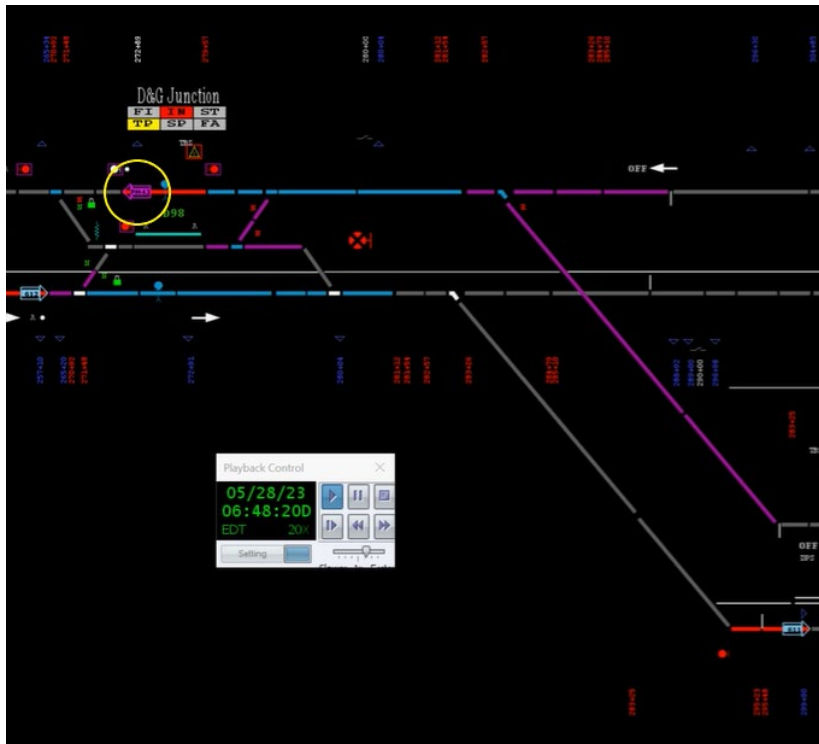
Figure 2 - AIMS depicting PM-43 clearing the D&G Junction.

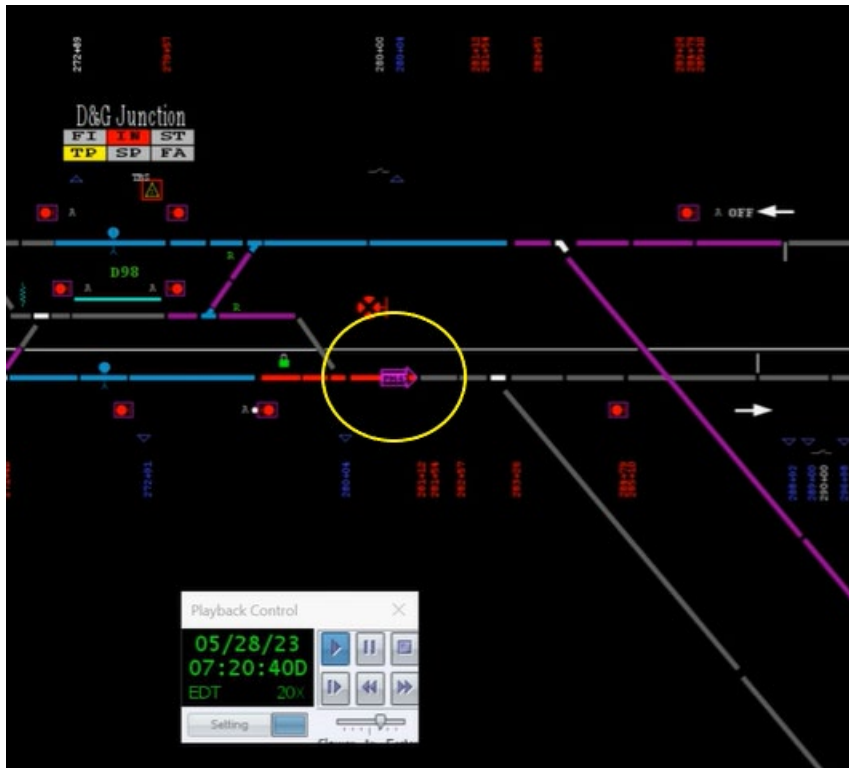
Figure 3 - AIMS depicting PM43 clearing the D&G Junction towards New Carrollton Station.
