**WMSC Commissioner Brief: W-0274 – Improper Rail Vehicle Movement – Addison Road Station – June 24, 2023**

FINAL REPORT OF INVESTIGATION A&I E23430

Date of Event:	June 24, 2023
Type of Event:	Improper Rail Vehicle Movement
Incident Time:	14:40 hours
Location:	Addison Road Station, track 1
Time and How received by SAFE:	15:15 hours – SAFE/MAC
WMSC Notification Time:	15:36 hours
Responding Safety Officers:	WMATA: None WMSC: None Other: None
Rail Vehicle:	Train ID 406 L3044-3045, 3228-3229, 3261-3260T
Injuries:	None
Damage:	None
Emergency Responders:	None
SMS I/A Incident Number:	20230703#109646

Addition Road Station – Improper Rail Vehicle Movement

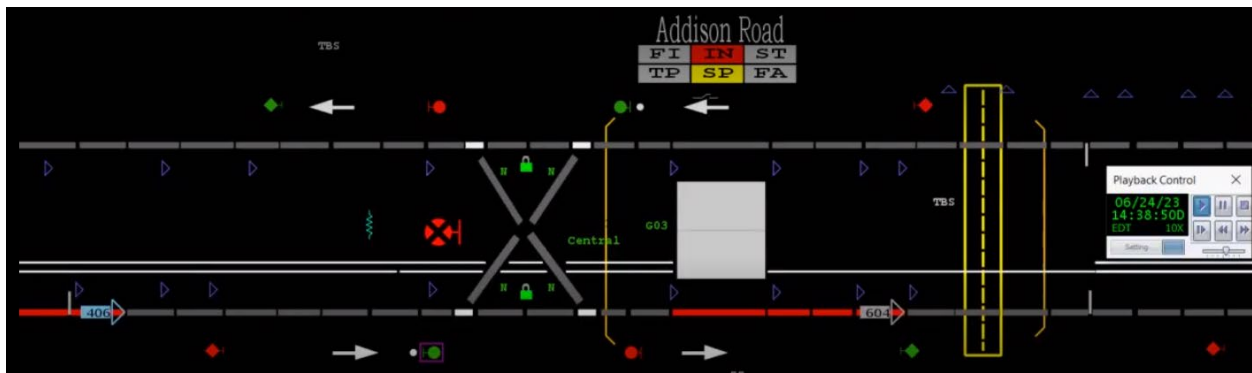
The Audio Recording System (ARS) revealed that seconds later, the ROCC Radio RTC instructed Train ID 406 to hold at Addison Road Station upon arrival, but the Train Operator did not respond.

Figure 1 – Train ID 604 departing Addison Road Station as Train ID 406 is approaching Addison Road Station at 14:38 hours.

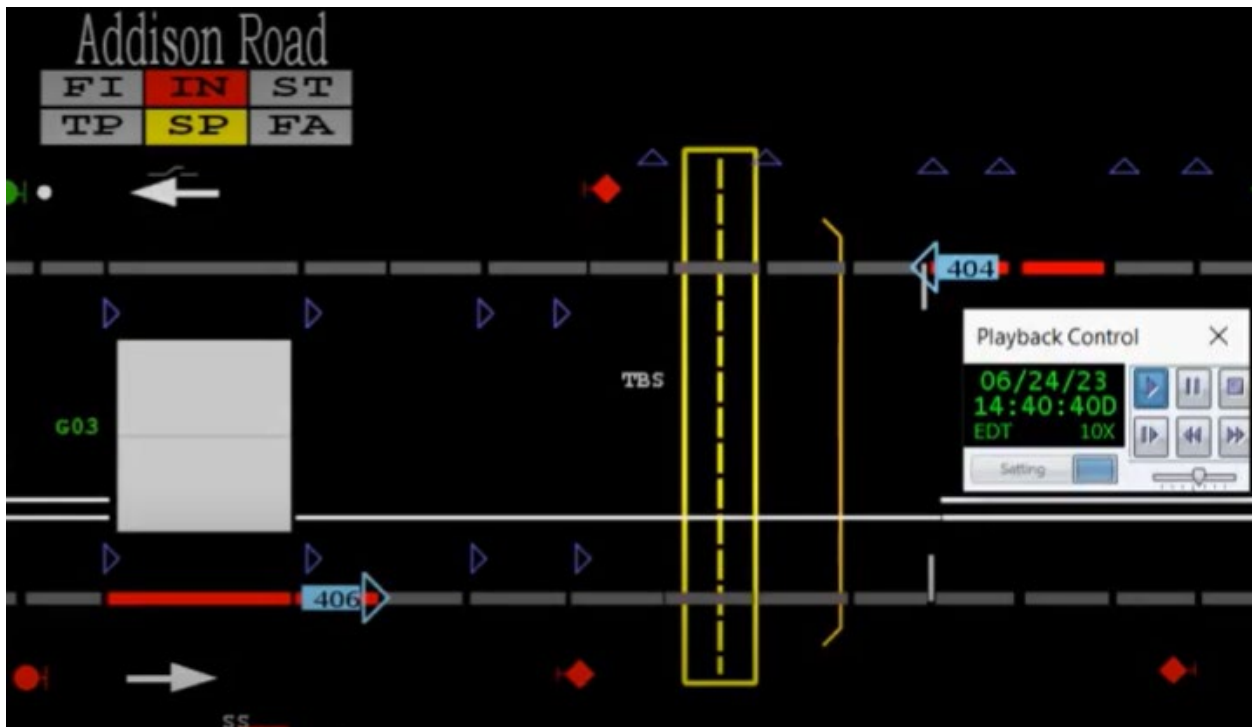
SPOTS revealed that at 14:39 hours, Train ID 406 arrived at Addison Road Station and departed at 14:40 hours.

Figure 2 – Train ID 406 departing Addison Road Station at 14:40 hours.

Seconds later, the Train Operator contacted ROCC and reported that the train was departing Addison Road Station and lost speed commands. At 14:41 hours, the Radio RTC attempted to contact the Train Operator, but there was no response.

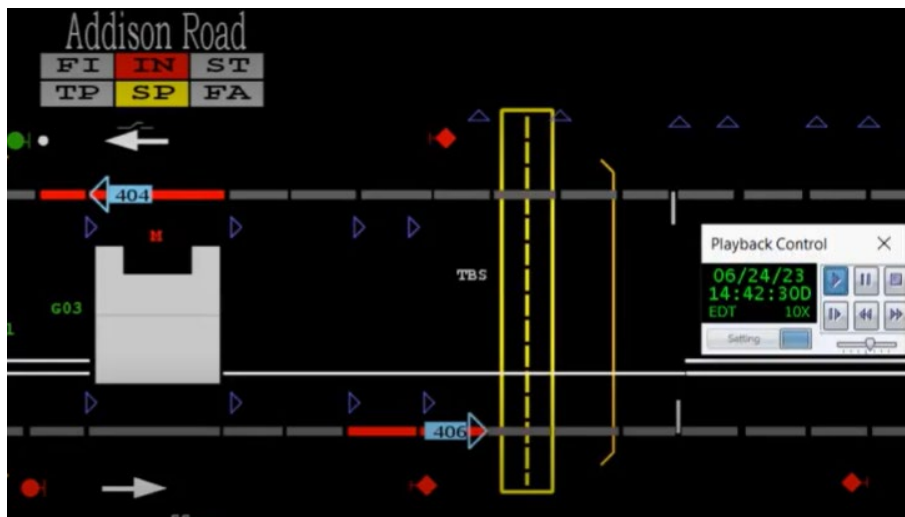
Train Operator that they instructed them to hold at Addison Road Station; the train moved from Addison Road Station without speed commands, and when the train passed the turnback¹, the speed commands returned. The Train Operator responded that the train did not pass the turnback without speed commands, and they did not hear the instruction to hold.

Figure 3 – Train ID 406 located at the turnback at 14:42 hours.

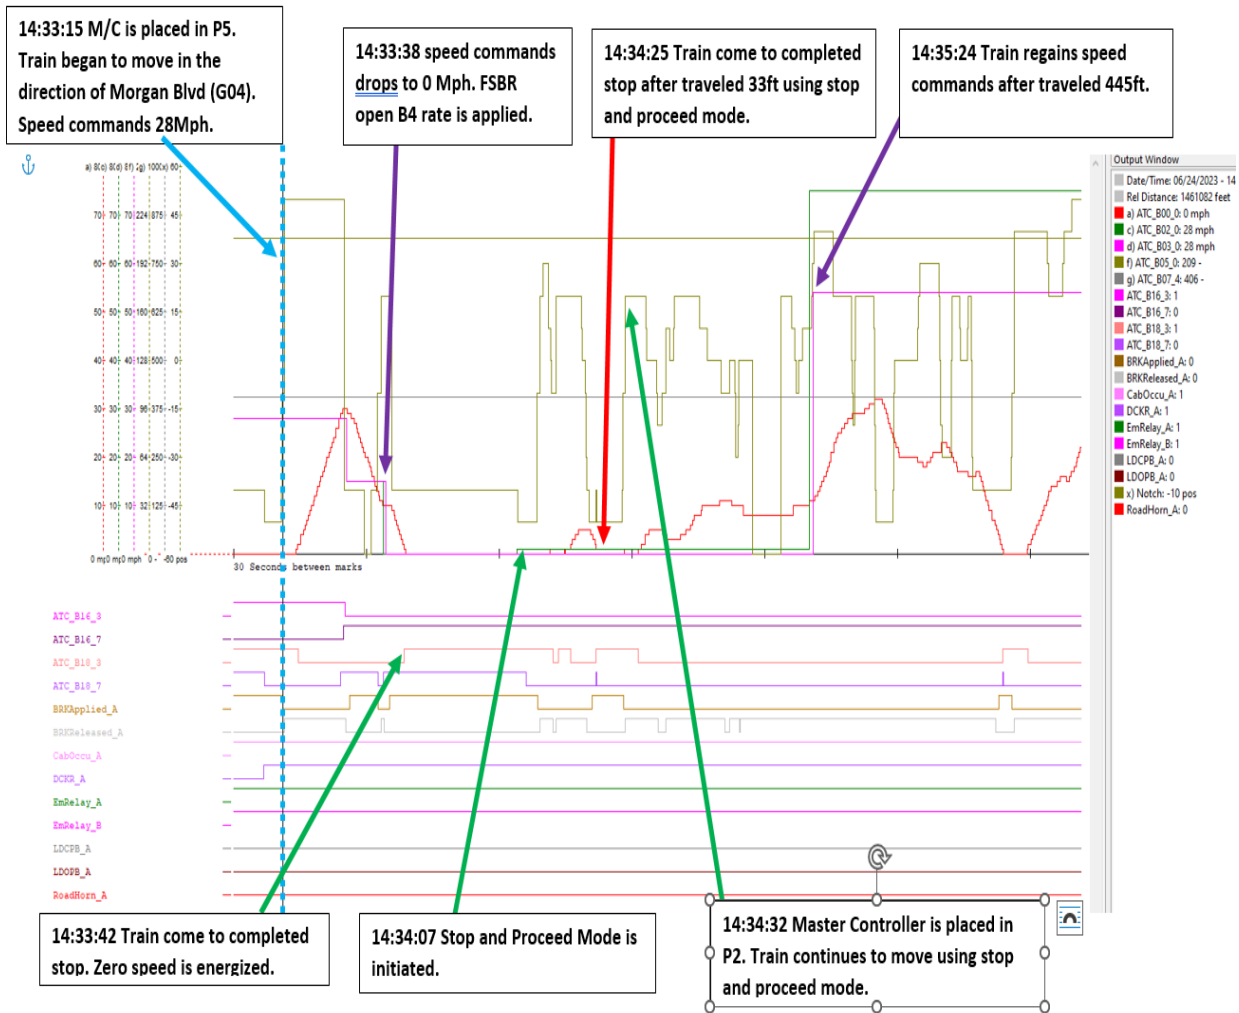
Graph 1 – 3044 VMS Graph

The speed commands dropped to 0 MPH. FSBR was de-energized, and the B4 rate was applied, bringing the train to a complete stop 563 feet after Addison Road Station. The train Stop and Proceed mode was initiated, the Master controller was placed in the “P2” position, and the train began to move without speed commands. The train stops completely after traveling 33 feet using Stop and Proceed mode.

The train began to move again using Stop and Proceed mode; speed commands were received at 445 feet while moving toward Morgan Boulevard. Note: The train traveled 478 feet using stop and proceed mode until speed commands were regained.

Based on VMS data, no fault was found with the train that may have contributed to the cause of this incident.”
