WMSC Commissioner Brief: W-0275 – Improper Vehicle Movement – near Van Dorn Street Station – May 24, 2023

FINAL REPORT OF INVESTIGATION A&I E23346

Date of Event:	May 24, 2023
Type of Event:	Improper Rail Vehicle Movement
Incident Time:	12:12 hours
Location:	Between Van Dorn Street Station and Franconia-Springfield Station, track 2 (CM J2 809+00)
Time and How received by SAFE:	12:30 hours SAFE/MAC
WMSC Notification Time:	12:48 hours
Responding Safety Officers:	WMATA: N/A WMSC: N/A Other: N/A
Rail Vehicle:	Train ID 409 (L6082-6083, 6111-6110, 6114-6115T)
Injuries:	None
Damage:	Wee-Z Bond – Water Damage
Emergency Responders:	N/A
SMS I/A Incident Number:	20230607#109024

Franconia Springfield Station – Improper Rail Vehicle Movement

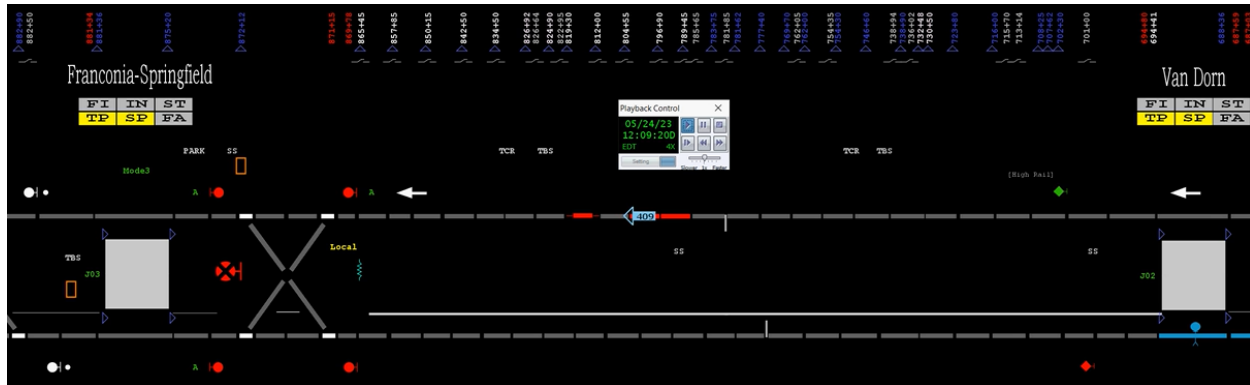
Figure 1 – AIMS Playback depicting Train ID 409 approaching the down track circuit at 12:09:20 hours.

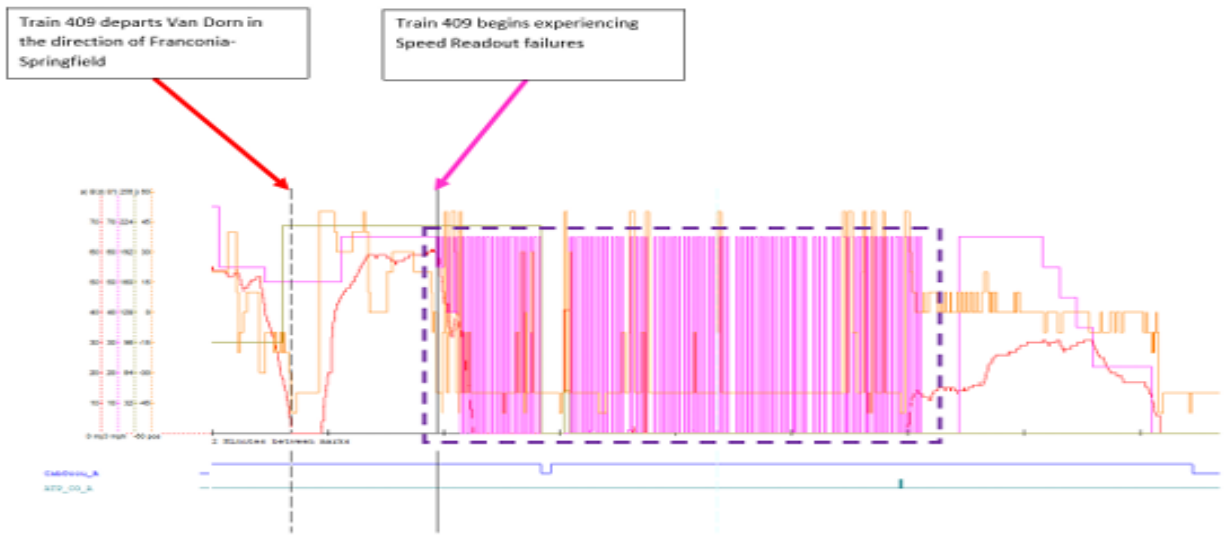
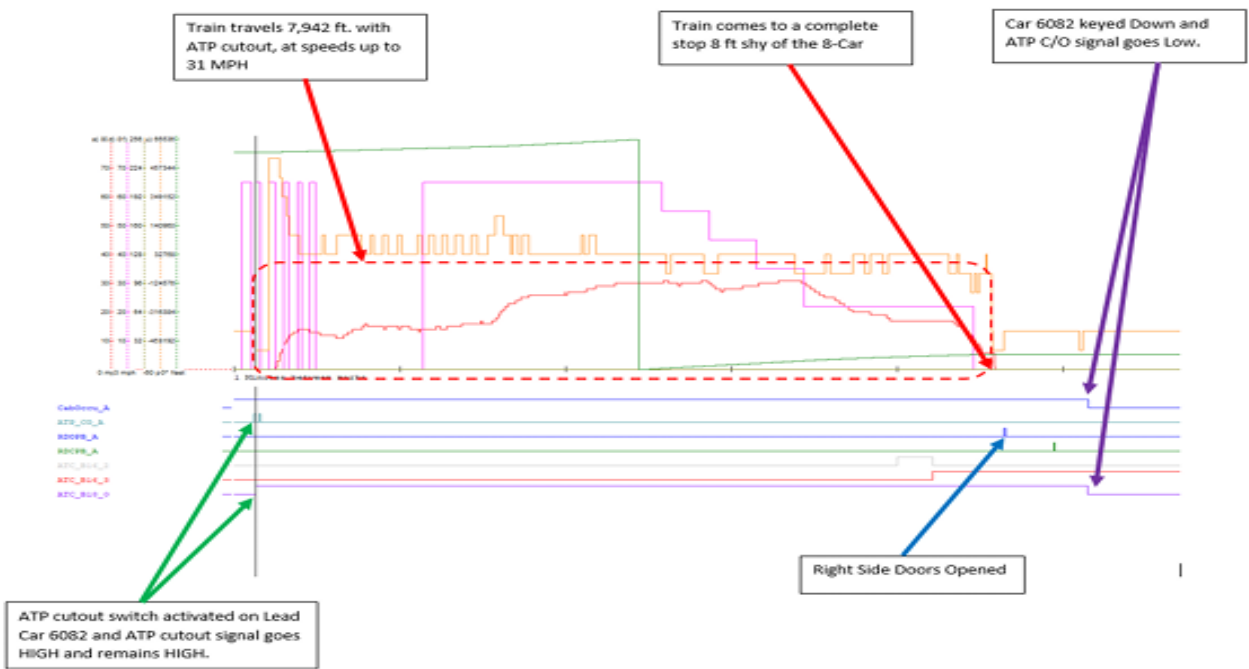
Graph 1 – VMS Graph

Time	Description of Events
12:09:26.572	9,019 ft. after departing Van Dorn, Train ID409 began to experience Speed Readout problems. VMS shows Speed Readouts repeatedly dropping from 65 MPH to 0 MPH

12:10:03.437	The train came to a complete stop after traveling an additional 1,755 ft. with SROs continuing to drop in and out.
12:11:12.772	Lead Car 6082 keyed down.

12:11:22.621	Car 6082 keyed back up.
12:12:49.320	Master Controller placed in a P4 power mode and train moves 7 ft. and comes to a complete stop
12:17:22.112	ATP cutout switch activated and ATP cutout signal goes high and remains high

12:17:27.132	The Master Controller was placed on P5 Power Mode and the Train began to move with ATP cutout.
12:17:38.096	The Master Controller placed in Coast, Train speed was 14 MPH, SROs still repeatedly falling to 0 MPH.

12:17:38.096 - 12:21:48.128	The Master Controller was cycled back and forth utilizing multiple operating modes ranging between from P2 Power Mode and B2 Braking Mode. Traveling at speeds up to 31 MPH.

12:21:18.140	Train entered into Franconia Springfield Station at a speed of 17 MPH, with the Master Controller in the Coast position.
12:21:48.320	Master Controller placed in a P5 Power Mode, Train speed was 6 MPH,

12:21:49.185	Train came to a complete stop 8 ft. from the 8-Car Marker at Franconia-Springfield, Track #1, traveling a total of 7,942 ft. with ATP cutout.

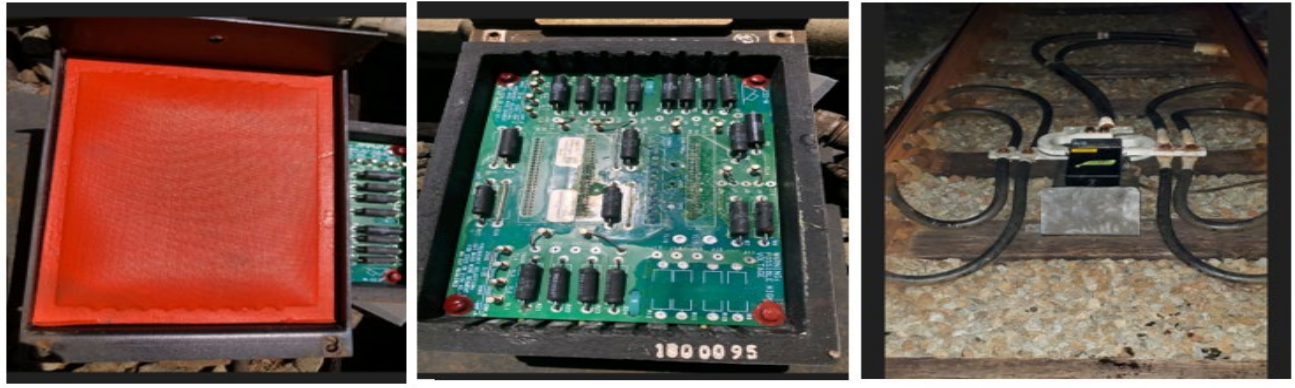
ATCM was notified of an intermittent false occupancy on the track circuit at J2 812+00. Upon inspection, ATCM found that the Rx Bond (Cross Bond) inside the Wee-Z Bond was wet, and the resistor was corroded. On May 27, 2023, ATCM replaced the damaged Wee-Z Bond.

- Wee-Z Bond failure led to a track circuit malfunction at J2 812+00 due to water intrusion.
- The Train Operator cut out ATP without permission from ROCC.
- After ATP was cut out, the Train Operator operated the train at speeds greater than the restricted speed (15 MPH).
- The Train Operator reported initiating Power Knockout; however, the VMS data does not support the Train Operator's statement.

Image 1 - Photo #1, the cover of the Wee-Z Bond with the anti-vibration pad saturated in water. Photo #2, corrosion on the control board. Photo #3, replacement Wee-Z Bond installed.

- The Train Operator was removed from service.
- The train consist was removed from service for post-incident inspection.
- The damaged Wee-Z Bond was replaced.
