WMSC Commissioner Brief: W-0277 – Red Signal Overrun – West Falls Church Rail Yard – July 21, 2023

FINAL REPORT OF INVESTIGATION A&I E23504

West Falls Church Yard – Red Signal Overrun

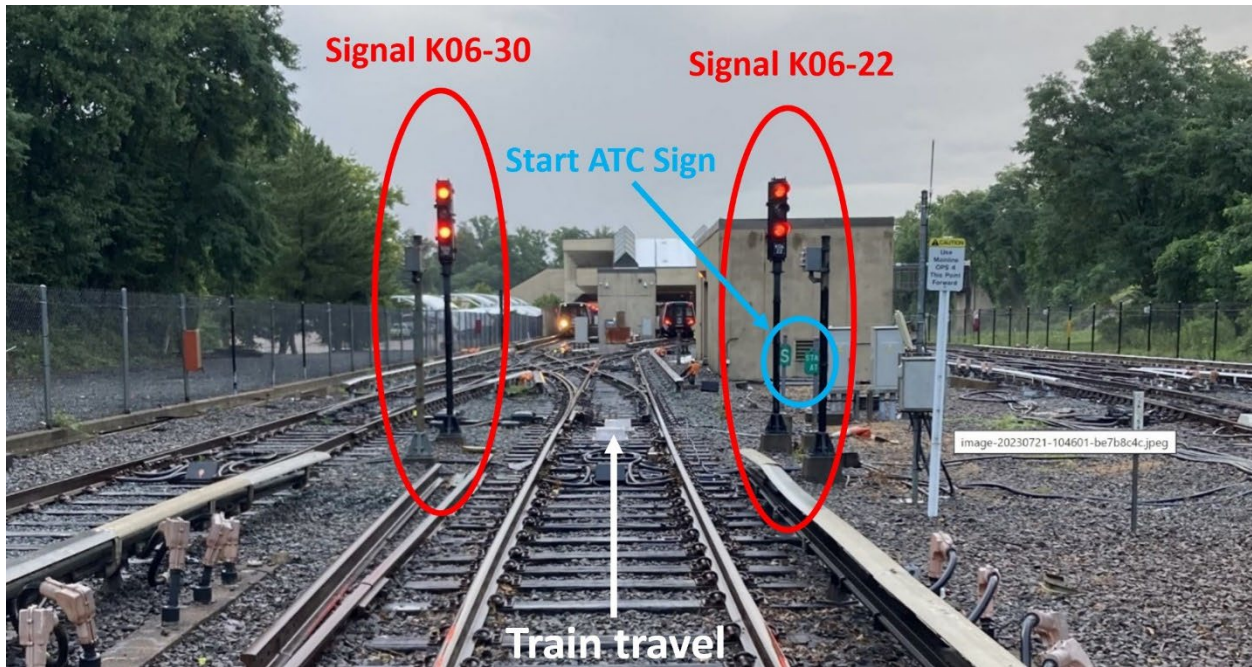
A Contributing Factor to the event was the adjacent mainline signal K06-30 displaying a flashing lunar aspect. Signal K06-30 is a mainline signal and was displaying a flashing lunar aspect to the train operator's left as they approached Signal K06-22, which was on their right. An additional Contributing Factor to the event was the Train Operator entering Stop and Proceed Mode while at the red signal, which is located at the start of ATC-controlled territory.

Photograph 1 – Yard Lead 2 with Signal K06-30 on the left and Signal K06-22 on the right. The Start ATC sign and “S” marker are pictured on the right side of Yard Lead 2, adjacent to Signal K06-22.

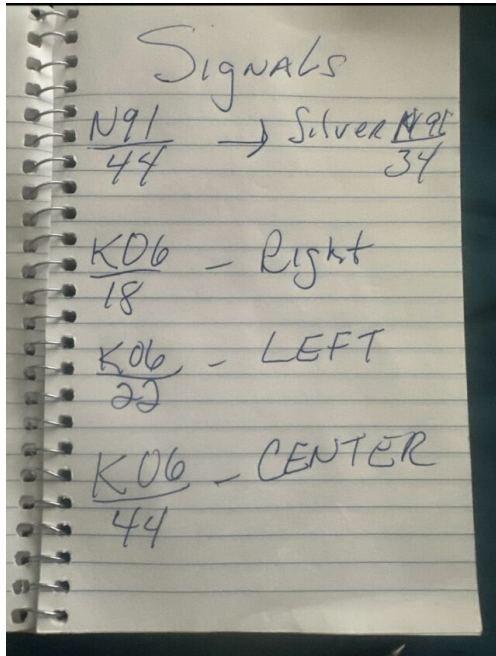
Photograph 2 – Train Operator’s handwritten notes from on-the-job training. They noted that Signal K06-22 was aligned on their left, which is incorrect.

The Train Operator disclosed their training notes during the interview, which did not include Signal K06-30 and notated that Signal K06-22 was on the left. The Train Operator said there are known radio communication issues within the West Falls Church Yard that may have contributed to not hearing clear instructions from ROCC.

Corrective Action Code	Description	Responsible Party	Estimated Completion Date
110200_SAF ECAPS_RT RA_001	(RC-1) RTRA Supervisors will be required to document [within the Rail Supervisory Daily Activity Report (RSDAR) application] a minimum of five (5) discussions per day regarding train operator operations near interlocking signals displaying a red aspect.	RTRA SRC	Completed
110200_SAF ECAPS_RT RA_002	(RC-1) RTRA Management will ensure the Train Operator is scheduled and completes refresher training emphasizing operating within the yard and approaching red signals.	RTRA SRC	Completed

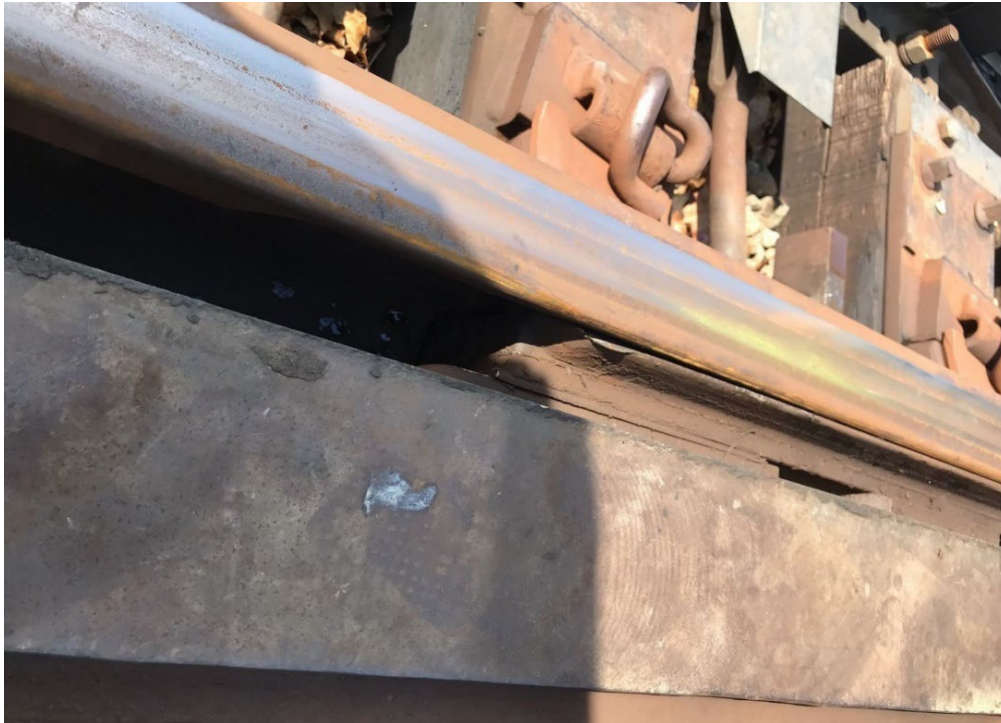
No injuries were reported. Switch 17A was reported to have sustained a slight bend at the tip of the point.

Photograph 3 – Switch 17A was not tucked during the red signal overrun and sustained a slight bend at the tip of the point.

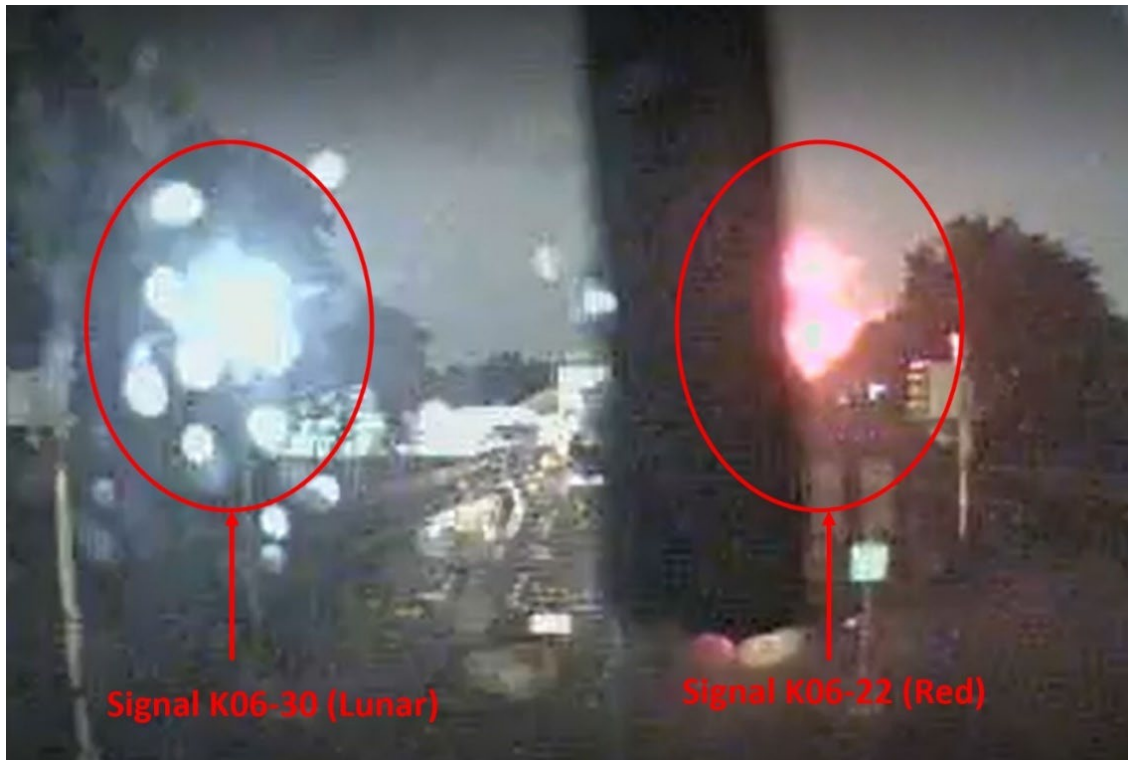
A review of the front-facing camera on Lead Car 7252 found that Signal K06-22 on the Train Operator's right side displayed a red aspect and Signal K06-30 on the operator's left had a flashing lunar aspect. The windshield wipers were operating due to the rainy weather conditions. At 05:21 hours, CCTV playback observed Train ID 904 entering the West Falls Church platform limits on Track 3.

Photograph 4 – Train ID 904 forward-facing camera showing the train operator's view of Signals K06-22 and K06-30 on Yard Lead 2 at approximately 05:20 hours.

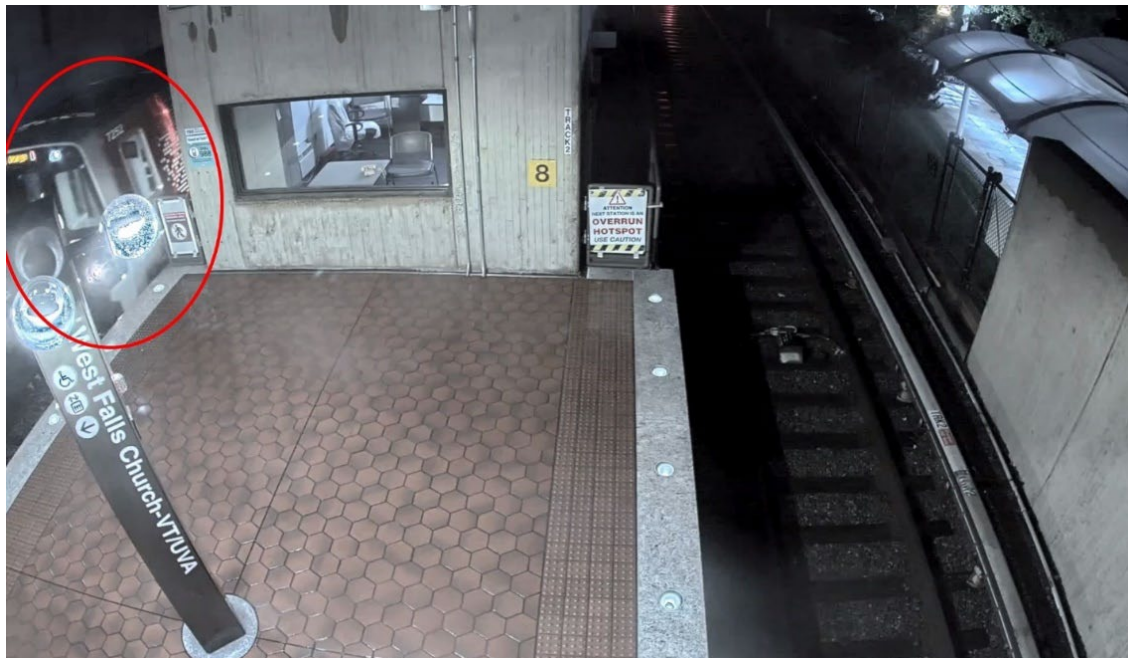
Photograph 5 – Train ID 904 entered West Falls Church platform limits on Track 3 at approximately 05:21 hours.

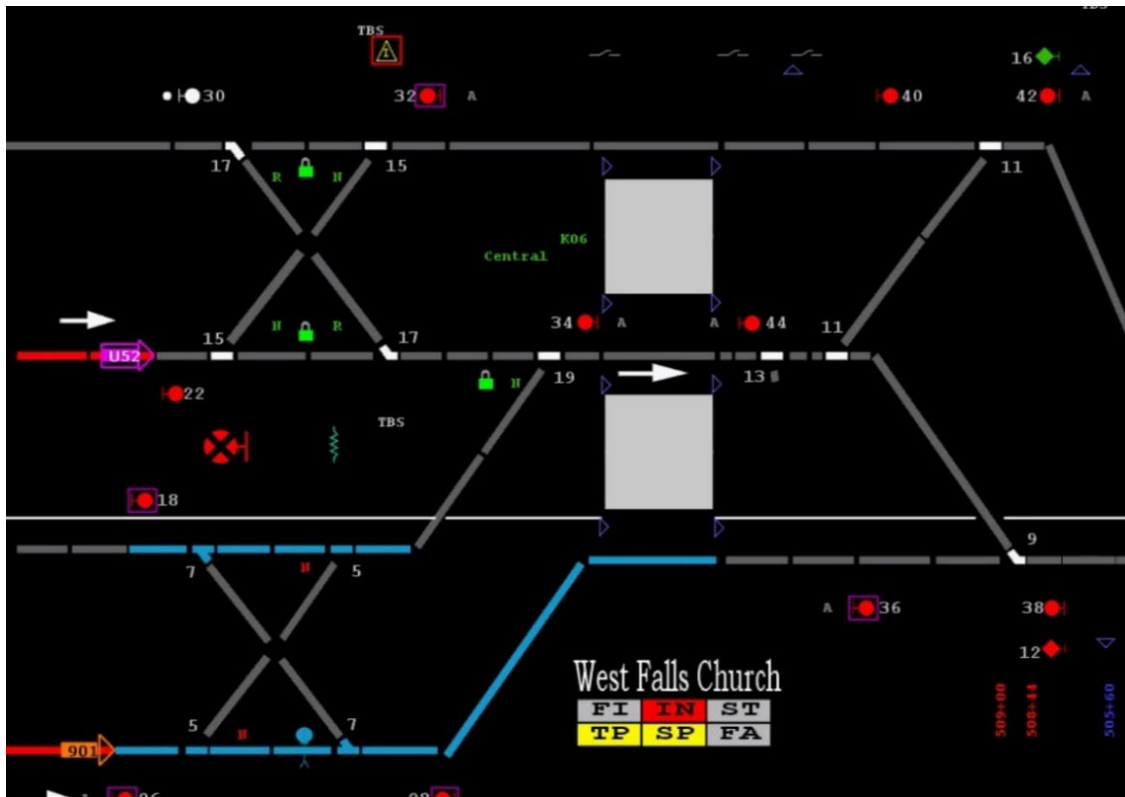
Figure 1 – Train ID 904 at Signal K06-22 (Red) on Yard Lead 2 at approximately 05:20 hours.

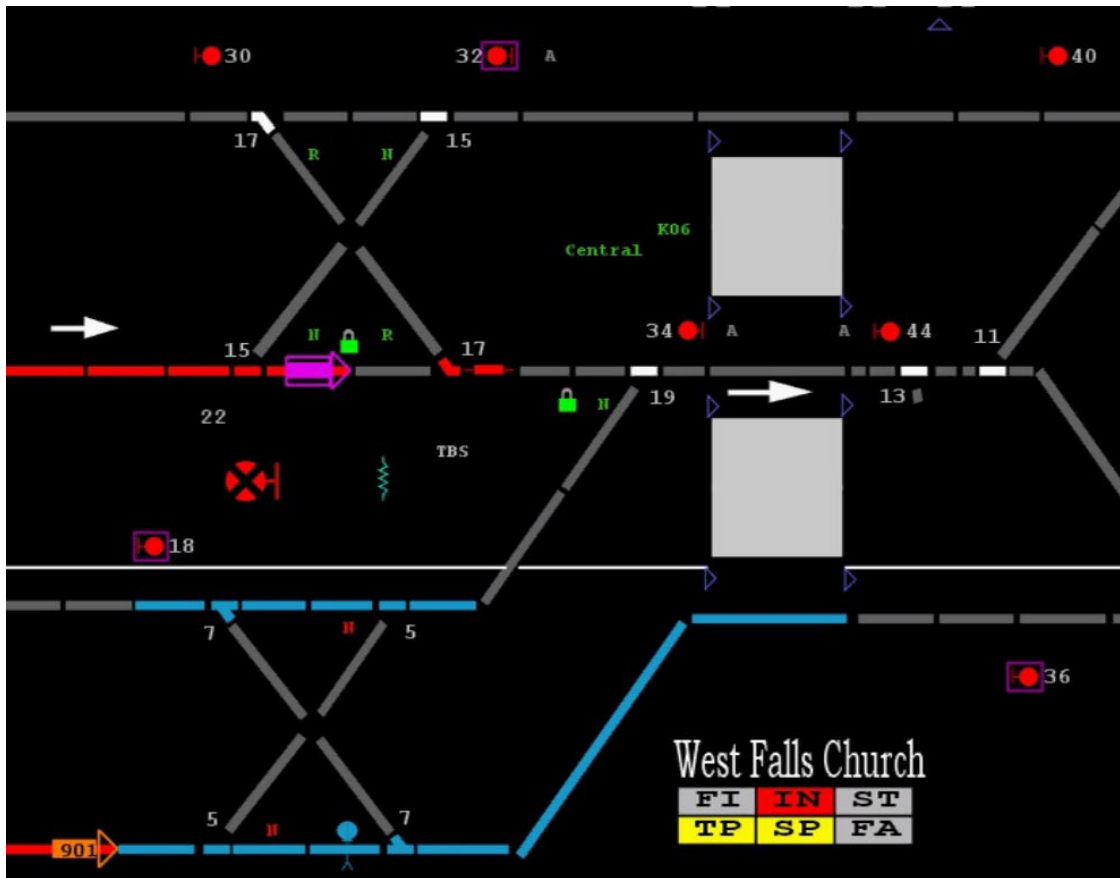
Figure 2 – Train ID 904 traveled beyond Signal K06-22 (Red) on Yard Lead 2 at approximately 05:22 hours.
