## **WMSC Commissioner Brief: W-0278 – W-081 Improper Roadway Worker Protection Events – January 2023**

*Prepared for Washington Metrorail Safety Commission meeting on May 14, 2024*

<b>Date of Event:</b>	January 11, 2023
<b>Type of Event:</b>	Improper Roadway Worker Protection (RWP)
<b>Incident Time:</b>	17:01 hours
<b>Location:</b>	Columbia Heights Station, Track 2
<b>Time and How received by SAFE:</b>	17:09 hours – SAFE/MAC
<b>WMSC Notification Time:</b>	17:57 hours
<b>Responding Safety Officers:</b>	WMATA: N/A WMSC: N/A Other: N/A
<b>Rail Vehicle:</b>	N/A
<b>Injuries:</b>	None
<b>Damage:</b>	None
<b>SMS I/A Incident Number:</b>	20230111#105445

# Columbia Heights Station – Improper RWP

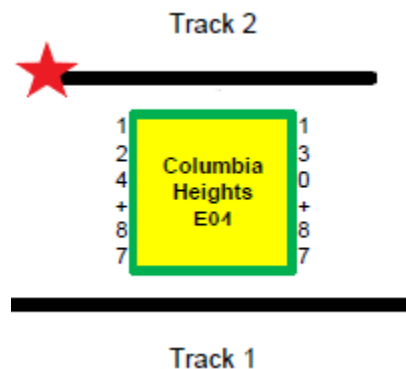
Columbia Heights Station, Track 2 - Between E2 105+00 and E2 106+00

*The above depiction is not to scale. Incident site marked with a red star.*

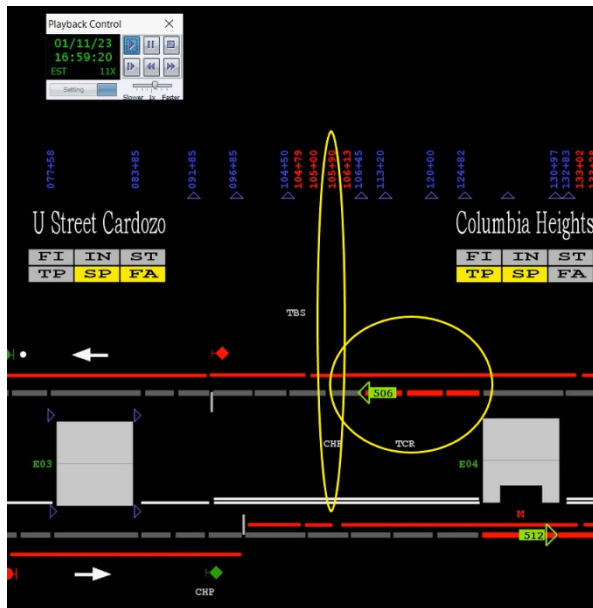
Figure 1: Train ID 506 can be observed within the area of the RWIC at 16:59 hours.

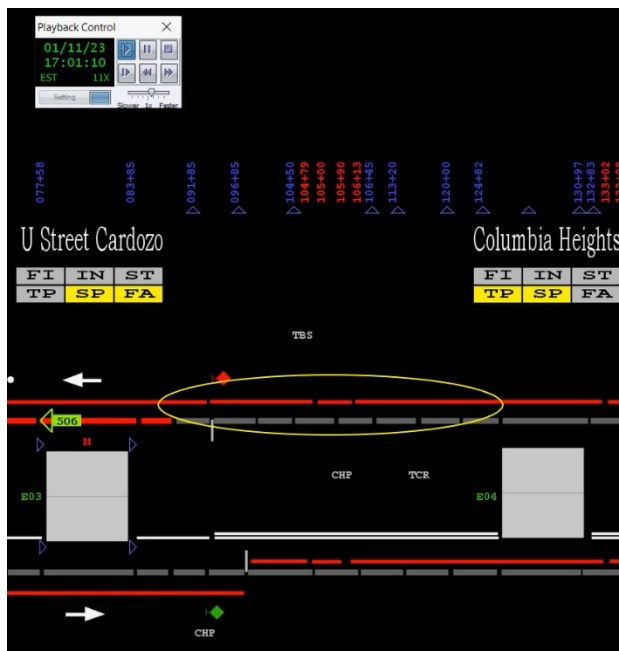
Figure 2: No "blue block" was established at 17:01 hours.

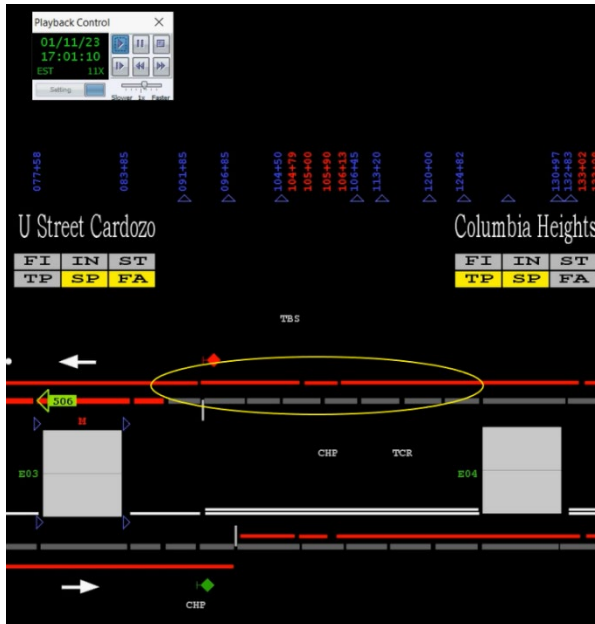
AIMS Playback confirmed that, at the time of the incident, foul time was not established by the ROCC for the area.

Figure 3: No foul time established at 17:01 hours.

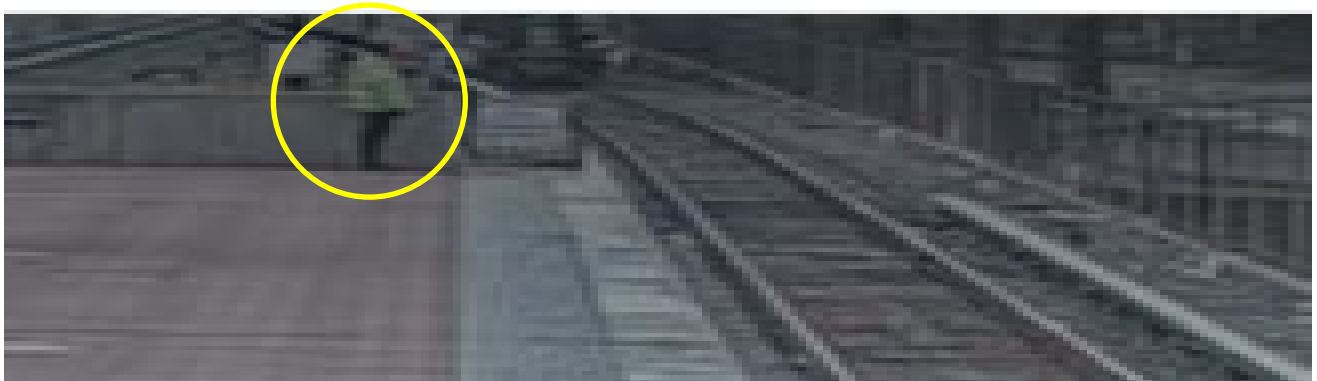
- At 10:23 hours the AMF arrived at Rockville Station and alighted from car 2336, Track 2
- The AMF affixed the amber light to the eight-car marker end gate horizontally, with the light facing the operator. They placed their helmet on the concrete ledge. The orange flag was not visible in their hand.

*Figure 1 - Figure 1 AMF after briefing train 103 at Rockville Station.*

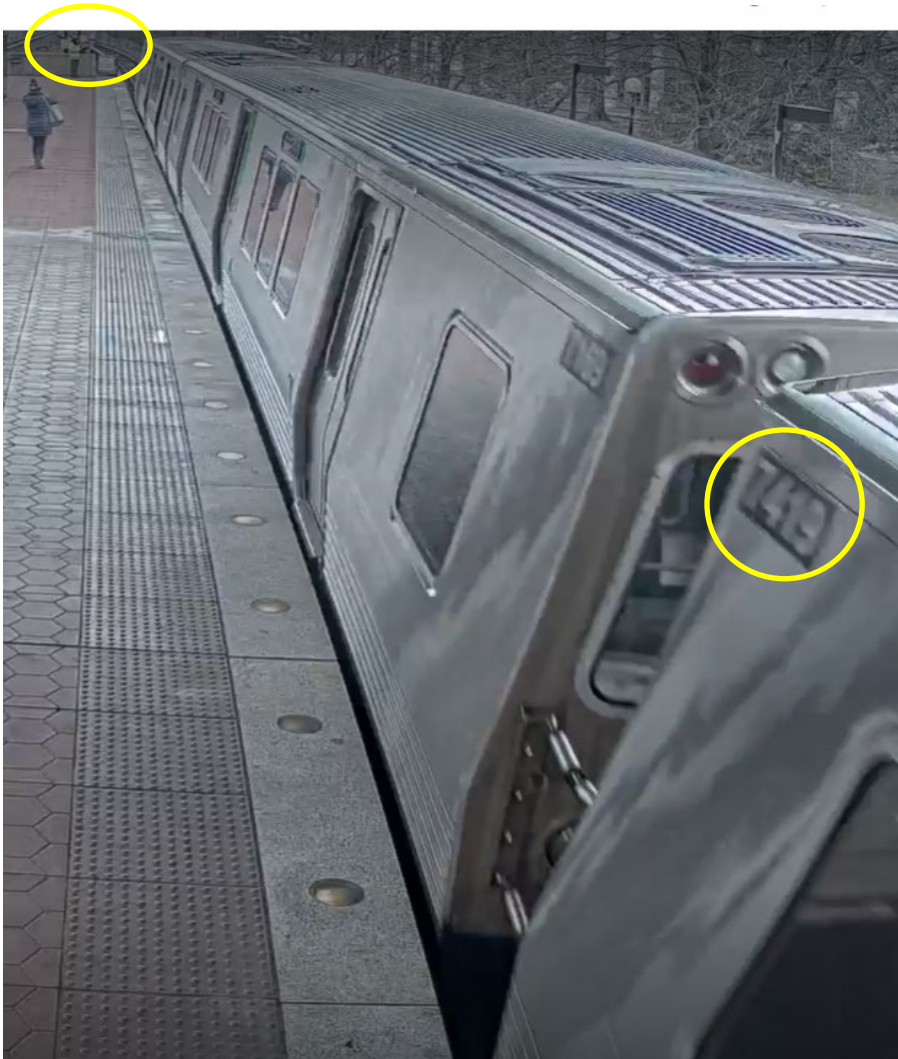
- At 11:00 hours, they briefed revenue train ID 103.
- At 11:04 hours, non-revenue Train ID 800 bypasses the station and the AMF does not attempt to stop the train.

Figure 2 - Train 800 bypassing Rockville Station

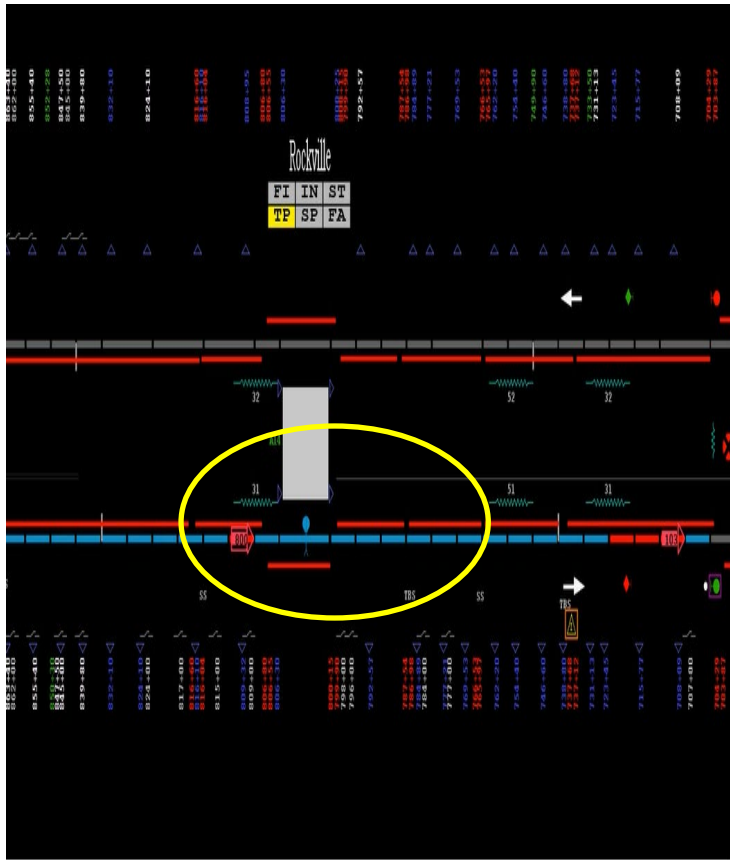
Figure 5 - AIMS-TRAIN 800 entering Rockville Station (Did not receive briefing)

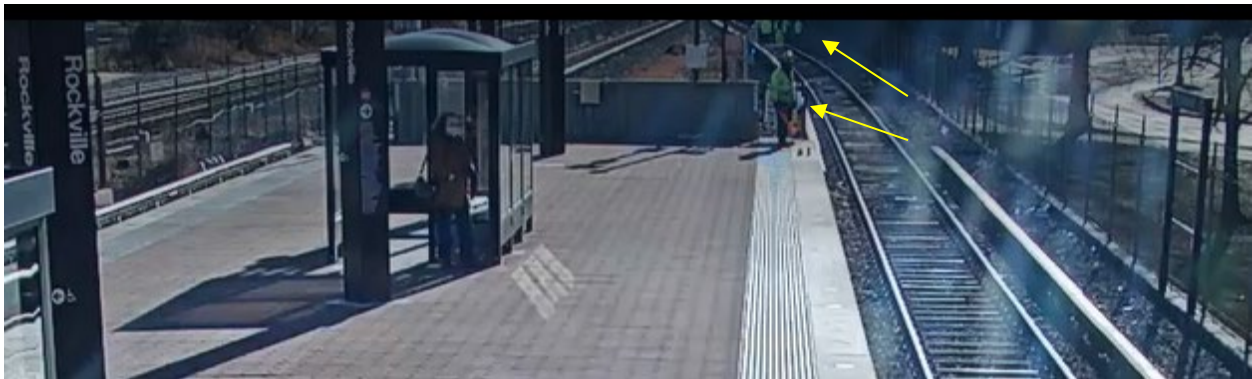
Figure 2 – ATCM crew surveying in the Restricted View: Curve area between CM 788+00 and 795+00.

At 10:29 hours, the RWIC advised the Radio RTC that the work crew was clear of the roadway and on the platform of Rockville Station. The RTC observed that the RWIC did not request FT at a listed hot spot location between CM 788+00 to 795+00. The area is designated as a “Restricted View: Curve” in the Track Access Guide. The RWIC was instructed to “landline” ROCC. A review of the Closed-Circuit Television (CCTV) revealed the ATCM crew surveying on the roadway in the Restricted View: Curve area.
