## **WMSC Commissioner Brief: W-0282 – W-0287 Improper Roadway Worker Protection Events – March-April 2023**

*Prepared for Washington Metrorail Safety Commission meeting on May 14, 2024*

# McPherson Square Station –Improper RWP

**CM N2 924+00 – Improper RWP**

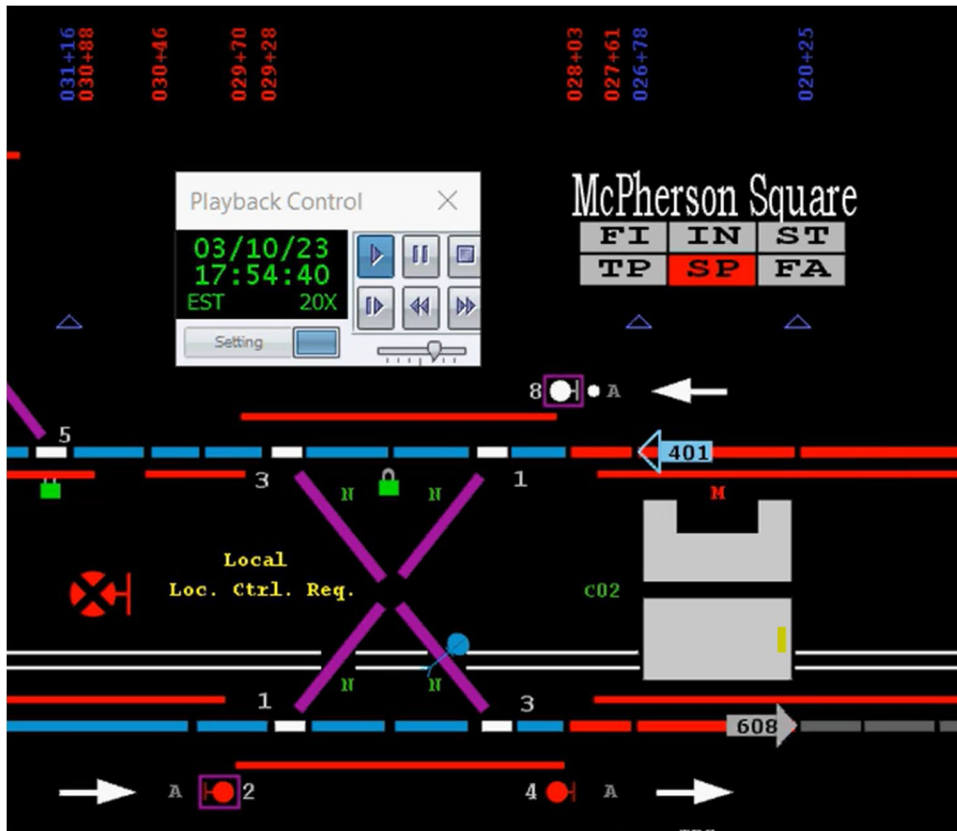
Figure 2: Train ID 401 located at McPherson Square Station with blue block displayed at 17:54 hours

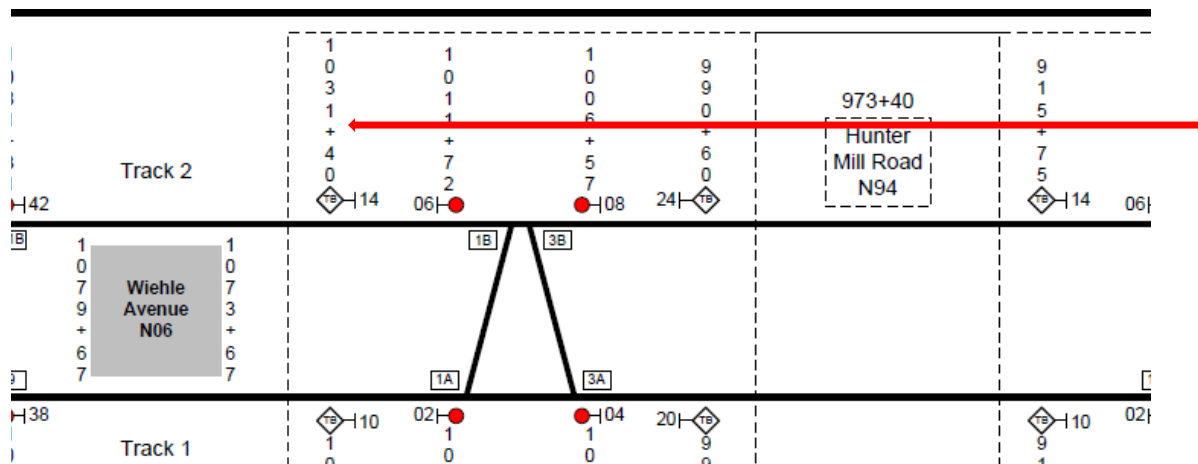
CM N2 924+00 - Location is described in the Track Access Guide as a "Restricted View: Hill" but not noted as a Hot Spot.

Figure 1 - AMF protected work area location

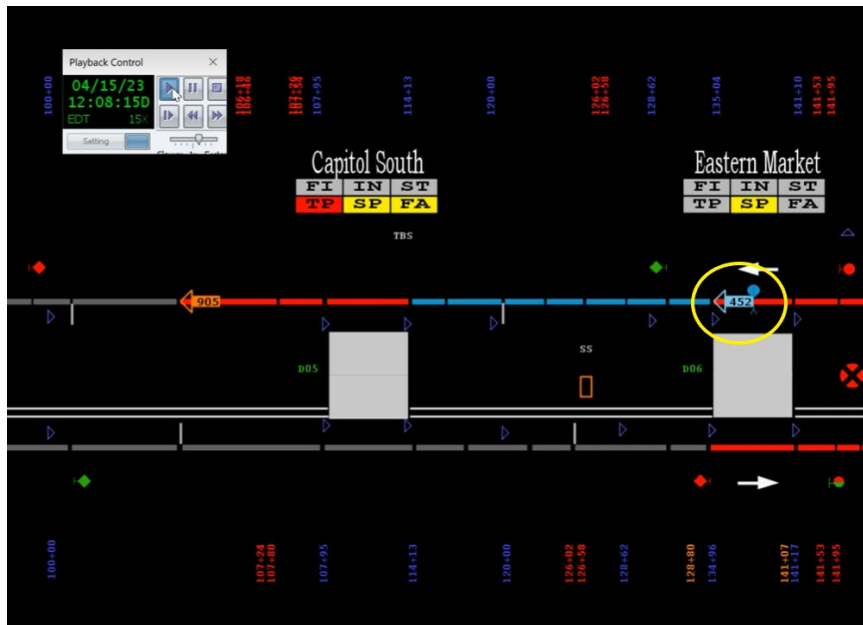
Figure 1 – AIMS depicting Train ID 452 located at Eastern Market Station, track 2 with blue block in place between Capitol South and Eastern Market Stations at 12:08 hours.

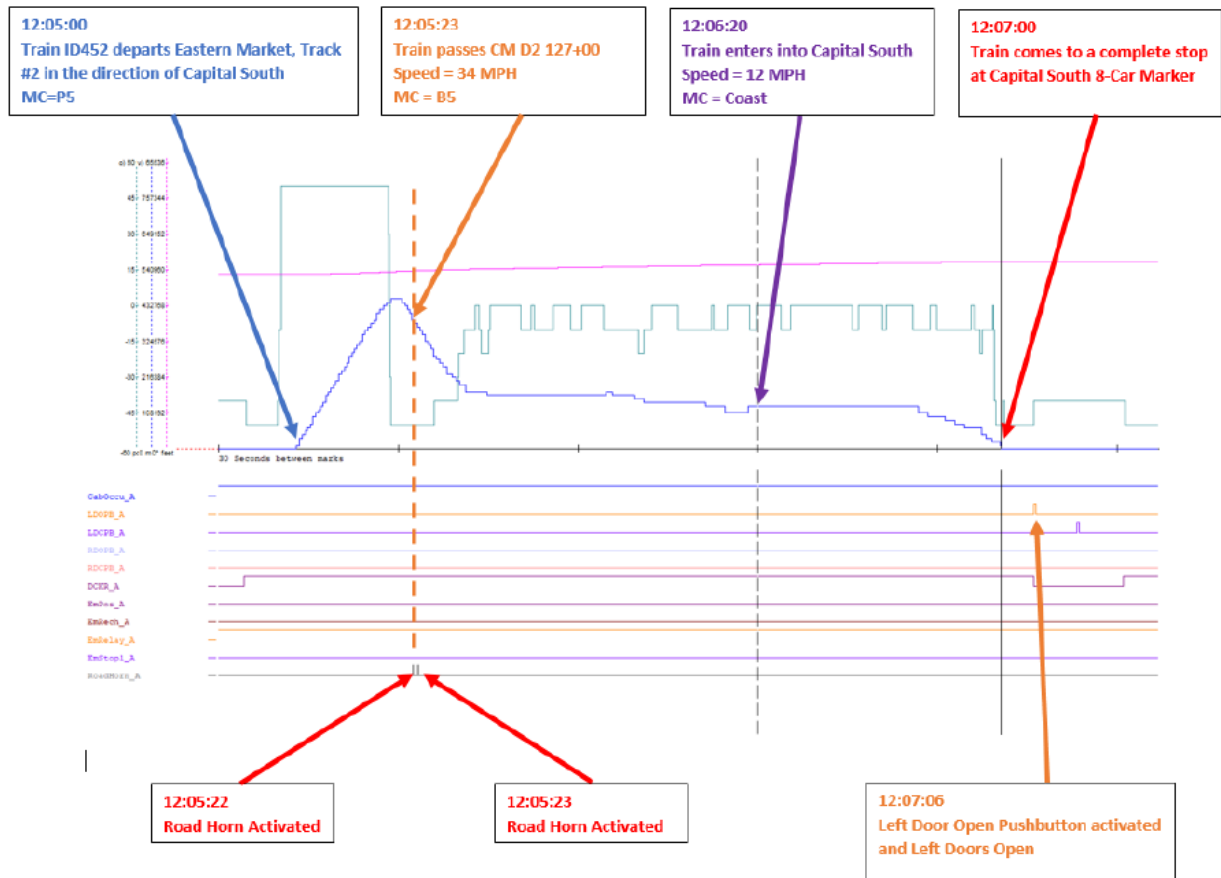
Graph 1 - Data Analysis from lead car 3242.

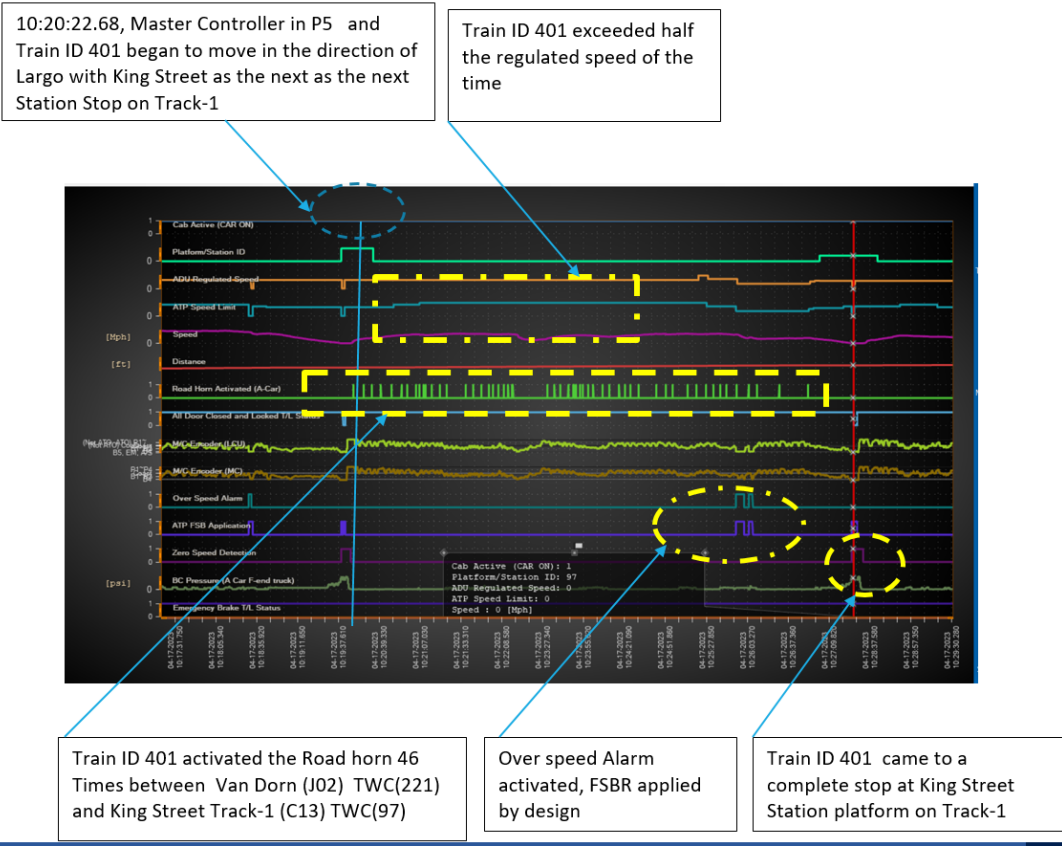
Figure 1: Lead Car 7230 ER Analysis Graph #1

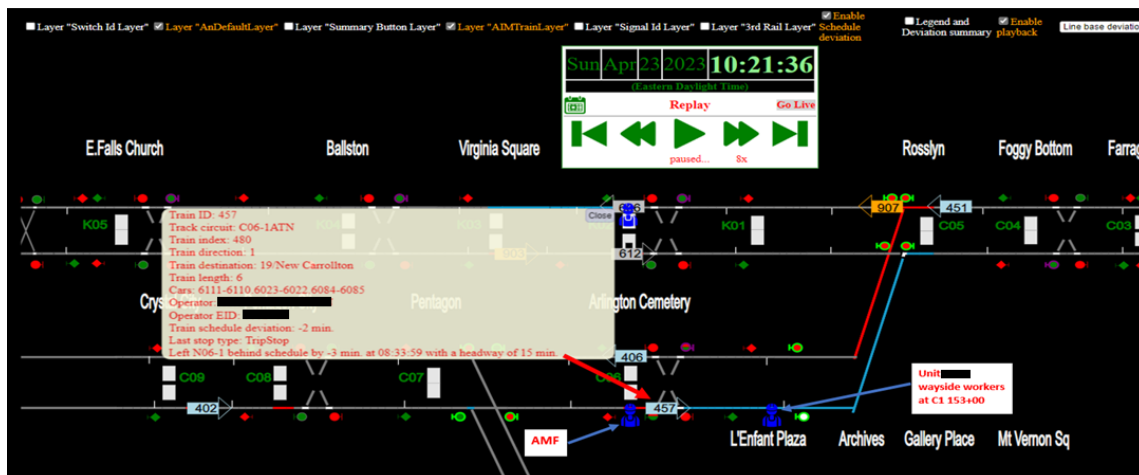
Figure 1 – AIMS snapshot of Train ID 457 proceeding from Arlington Station to Rosslyn Station, track 1, with identifying information.

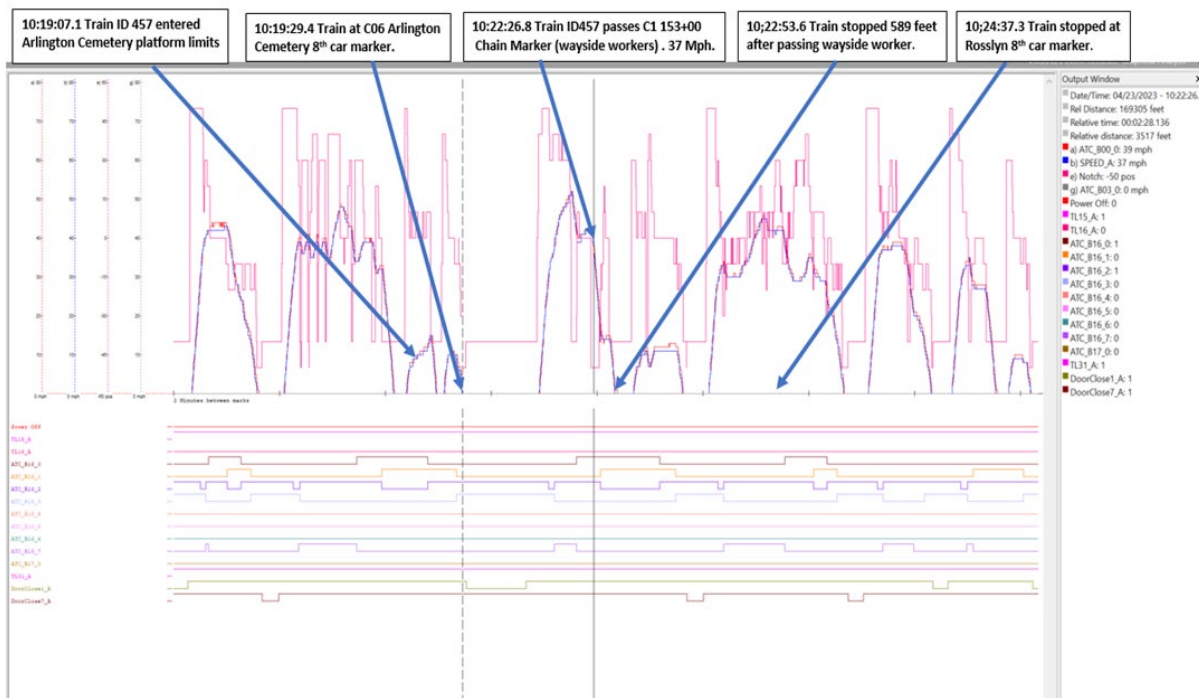
Figure 2 – VMS data depicting Train ID 457 passed the work crew at 37 MPH. Horn activation data was not available.

Figure 3 – VMS Graph.

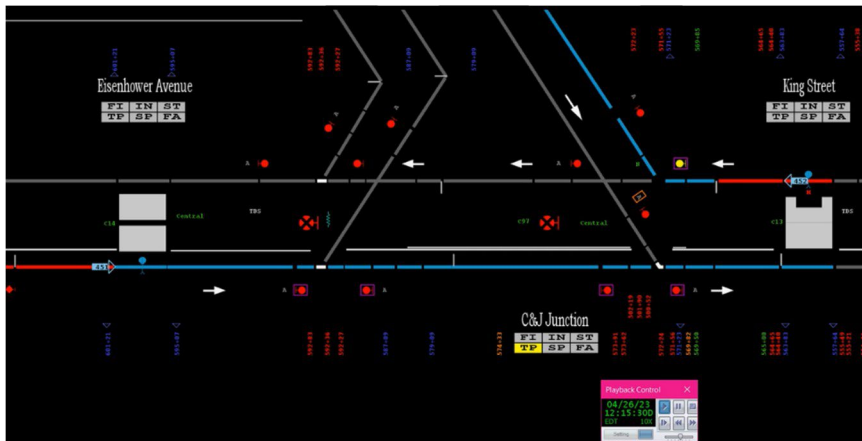
Figure 1 - Blue block in place between King Street Station and Eisenhower Avenue Station, track 1 at 12:15:30 hours.

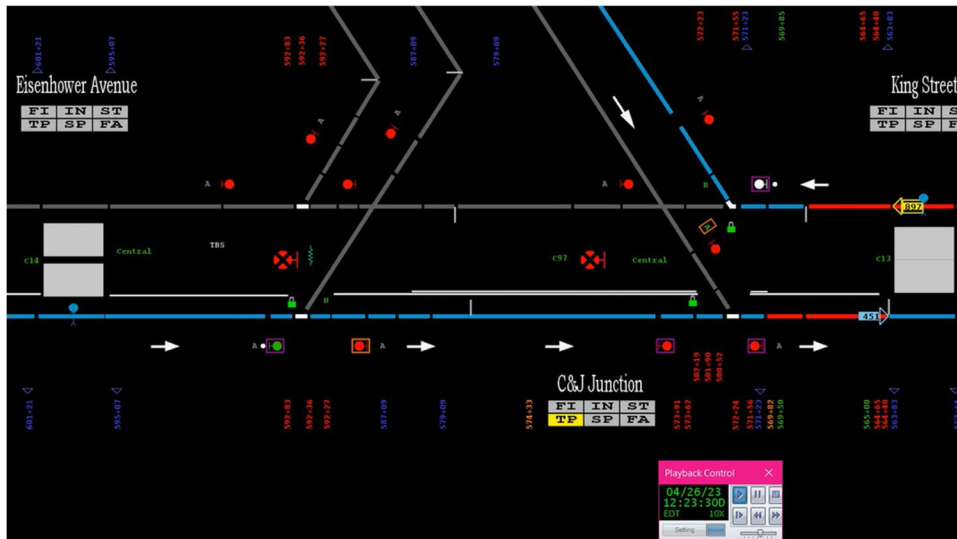
At 12:31 hours, the RWIC contacted ROCC via landline and reported that they were located at Eisenhower Avenue Station and Train ID 451 passed their location at a high rate of speed after Foul Time was relinquished. The Radio RTC made an announcement that personnel were walking between King Street Station and Eisenhower Avenue Station on track 1.

Figure 2 – Train ID 451 arriving at King Street Station at 12:23:53 hours.

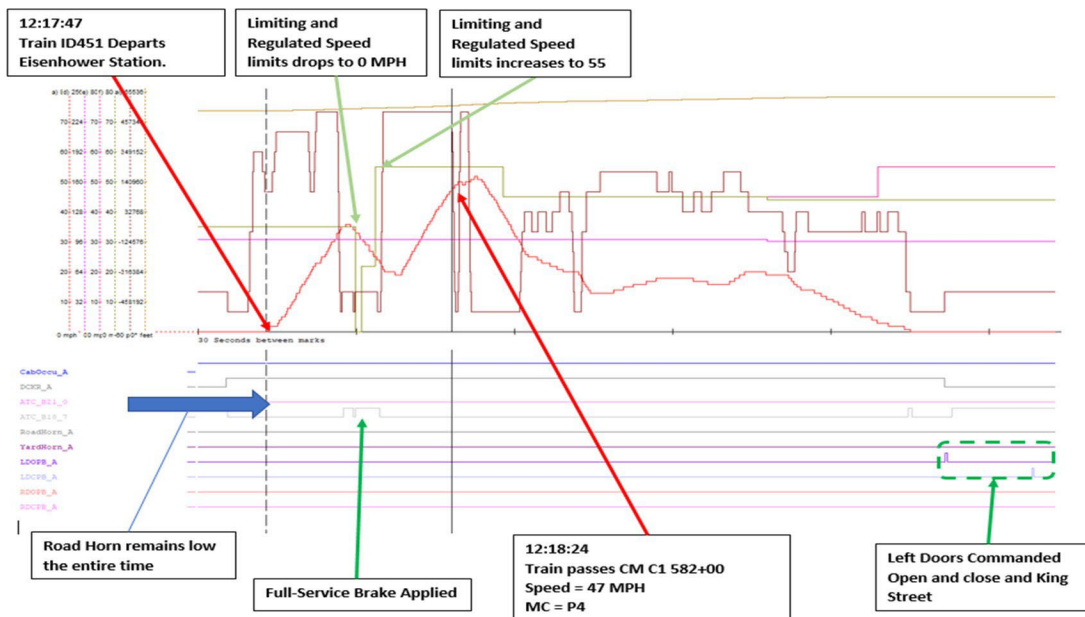
Figure 5 - Graphical analysis of VMS Data
