WMSC Commissioner Brief: W-0288 – W-0291 Improper Roadway Worker Protection Events – May 2023

Prepared for Washington Metrorail Safety Commission meeting on May 14, 2024

Medical Center Station, CM A2 484+00 – Improper RWP

Braddock Road Station – Improper RWP Event

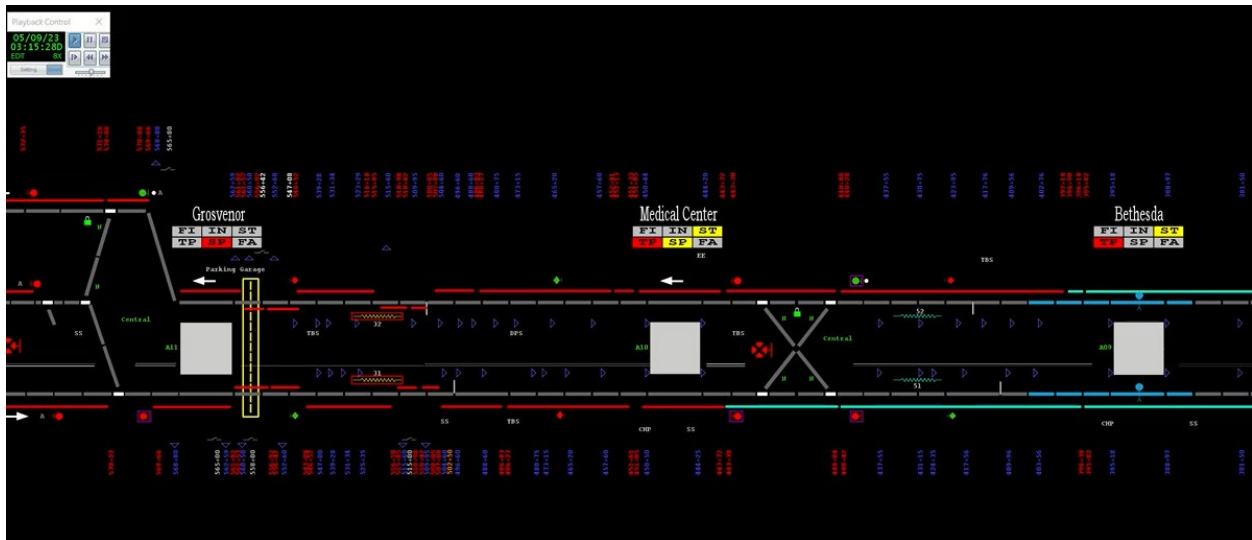
There was no vehicle movement at Medical Center Station according to the Advance Information Management System (AIMS). Workers were on the roadway at Bethesda Station with blue blocking and prohibited exits in place.

Figure 1 - AIMS screen depicts no vehicles present, blue blocking, and prohibited exits.

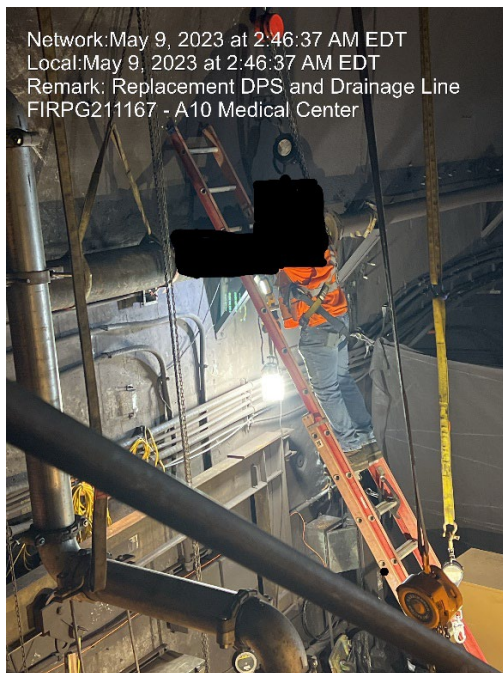
According to the incident report, at 03:15 hours, the Contractor stepped from the catwalk onto Track 2 and fouled the roadway, crossing from Track 2 to Track 1 to meet the crew on the Track 1 side. The work crew were replacing Drainage Pumping Stations and Discharge Line Piping. The work was behind a safety barrier, not in the roadway, and had no track rights.

Image 1 – Depicts the remote work area that does not foul the roadway at Medical Center Station.

- The Contractor was removed from the job site and their WMATA credentials were confiscated.
- The importance of reviewing the site conditions and track access rights was highlighted during Job Site Safety Briefings.

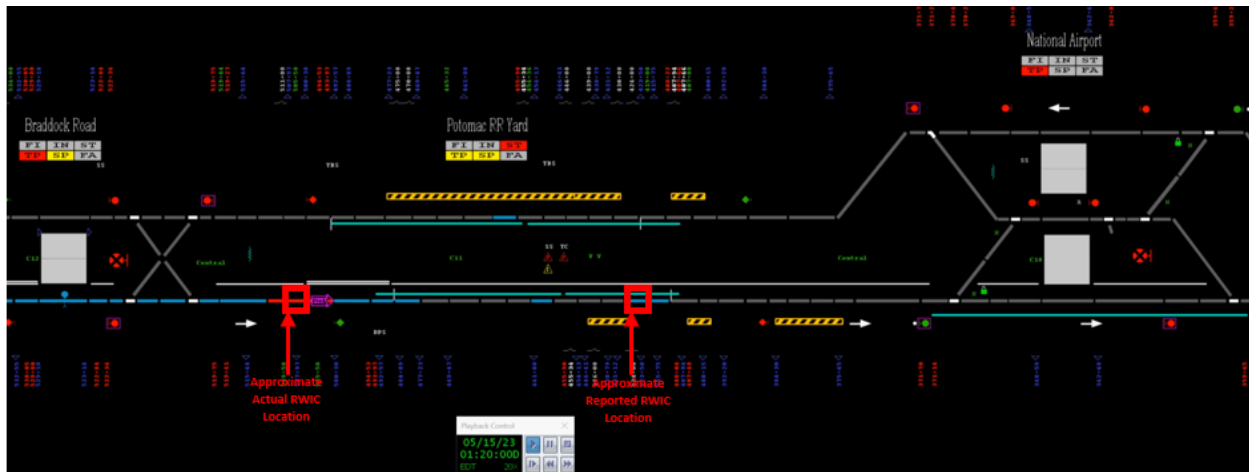
Figure 1 – AIMS Playback displaying the location of PM-42 when they reported passing the Mobile Work Crew near the Braddock Road Station Portal with depictions of approximate locations where the RWIC initially requested foul time and where they were observed near Braddock Road Station.

At 01:23 hours, the Radio RTC contacted the Equipment Operator operating PM-42 and inquired if they observed the Mobile Work Crew at CM C1 428+00. The Equipment Operator reported that they passed the Mobile Work Crew on the roadway near the Braddock Road Station Portal after they departed Braddock Road Station on track 1.

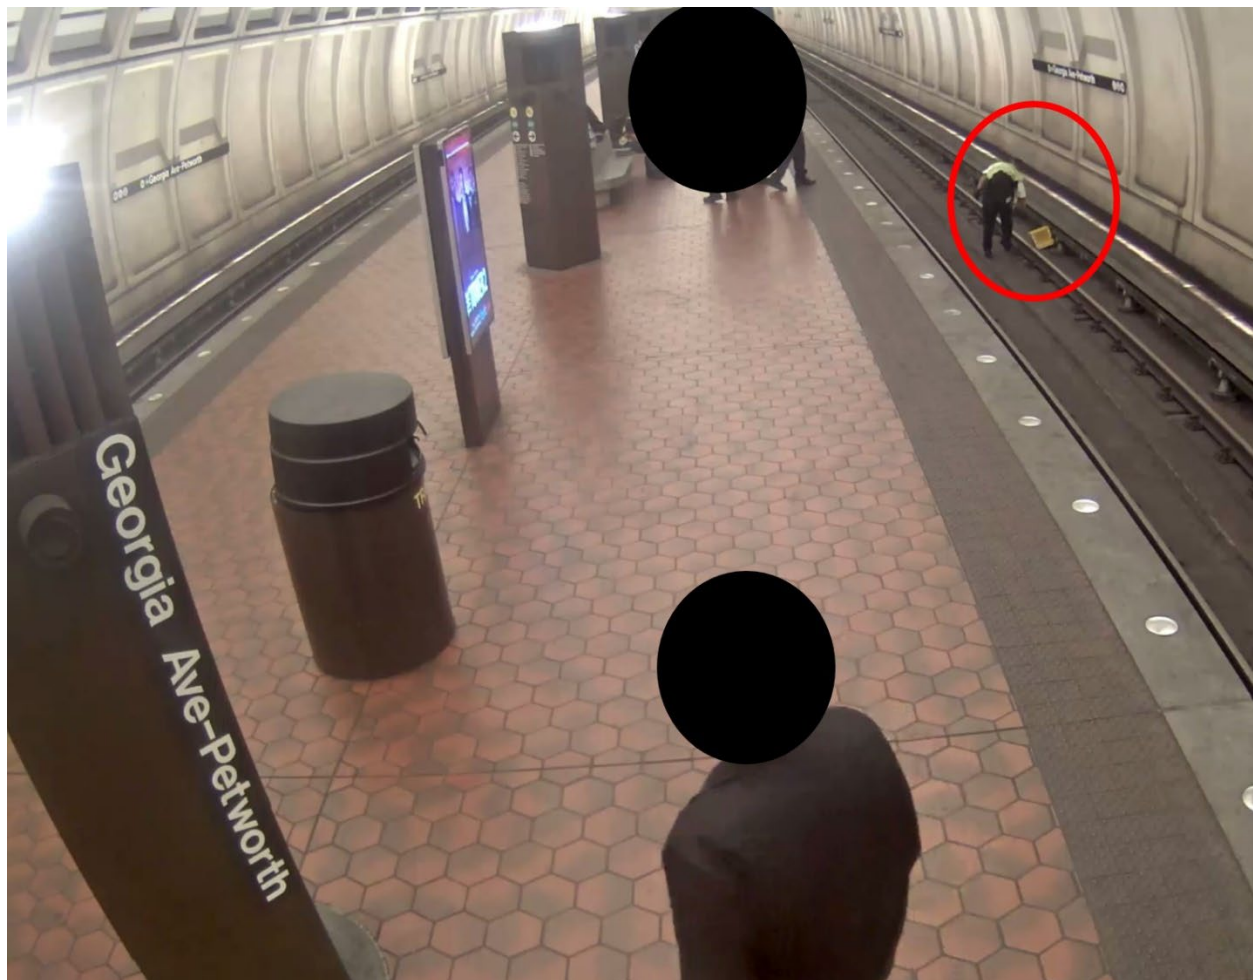
The probable cause of the Improper Roadway Worker Protection (RWP) event was a misapplication of established rules and procedures. The Rail Supervisor retrieved the Wet Floor sign while it was in close proximity to the energized third rail, which was a violation of established procedure. The possibility of incidental contact existed, and to minimize this risk, the third rail power should have been de-energized or other preventive measures enacted.

A review of CCTV recordings at the station found that the customer intentionally tossed the Wet Floor sign onto the roadway at 12:25 hours. At 12:26 hours, Train ID 507 entered the platform limits and serviced the station. After servicing, Train ID 507 departed and the Wet Floor sign remained on the roadway, in close proximity of the third rail. The Rail Supervisor was observed at 12:55 hours walking towards the Wet Floor sign. The Rail Supervisor was wearing standard safety work gloves only during the retrieval of the Wet Floor sign.

Figure 3 – Rail Supervisor retrieving the Wet Floor sign, in close proximity to the third rail, within the platform limits at Georgia Avenue – Petworth, Track 1 at approximately 12:55 hours.

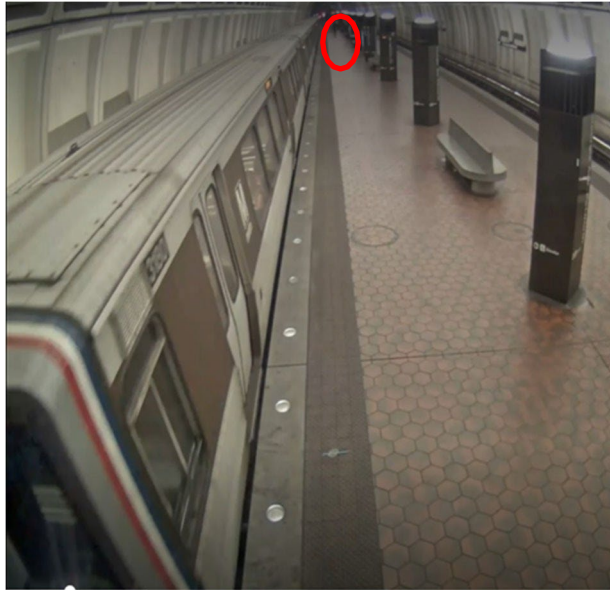
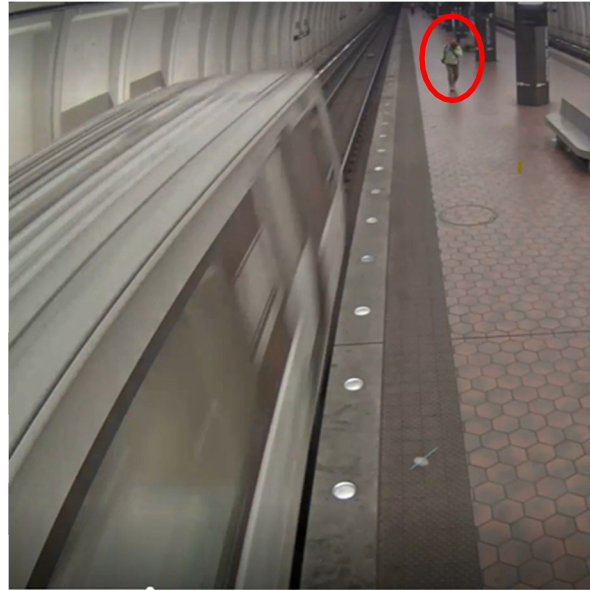
Image 1 – AMF arriving to flag as Train ID 512 departs Georgia Avenue Station.

Closed-Circuit Television (CCTV) revealed that at 19:06 hours, the AMF descended an escalator from the mezzanine to the platform as Train ID 512 arrived at Georgia Avenue Station. The AMF appeared to grasp the shoulder microphone while walking.

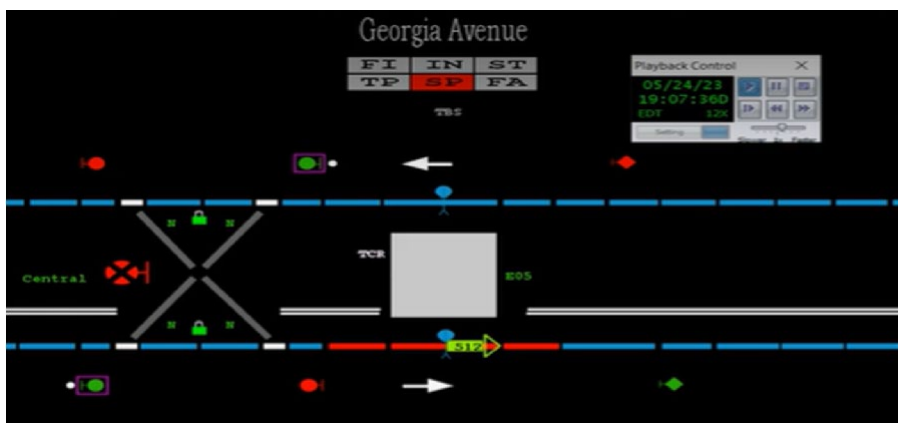
AIMS Playback affirmed that at 19:07 hours, Train ID 512 departed Georgia Avenue Station on track 1. There was a blue block in place on track 1.

Figure 1 – Train ID 512 Departs Georgia Avenue Station
