WMSC Commissioner Brief: W-0293 – Improper Door Operation – Archives Station – May 26, 2023

FINAL REPORT OF INVESTIGATION A&I E23358

Archives Station – Improper Door Operations

May 26, 2023

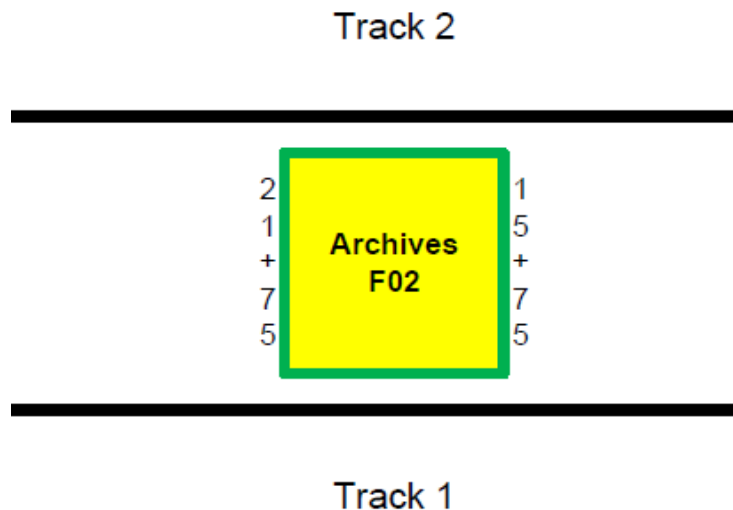
Field Sketch/Schematics

Archives Station - a center platform station, Track 1

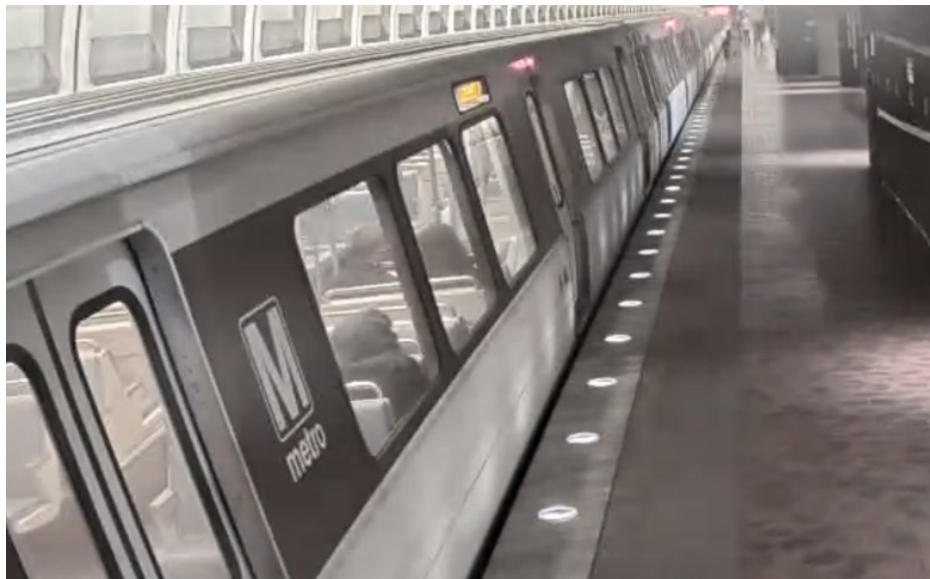
Figure 1 - Train ID 514 door signal lights illuminated, indicating train doors are open along consist. (Door closed on platform side)

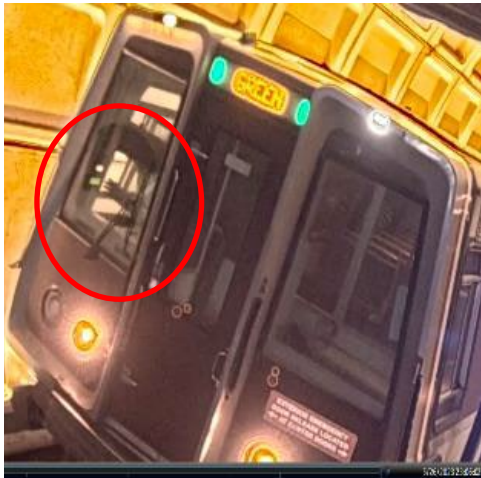
The Train Operator reported in their written statement and interview that they were sneezing and spitting out of the Operator's control-side cab window as they stopped at the eight-car marker and mistakenly pressed the Door Open pushbutton.

Figure 2 – Depicts the Train Operator pressing the door open button on Train ID 514 opening the train doors off-platform.

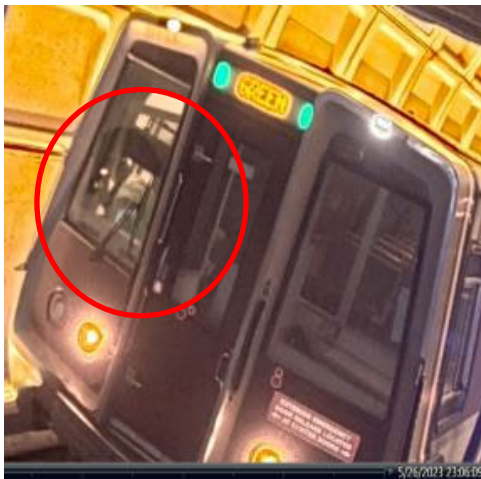
Figure 3 – Depicts the Train Operator's head out of the operator cab window on the off-platform side closing the train door.

The Train Operator immediately realized their error and pressed the Door Closed pushbutton. When they looked down the platform, they did not see the doors open off the platform side, so they believed the doors didn't actually open.

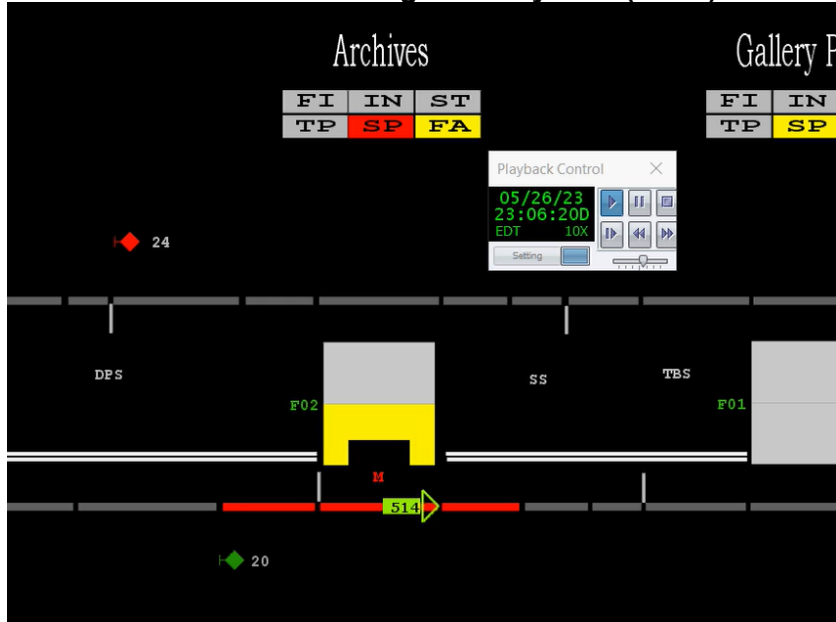
The Advanced Information Management System (AIMS) playback confirmed Train ID 514 opening the train door off the platform, displaying a yellow square instead of a grey square (See Figure 4).

Figure 4 - AIMS playback depicting Train ID 514 opening the train door off the platform. (*yellow square indicates train door open on the wrong side)

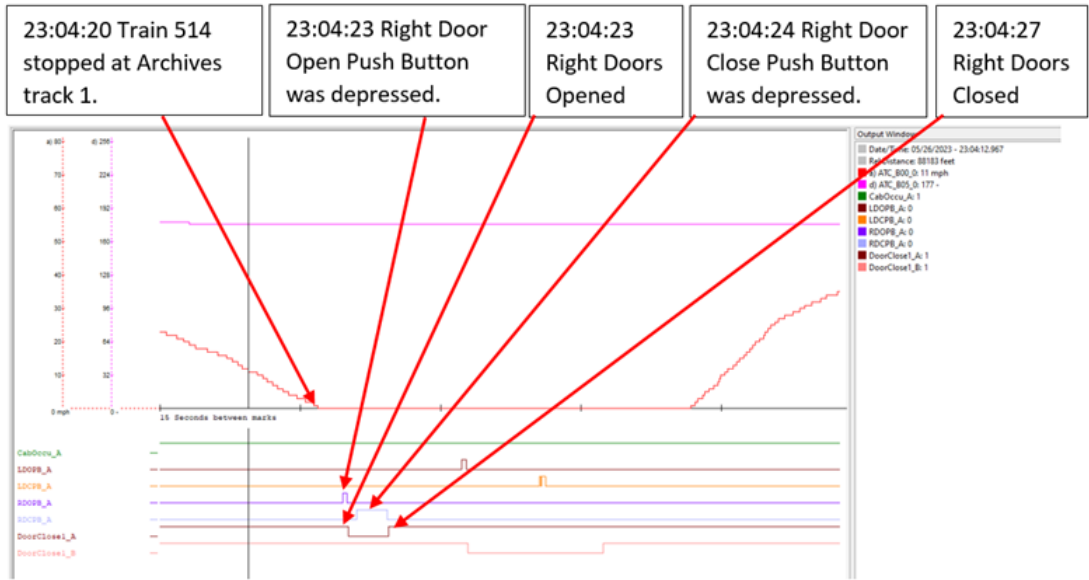
“IIT completed the data analysis of the incident below. Based on the data, Train 514 stopped at Archives (Archives are a Center Platform; hence the left doors face the Platform); after stopping at Archives, a Right Door Operation was Performed (Doors Opened off the platform side). A second after the doors opened off the platform, the right doors close button was depressed, and the doors closed. The right doors were opened or transitioned to the closed position for 4 seconds. The doors were opened on the platform side, and the station was serviced after the improper door operation. Based on the VMS data, no mechanical failure could have contributed to this incident; the doors responded to the commands that the door push buttons entered.”

Figure 5 - Data Analysis from the lead railcar 3250.
