WMSC Commissioner Brief: W-0294 – Evacuation for Life Safety Reasons – Greenbelt Rail Yard – December 5, 2023

FINAL REPORT OF INVESTIGATION A&I E23867

Greenbelt Yard S & I Shop – Evacuation for Life Safety Reasons

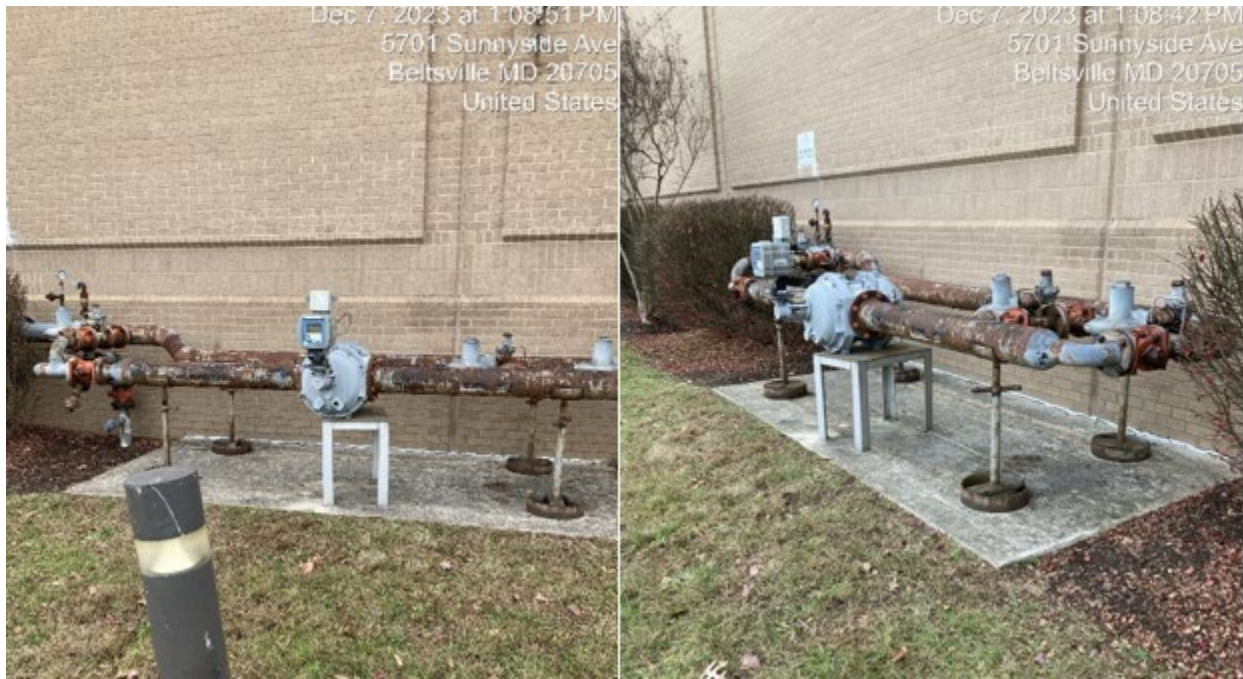
The probable cause of the Evacuation for Life Safety Reasons on December 5, 2023, at Greenbelt Yard S&I Shop (Building B) was a gas leak from the first shut off valve on the gas meter located outside the S&I Shop.

Image 1 front view of leaking gas meter & Image 2 angle view of leaking gas meter.

- PGFD was dispatched and shut the gas off.
- COMM reset the manual pull station (fire alarm).
- The first valve on the gas meter was repaired.
