The Washington Metrorail Safety Commission

Safety Audit

of the Washington Metropolitan Area Transit Authority
Audit of Revenue Vehicles (Railcar) Program

Final Report:
May 21, 2024

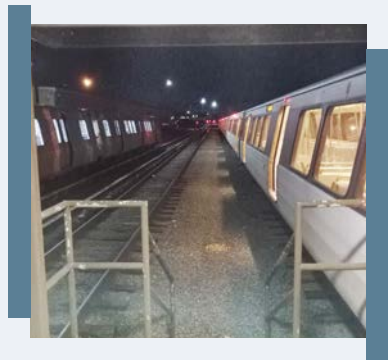
The WMSC also observed that Metrorail personnel are not properly crimping the seals in accordance with Metrorail requirements. Metrorail requires use of a special crimping tool for VMS/VMDS switches as an additional layer of assurance that these critical safety monitoring systems have not been unsealed without proper communication. Most railcar shops the WMSC asked to show these tools did not immediately know where they were, and spot checks showed railcars without this special stamp on the VMS seal. As the audit process was concluding, Metrorail provided a planned procedural revision that explicitly notes this as a required special tool in the 2000/3000 Series and 6000 Series C Periodic Inspection. Separate crimping tools are intended to be used to crimp other seals in place, however personnel stated they frequently use pliers or other tools rather than the intended crimping tools. These other tools do not assure that the fragile seals properly remain in place between inspections. Metrorail had been working to implement CAP C-0138 to address the identification of and availability of necessary special tools.

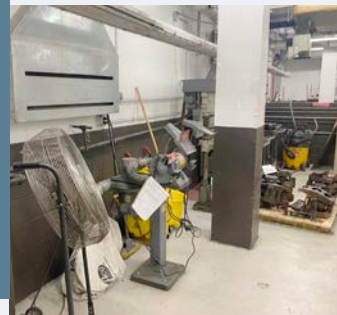
The WMSC observed materials such as cardboard and other items in the immediate area of these grinders, within the rooms where these grinders are placed in areas including the Greenbelt and Brentwood facilities.

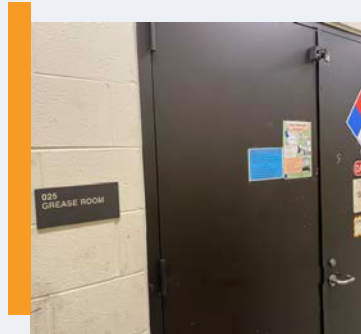
The WMSC also identified some fire extinguishers in railcar shops that had not been checked for several months.

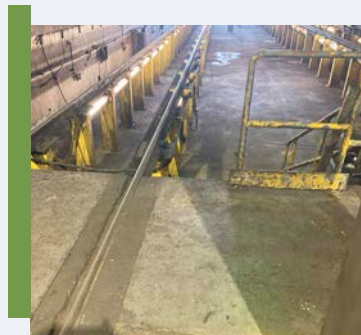
Metrorail railcar maintenance facilities include open pits to permit for undercar maintenance and cleaning without the use of lifts and elevated work platforms for railcar roof work. For some of these pits and platforms, Metrorail has railings along the sides of the pit or visible safety markings. However, Metrorail does not have fall protection that encompasses areas such as its wheel lathes, has floor markings in other areas placed directly at the edge of the pit rather than several feet away as specified in OSHA requirements within 29 CFR

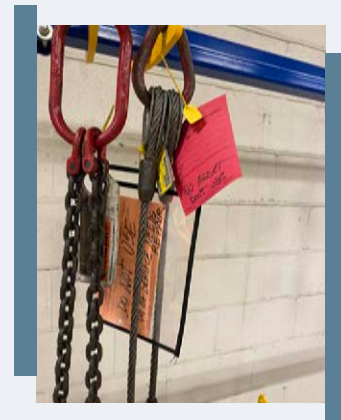
Equipment in the basement of the Brentwood Service and Inspection building was stored without any tags indicating it was nonfunctional.

Metrorail processes require out of service equipment to be tagged to mitigate the hazard of personnel using inoperable or otherwise unsafe equipment.

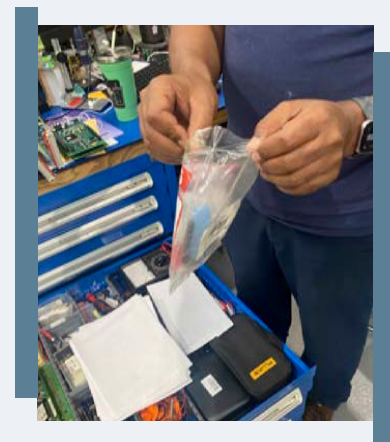
The boards were together in a container without protection, and each board was placed and removed by personnel not using electrostatic protection.
