## W-0295 – Collision at Twinbrook Station – December 9, 2023

**FINAL REPORT OF INVESTIGATION A&I E23878**

# Twinbrook Station – Collision

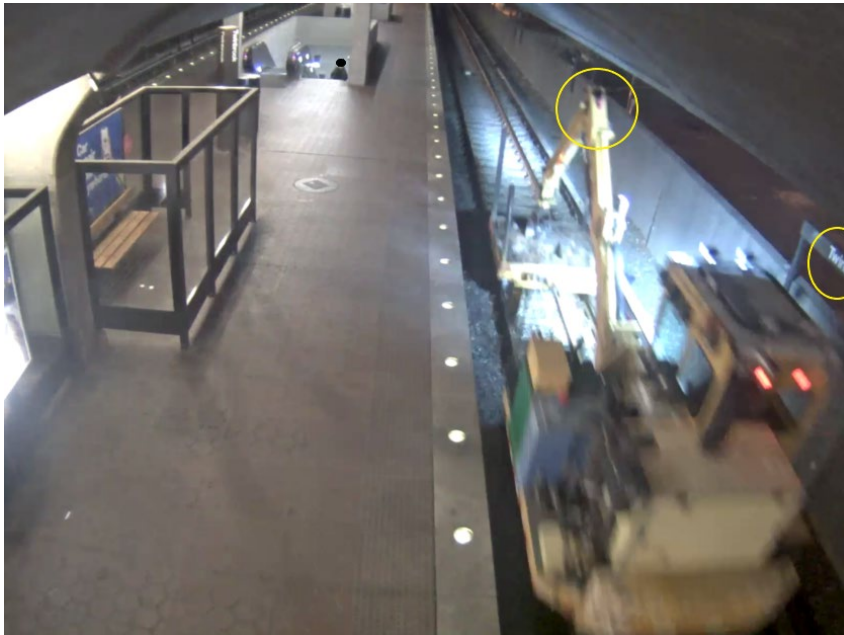
At 01:17 hours, CCTV observed TC-07 enter the platform limits of Twinbrook Station on track 1. TC-07's boom was observed unsecured, which increased the clearance height of the unit.

*Image 1 - TC-07 traversing Twinbrook Station, track 1 at 01:17 hours with the boom elevated.*

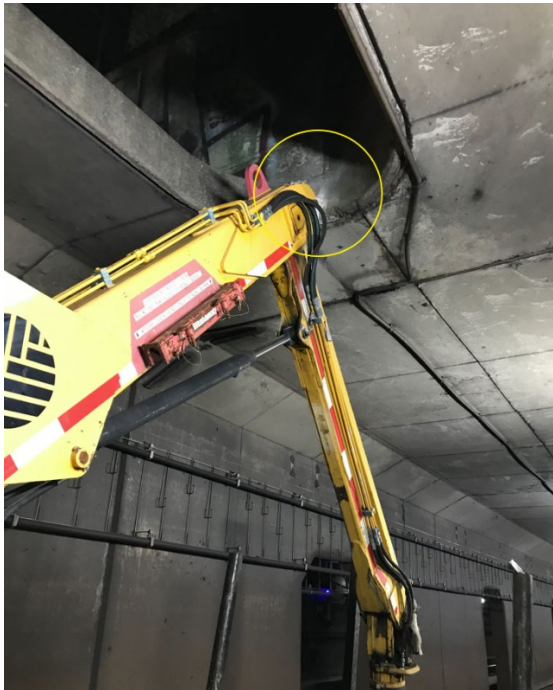
The Advanced Information Management System (AIMS) revealed that at 01:23 hours, TC-07 stopped moving at the portal between Twinbrook Station and North Bethesda Station at CM A1 674+00, inferring the boom impacted the portal entrance.

Image 2 - TC-07 stopped at the point of rest at CM A1 674+00.

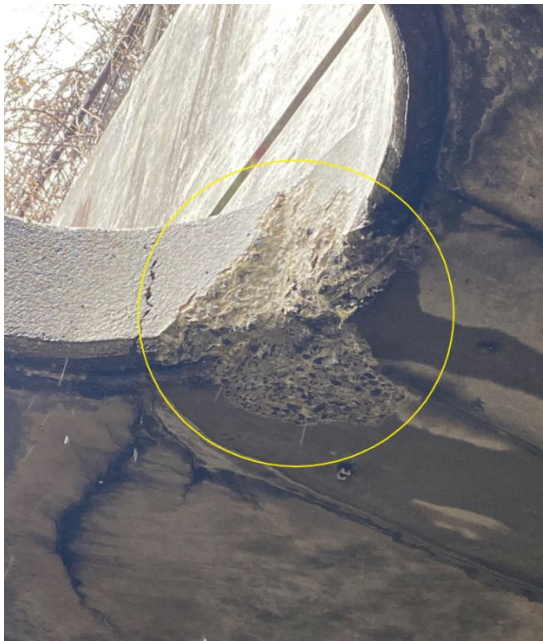
An assessment of the portal for infrastructure damage was conducted after the incident. TRST determined that there was minor damage to the portal and that there was a pre-existing crack in the concrete where the surface had been chipped away by the impact; structural damage was not present.

*Image 7 - Superficial chipping of the portal was observed during an inspection by TRST.*

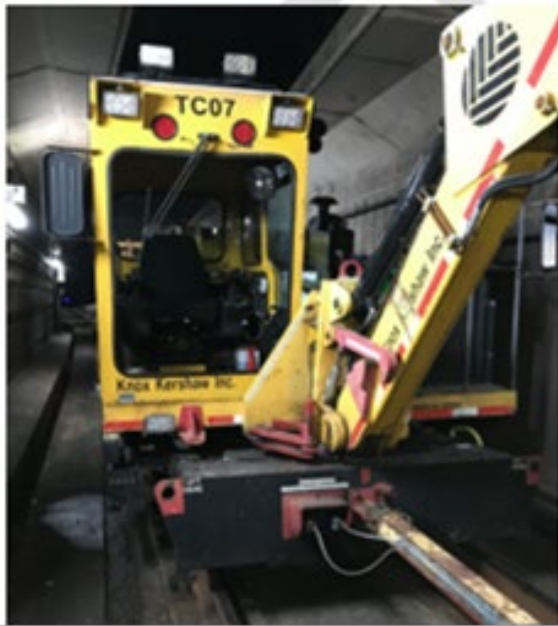
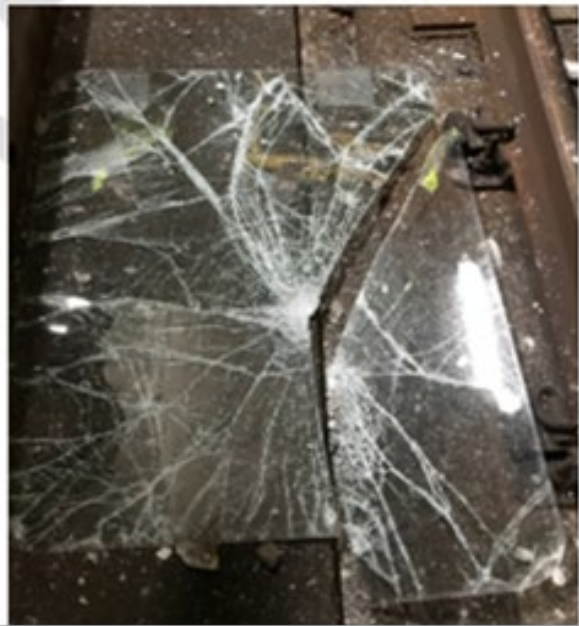
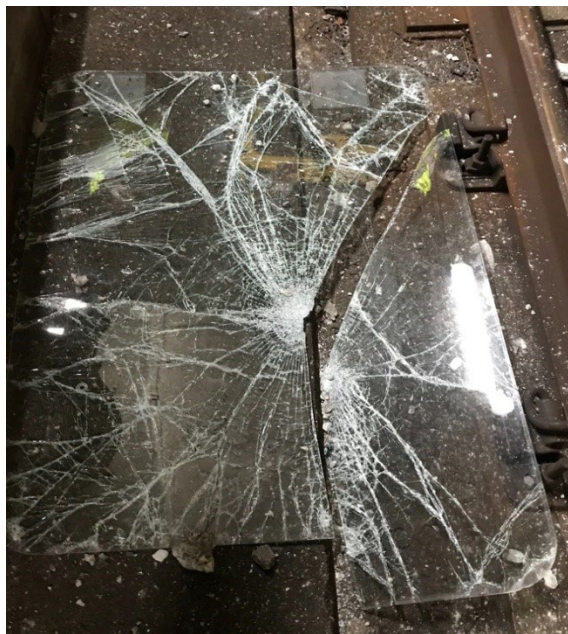
TRST confirmed that TC-07's boom was not locked into place during travel, allowing for the boom to impact the portal. The collision, coupled with the unit not having a seat belt, caused the Equipment Operator to be ejected from the unit through the windshield and landing on the roadway.

Image 8 - The Equipment Operator's seat of TC-07 and the shattered glass from TC-07.

- Metrorail developed a Personnel Notice to ensure restraint systems are utilized where available
- Equipment Operator attended retraining
- Metrorail conducted an audit to ensure all existing RMMs have restraint systems
- Metrorail updated maintenance instructions to inspect the restraint system during scheduled maintenance
- Metrorail is retrofitting existing RMMs without restraint systems with appropriate restraint systems (Scheduled completion date January 2025)

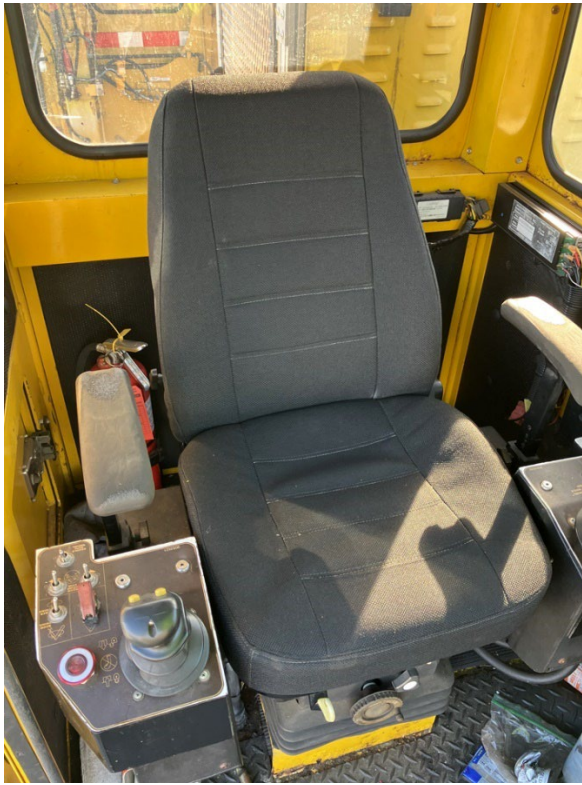
Image 9 - TC-07's main cabin and seat are not equipped with seat belts.

CTEM also conducted an audit of all existing RMMs and found several without functioning restraint systems, including equipment that was never designed to be equipped with a restraint system. CTEM has stated they intend to rectify this by retrofitting restraint systems across all RMMs.

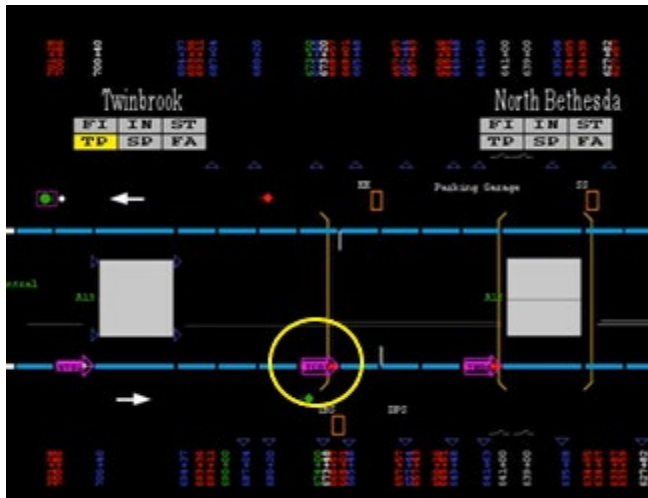
Figure 3: TC-07 stopped at CM A1 674+00 01:23 hours, as ST-02 approached Twinbrook Station, track 1 from behind.
