Improper Roadway Worker Protection

At or Near Branch Ave., Stadium-Armory, Federal Center SW, and Rosslyn stations

January 26, 2023 – February 25, 2023 – June 8, 2023 – September 12, 2023

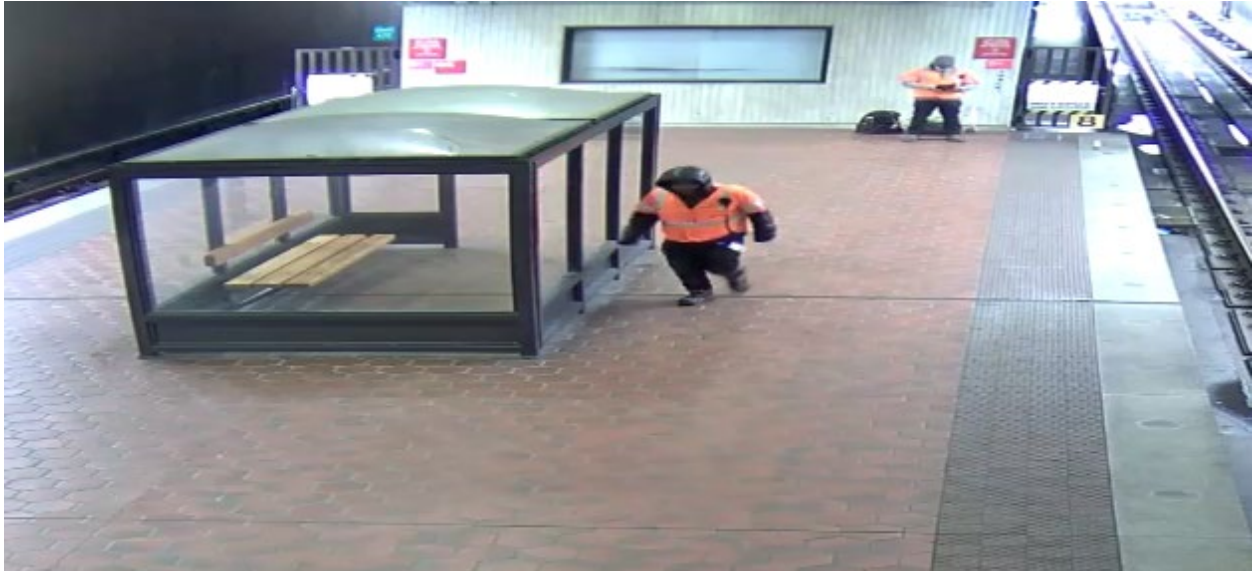
At 11:34 hours, AMF #1 departed the platform area. AMF #2 appeared to be engaged with a tablet device while performing their duties.

Image 1 –AMF #1 departing their post and another AMF #2 utilizing a tablet at 11:34 hours, while the Mobile Work Crew is under foul time.

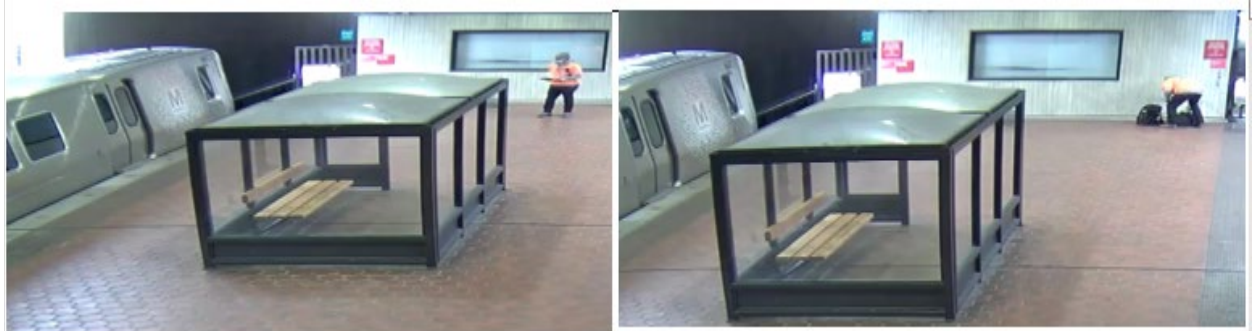
At 11:37 hours, Train ID 896 adjusted to the 8-car marker and the cab window appeared to be closed. AMF #2 walked towards the train, then at mid-platform turned back towards track 1. At 11:38 hours, AMF #2 placed the tablet in a bag, then walked towards Train ID 896. Train ID 896 departed Branch Avenue Station prior to the AMF reaching them.

Image 2 – Depicting Train ID 896 adjusted to the 8-car marker and the AMF placed the tablet in a bag.

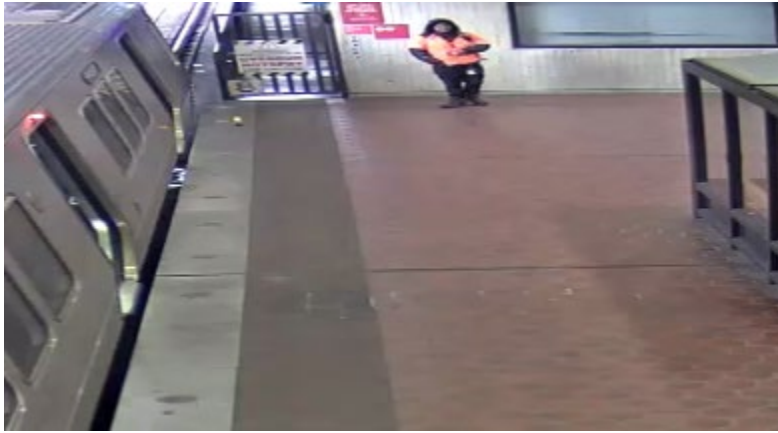
At 11:40 hours, AMF #1 returned and positioned themselves to flag on track 2.

Image 3 - AMF returned and positioned themselves near the 8-car marker on track 2.

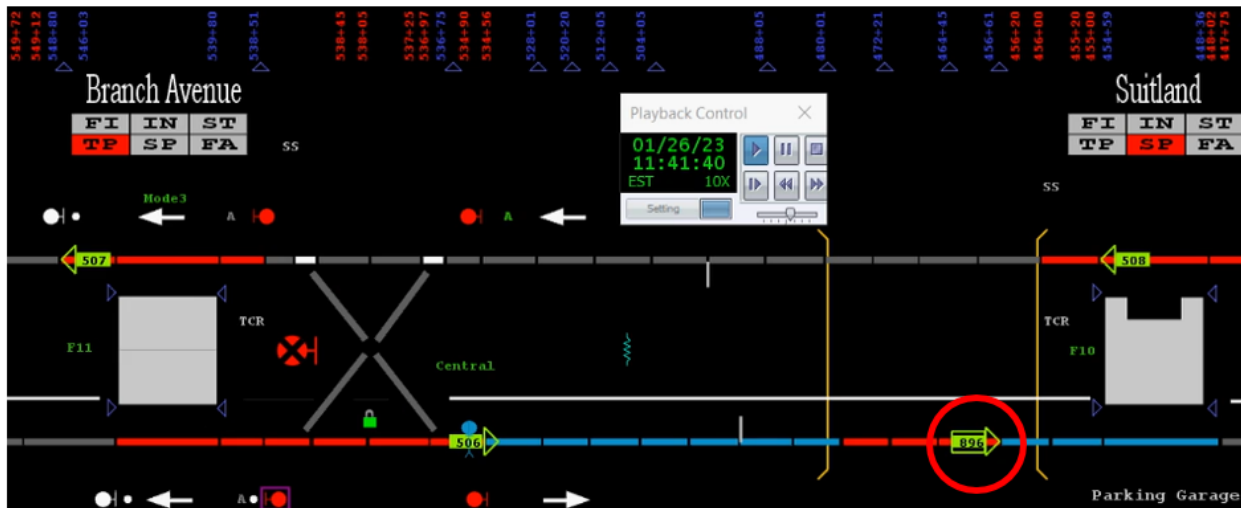
At 11:41 hours, Train ID 896 reported that they observed personnel on the roadway and did not receive a briefing from an AMF before departing Branch Avenue Station. The Training Instructor advised the Radio RTC that there was an AMF at Branch Avenue Station but they did not approach their train. The Button RTC notified the AOM of the event.

Figure 1 – AIMS depiction of Train ID 896 at 11:41 hours, as they reported observing personnel on the roadway.

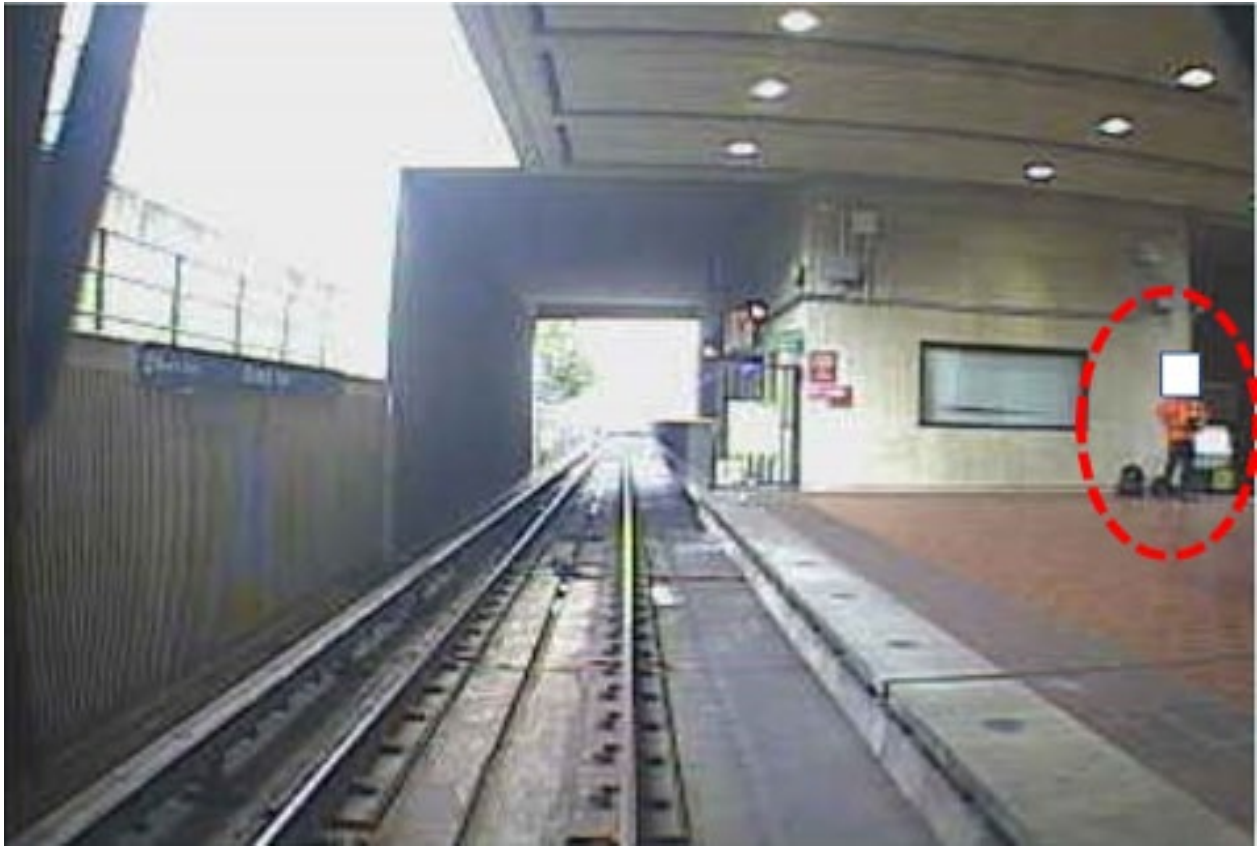
In the NVR video, the AMF can be seen on the opposite side of Branch Avenue Station (track 1 side), but there is no evidence that the AMF spoke with the operator prior to Train ID 896 departing Branch Avenue.”

Figure 2: AMF at the platform track 1 side

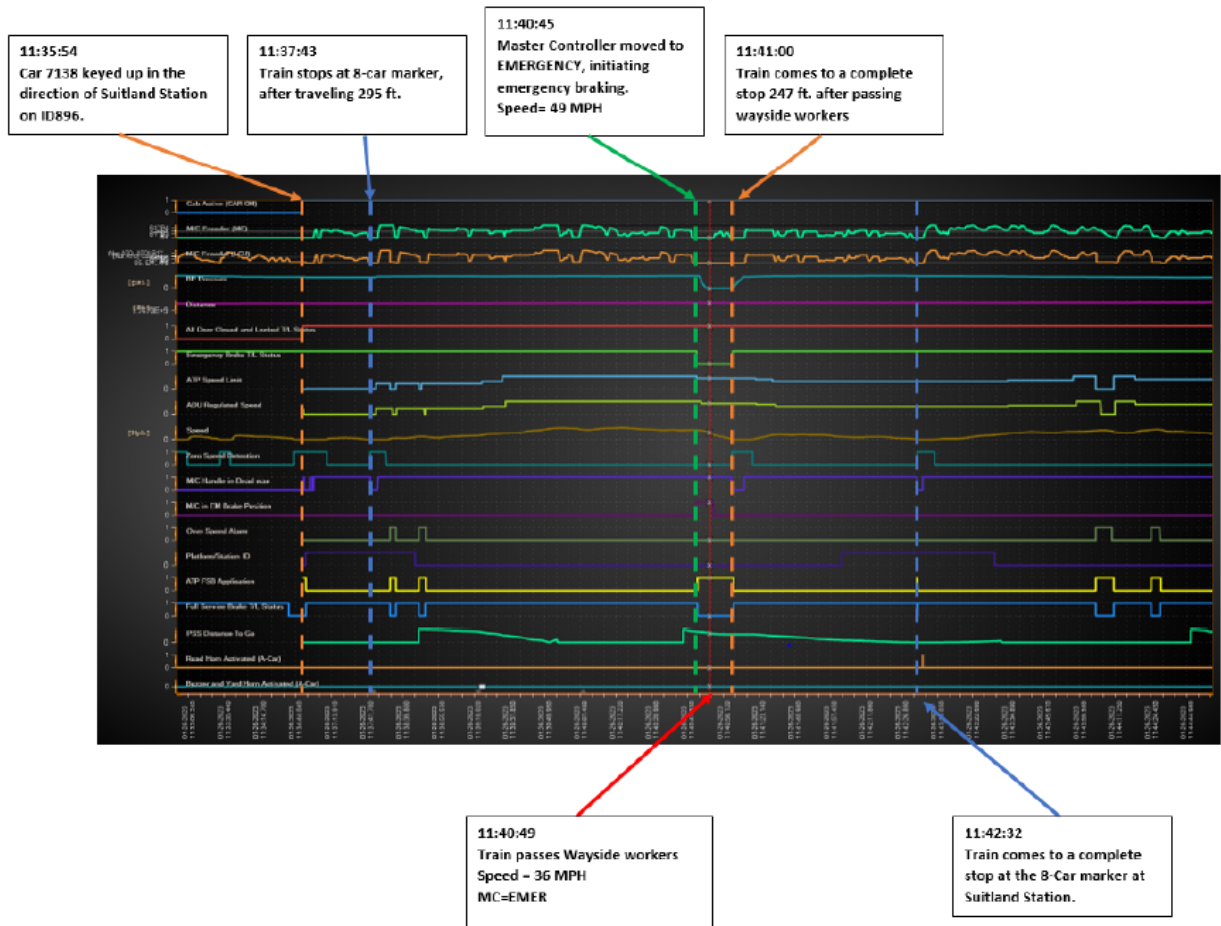
Figure 3: Car 7138 ER Data Analysis

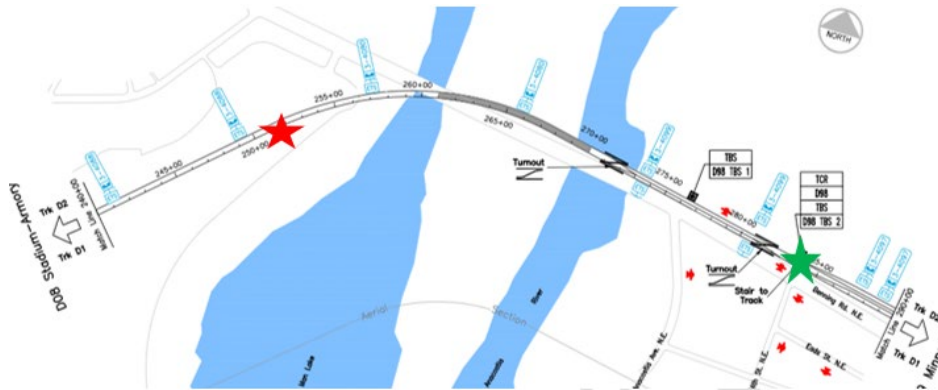
Figure 1 - Figure 1: The green star indicates where Train ID 607 made the work crew drop off. The red star indicates the location of the work crew that reported that Train ID 607 passed them at an excessive speed. The above depiction is not to scale.

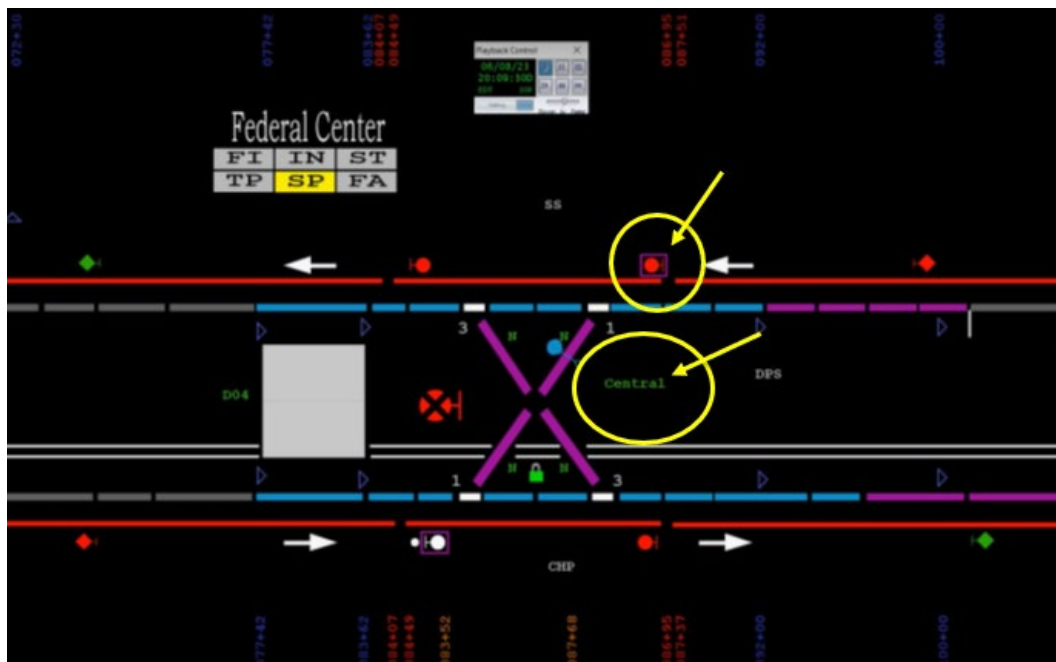
Figure 1 - AIMS depicting LCP in Central position and D04-08 signal is red protecting the FT area at 20:09 hours.

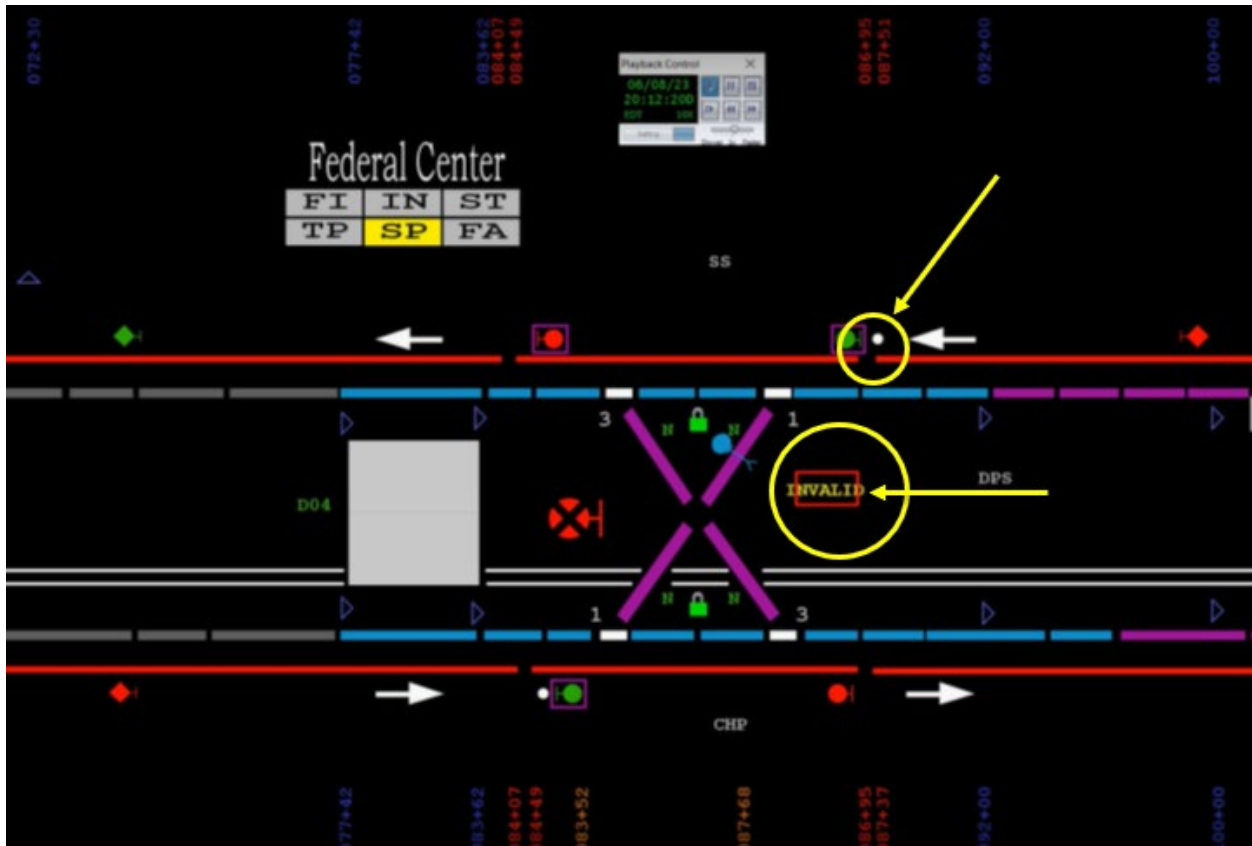
Figure 2 - AIMS depicting LSC in an Invalid Status and D04-08 signal is Lunar while the area is under FT and signals are at 20:12 hours.

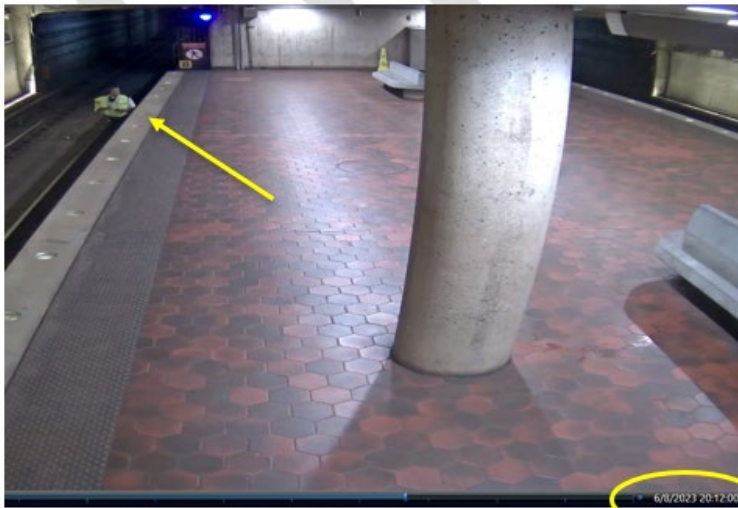
According to the CCTV at 20:12 hours, the RTRA Supervisor is seen entering Track 2 roadway at L'Enfant Plaza to retrieve a cellphone.

Figure 3 - RTRA Supervisor on the roadway at 20:12 hours.

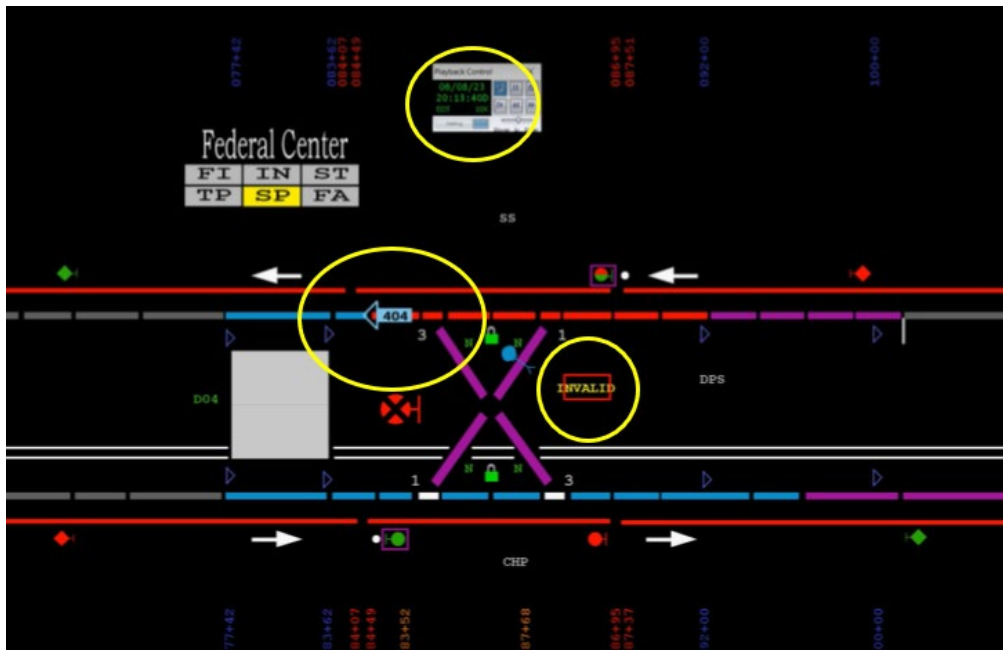
Figure 4 - AIMS depicting LCP in an Invalid Status as Train ID 404 passes through the FT area at 20:13 hours.

At 20:13 hours, the Rail Supervisor relinquished FT, and simultaneously, Train ID 404 passed D04-08 signal lunar into the FT area. At the time of that incident, the Control Panel indication on

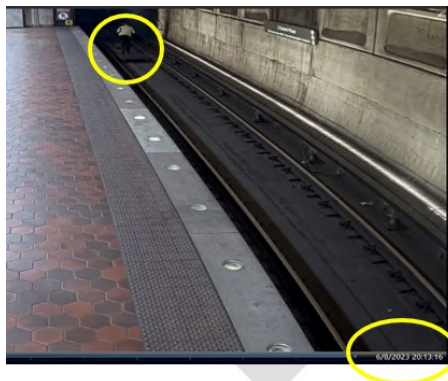
Figure 5 - RTRA Supervisor on the roadway at 20:13 hours.

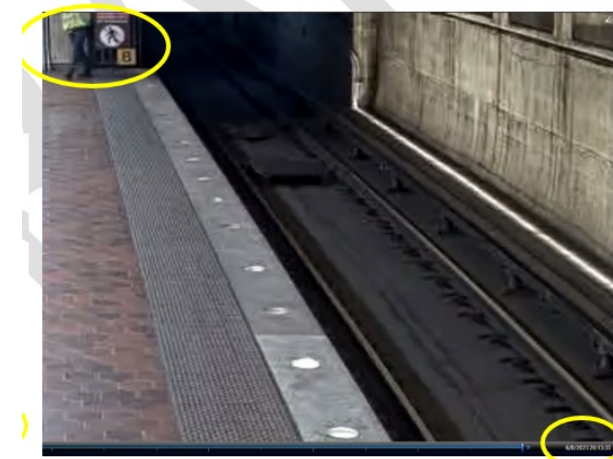
Figure 6 - RTRA Supervisor clear from the roadway at 20:13:33 hours.

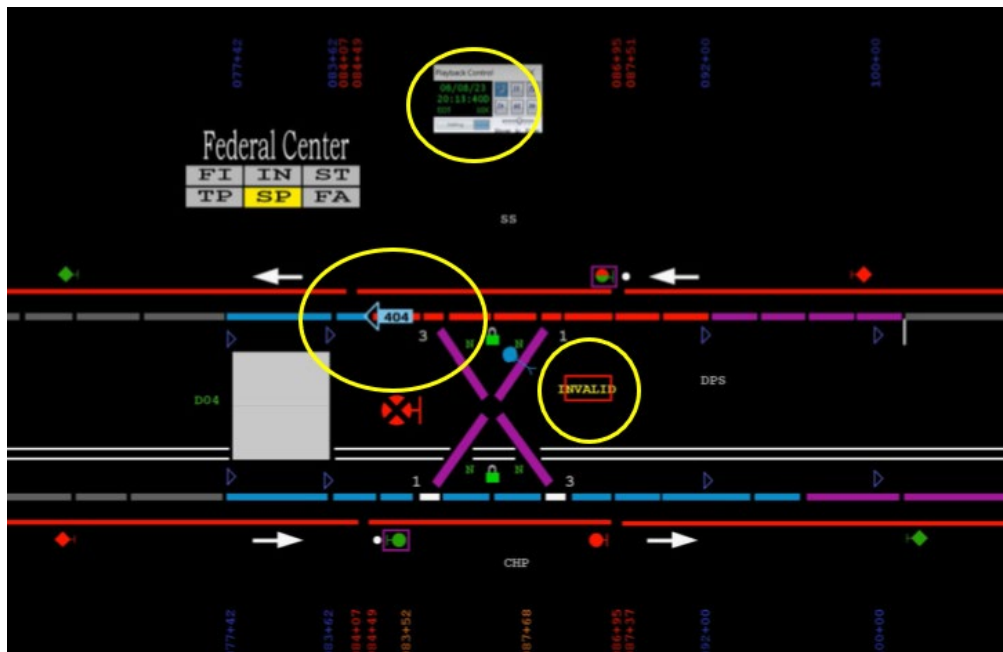
Figure 7 - AIMS depicting LCP in an Invalid Status as Train ID 404 passes through the FT area at 20:13 hours

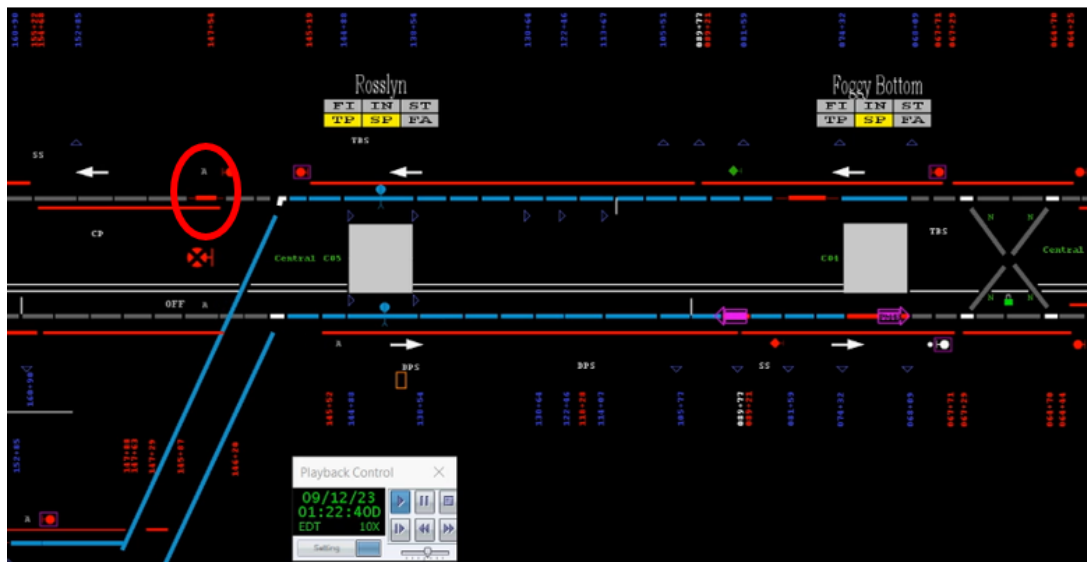
On Tuesday, September 12, 2023, at 01:22 hours, the SMNT Communication Technician placed a shunt at CM K2 148+00 outside of their work area without receiving foul time from the ROCC Radio RTC. This time was established by the AIMS display showing an occupied track circuit at CM K2 148+00.

Figure 1 - AIM Playback depiction of track occupancy shunt placed at CM K2 148+00 at 01:22 hours.

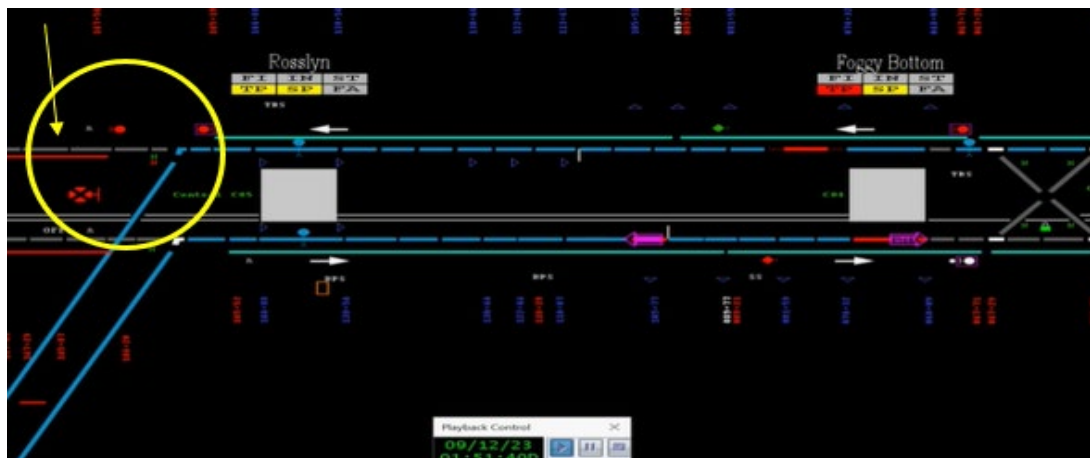
Figure 2 - Depicts the track occupancy cleared and shunt removed at K2 148+00 at 01:51 hours..

The AIMS event playback indicated that at 01:51 hours, the shunt was removed from the track at K2 148+00.

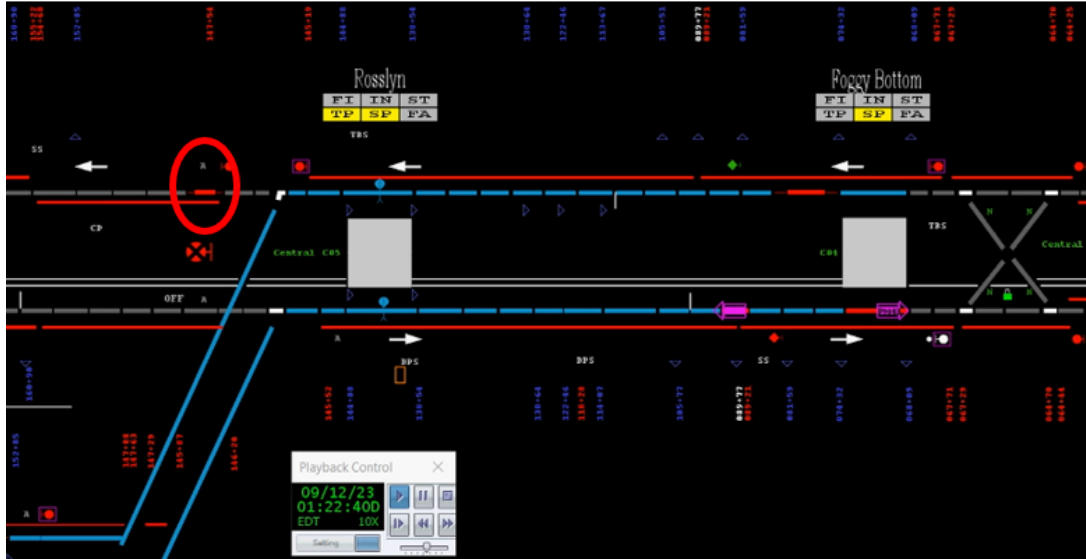
Figure 3 - AIM Playback depiction of track occupancy shunt placed at CM K2 148+00 at 01:22 hours.

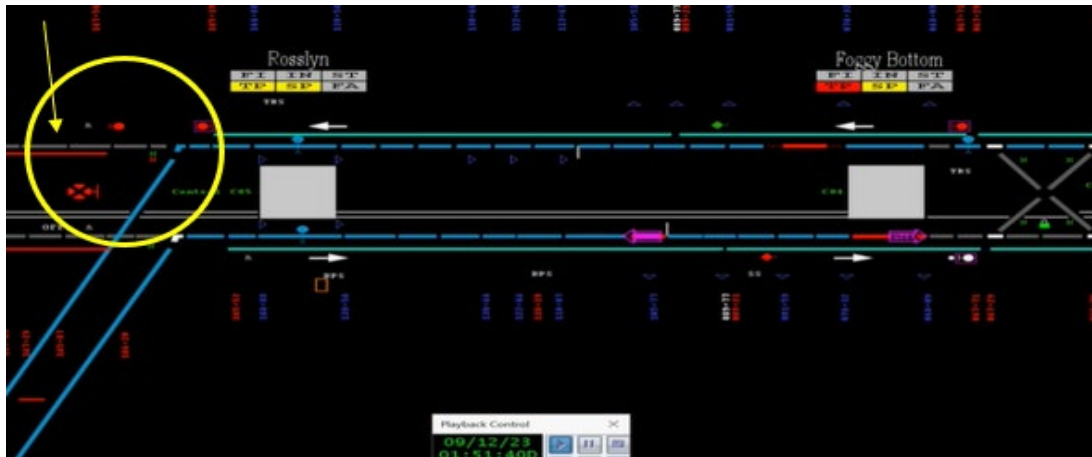
Figure 4 - Depicts the track occupancy cleared shunt removed at K2 148+00 at 01:51 hours.

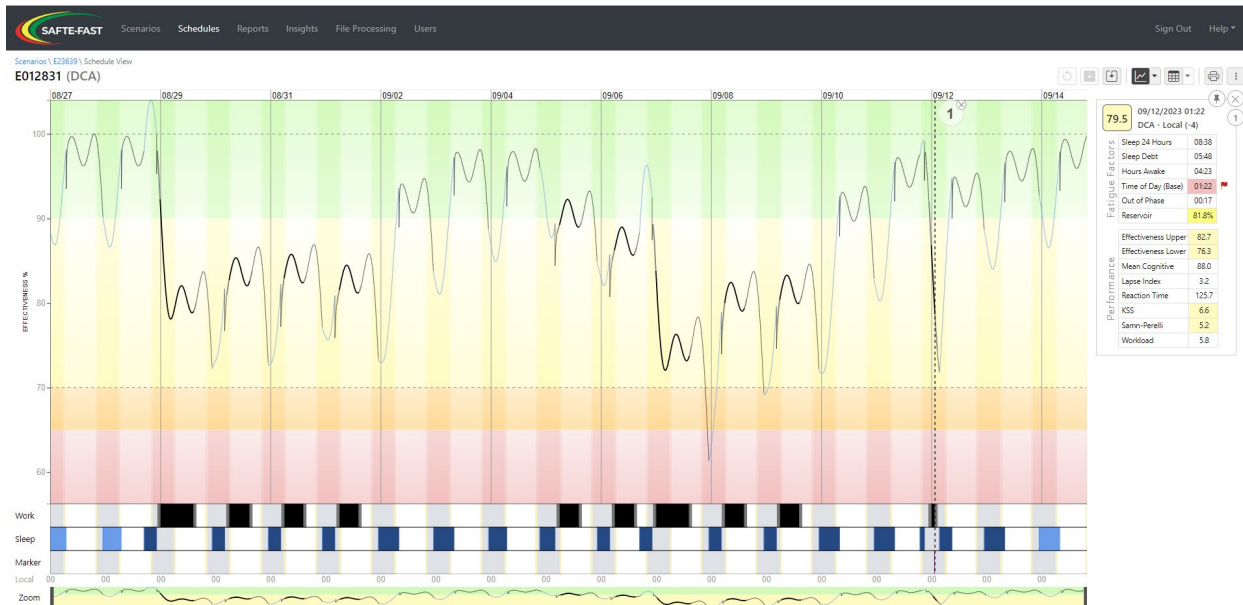
A biomathematical fatigue modeling application (SAFTE-FAST WebSFC) was used to evaluate further fatigue risk factors that may have been present in the Technician's schedule. The analysis was based on the Technician's work schedule, reported sleep from the day before the incident, and reported habitual sleep durations. The estimated performance effectiveness at the time of the incident was 79.5%. Specifically, the analysis identified the circadian effects of night work as a factor contributing to an increased risk of fatigue during the incident.

Modeling analysis output shows estimated performance effectiveness during the incident work shift and for the week leading up to the work shift, based on the employee work and reported sleep schedule. Estimates were based on the Technician's work schedule, reported sleep from the day preceding the incident, and reported habitual sleep durations (5.5 hours a day). Bold portions of the modeled curve show work (in black) and sleep times (in blue). Effectiveness is shown on the vertical axis, with colored fields in the chart background signifying ranges of effectiveness scores including high effectiveness (>90%) in green, and low effectiveness (<65%) in red. Time is shown on the horizontal axis. Markers for work and sleep times are shown in the lanes above the time of day on the horizontal axis.
