**Improper Door Operations – West Hyattsville, Downtown Largo, Deanwood, Smithsonian stations
March 7, 2023 – July 12, 2023 – July 14, 2023 – August 23, 2023**

Document Purpose

Improper Door Operation

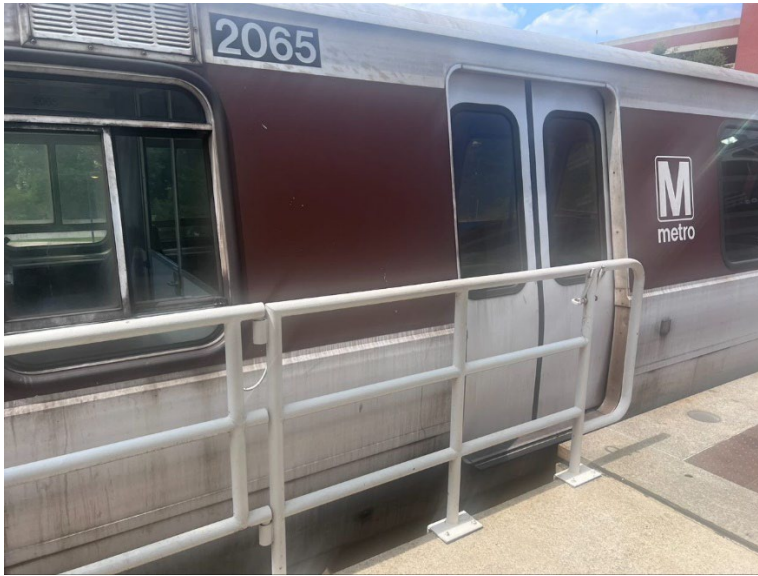
Figure 1 - depicts Train ID 402's trailing two-door leaves on railcar #2065 in front of the platform railing at the end gate.

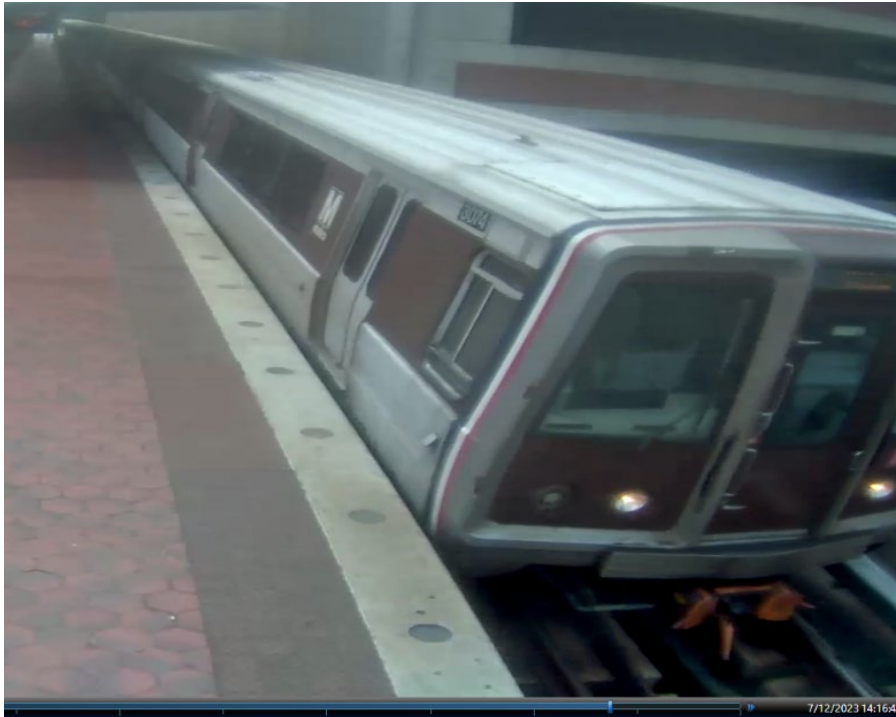
Figure 2 - depicts Train ID 402 lead car 3074 stopping approximately 30 feet from the 8-car marker at 14:16:42 hours.

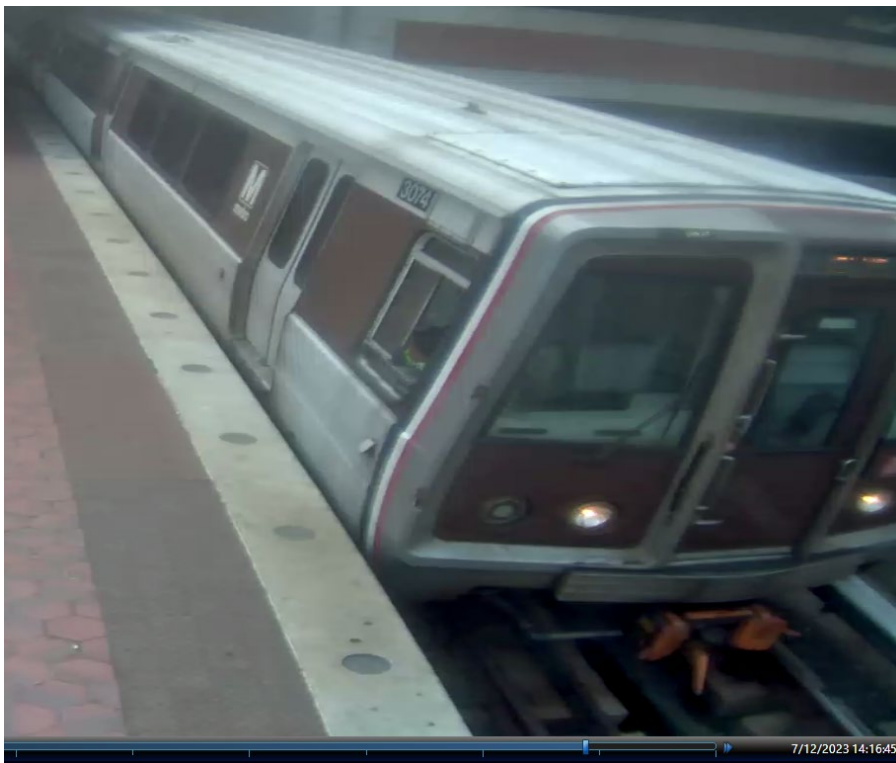
Figure 3 - depicts the Train Operator placing their head out the operator's cab window before opening the train doors at 14:16:45 hours.

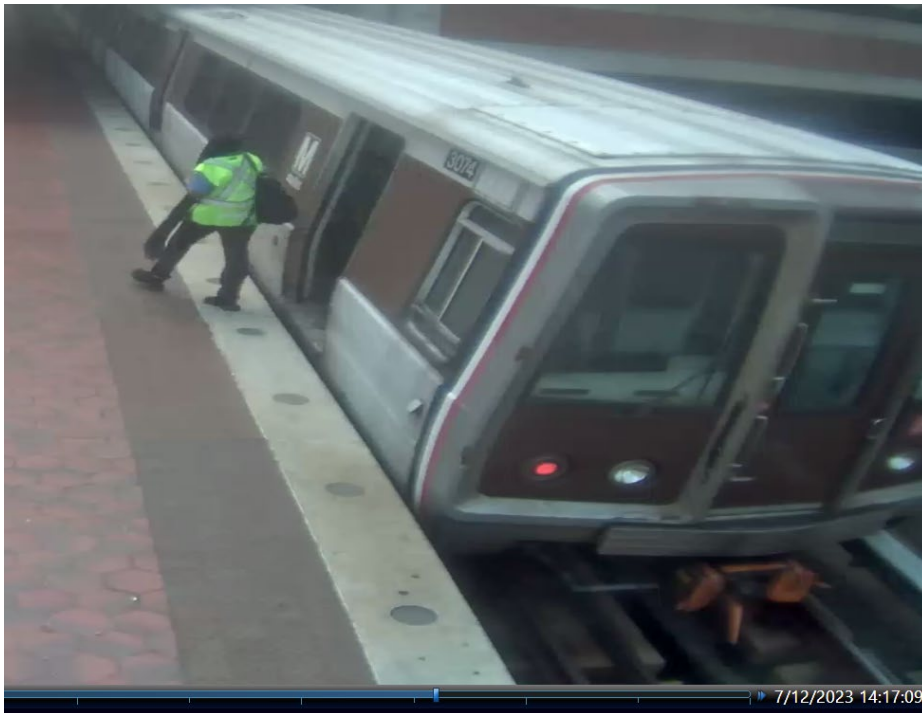
Figure 4 - depicts the Train Operator departing Train ID 402's lead car 3074 with the train doors open and the train not berthed at the 8-car maker.

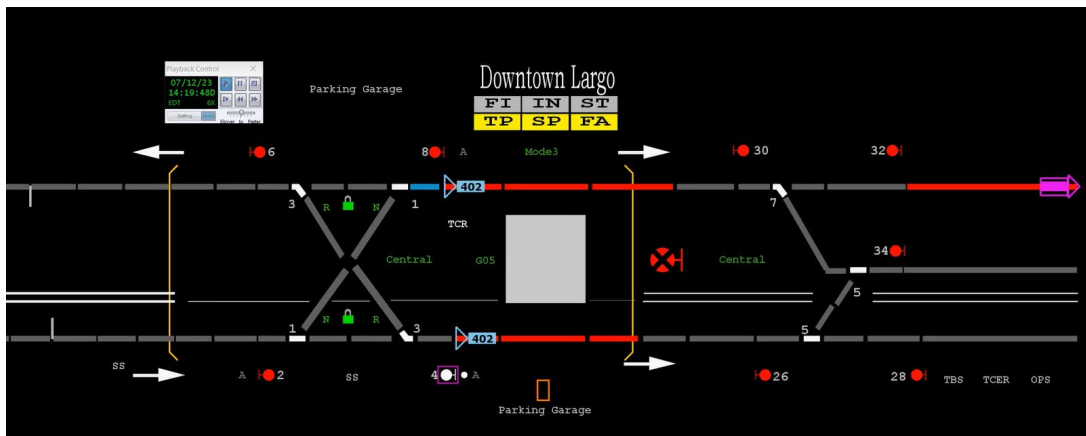
Figure 5 - AIMS depicting Train ID 402 on Track 2 slightly past the G05-08 signal.

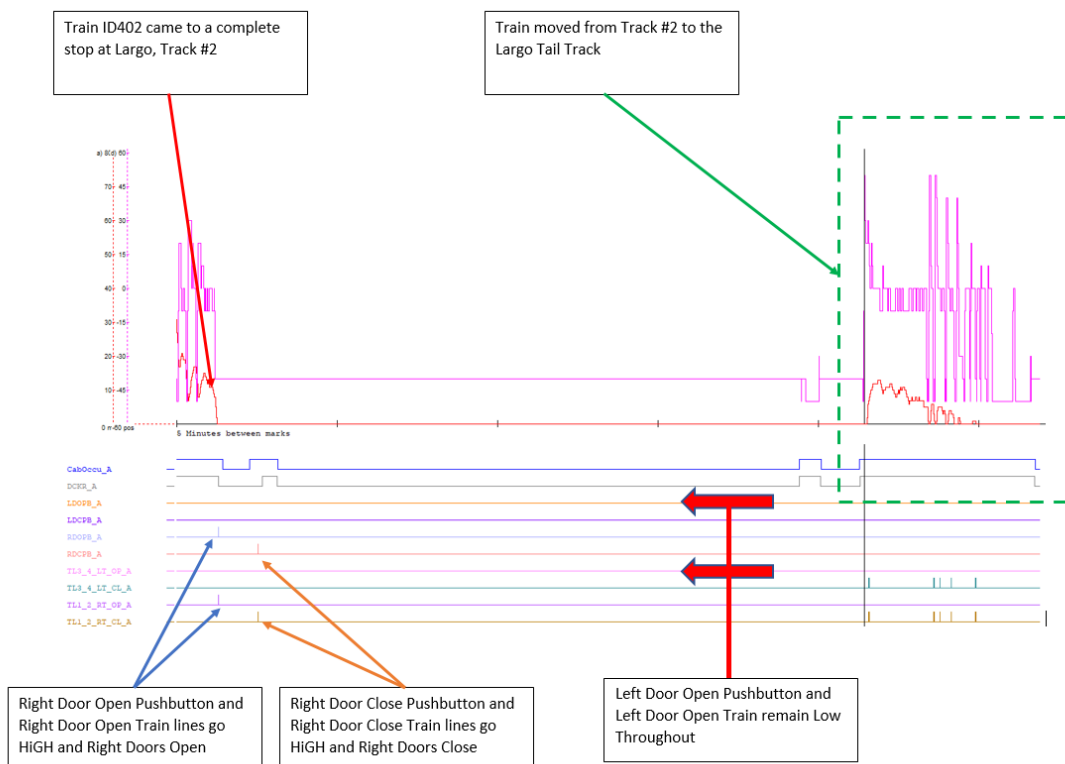
Figure 6 - Data analysis from the lead car 3074.

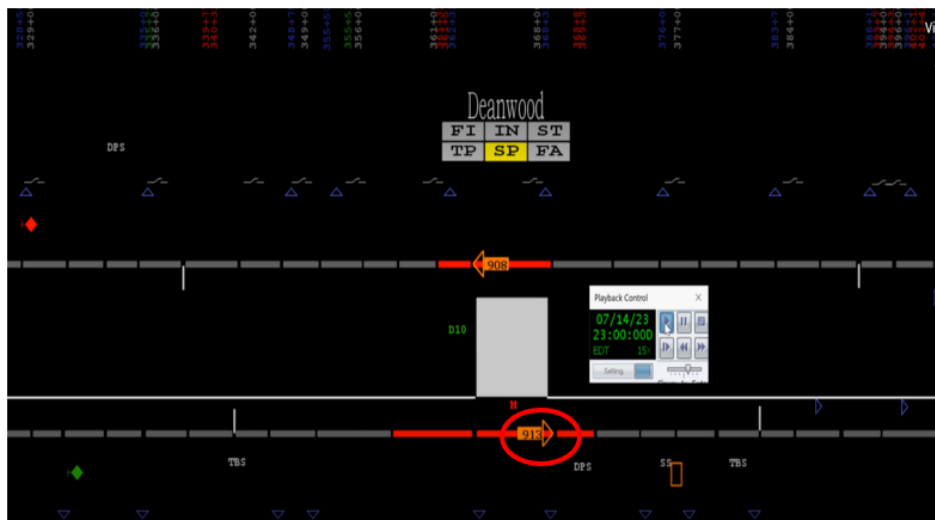
Figure 1 - AIMS playback depicting Train ID 913 at Deanwood Station.

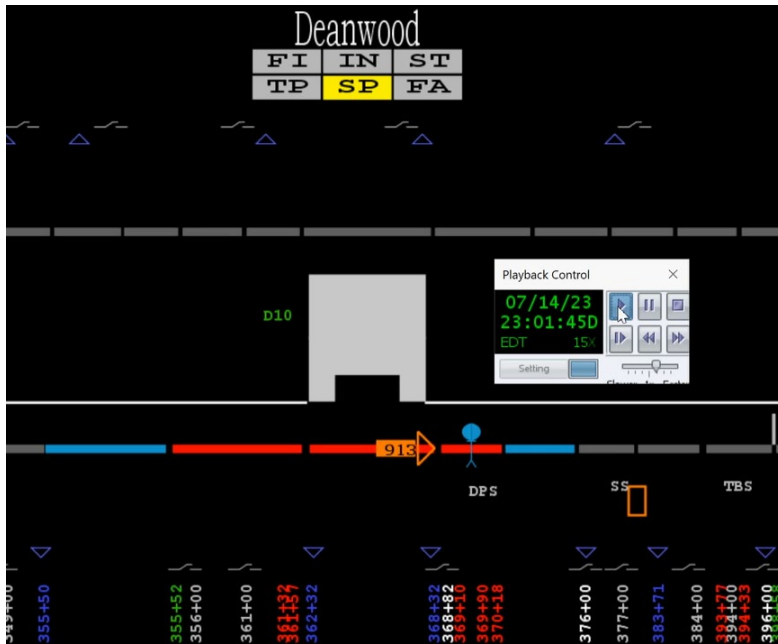
Figure 2 – AIMS playback depicting blue block and human form in place at 23:01 hours.

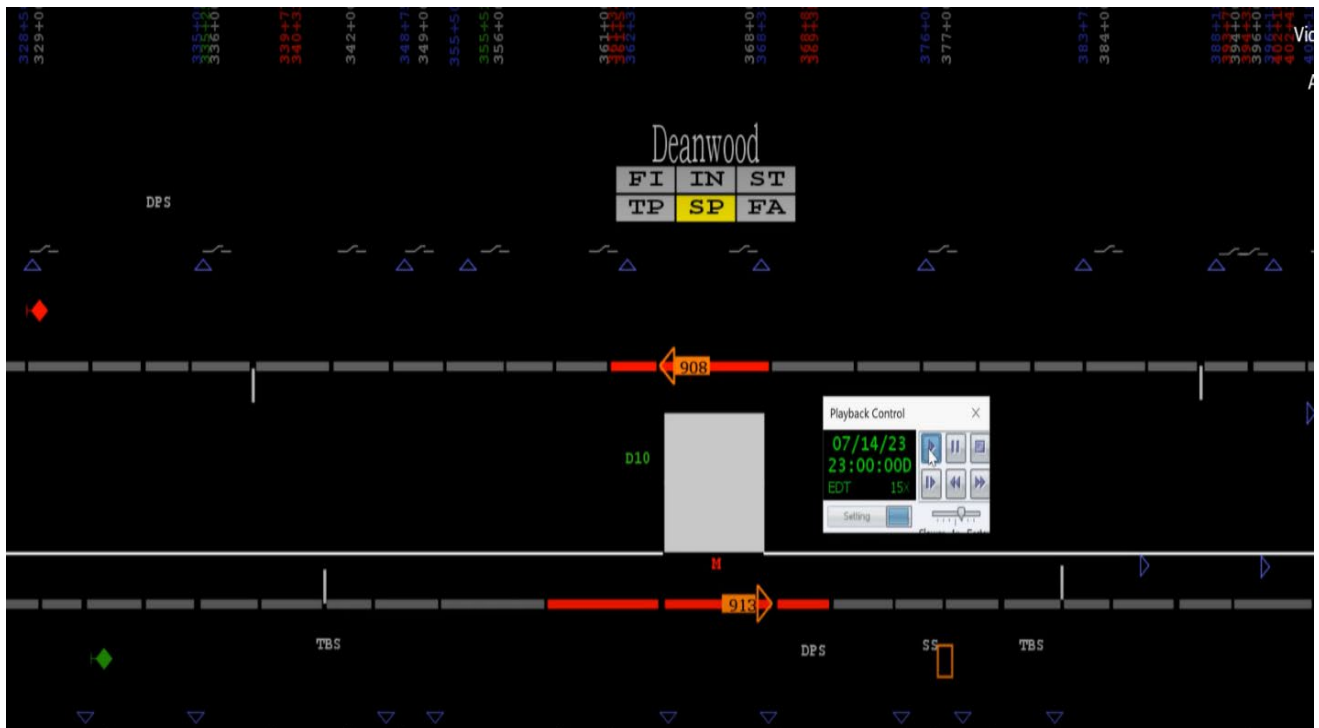
Figure 3 – AIMS playback depicting Train ID 913 at Deanwood Station.

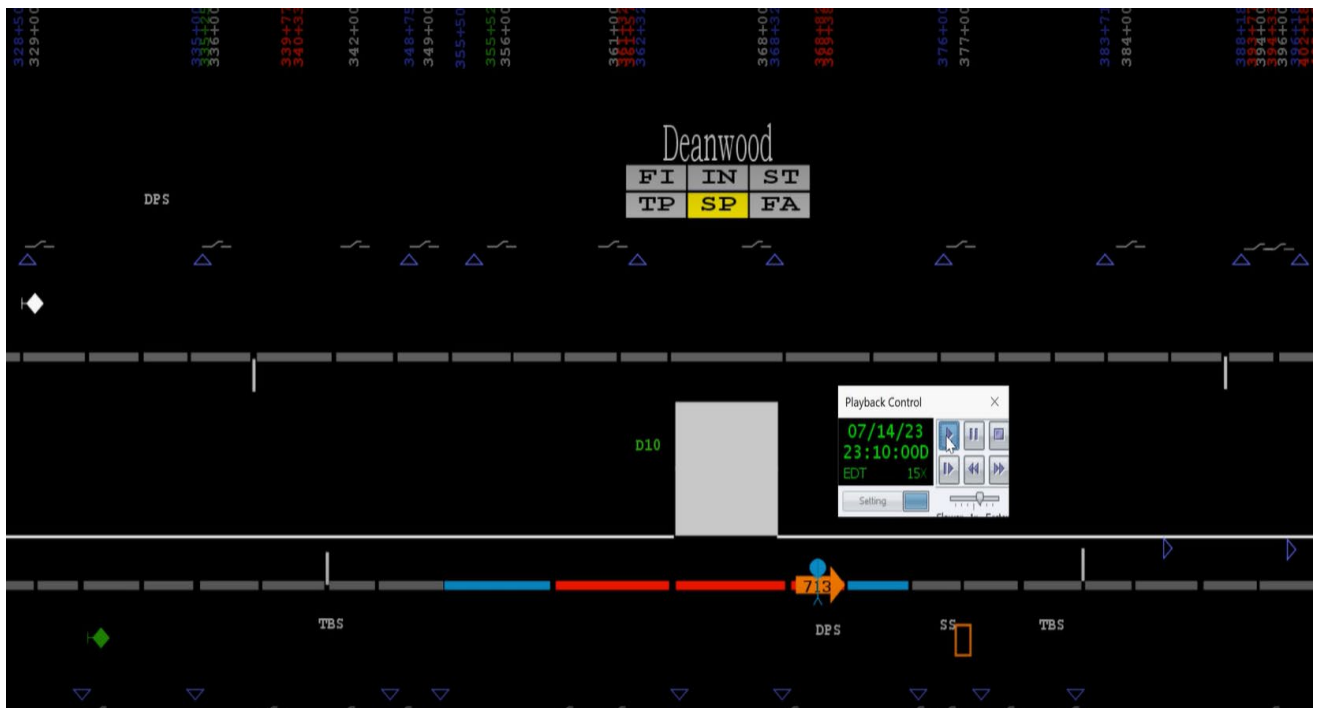
Figure 4 – AIMS playback depicting blue block and human form in place at Deanwood Station on track 1.

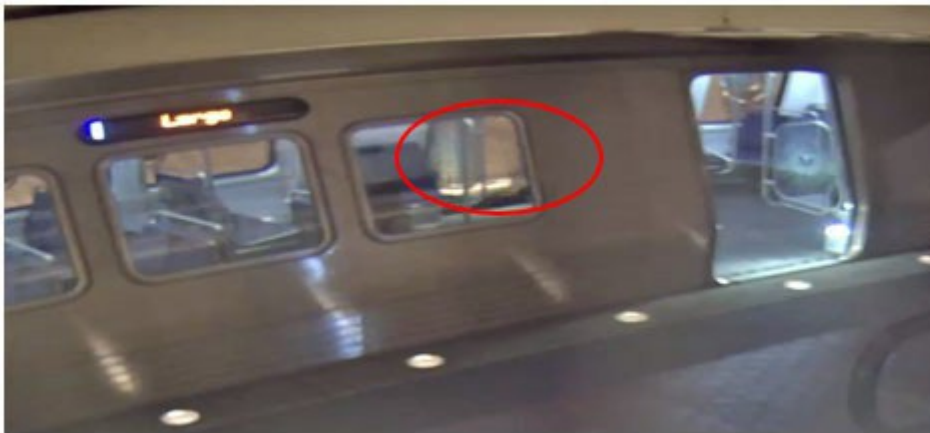
Image 1 – Train ID 603 located at Smithsonian Station with the doors open on the non-platform side.

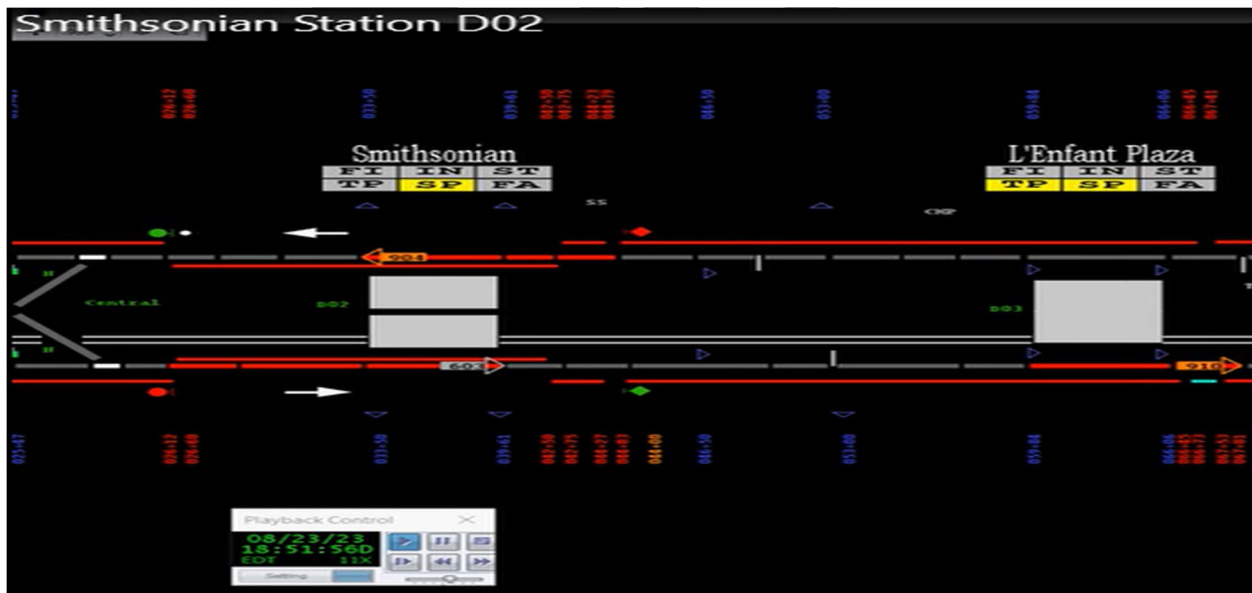
Figure 1 – AIMS playback depicting Train ID 603 at Smithsonian Station
