## **Improper Door Operation**

**Glenmont Station, Alexandria Rail Yard Employee Platform, Glenmont Station, and Stadium-Armory Station**

**July 1, 2023 – August 25, 2023 – November 12, 2023**

# Glenmont Station & Alexandria Yard Employee Platform Stop – Improper Door Operation

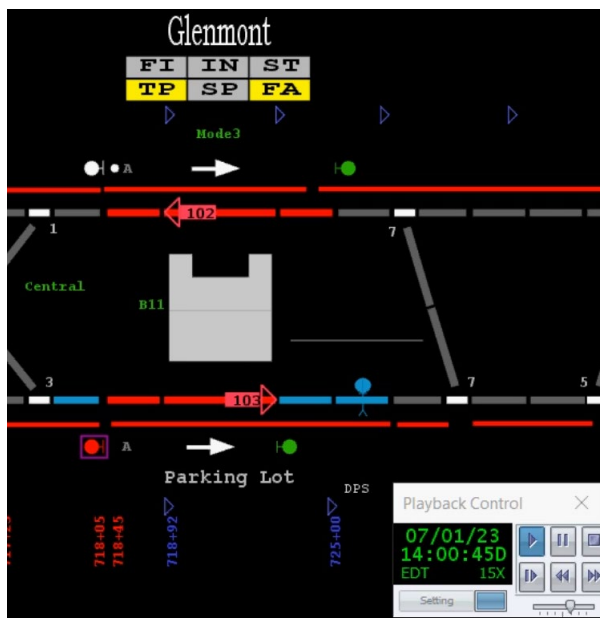
Image 1 - AIMS Playback depicting blue block and human form in place at Glenmont Station, track 1 at 14:00 hours.

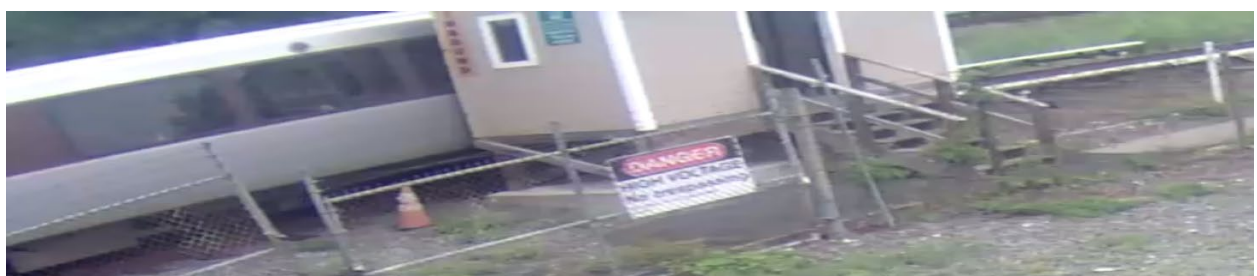
Image 2 – Train ID 410 arriving at the Alexandria Yard Employee Platform Stop at 14:00 hours.

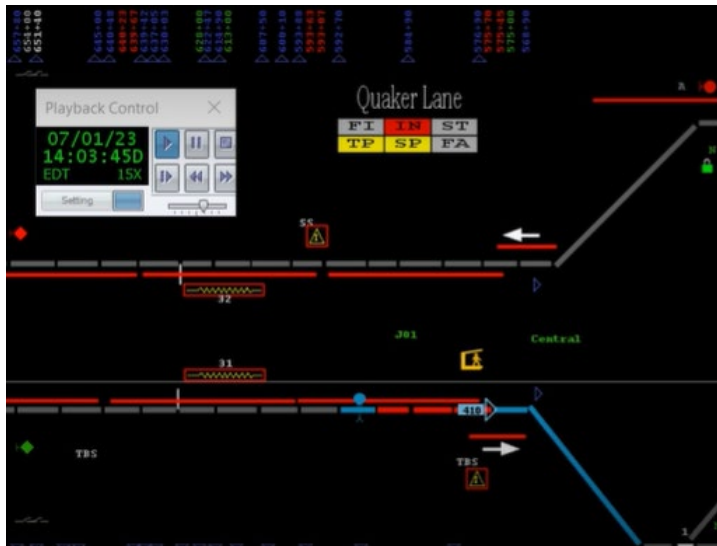
Figure 1 – AIMS Playback depicting blue block and human form in place at 14:03 hours.

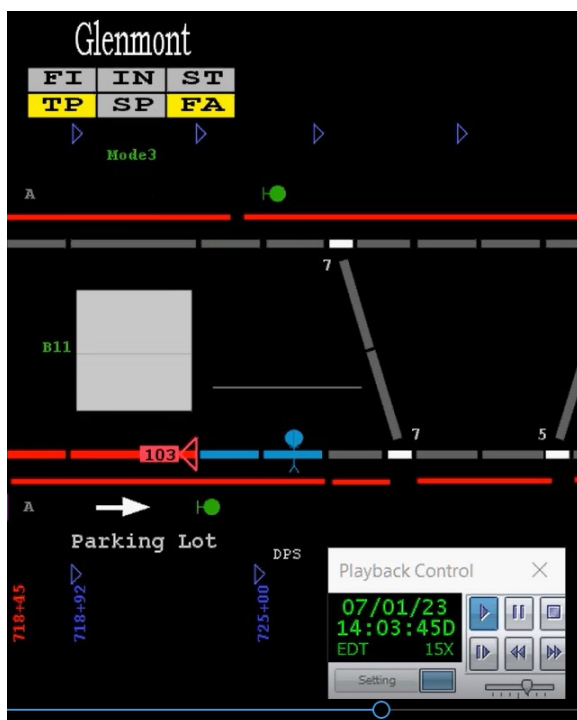
Figure 2 – Train ID 103 located at Glenmont Station, track 1 at 14:03 hours.

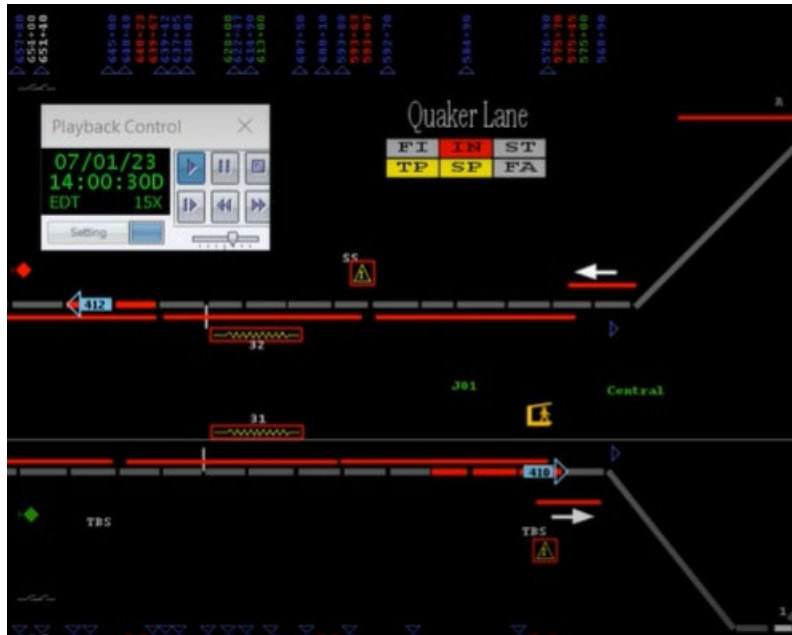
Figure 3 – Train ID 410 located at the Alexandria Yard Employee Platform Stop, track 1 at 14:00 hours.

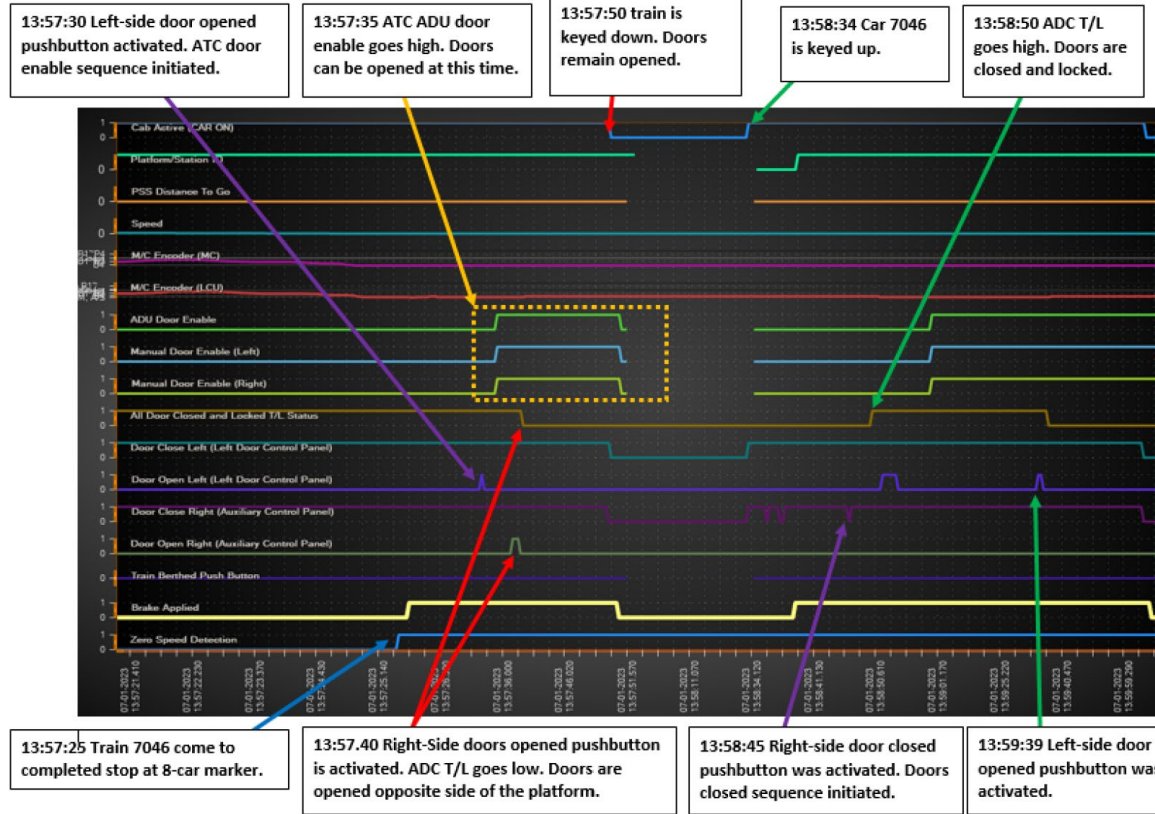
**Graph 1 – Data Analysis**

13:59:40.010	All door closed and locked T/L signal goes low, doors opened on platform side, and station serviced.
14:00:01.980	Car 7046 is keyed down.

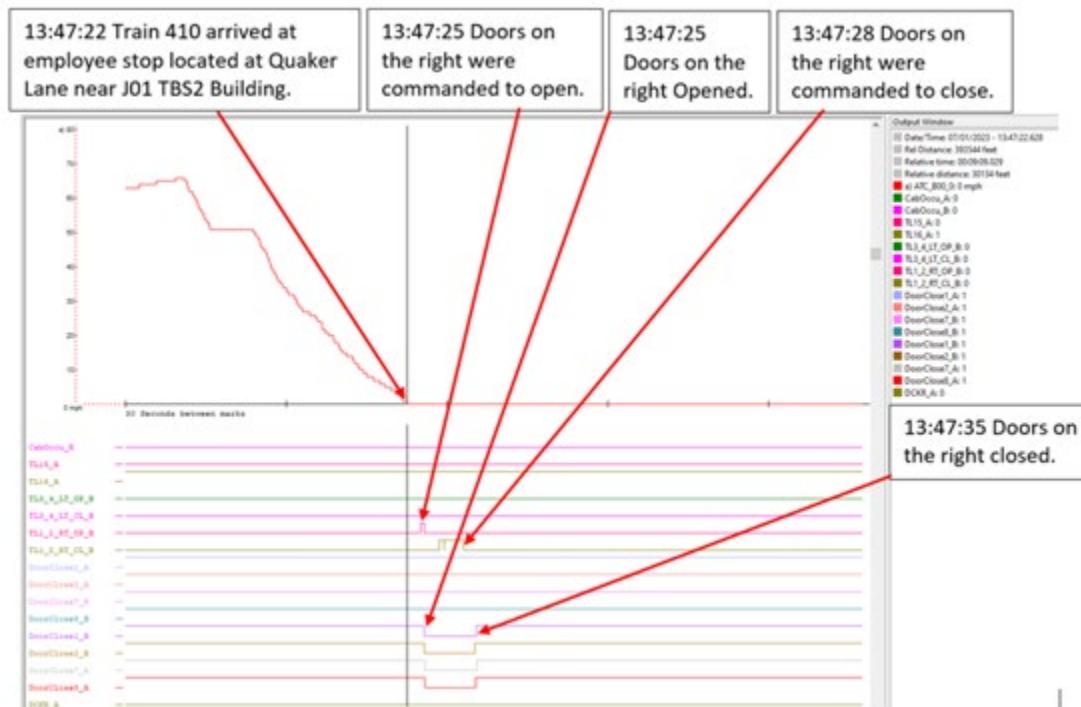
Graph 1. Data Analysis.

Upon arrival, the right-side doors of the train were commanded to open. However, they were subsequently commanded to close just 3 seconds after opening. This sequence of actions is classified as an improper door operation, as there is no platform present at this location. Consequently, the doors momentarily opened to the wayside during the incident. Notably, no

mechanical defects that could have contributed to the cause of this incident were identified during the data analysis process.”

Time	Event
13:47:22	Train 410 arrived at employee stop located at Quaker Lane near J01 TBS2 Building.
13:47:25	Doors on the right were commanded to open.
13:47:25	Doors on the right opened.
13:47:28	Doors on the right were commanded to close.
13:47:35	Doors on the right closed.

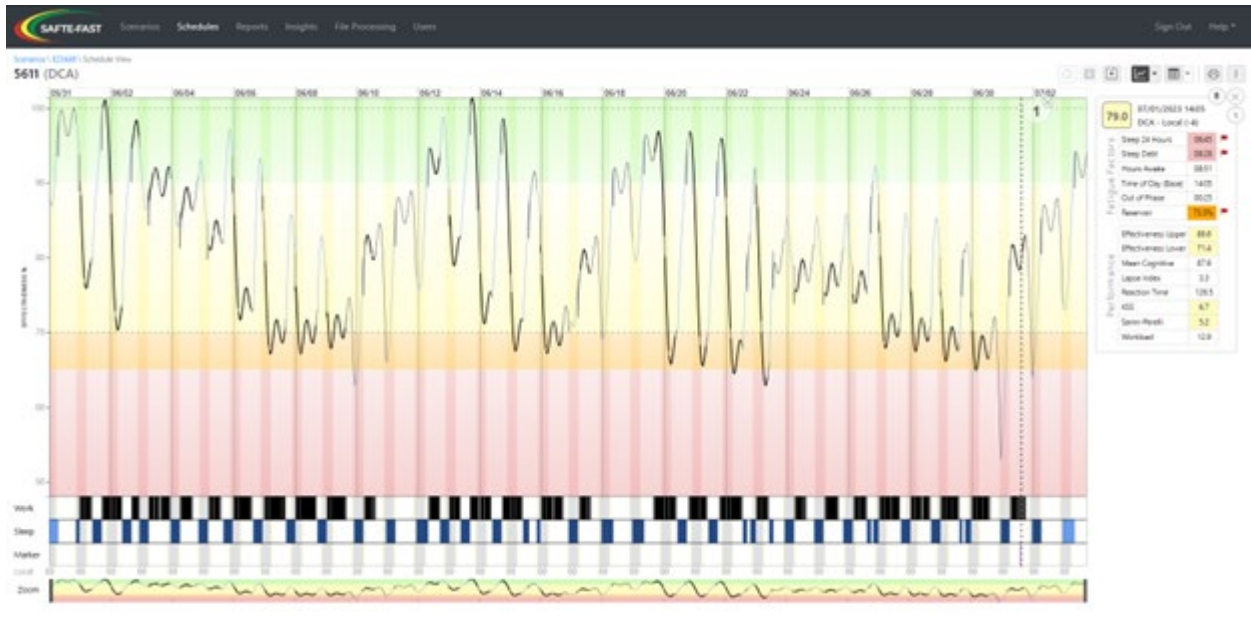
A biomathematical fatigue modelling application (SAFTE-FAST WebSFC) was used to further evaluate fatigue risk factors that may have been present in the Train Operator's schedule. The analysis was based on the Train Operator's work schedule, reported sleep from the day before the incident, and reported habitual sleep durations. Estimated performance effectiveness at the time of the incident was 79%. Specifically, the analysis identified sleep debt (inferring accumulated sleep loss of more than 8 hours) as a factor contributing to an increased risk of fatigue at the time of the incident.

Modeling analysis output shows estimated performance effectiveness during the incident work shift and for the 30 days leading up to the work shift, based on the employee work and reported sleep schedule. Estimates were based on the Train Operator's work schedule, reported sleep from the day preceding the incident, and reported habitual sleep durations (7 hours a day). Bold portions of the modeled curve show work (in black) and sleep times (in blue). Effectiveness is shown on the vertical axis, with colored fields in the chart background signifying ranges of effectiveness scores including high effectiveness (>90%) in green, and low effectiveness (<65%) in red. Time is shown on the horizontal axis. Markers for work and sleep times are shown in the lanes above the time of day on the horizontal axis.

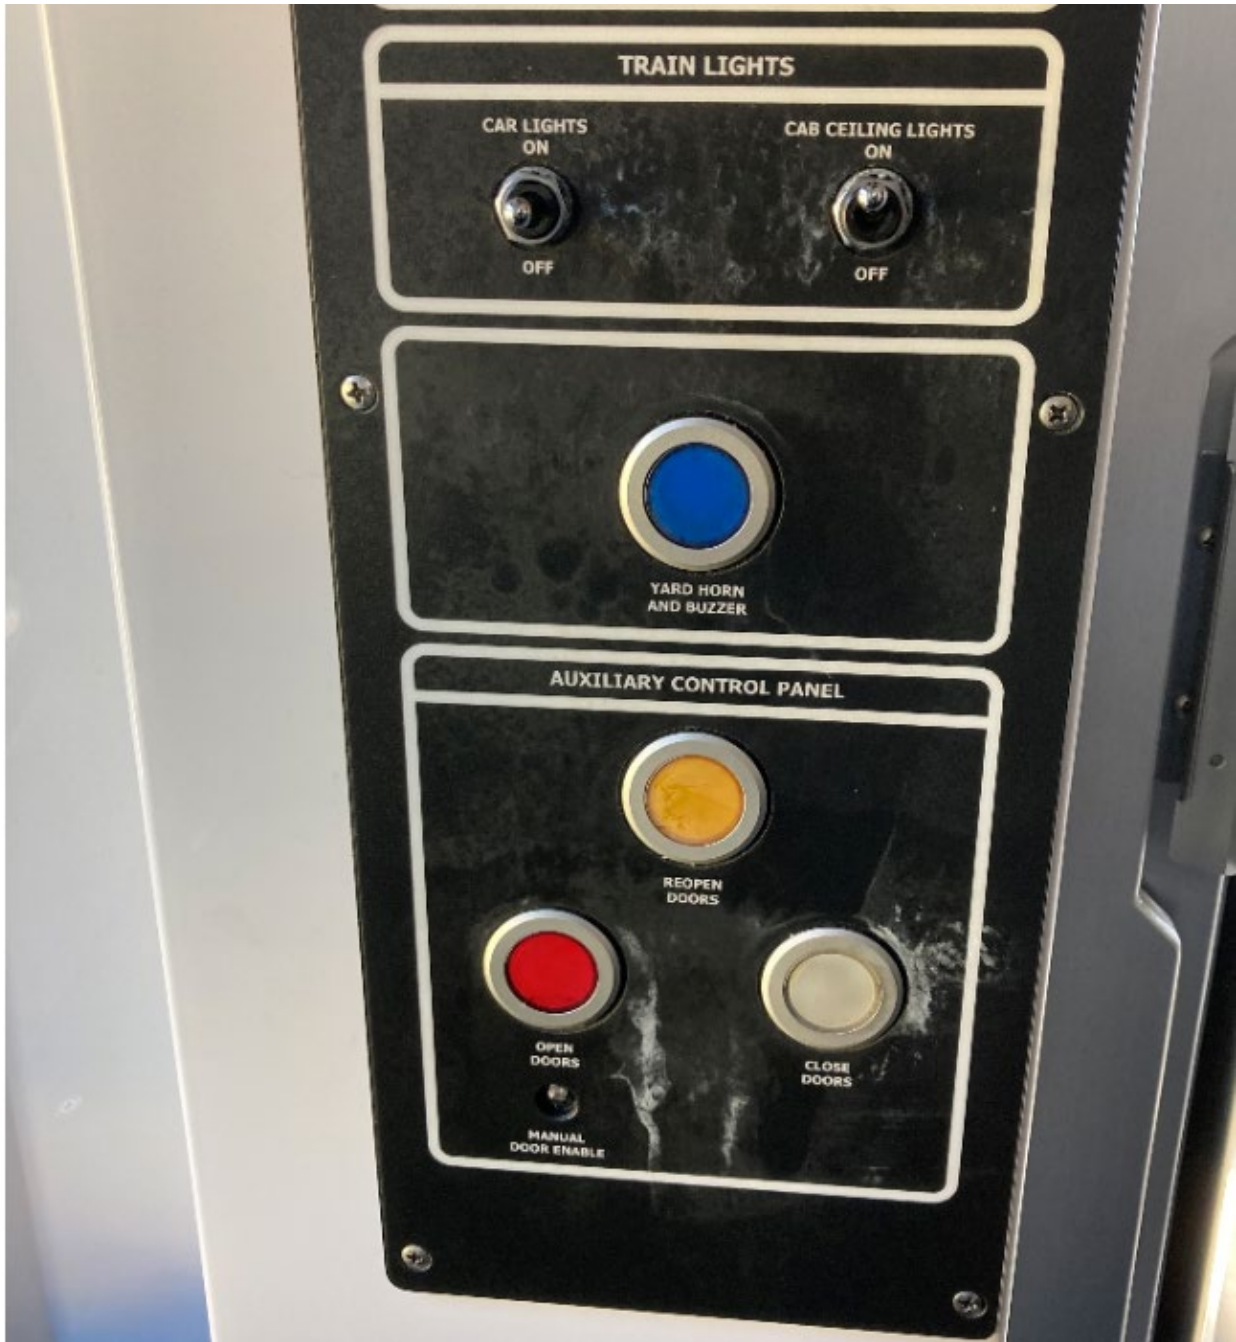
*Train operator door control panel*

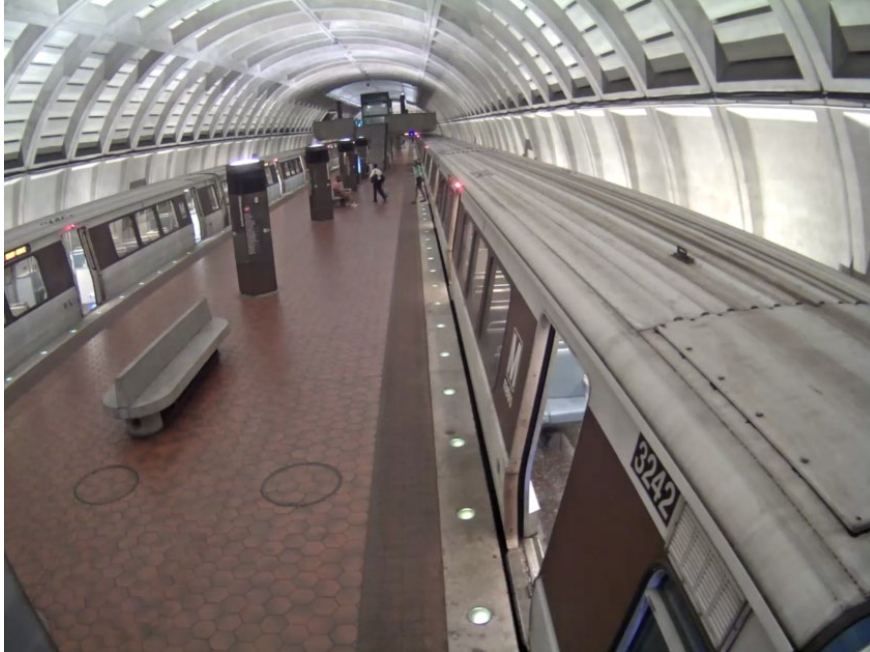
*Image 1 - Train ID 120 arrived at Glenmont Station track 2 at approximately 20:48 hours and all platform side doors were activated.*

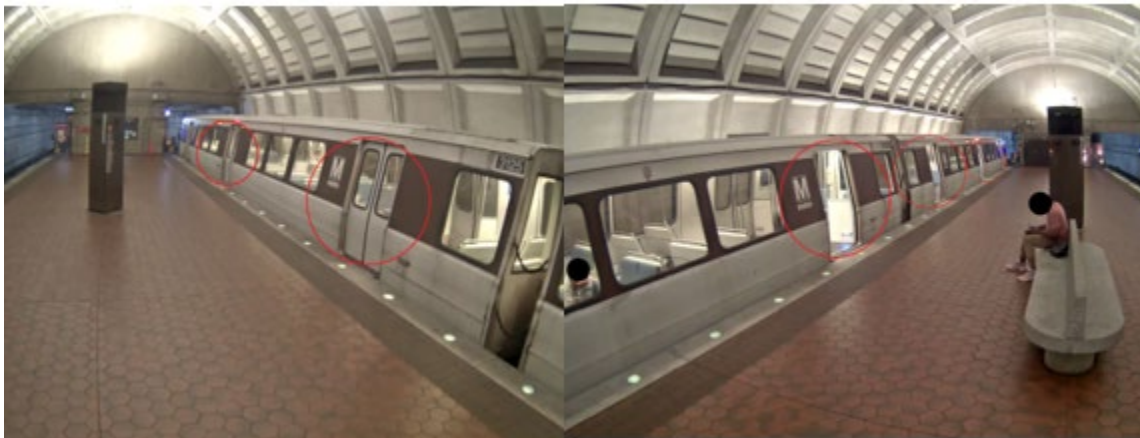
*Image 2 - Train ID 120 with lead car platform-side doors closed (left) and trailing cars with platform-side doors open (right), at 20:51 hours.*

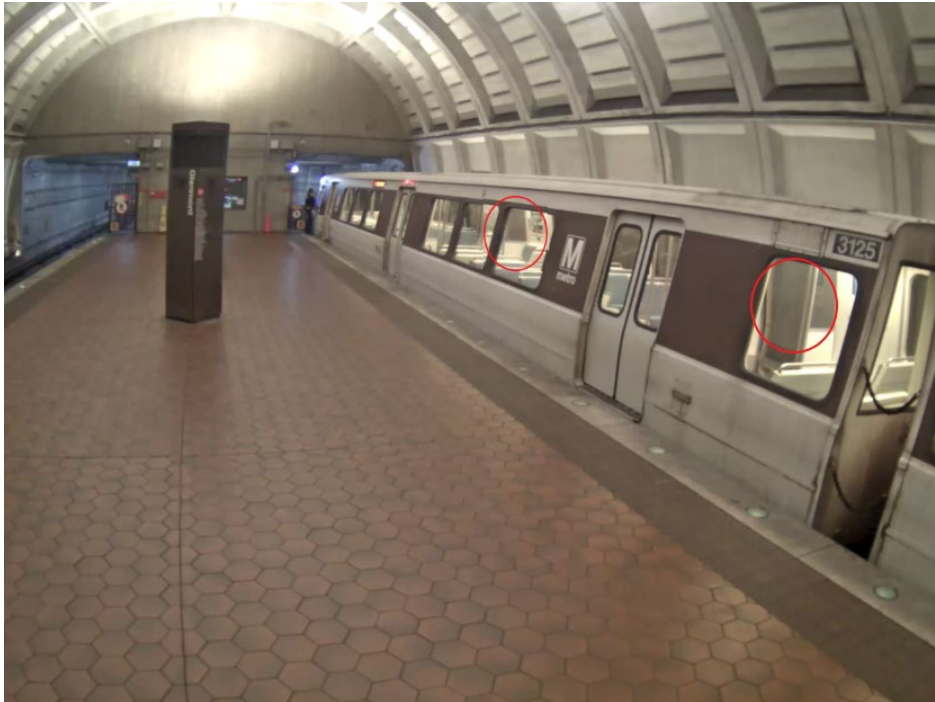
*Image 3 - Train ID 120 non-platform side doors opened at 20:52 hours with the RTRA Supervisor present.*

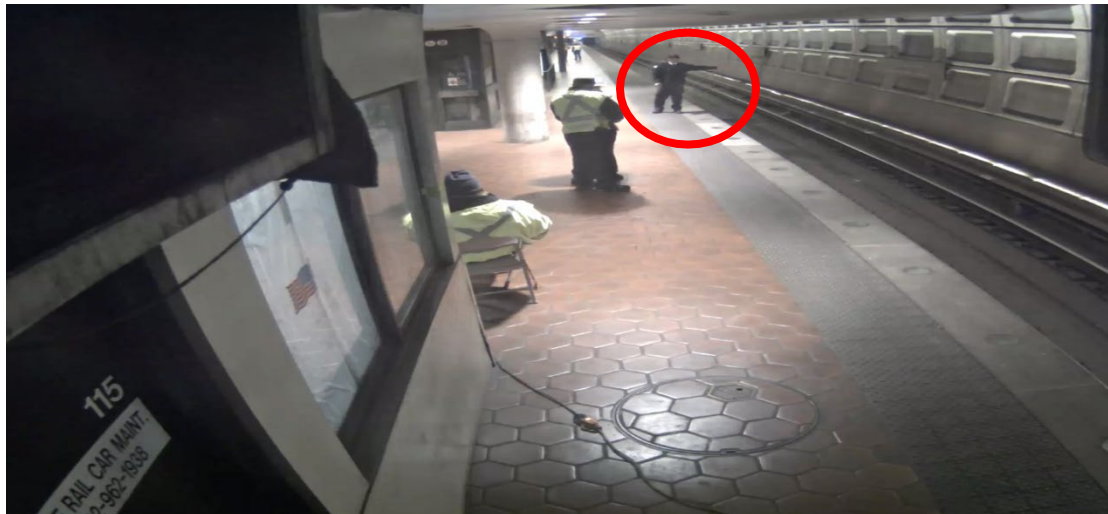
*Image 1 - Rail Supervisor directing Train ID 405 to short-stop at Stadium-Armory platform at 12:34:52 hours.*

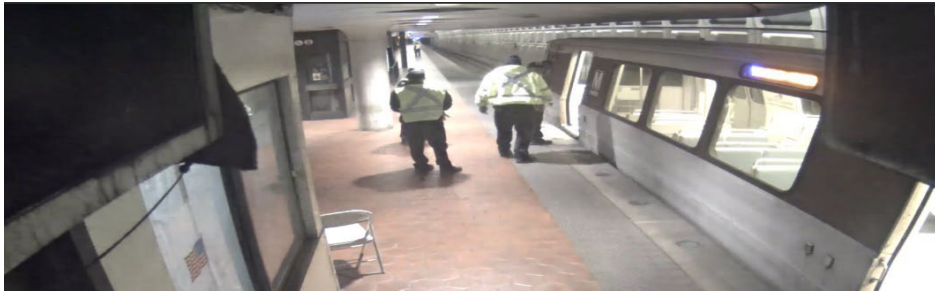
Image 2 - Train ID 405 doors open off the platform at 12:35:14 hours.

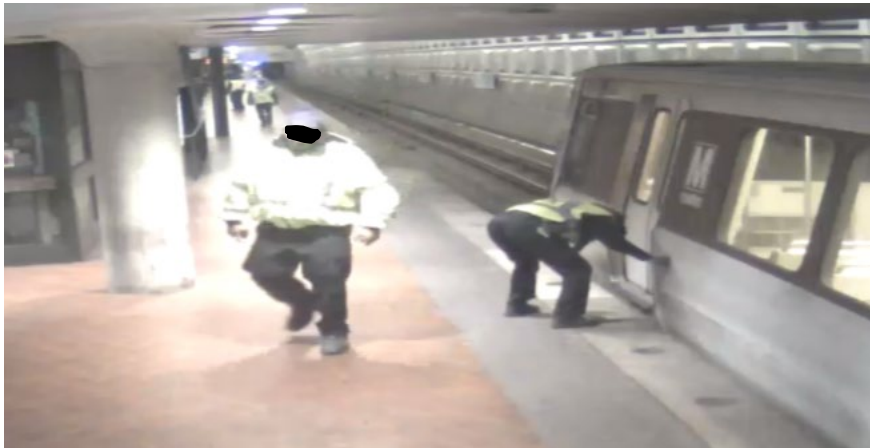
Image 3 - AD Train Operator keys aboard Train ID 405 at 12:36 hours

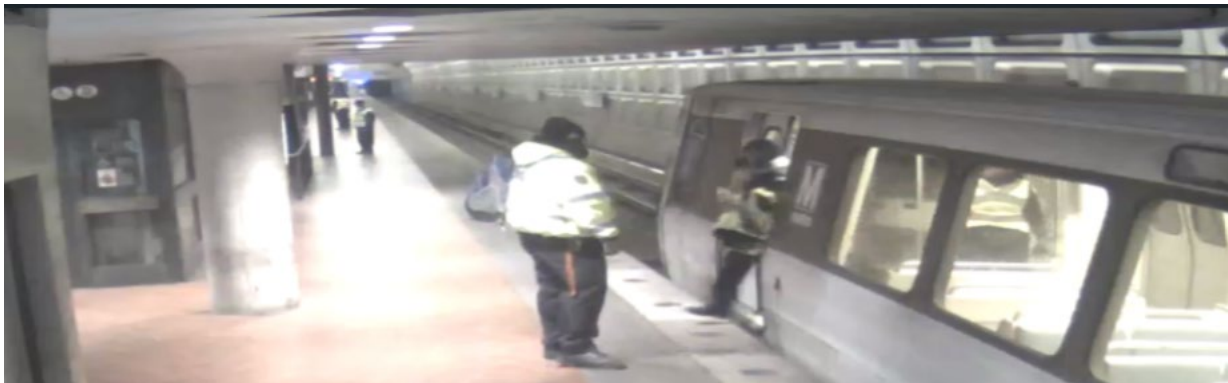
Image 4 - Train Operator of Train ID 405 departed Train ID 405 and is removed from service at 12:36 hours.

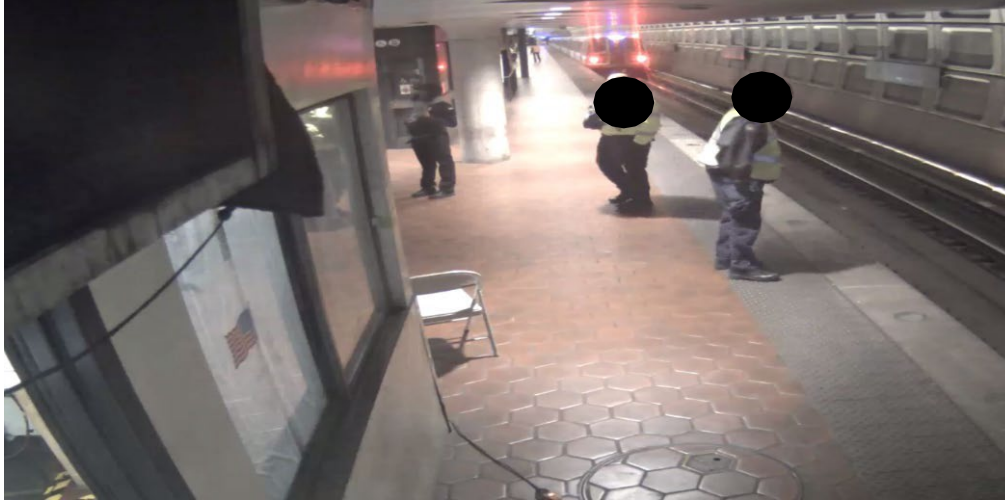
Image 5 - Train ID 405 moves to berth at 8-car marker and off load at Stadium-Armory platform at 12:40:32 hours.
