Improper Roadway Worker Protection

At or Near College Park-UMD, Forest Glen, Potomac Ave, Ballston-MU, Wiehle-Reston East, Metro Center, Morgan Boulevard and Southern Ave stations

Document Purpose:

Improper RWP College Park Station
February 25, 2023
 Table of Contents

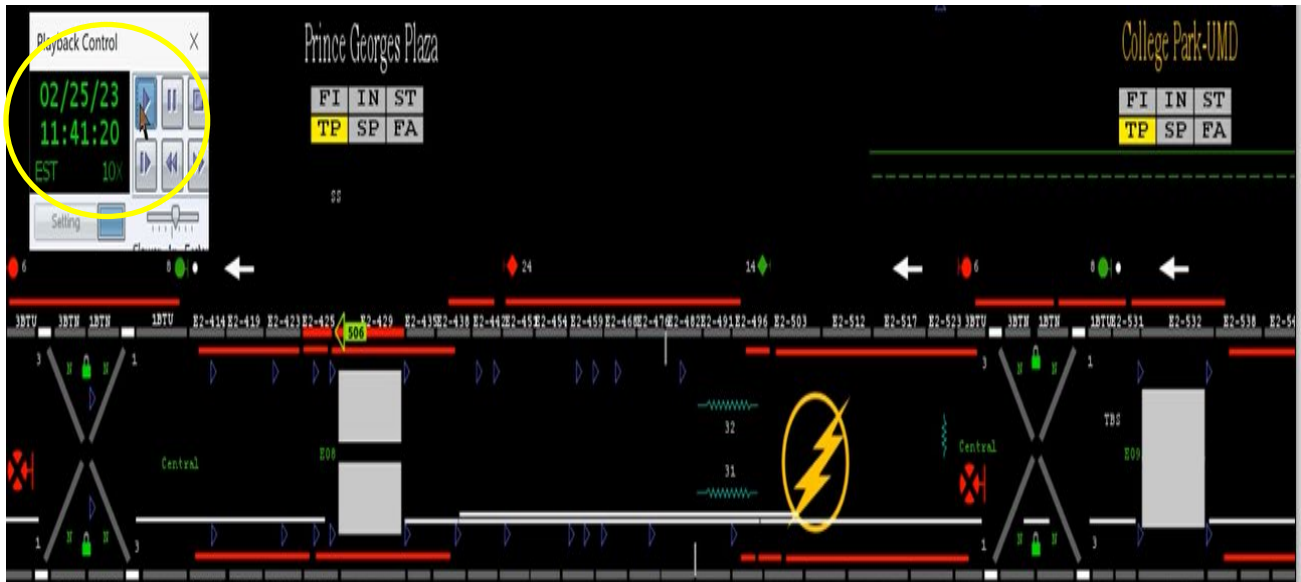
Figure 2 AIMS Playback. Train ID 506 Picking up Personnel at CM E2 482+00

Figure 3 AIMS Playback - Roadway clear of all personnel

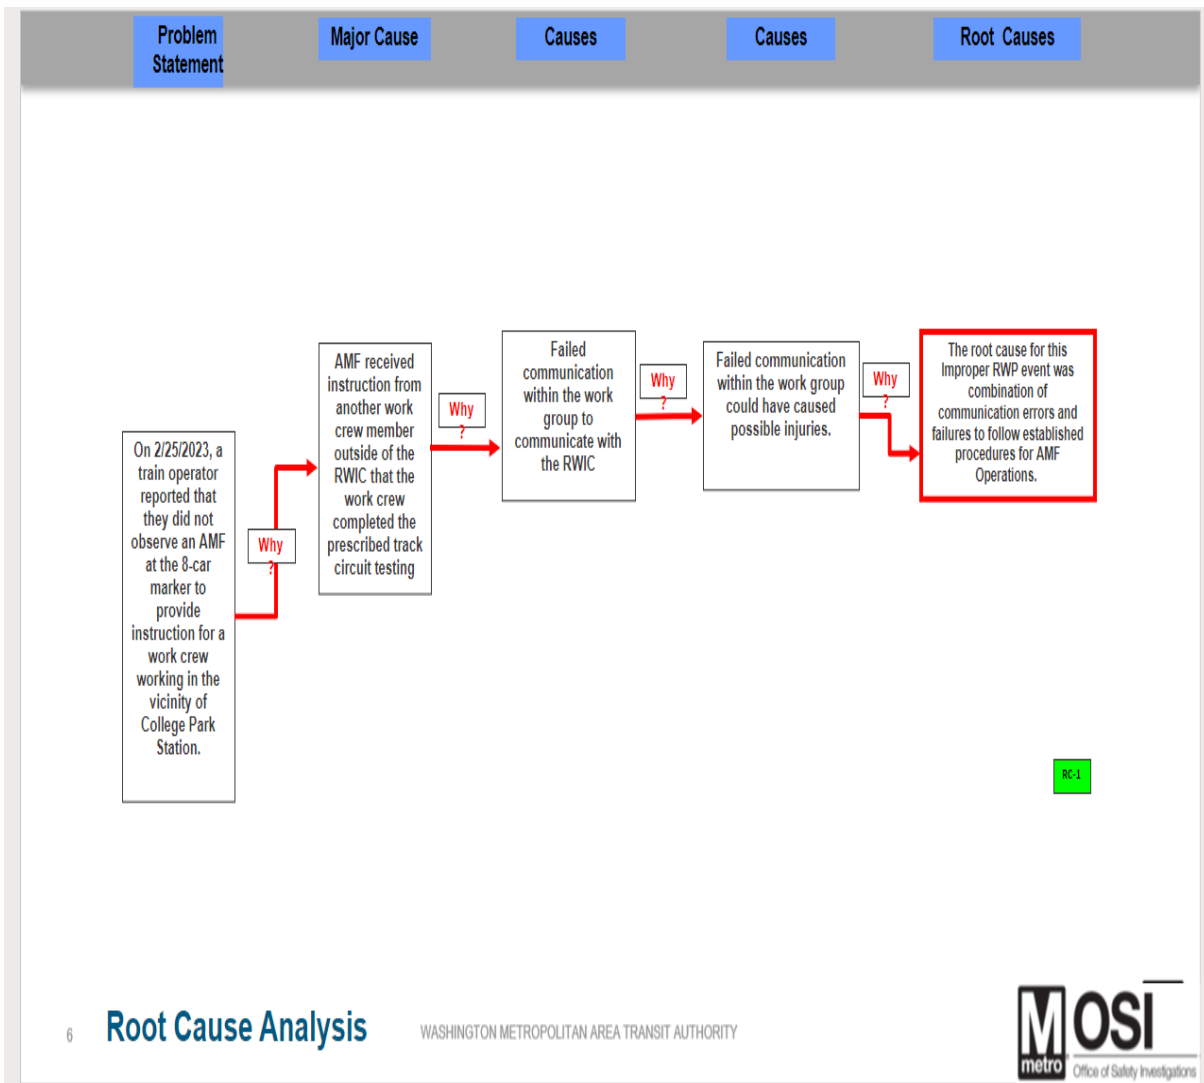
The probable cause for this Improper RWP event was the combination of communication errors and failure to follow established procedures for AMF Operations, resulting in an AMF abandoning their assigned post while personnel were still on the roadway. A Contributing Factor to the event was the AMF's acceptance of instruction from a crew member instead of the RWIC.

Figure 19 - Root Cause Analysis page 1 of 1 .

| Corrective Action Code | Description | Responsible Party | Estimated Completion Date |
|---|--|---|---|
| 106429_SAFE CAPS_ATCM _002 | Develop a Lessons Learned document to parallel Safety Bulletin 23-01-13 and reviewing the proper steps when communicating with the RWIC during field operations when radio communications fail to include the use of cellular devices. | ATCM | Completed |

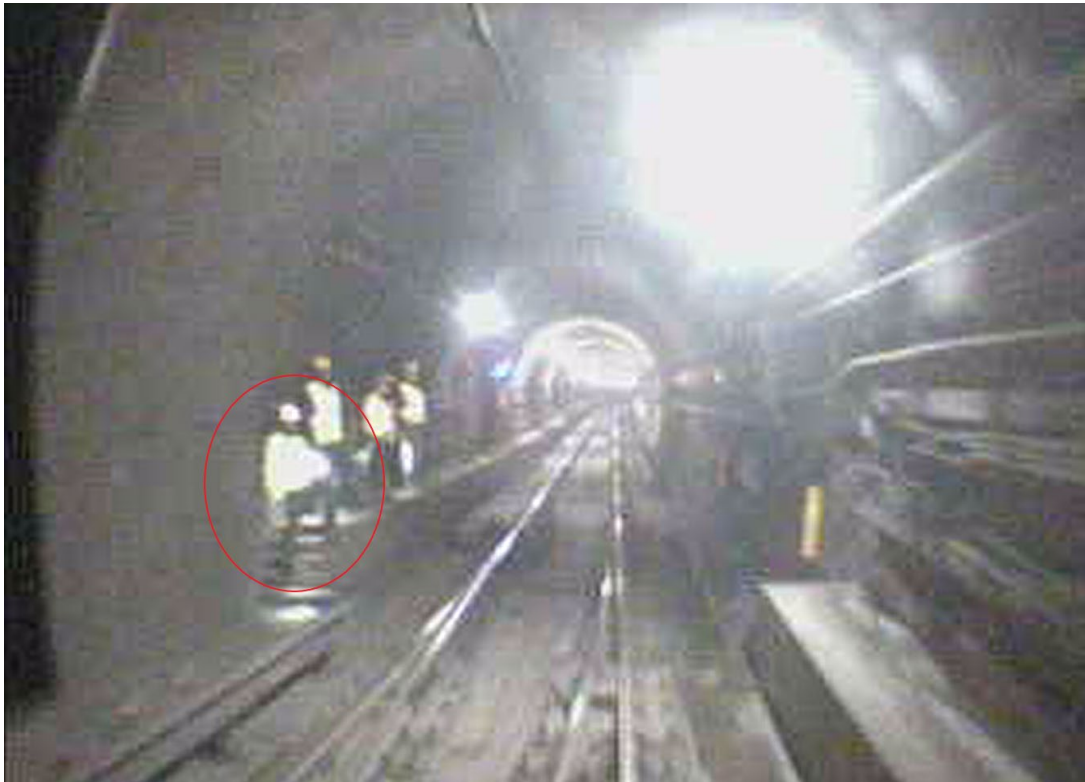
Closed-Circuit Television (CCTV) revealed at 09:32:25 the flashlight from the RWIC can be observed as the train approached the work crew which would have allowed the Train Operator 35 seconds to begin reducing the train speed and have enough time to stop the train to allow the work crew to board before passing the work crew at 09:33:00 hours. The RWIC is observed standing at an angle with their flashlight held at hip level. The physical position of the RWIC caused confusion to the Train Operator since the RWIC was not facing the train and displaying the stop hand signal.

Figure 2 - Footage taken from the forward-facing camera of rail car 7018 determined the train observed the work crew at 09:33 hours.

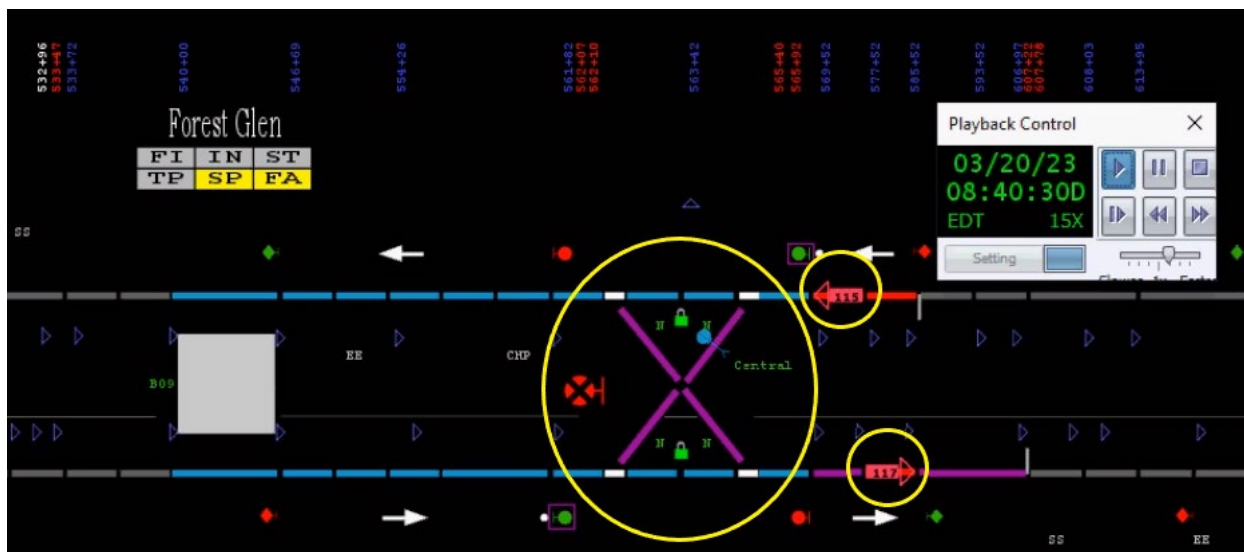
Figure 3: Train ID 115 and Train ID 117 traversing the interlocking at 08:40 hours.

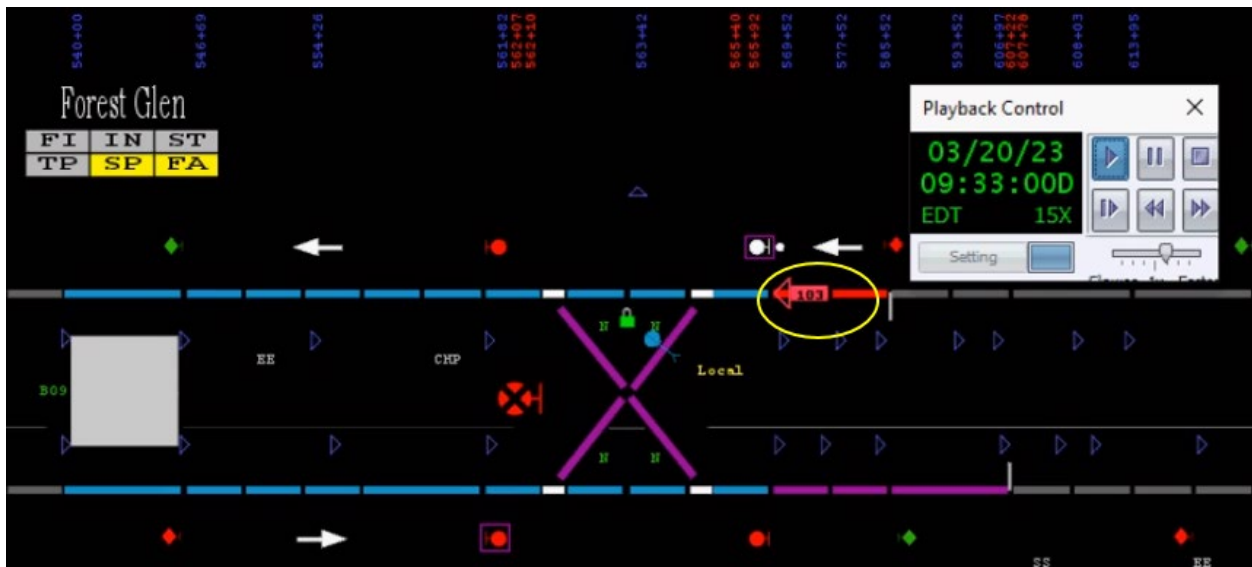
Figure 4: Train ID 103 traversing the interlocking at 09:33 hours.

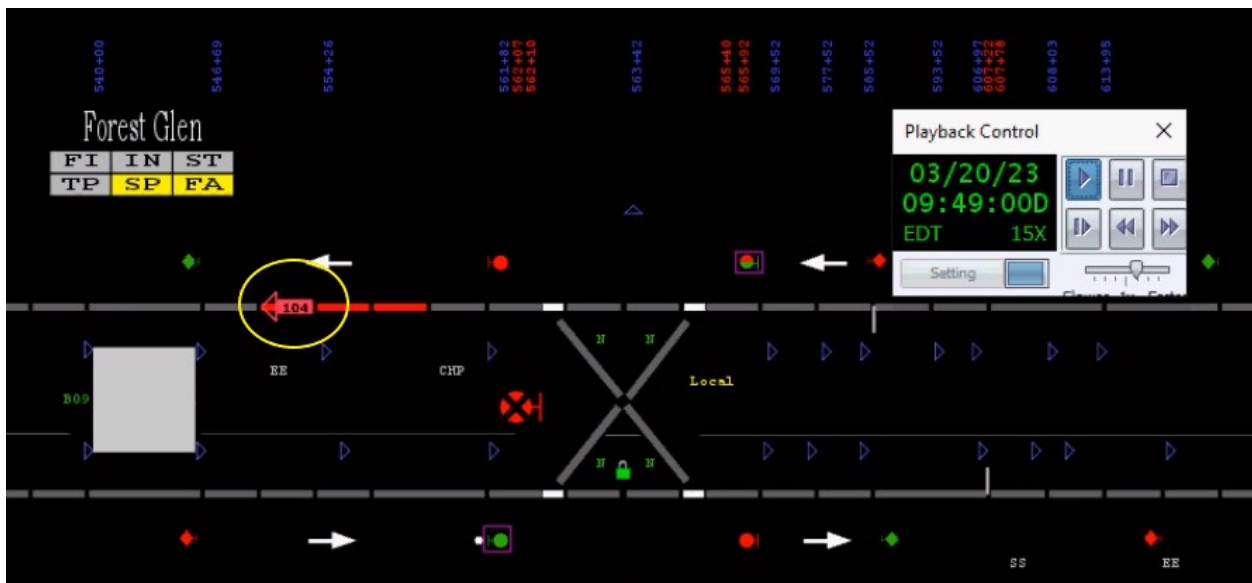
Figure 5: Train ID 104 observed transporting work crew from the site as the crew relinquished control to the ROCC at 09:49 hours.

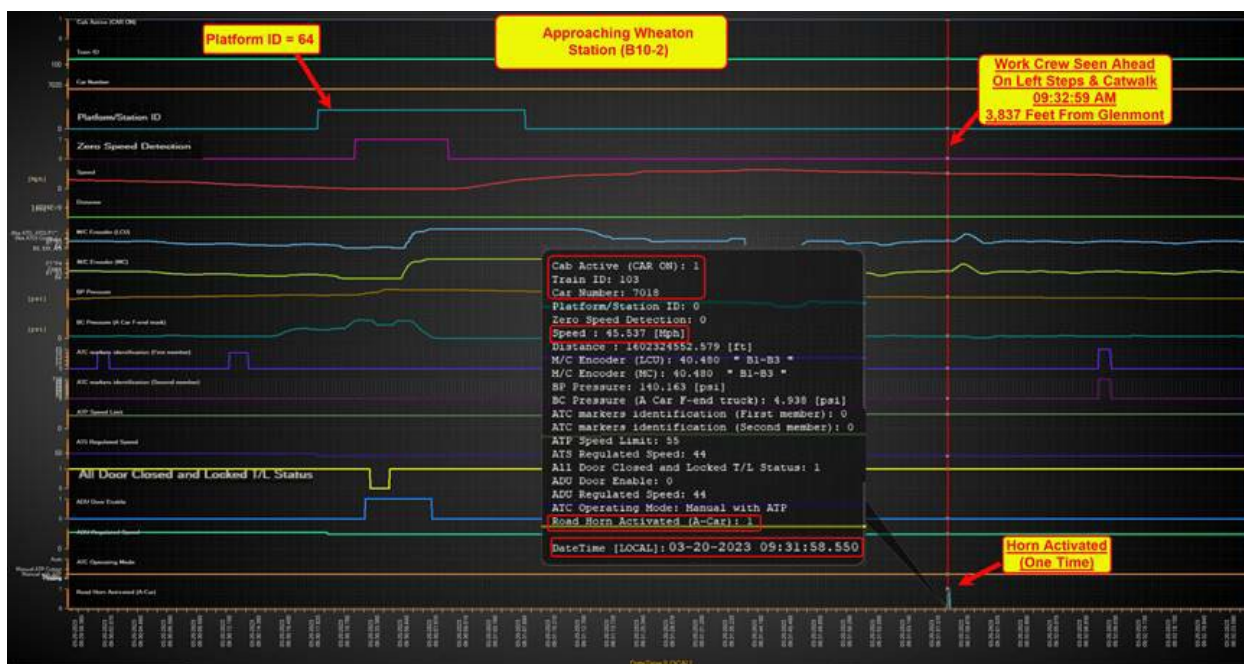
Figure 7: CMOR-IIT EMM graph established Train ID 103 activated their horn one time during the course of the incident.

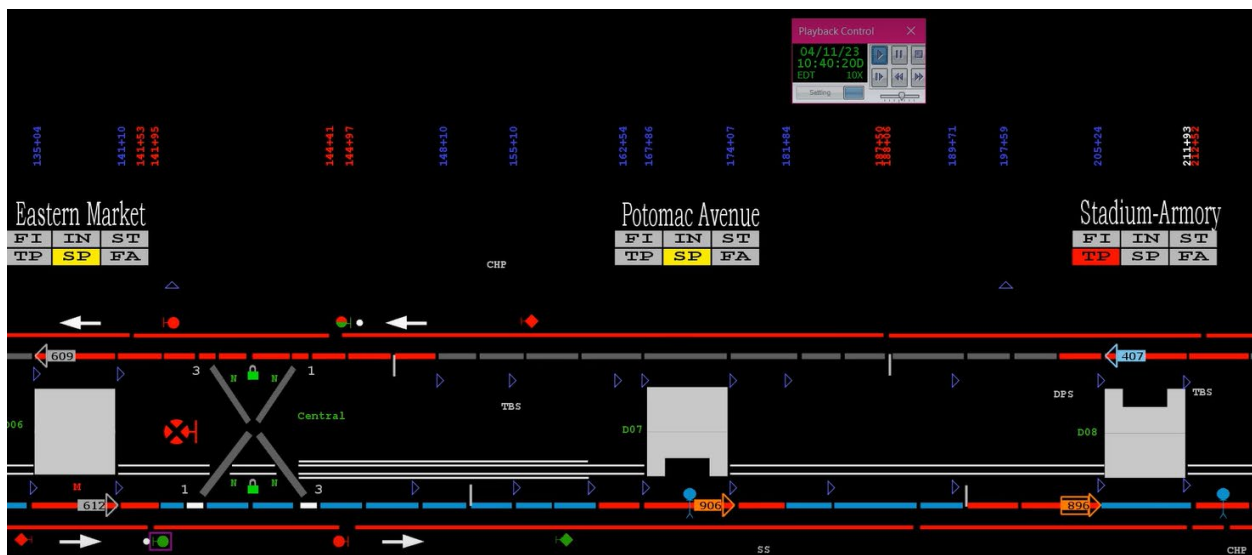
Figure 1 – AIMS depicting the position of Train ID's 896, 906 and 612 on track 1 at the time that the RWIC was instructed to allow 2 trains to pass at Stadium-Armory Station.

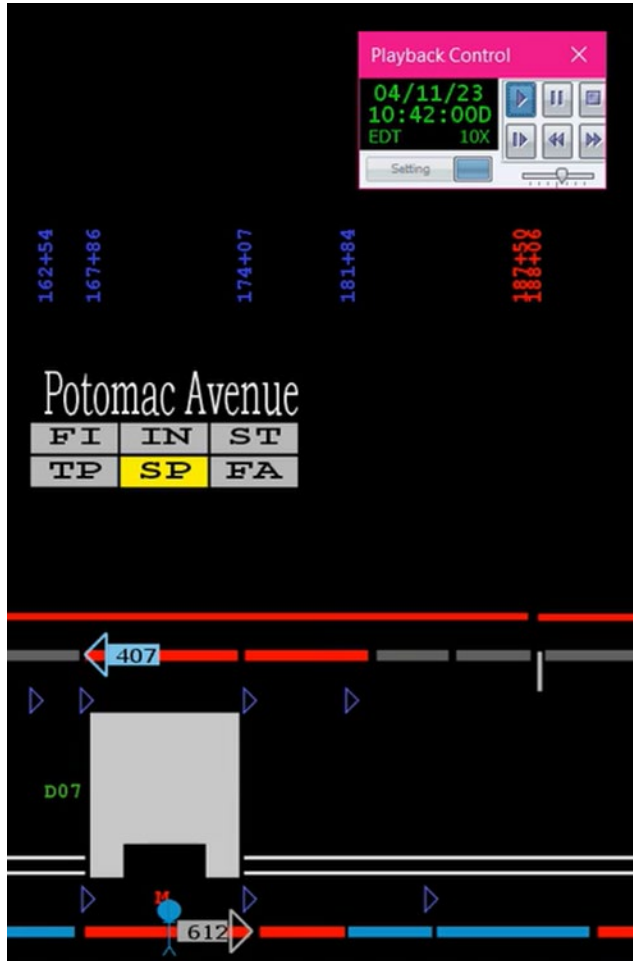
At 10:41 hours, Train ID 612 arrived at Potomac Avenue Station, track 1. The AMF did not brief the Train Operator that the Mobile Work Crew was on the roadway. At 10:42 hours, Train ID 612 departed Potomac Avenue Station and the AMF placed the amber lantern to begin AMF duties.

Figure 2 - Train ID 612 located at Potomac Avenue Station, track 1 at 10:42 hours.

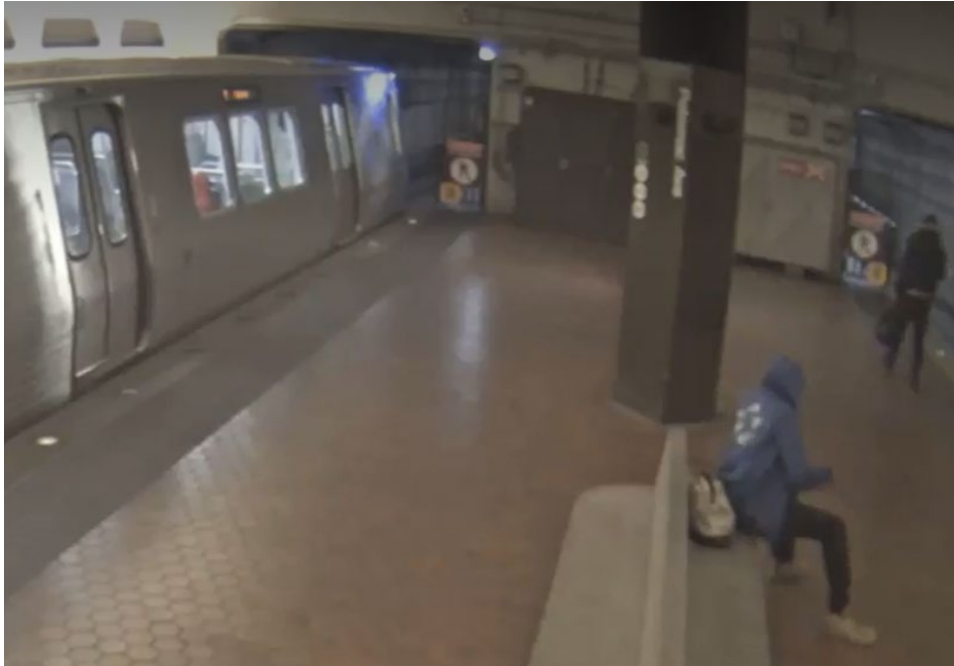
Image 1 - AMF (black jacket) and coworker (blue sweatshirt) arriving on the platform by train at 10:31 hours.

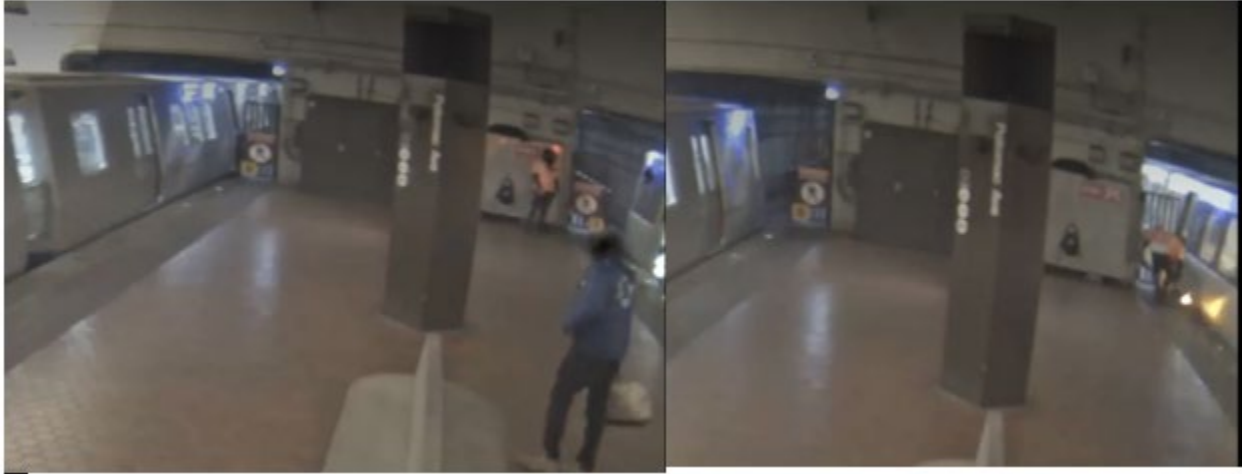
Train ID 612 departed Potomac Avenue Station at 10:42 hours without being briefed by the AMF. As the train was departing, the AMF activated the amber light and placed it in position on the platform. This action indicated tht they believed that Train ID 612 was the second train they were instructed to let pass before beginning AMF operations.

Image 2 - AMF standing by Train ID 612 and AMF placing the amber light as Train ID 612 departs the platform at 10:42 hours.

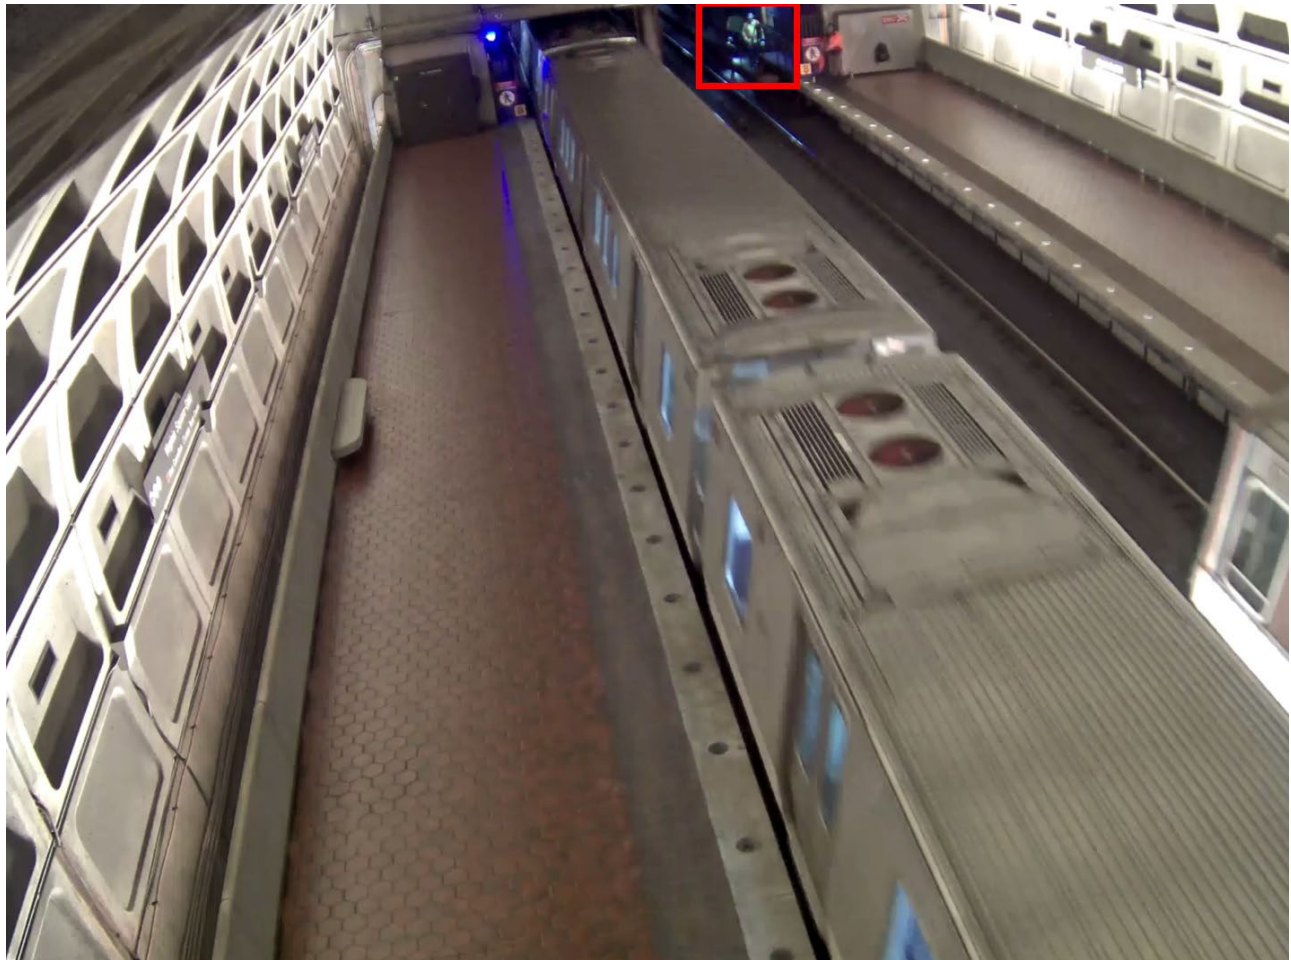
Figure 2 – TRST RWIC was arriving at Virginia Square – GMU Station, Track 2 platform limits at approximately 10:38 hours.

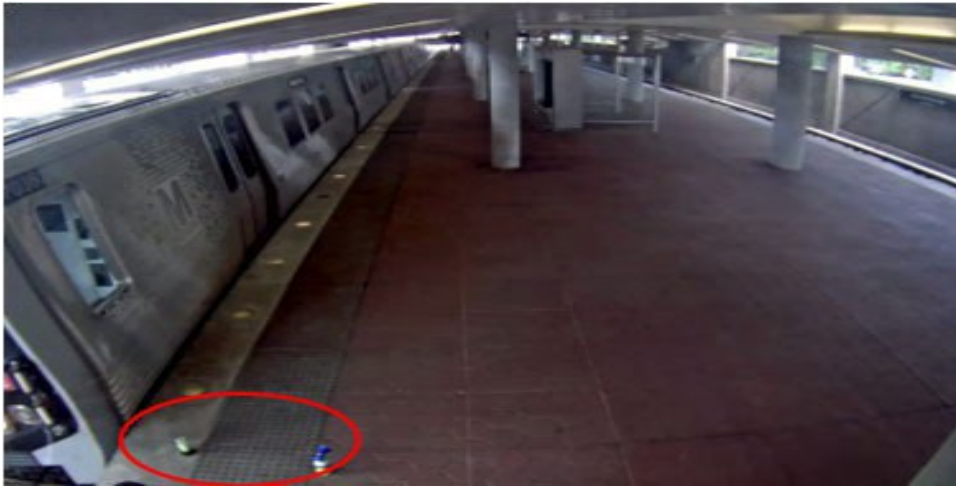
Image 1 – AMF equipment and Train ID 725 located at Wiehle-Reston East Station, track 1 at 10:38 hours.

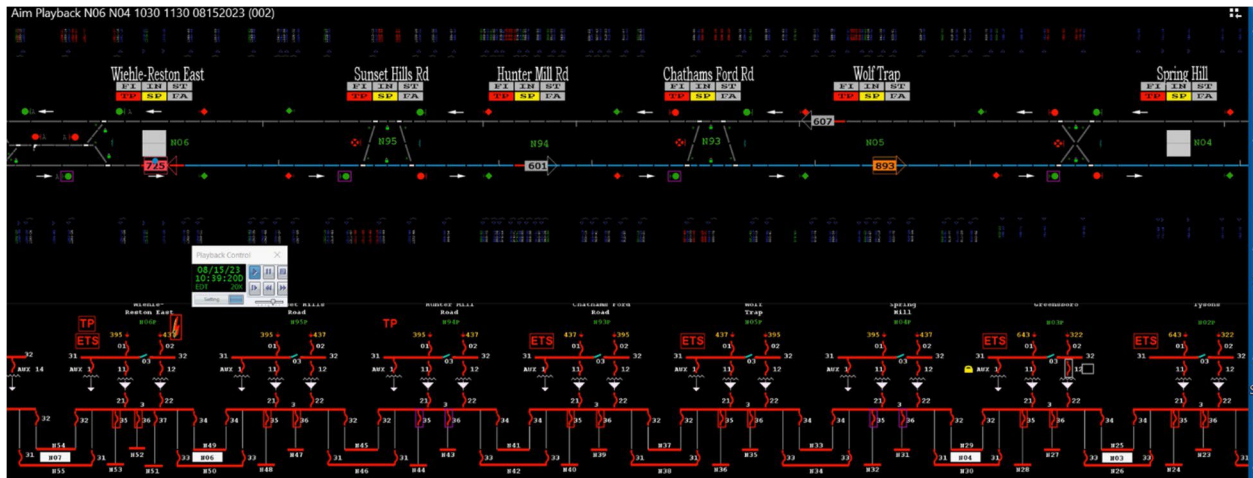
Figure 1 –Train ID 725 located at Wiehle-Reston East Station. Blue block and human forms in place to Spring Hill Station, track 1.

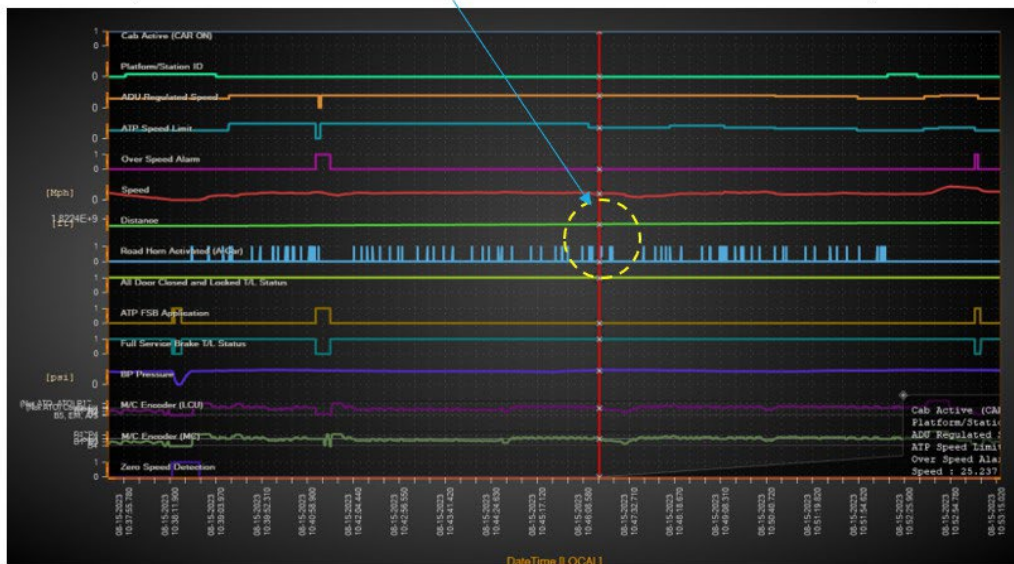
Graph 1 - Lead Car 7036 Analysis

10:46:42.01 Train ID 725 passed CM 883+00 Roadway Worker location at Speed 25MPH, Master Controller in Coast, ADU Regulated Speed 54MPH, Limiting Speed 55MPH, Distance from Wiehle-Reston East Station, 19,067 Feet/Road horn activated multiple times

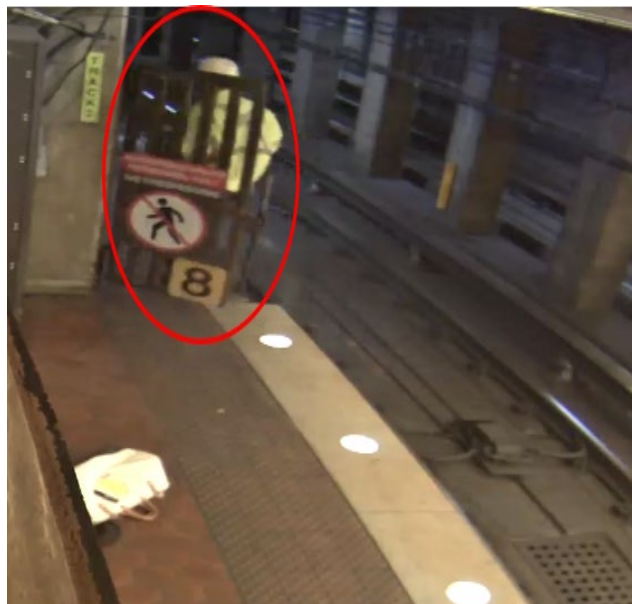
Image 1 – Image of IT Network Technicians entering the roadway at Metro Center Station at 01:08 hours.

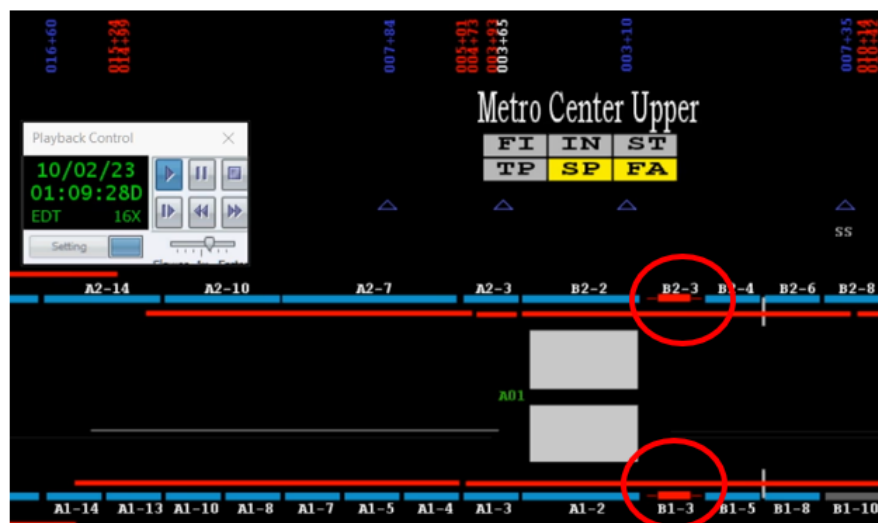
At 01:08 hours, the Advanced Information Management System (AIMS) revealed that the track circuits at Metro Center Station on tracks 1 and 2 displayed occupancy on the roadway; this occurs when a shunt is placed on the running rail as part of the work zone setup.

Figure 1 – AIMS Playback displaying track occupancy at CM B1 and B1 03+00 at 01:09 hours.

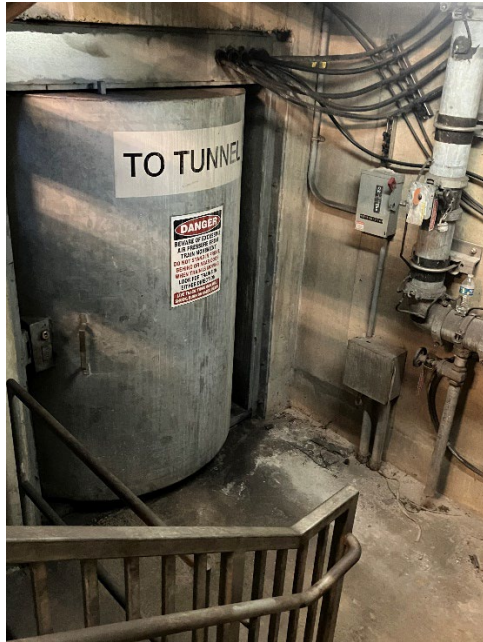
On October 17, 2023, at 10:27 hours, the GEM contacted the Radio RTC to request FT to enter the jet fan control room. A carpenter was accompanying them to check a lock on the room door. The ARS confirmed that the GEM initially requested FT to walk to the jet fan control room from an emergency egress entrance.

Figure 1: This shows the emergency egress door that was used to access the roadway.

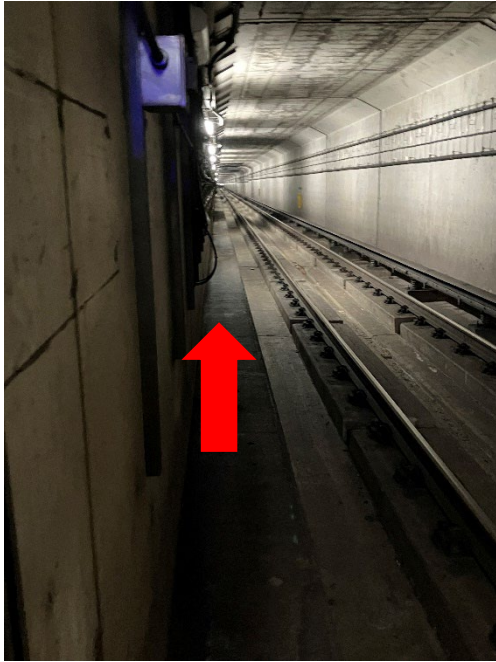
Figure 2: This shows the catwalk the personnel were on when Train ID 613 passed them.

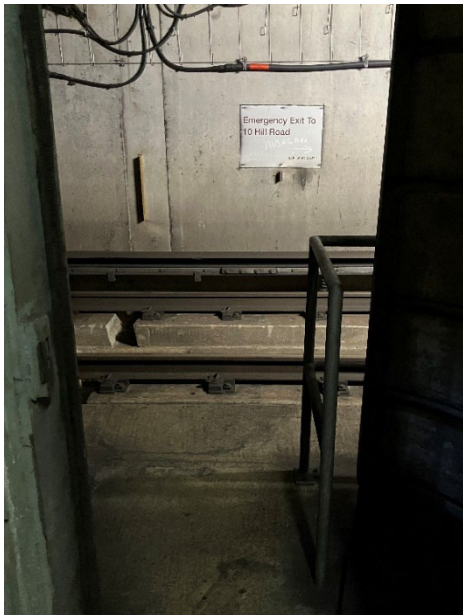
The Radio RTC then contacted the GEM to request their location. The GEM informed the Radio RTC they were at the emergency egress door. The emergency egress door is six feet from the running rail.

Figure 3: This image shows the proximity of the emergency egress door to the roadway.

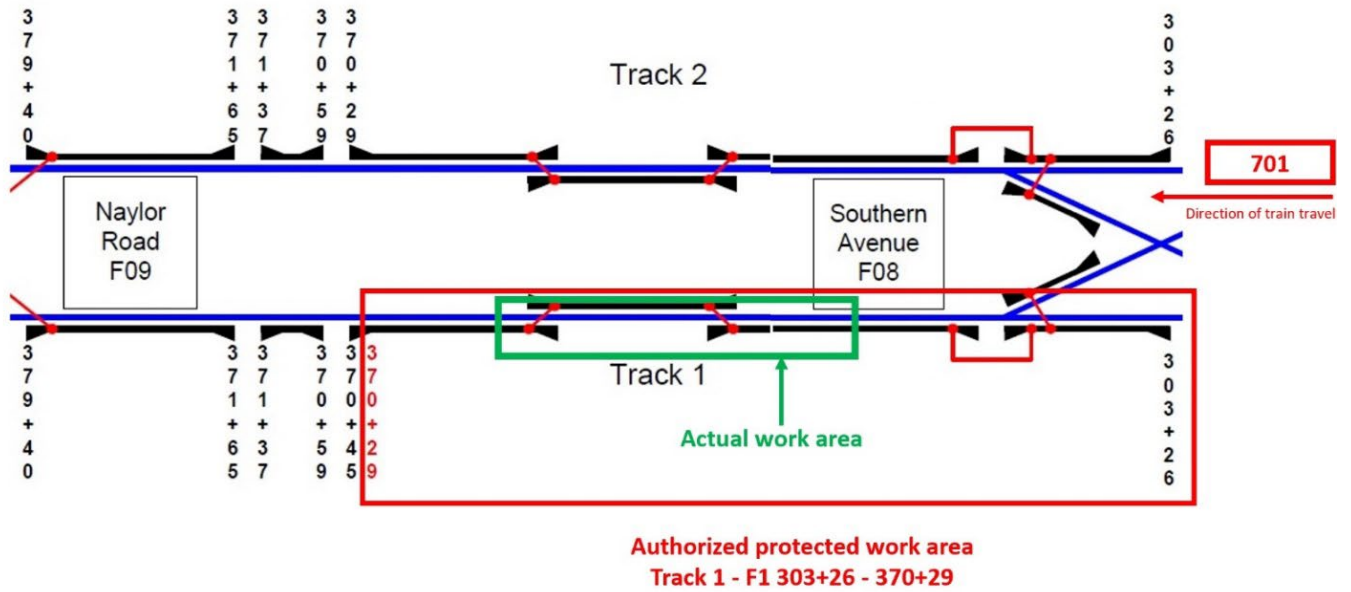
Figure 1 – Sketch illustrates the authorized work location on Track 1.

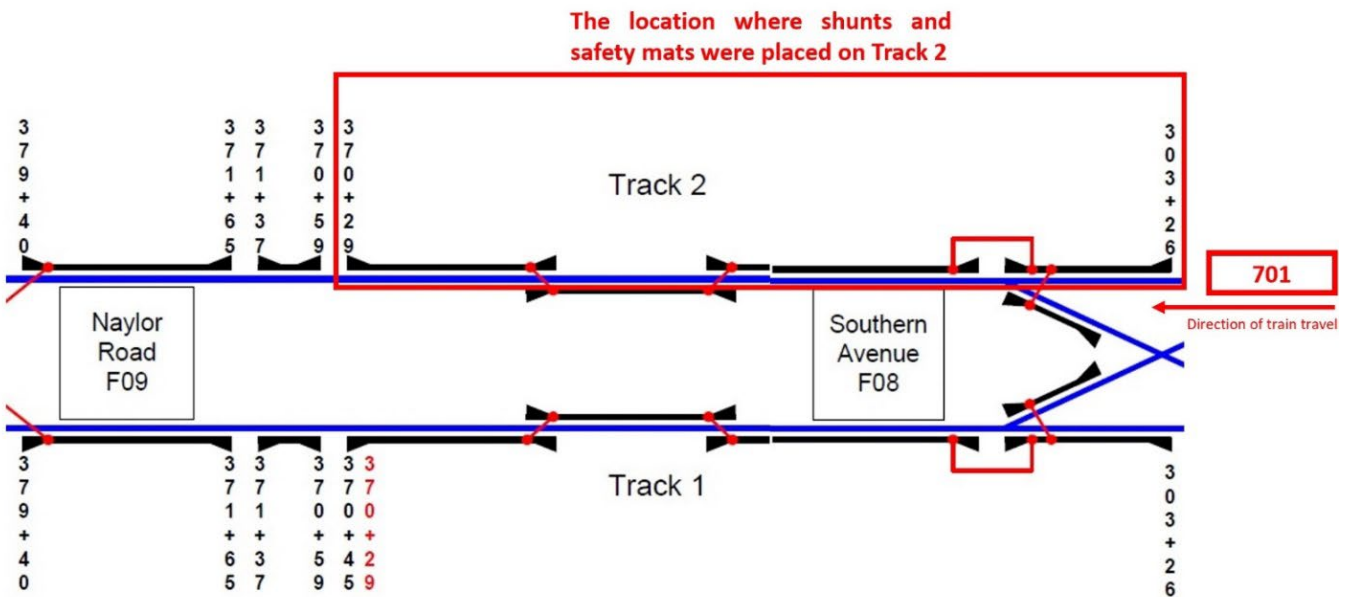
Figure 2 – Sketch illustrates the actual location where the RWIC set up their work area.

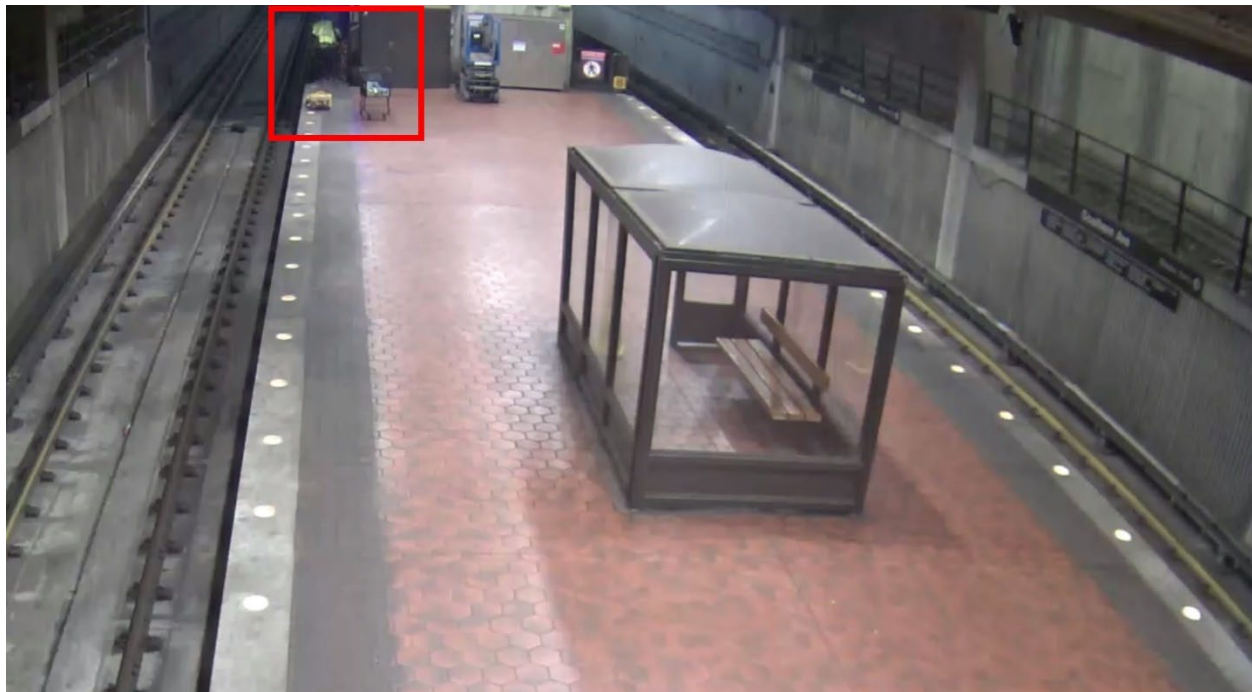
The Closed-Circuit Television (CCTV) revealed that at 01:47 hours, the RWIC passed the 8-car marker end gate at Southern Avenue Station on Track 2 and proceeded to install shunts, red lanterns, and other safety equipment on Track 2. At 01:52, the RWIC installed shunts and red lanterns at CM F2 303+26. The RWIC then proceeded to install safety equipment at CM F2 370+29.

Image 1 - RWIC entered the 8-car Marker end gate on Track 2 at Southern Avenue Station at 01:47 hours.

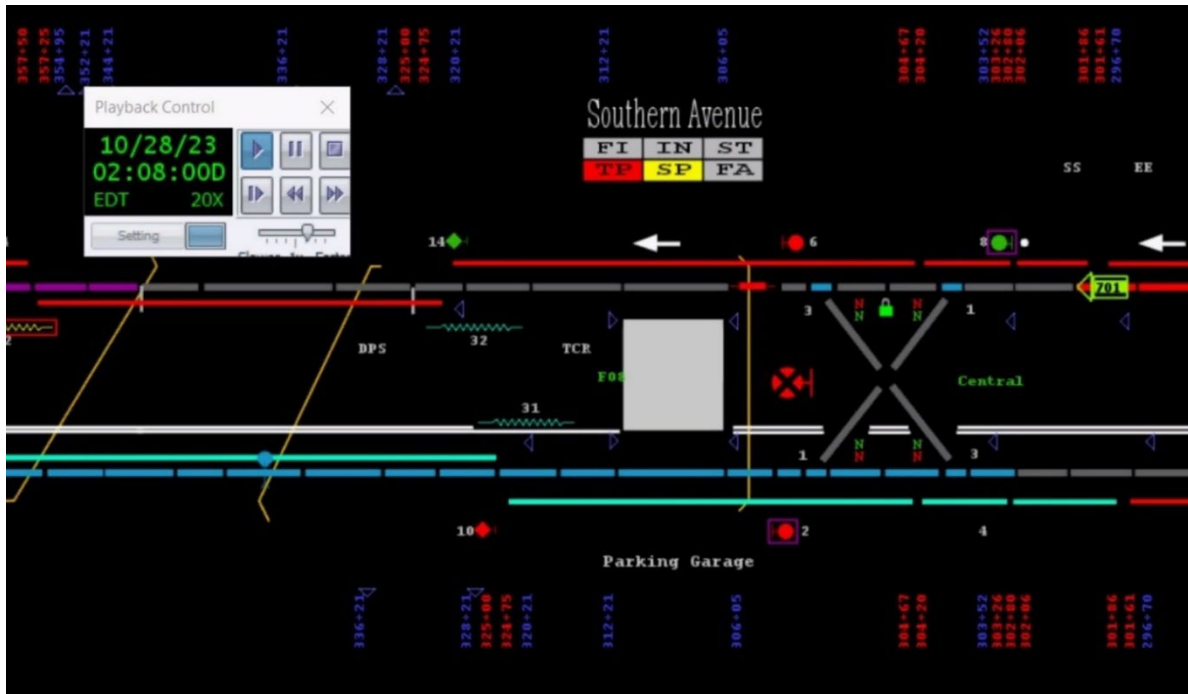
Figure 3 - Train ID 701 approaching Southern Avenue Station on Track 2 at 02:08 hours.

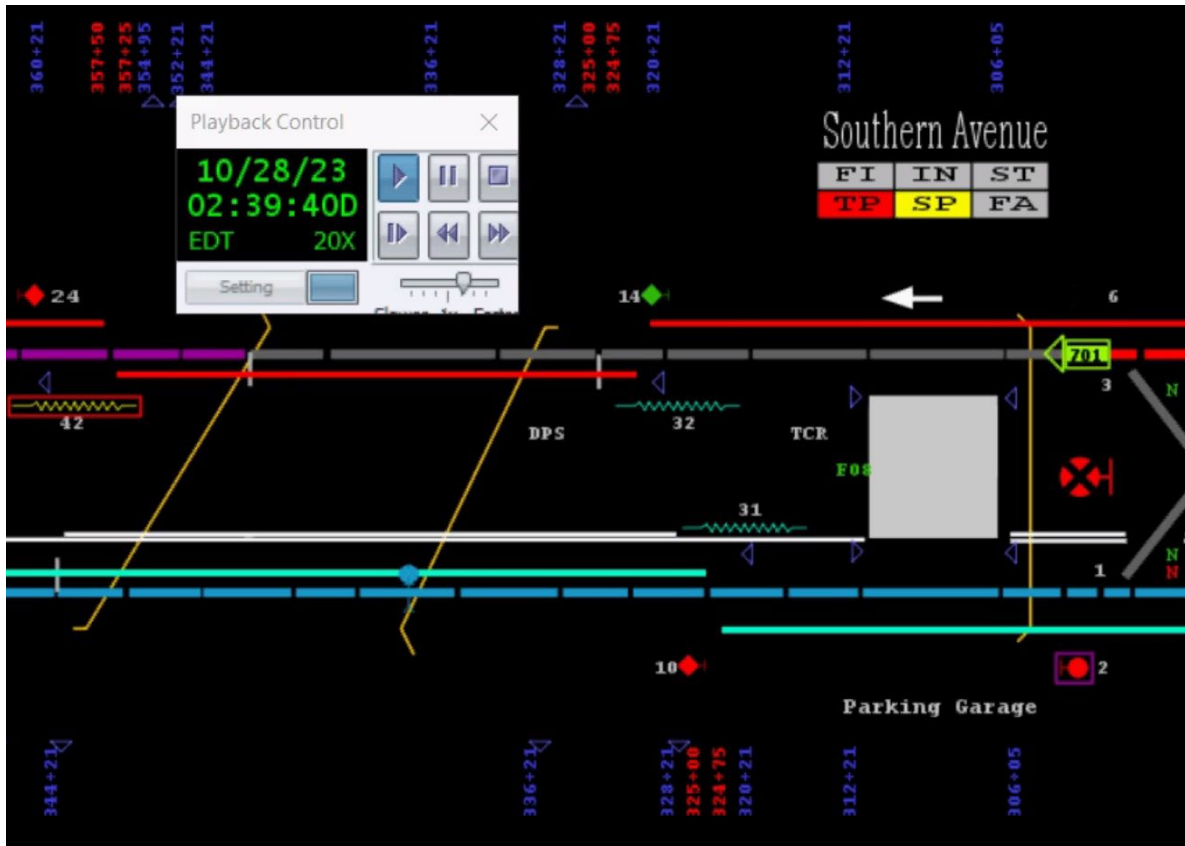
After the Radio RTC reestablished communications with the RWIC, the Radio RTC directed the Train Operator to proceed towards Southern Avenue Station on Track 2. The RWIC was subsequently removed from service for post-incident testing. No injuries or damages were reported as a result of this incident.

Figure 4 - Train ID 701 began to move in the direction of Southern Avenue Station, Track 2 at 02:39 hours.

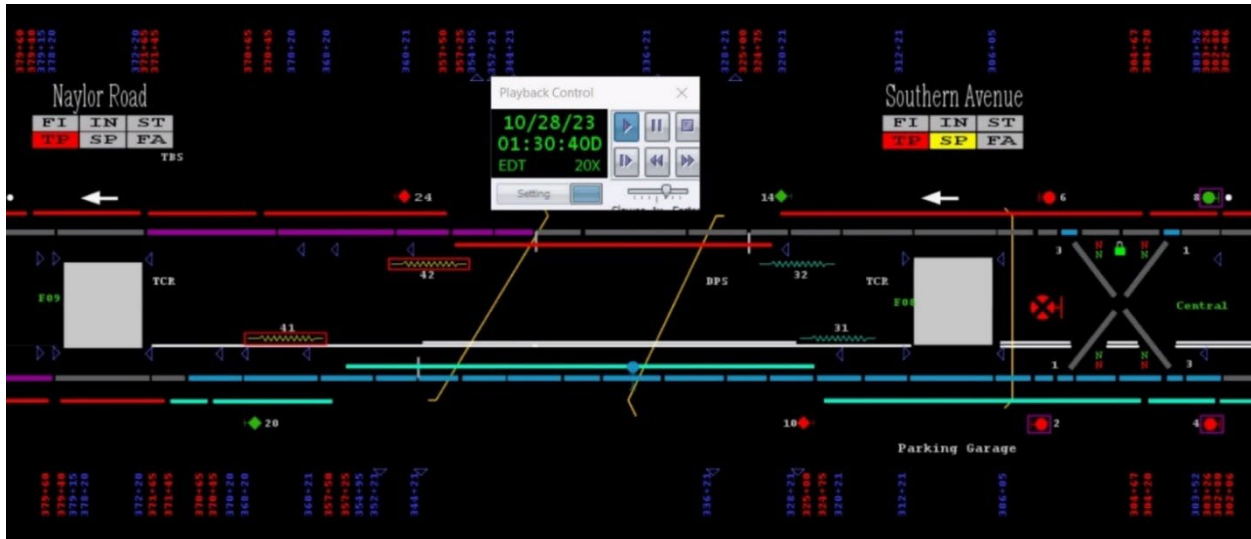
Figure 5 - Third rail power displaying as de-energized on Track 1, Southern Avenue Station at 01:30 hours via AIMS.

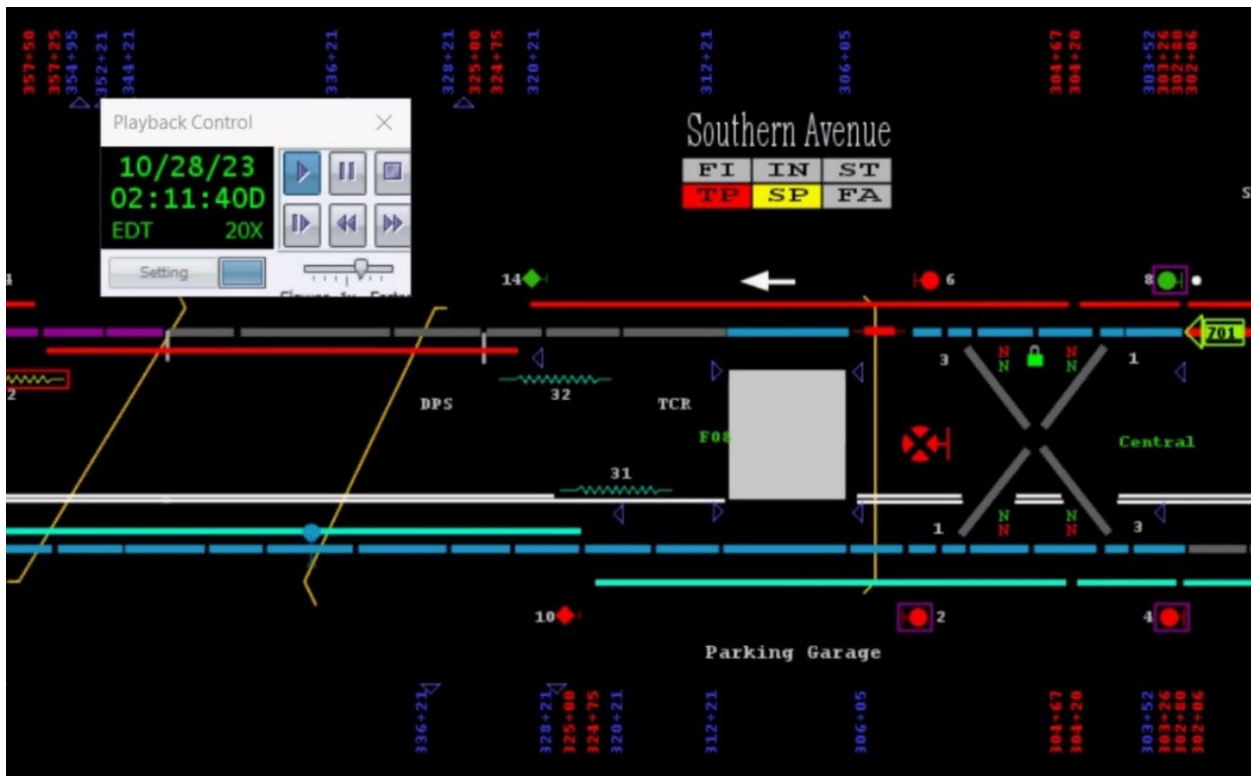
Figure 6 - Third rail power was still de-energized at 02:11 hours on Track 1 at Southern Avenue Station.

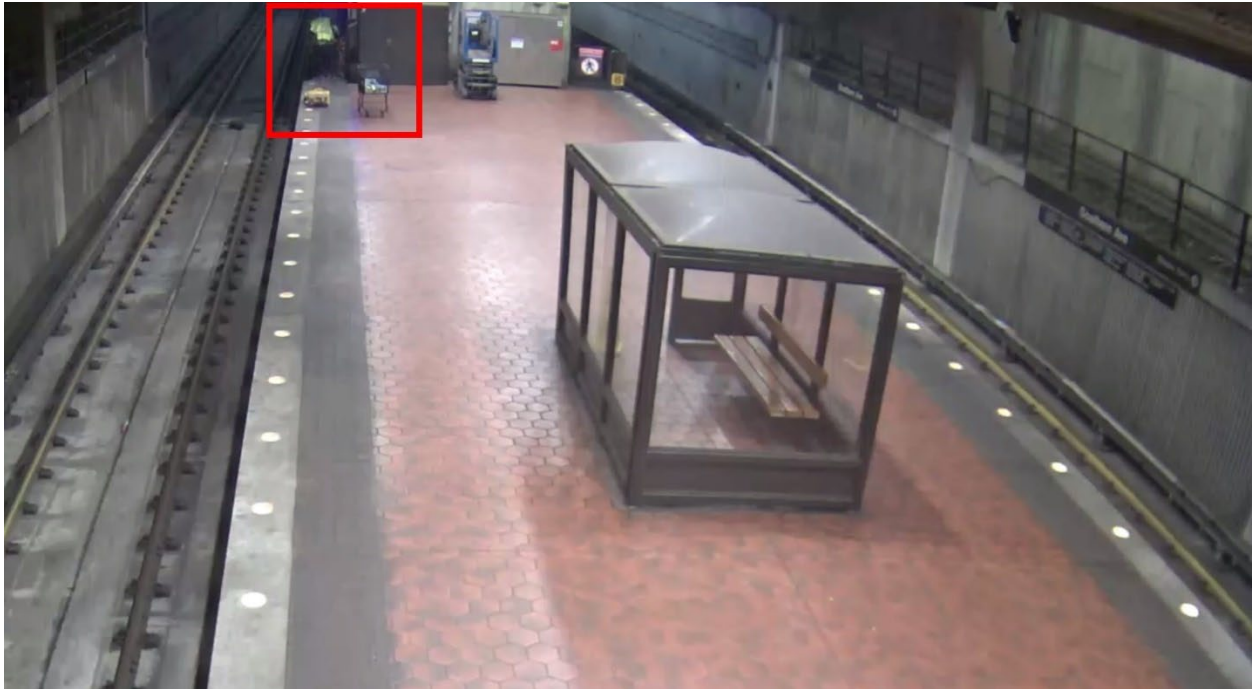
Image 2 - RWIC entered the 8-car Marker end gate on Track 2 at Southern Avenue Station at 01:47 hours.

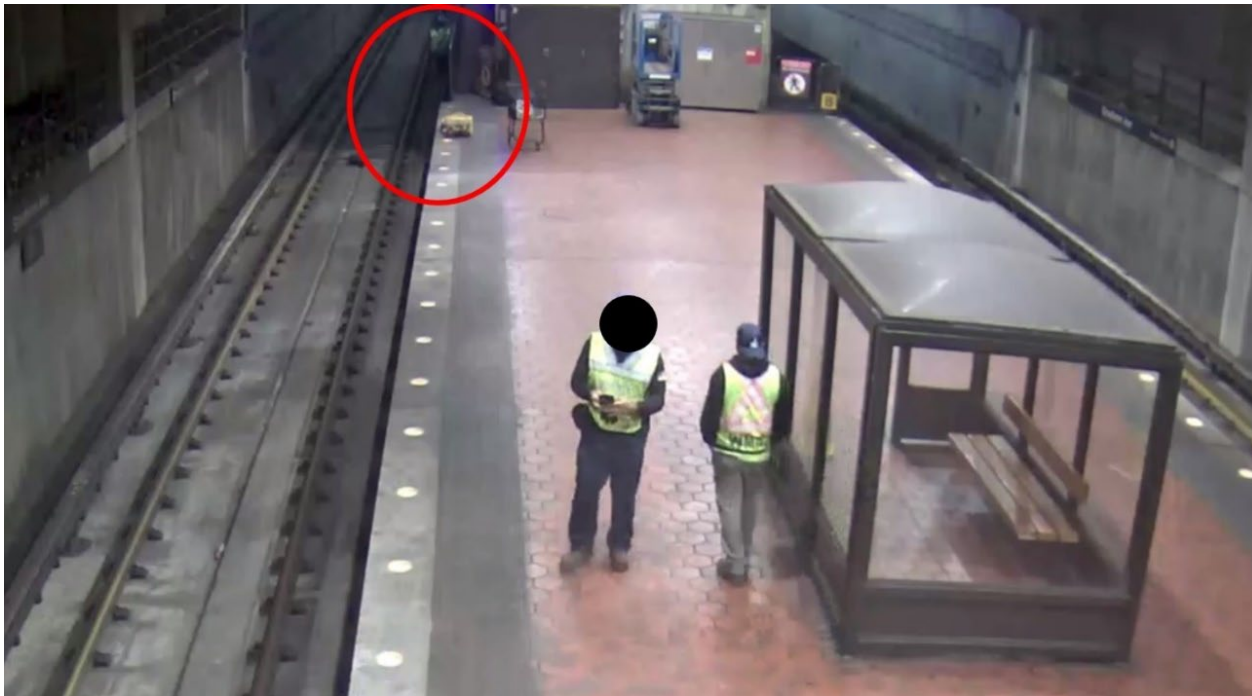
Image 3 - RWIC walking back towards the platform limits at Southern Avenue Station on Track 2 at 01:48 hours.
