Improper Roadway Worker Protection

At or Near College Park-UMD, Forest Glen, Potomac Ave, Ballston-MU, Wiehle-Reston East, Metro Center, Morgan Boulevard and Southern Ave stations

Document Purpose:

Improper RWP College Park Station
February 25, 2023
 Table of Contents

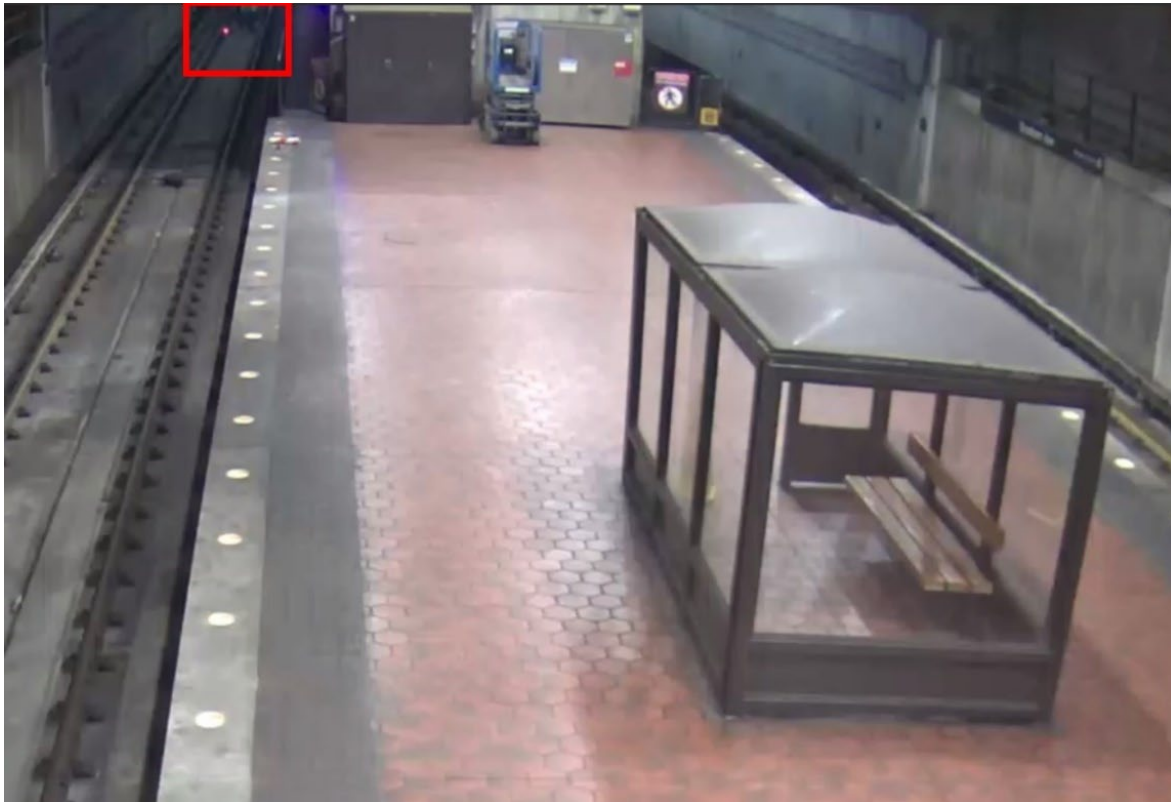
Image 4 - The RWIC installed shunts and red lanterns at 01:52 hours on Southern Avenue Station, Track 2.

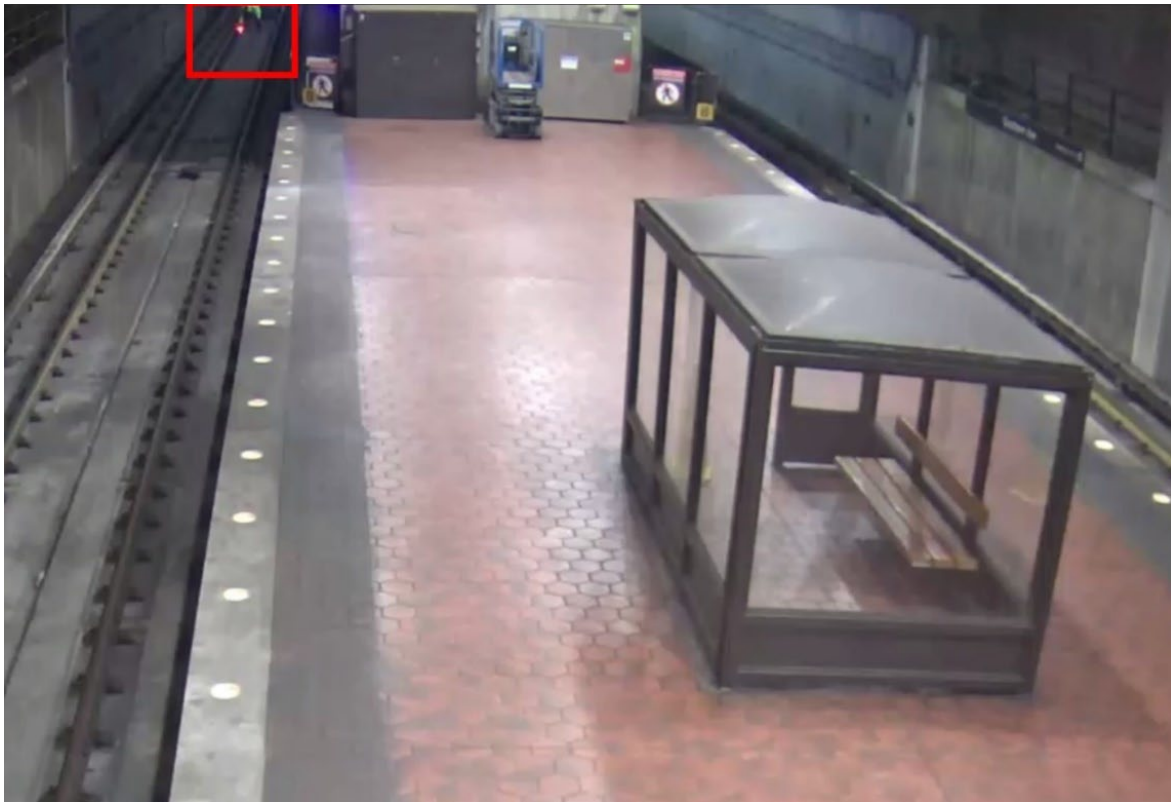
Image 5 - The RWIC removed the shunts and red lanterns at 02:14 hours on Southern Avenue Station, Track 2.

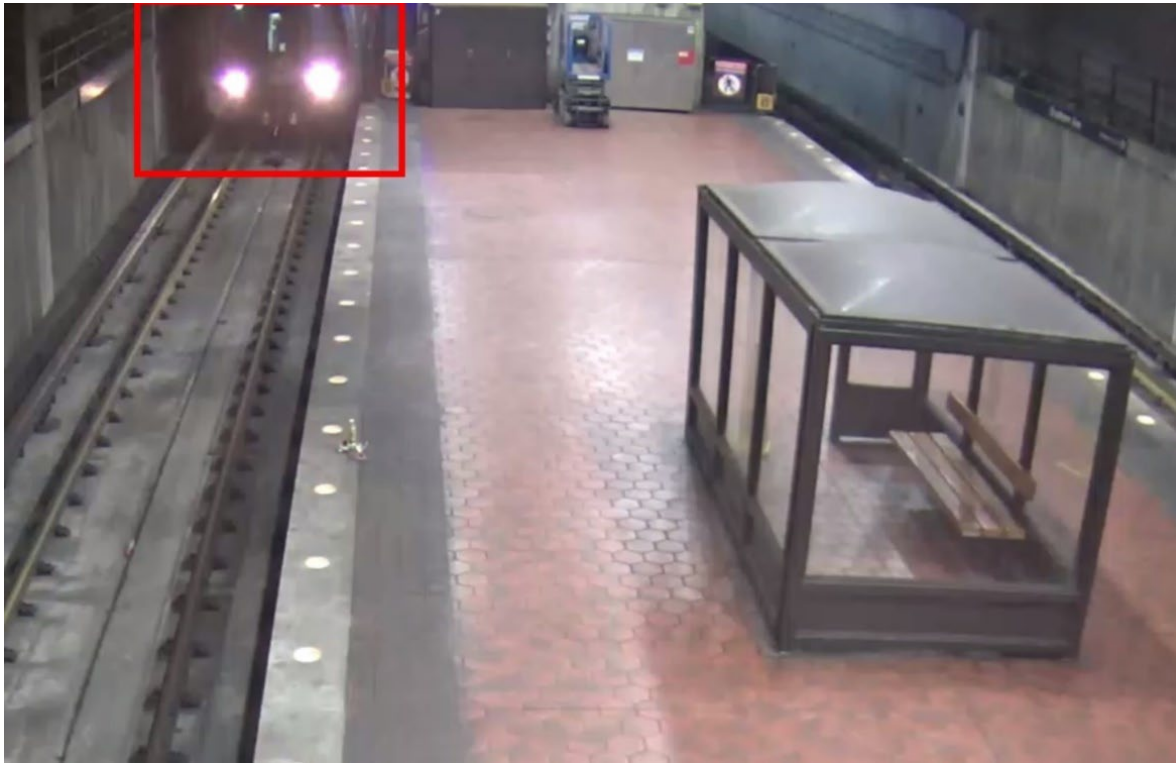
Image 6 - Train ID 701 entered Southern Avenue Station platform limits on Track 2 at 02:39 hours.

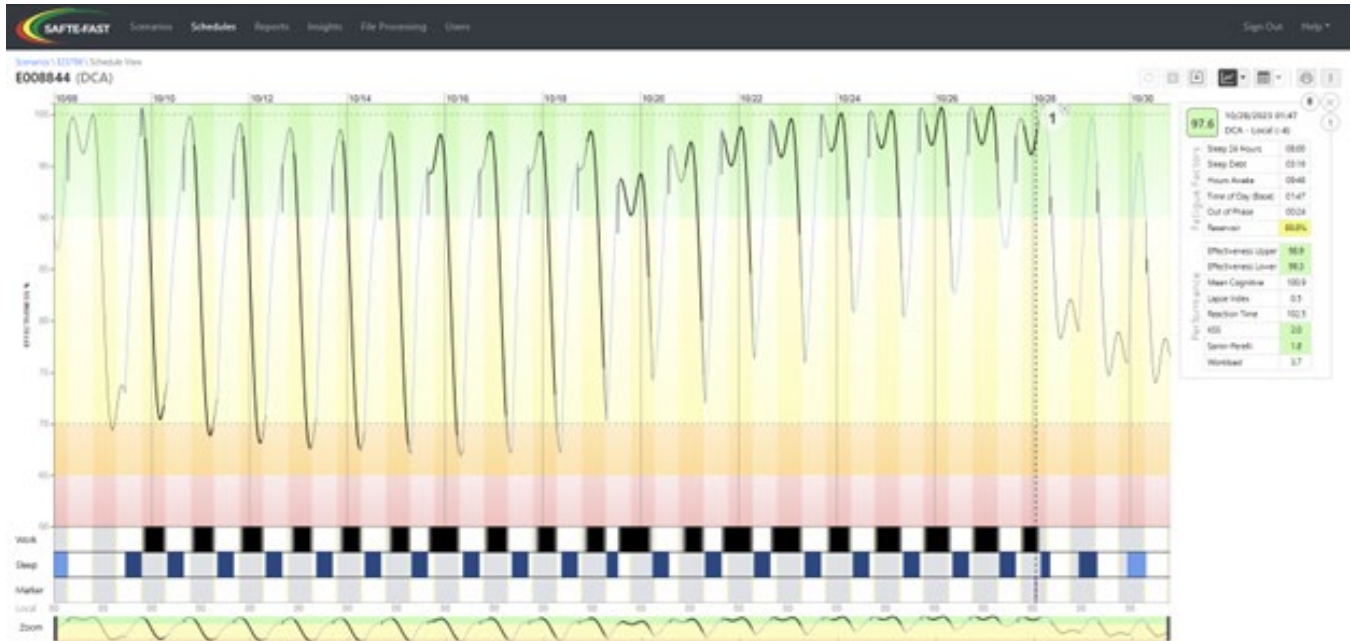
A biomathematical fatigue modelling application (SAFTE-FAST WebSFC) was used to further evaluate fatigue risk factors that may have been present in the Track Walker's schedule. The analysis was based on the RWIC's work schedule, reported sleep from the day before the incident, and reported habitual sleep durations. The estimated performance effectiveness at the time of the incident was 97.6%. There were no major risk factors for fatigue identified.

Graph 1 - Modeling analysis output shows estimated performance effectiveness during the incident work shift and for the 18 days leading up to the work shift, based on the employee work and reported sleep schedule. Estimates were based on the Track Walker's work schedule, reported sleep from the day preceding the incident, and reported habitual sleep durations (8 hours a day). Bold portions of the modeled curve show work (in black) and sleep times (in blue). Effectiveness is shown on the vertical axis, with colored fields in the chart background signifying ranges of effectiveness scores, including high effectiveness (>90%) in green and low effectiveness (<65%) in red. Time is shown on the horizontal axis. Markers for work and sleep times are shown in the lanes above the time of day on the horizontal axis.
