Improper Train Movement

At or Near Federal Center SW Station, McPherson Square Station, Federal Center SW Station, and Huntington Station

April 26, 2023 – June 14, 2023 – September 23, 2023 – November 20, 2023

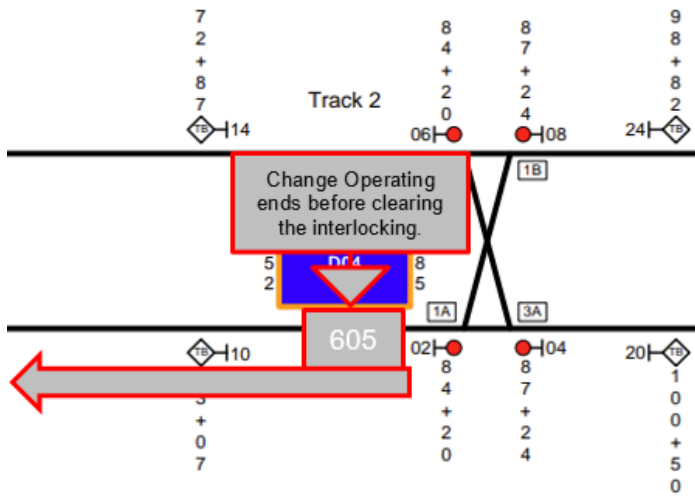
Actual Move (Improper Movement). Not to Scale.

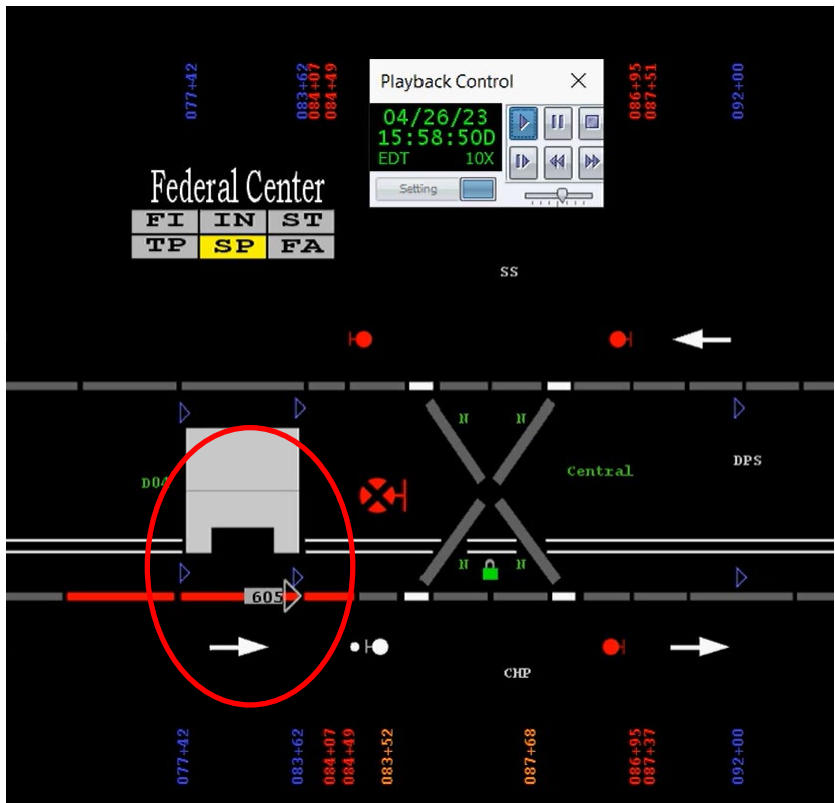
Figure 1 - AIMS view of intended movement of Train ID 605. Note straight-through move aligned and lunar aspect in the normal direction of traffic.

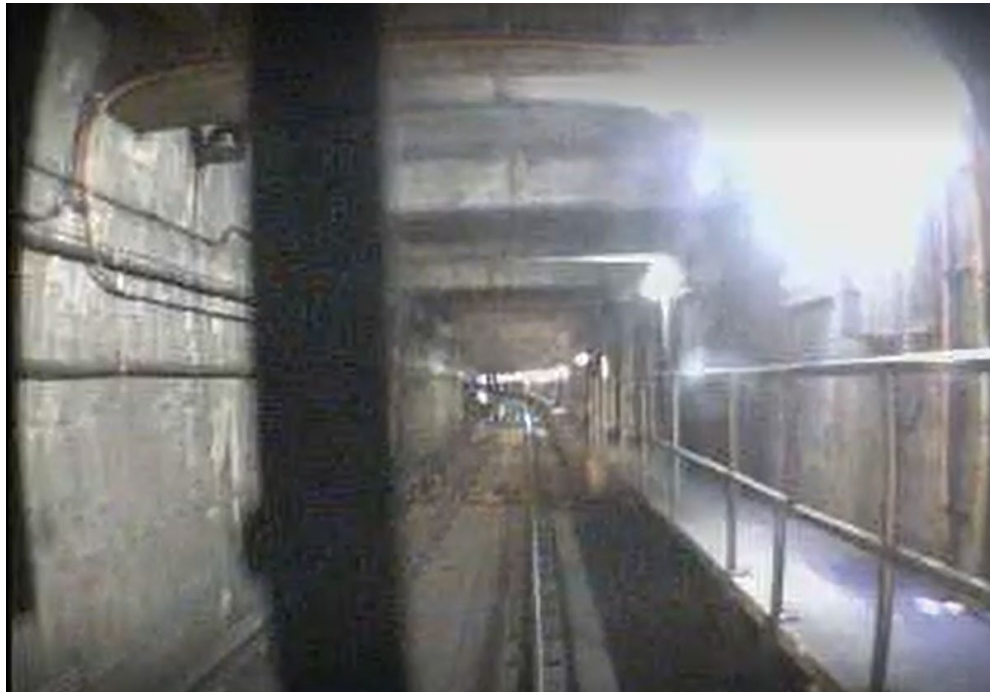
Figure 2 - Train ID 605 lead car, now 7650, headed in Ashburn Stations' direction on Track 1.

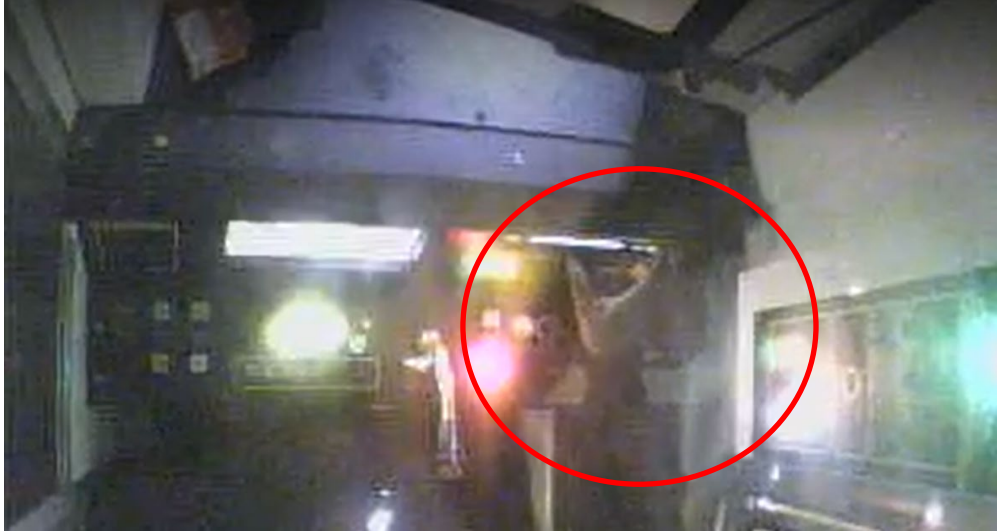
Console footage from Car 7650 and the CMOR IIT data showed the Operator entered Stop and Proceed mode after cycling the Master Controller several times in an effort to move the train. By procedure, this action required permission from the ROCC, but was not requested or received. At 16:02 hours, Train ID 605 moved their train against the normal traffic flow. Operating against the normal traffic flow requires an Absolute Block from ROCC, which was not requested or received.

Figure 3 - Train ID 605 Train Operator entering Stop and Proceed mode.

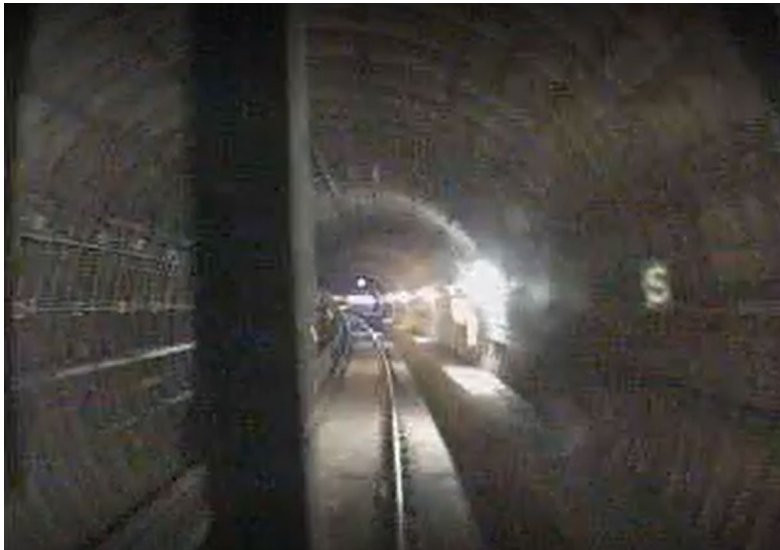
At 16:03 hours, the Radio RTC instructed Train ID 605 to stop their train multiple times. CMOR IIT data determined that Train ID 605 moved approximately 256 feet off the platform before stopping.

Figure 4 – Forward-facing footage showed no train in the immediate location during this incident after moving 256 feet.

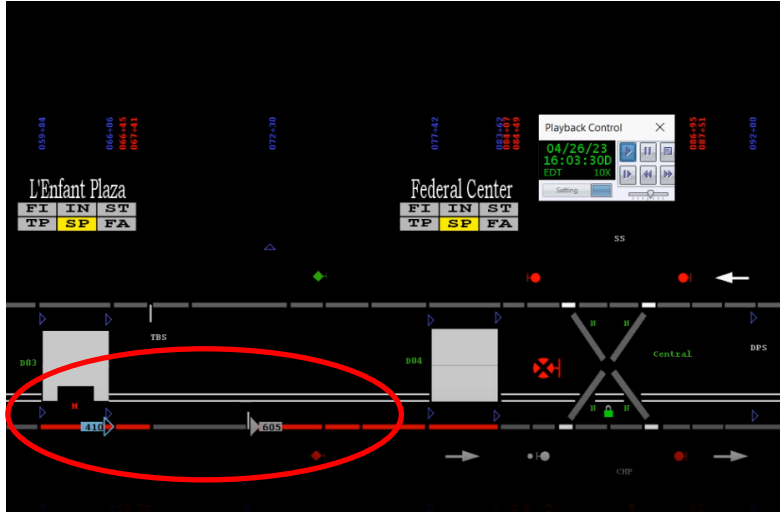
Figure 5 - AIMS Playback shows Train ID 605 moving against the normal flow of traffic. The displayed location is not exact and cannot be used to calculate distance.

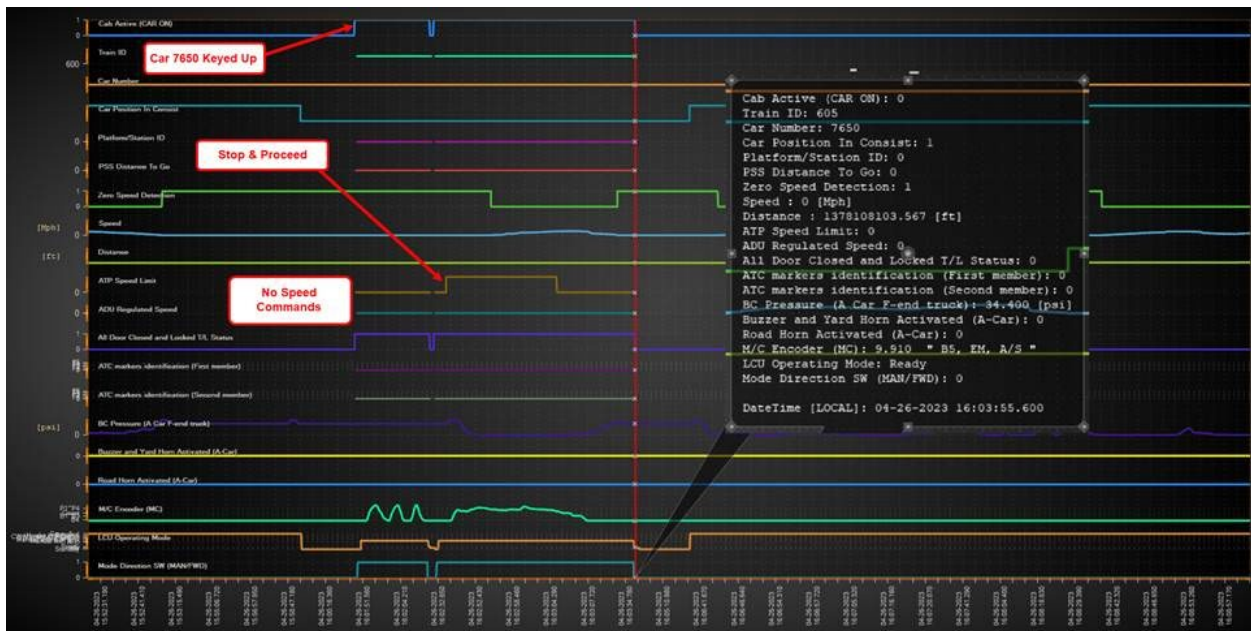
VMS Graphic # 2 Car 7650 Moving Against Normal Flow of Traffic Federal Center

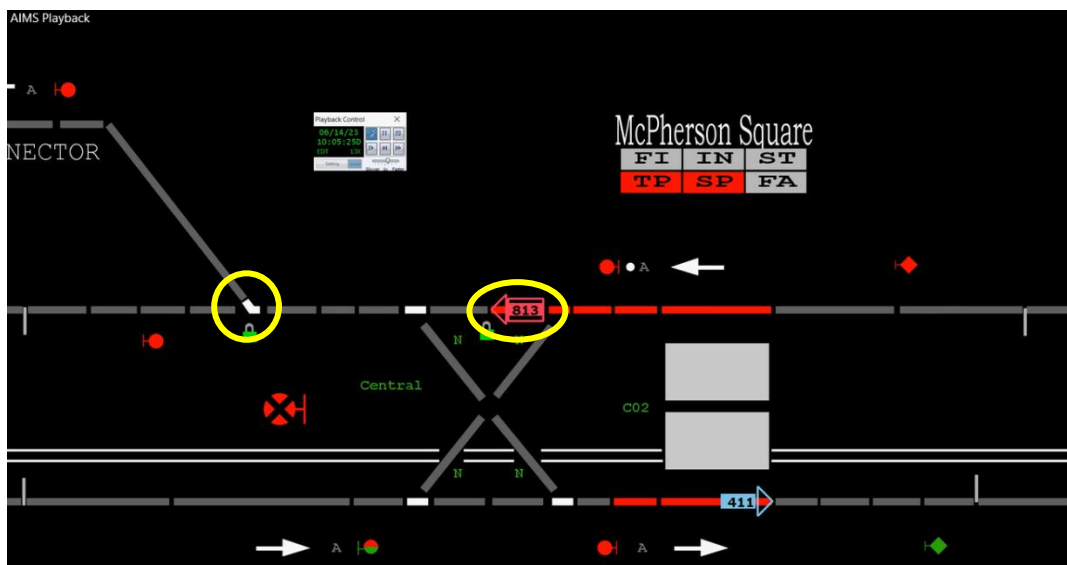
Figure 2: This image shows that when the train departed McPherson Square Station, it still appeared as ID 813 and the lead was set to the C & A Connector.

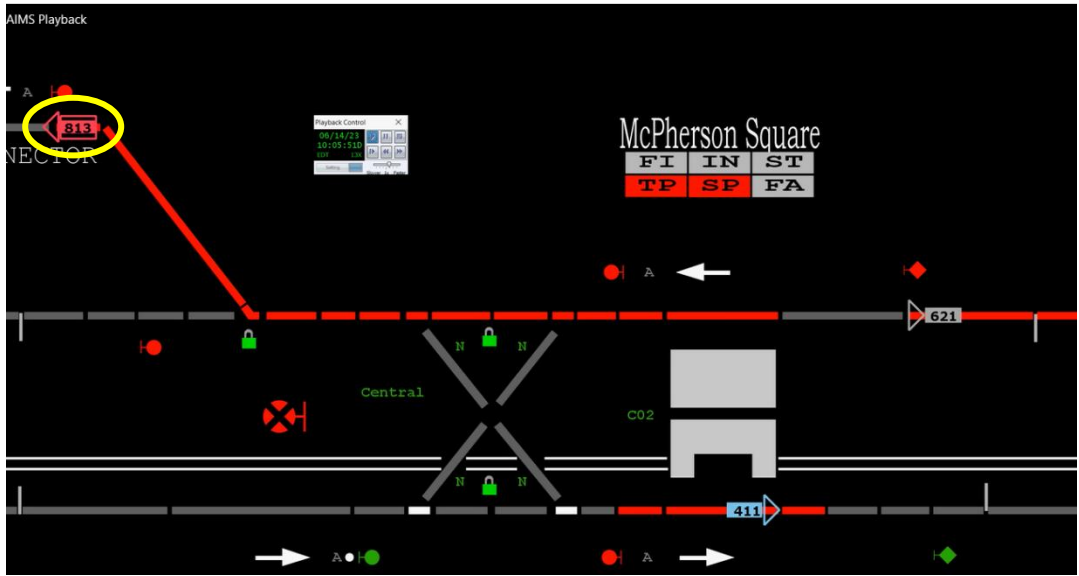
Figure 3: This image shows that Train ID 813 took the lead into the C & A Connector.

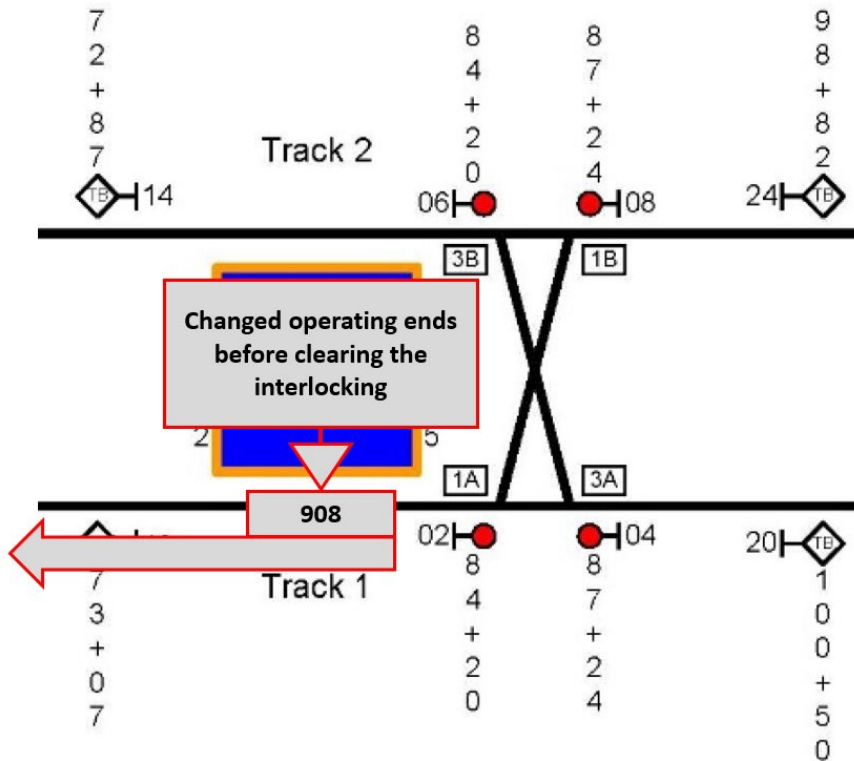
Actual move (Improper movement). Not to scale.

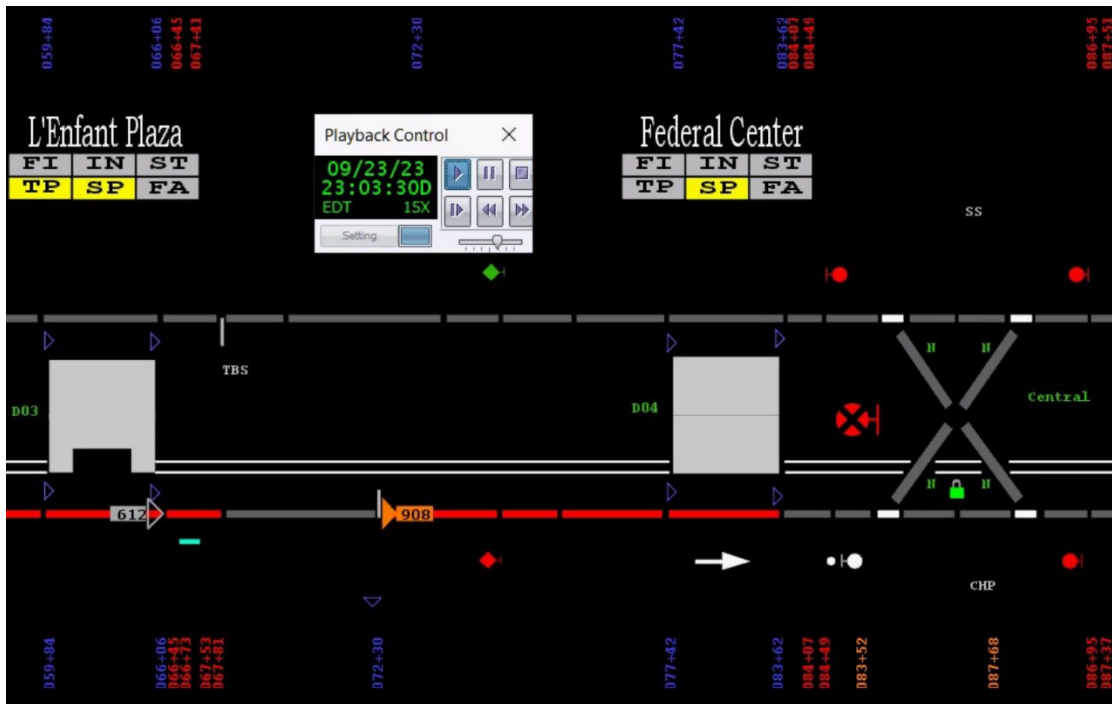
Figure 4 - AIMS Playback shows Train ID 908 traveled in the opposite direction of normal traffic flow as Train ID 612 was berthed at L'Enfant Plaza Station on Track 1 at 23:03 hours. The displayed location is not exact and cannot be used to calculate distance.

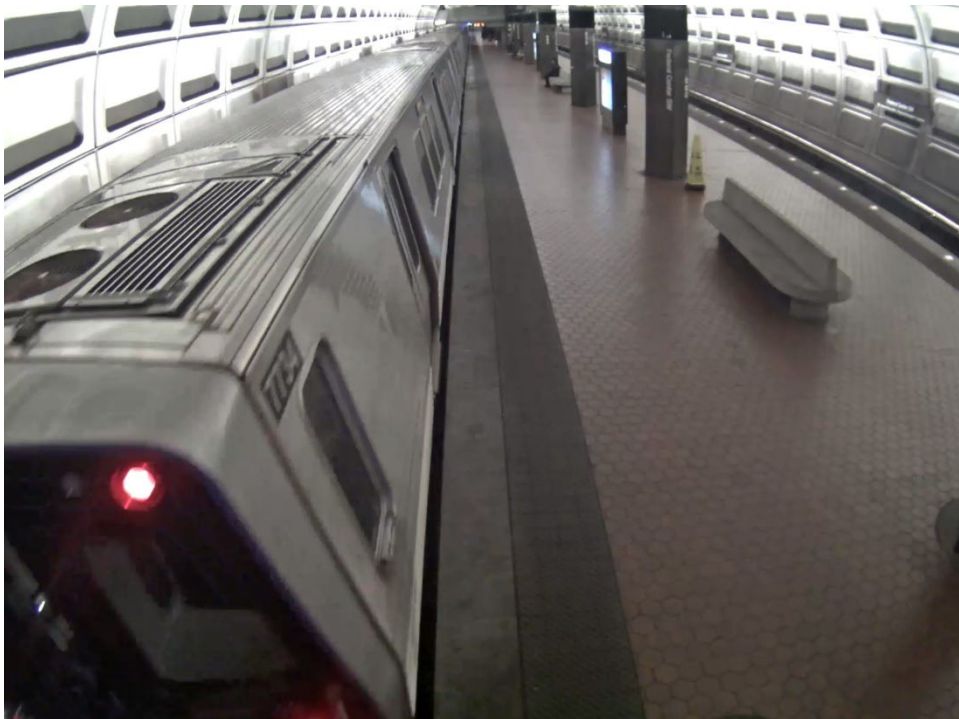
Figure 8 - Train ID 908 departed Federal Center SW Station, Track 1, at 23:02 hours in the direction of L'Enfant Plaza Station (against the normal flow of train traffic).

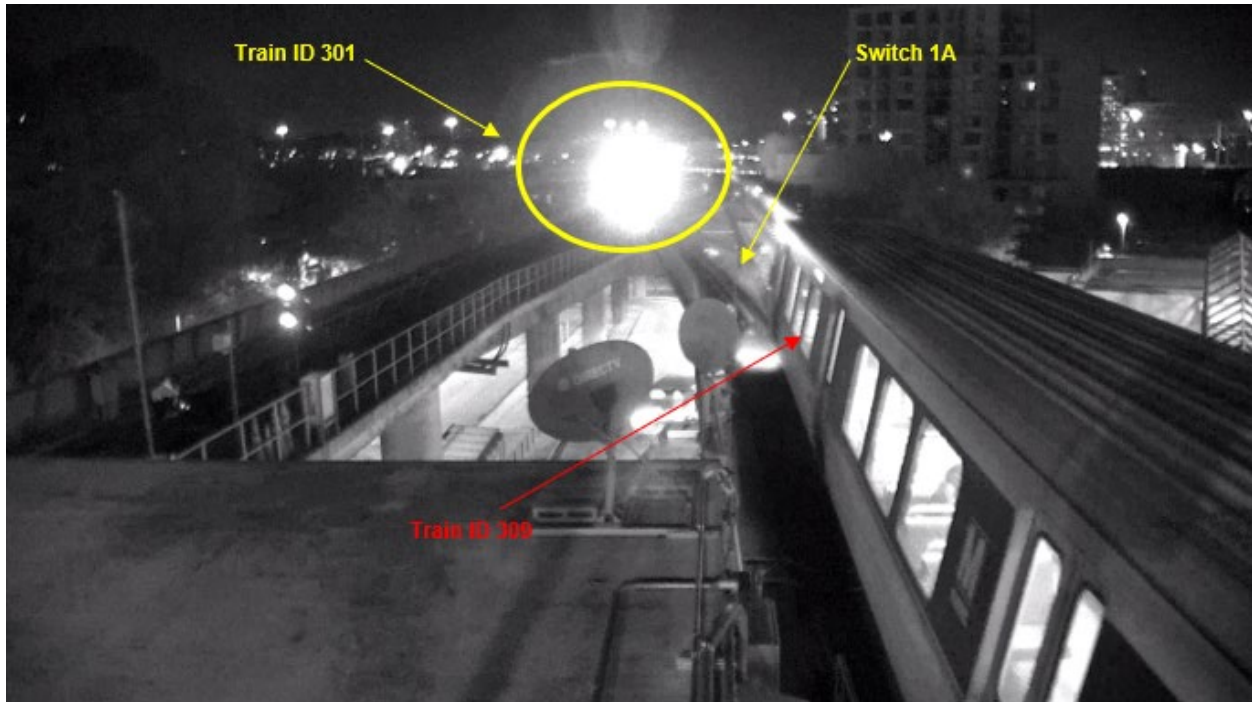
Figure 2 – CCTV image depicting Train ID 309 diverging towards Train ID 301.

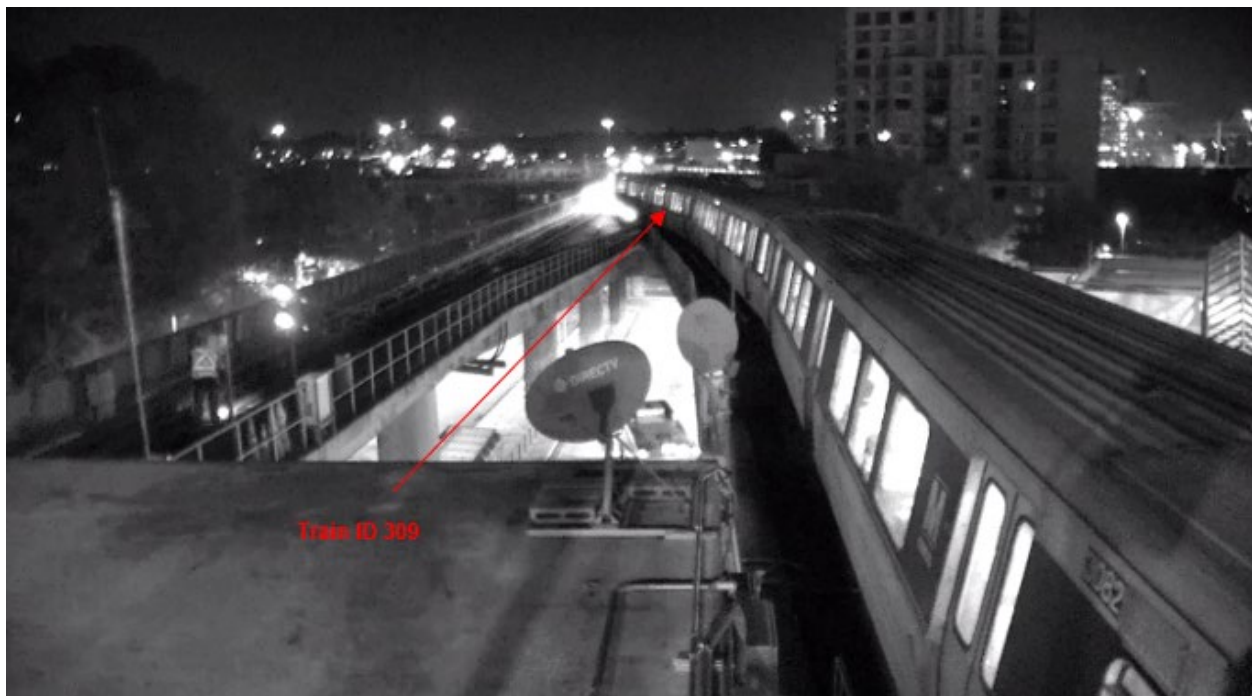
Figure 3 – CCTV image depicting Train ID 309 traversing the interlocking from Track 1 toward Track 2.

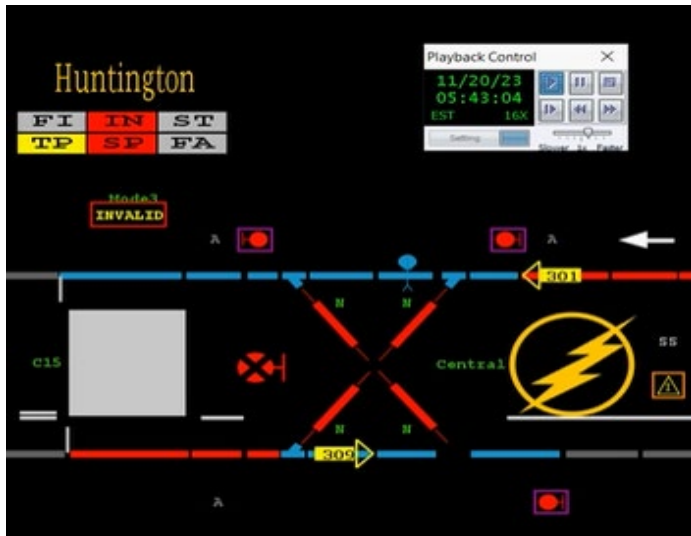
Figure 4 - AIMS depicts a false Train ID 309 straight-through switch 1A image.

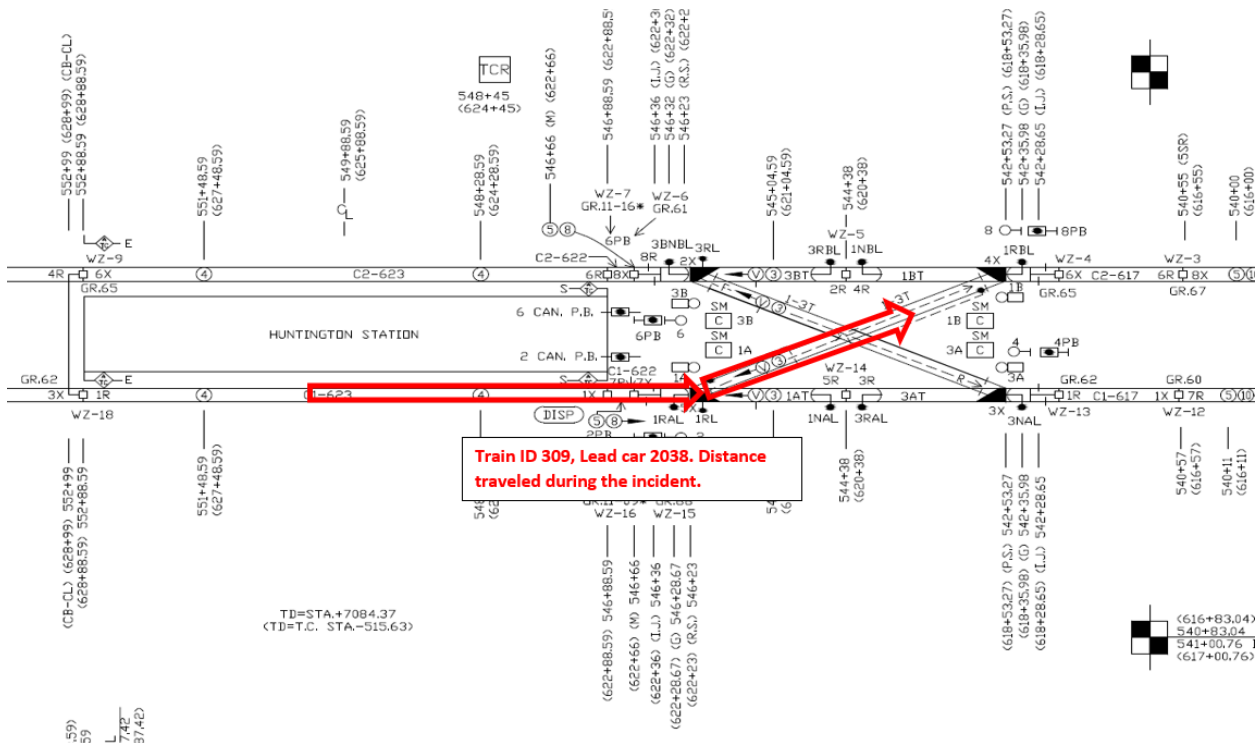
Figure 7 - depicts the distance Train ID 309 traveled from the platform to the interlocking.
