## Red Signal Overruns

At or Near Ronald Reagan Washington National Airport Station, West Falls Church Yard and Spring Hill Station

July 23, 2023 – November 19, 2023 – November 25, 2023

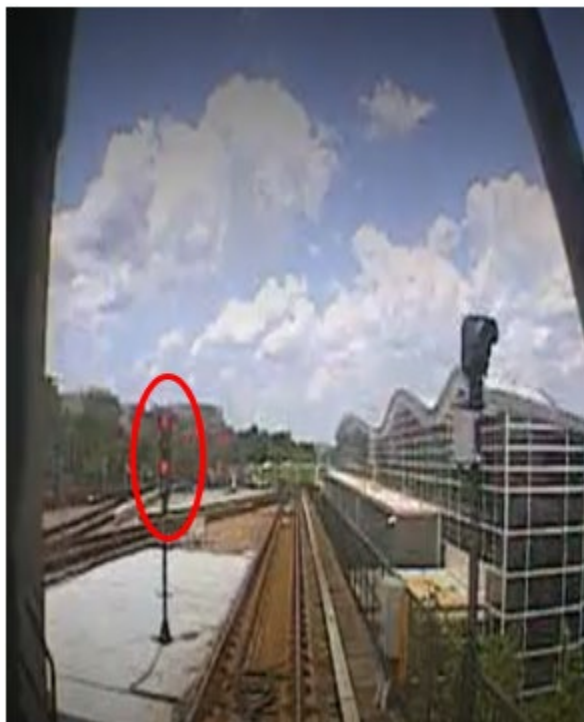
*Image 1 – Train ID 304’s Forward-Facing Camera showing the train passing C10-36 signal with a red aspect.*

The Advanced Information Management System (AIMS) revealed that Train ID 304 arrived at National Airport at 13:33 hours, and at 13:35 hours, the Train Operator moved the train past C10-36 signal, displaying a red aspect<sup>2</sup>.

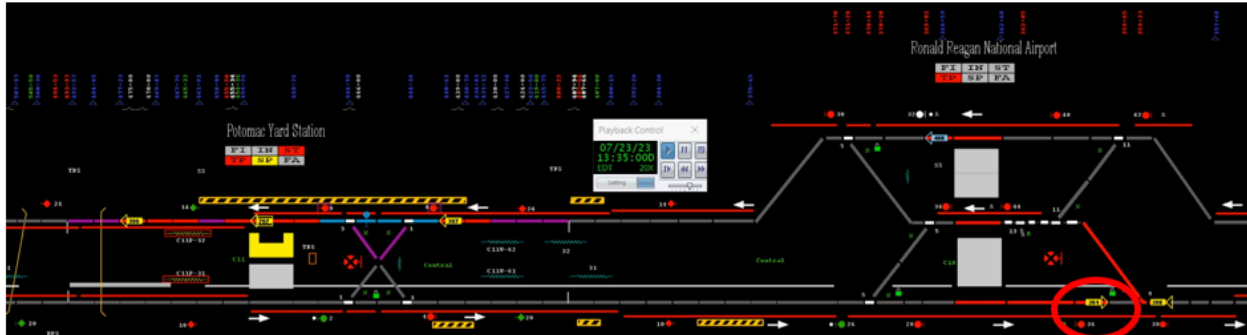
Figure 1 - AIMS Playback of Train ID 304 overrunning C10-36 signal red at National Airport Station at 13:35 hours. Train ID 308 departed National Airport pocket signal at C10-44 crossing over from Track 3 to Track 1.

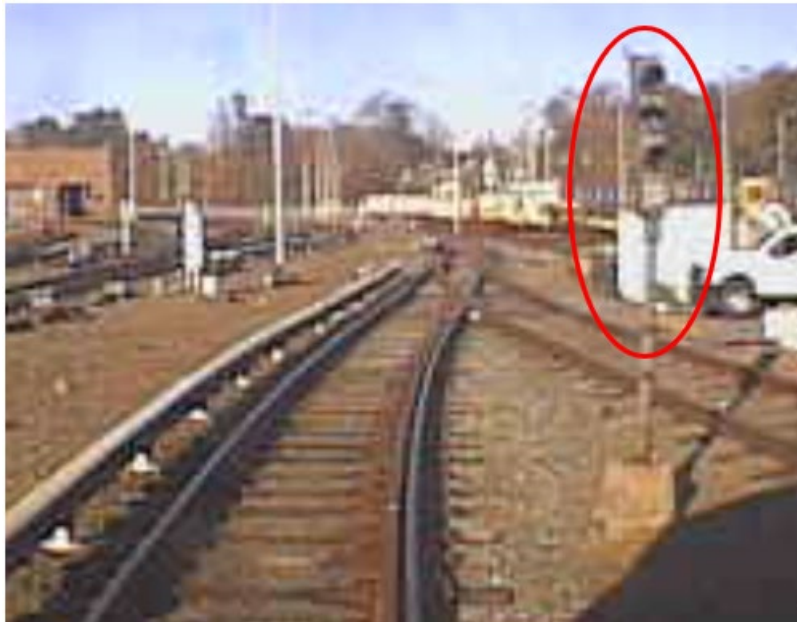
On Sunday, November 19, 2023, at 09:12 hours, a Train Operator performing yard duties in West Falls Church Yard passed signal K99-302, displaying a red aspect, traversing switches 301 and 303A.

*Image 1 – Forward-facing Camera Image of the consist passing K99-302 at 09:12 hours.*

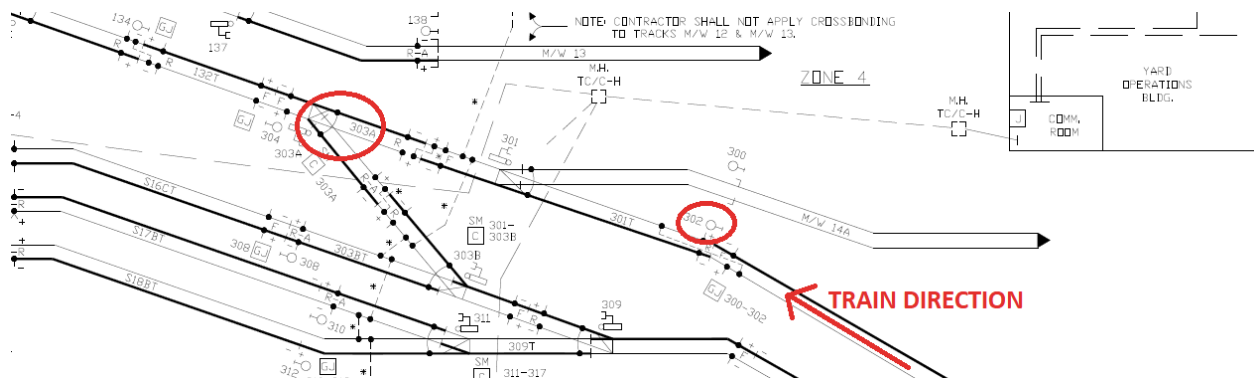
The Closed-Circuit Television (CCTV) revealed that the consist arrived at the road crossing at 09:12 hours, stopped briefly, and then continued across the road crossing, exceeding the absolute block and instructions from the Interlocking Operator. Seconds later, the consist passed signal K99-302, displaying a red aspect traversing switch 301 and trailed switch 303A.

Figure 1 – West Falls Church Yard Layout Map of the incident area. The path of the train operating from the roadway towards the west side of the yard. The first circle is signal K99-302, which was red. The second circle is switch 303, which was trailed. It also shows switch 301 (after K99-302), which is not circled.

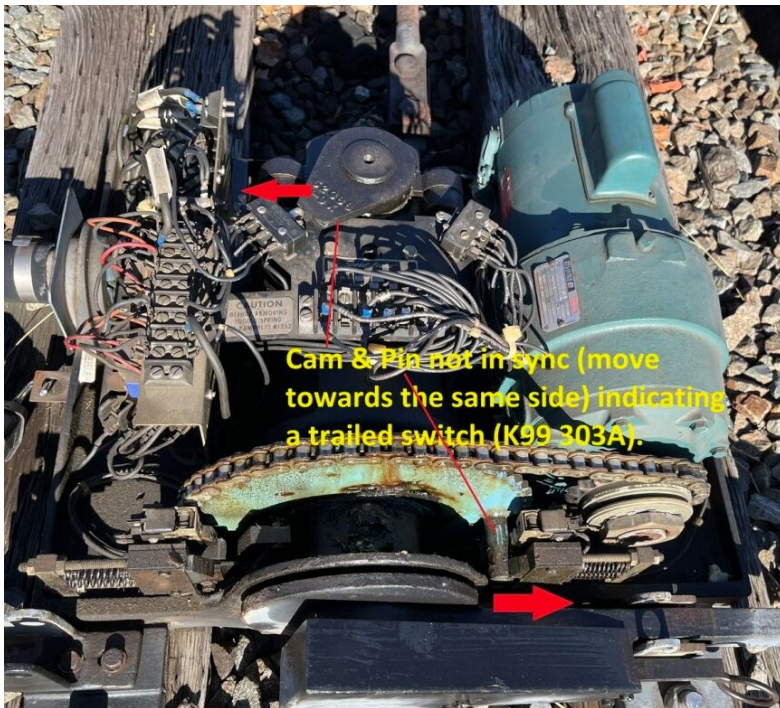
Image 4 – Image of Switch 303A, indicating a trailed switch.

ATCM confirmed that switch 303A had been trailed, Switch Obstruction Track Circuit Testing, Signal Light Testing, Switch Detector and Route Locking Testing, and Switch Indication Locking Test were conducted, and no damages were found to the switch points, the switch machine, or the layout. Switch 303A was restored and placed back in service.

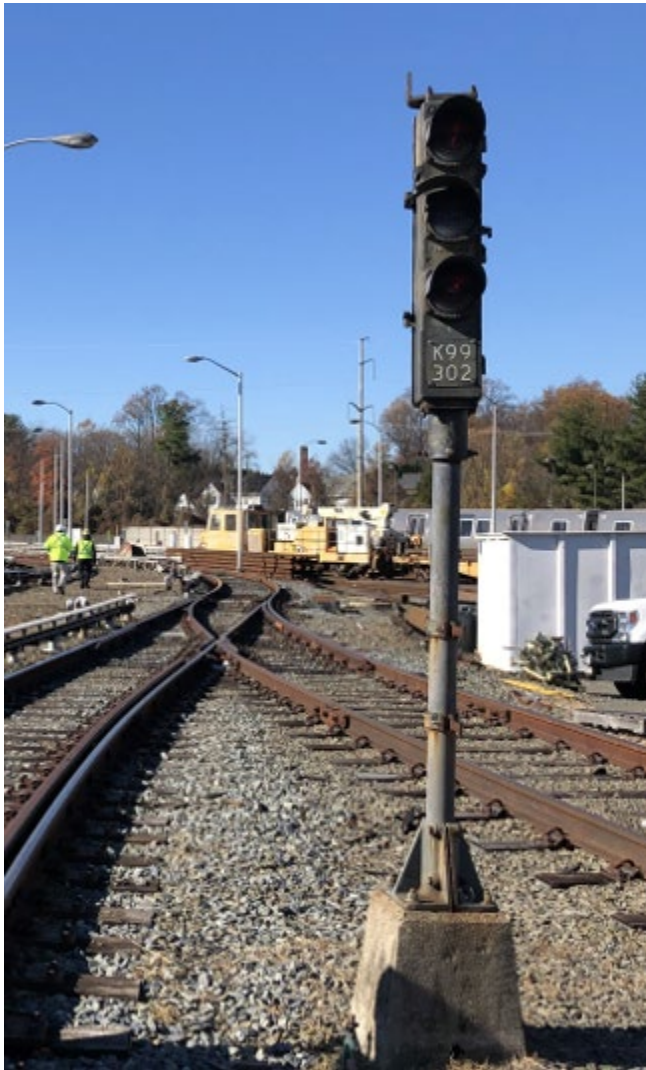
Forward-facing video and on-site investigation following the event show that the lighting conditions and condition of the signal at K99-302 made it difficult for the Train Operator to see the red indication. Metrorail procedures require dark signals to be treated as red signals.

*Image 6 – Image of Signal K99-302, with red aspects faintly noticeable.*

ATCM performed an inspection of signal K99-302 and found that bulbs were “burned out” within the red aspects; the bulbs were replaced

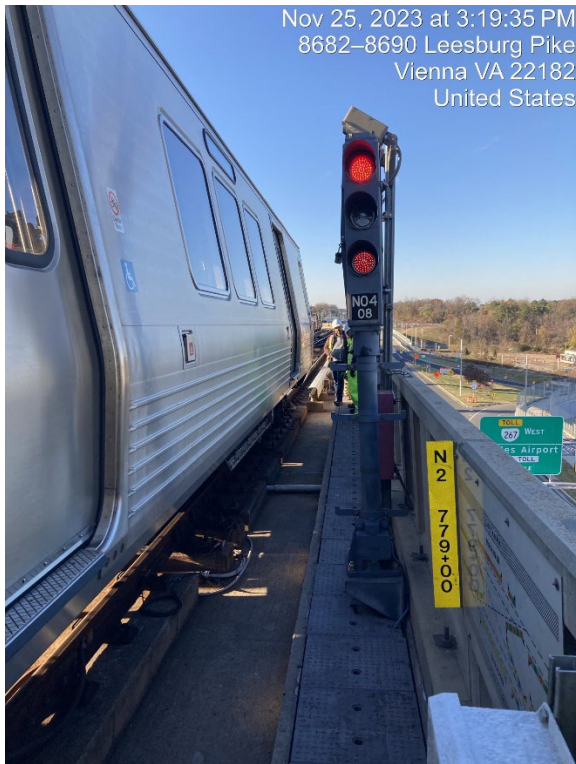
Figure 1: Shows N04-08 signal was red when Train ID 613 overran it.

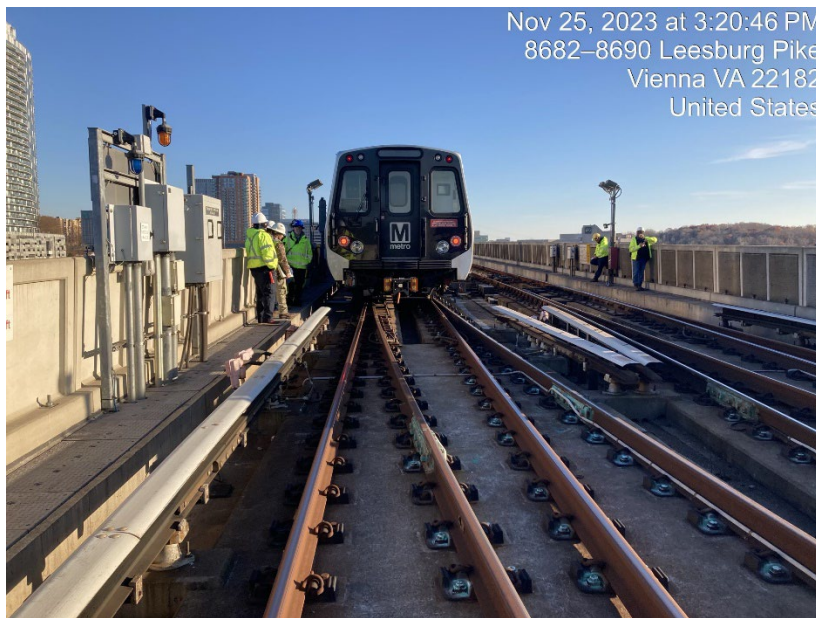
Figure 2: Shows Train ID 613 stopped prior to crossing the switch point.

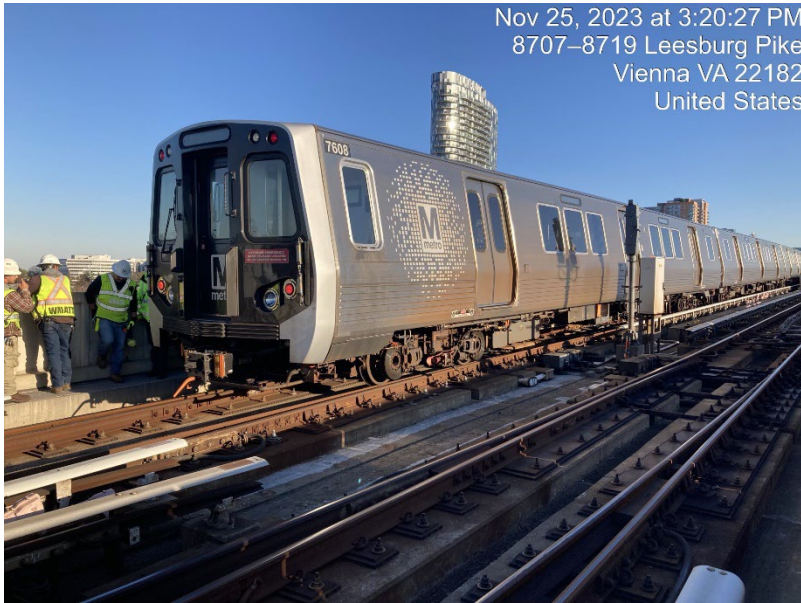
Figure 3: Shows distance of travel Train ID 613 traversed past the red signal.

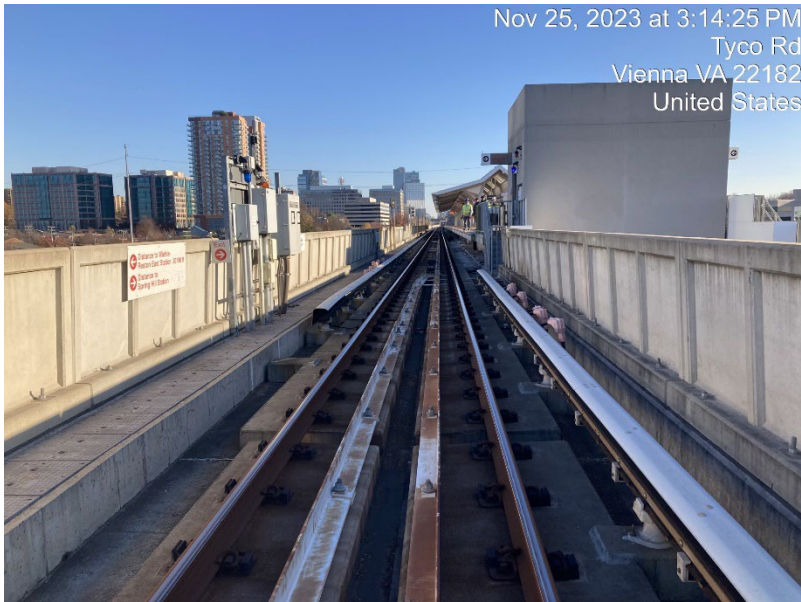
Figure 4: Shows how close Spring Hill Station was to the trailing car of Train ID 613.
