W-0304 Derailment – Near Ronald Reagan Washington National Airport Station – September 29, 2023

Document Purpose

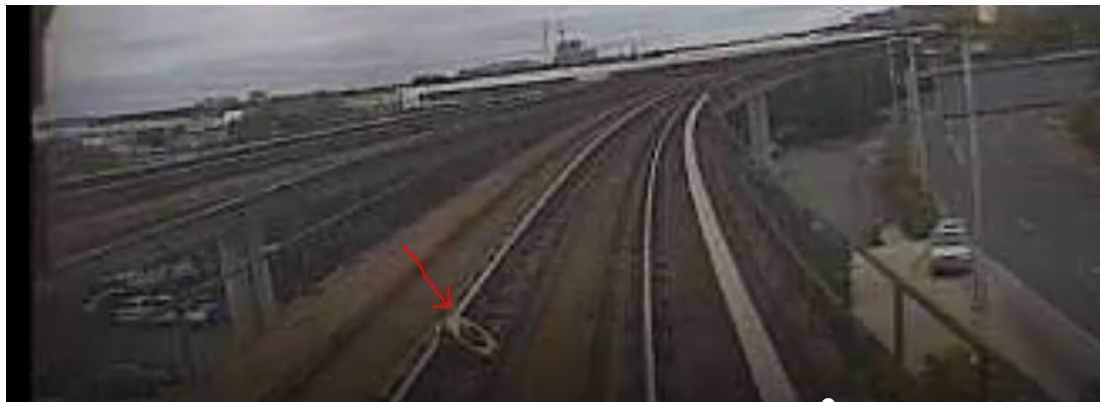
Image 1 – Forward-facing camera view from Train ID 406 of brake disc #4 from Train ID 308 before the derailment.

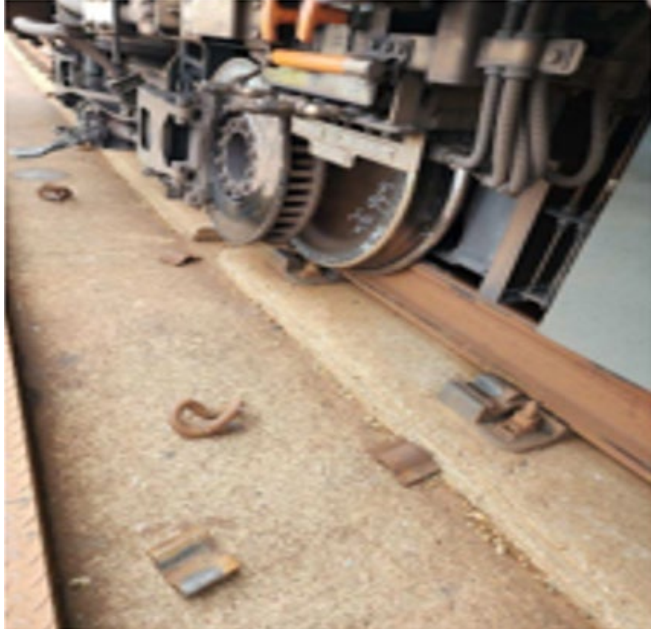
Image 2 – Train ID 406, lead car 7246 derailed.

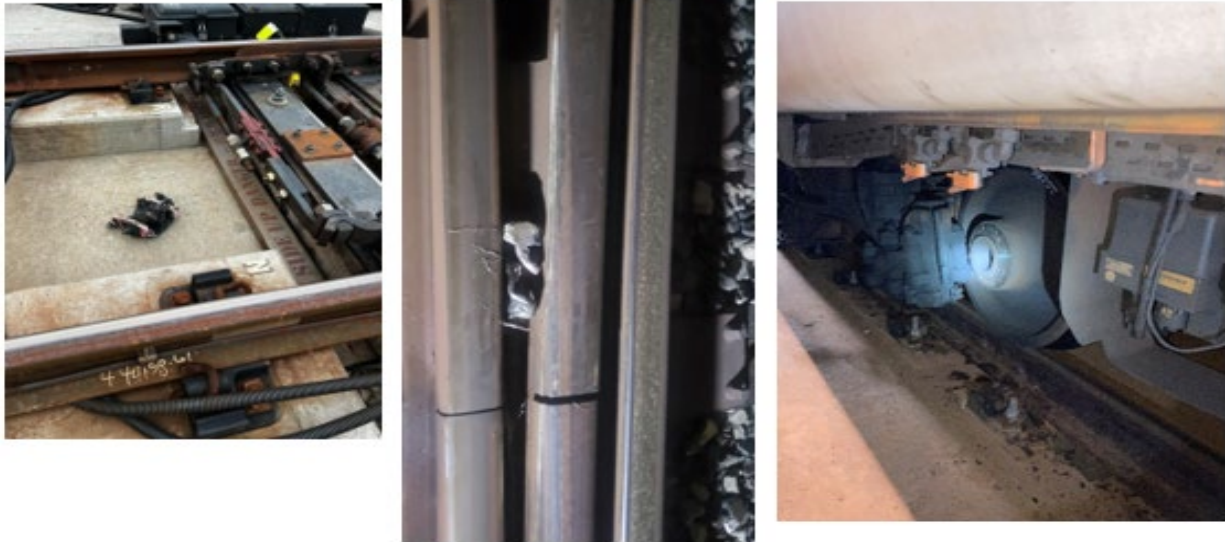
Image 1 – Collector Shoe parts and a missing brake disc from Train ID 308.

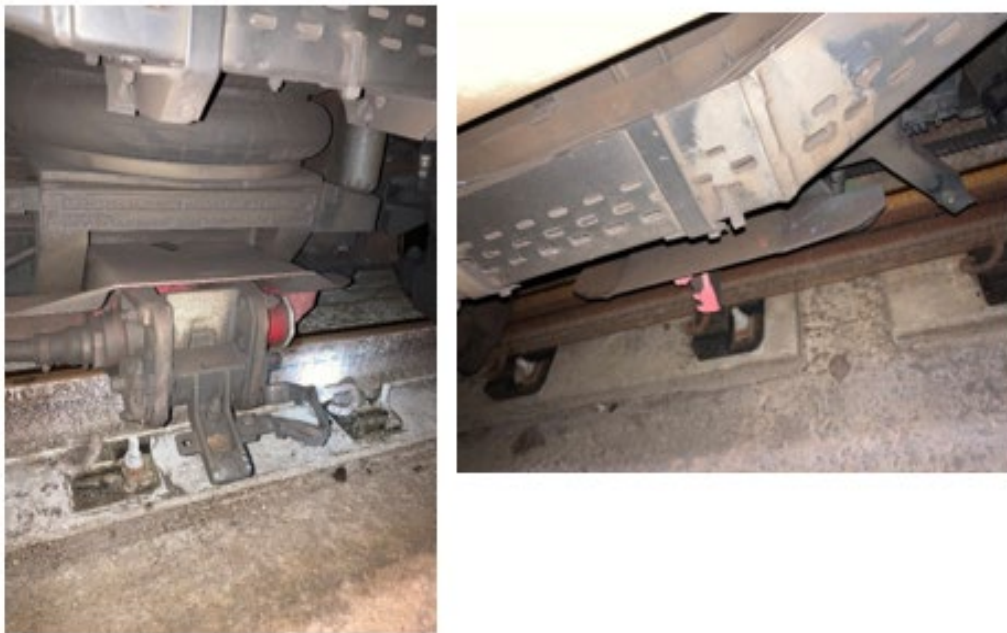
Image 2 - Missing Collector Shoe assembly from Train ID 308.

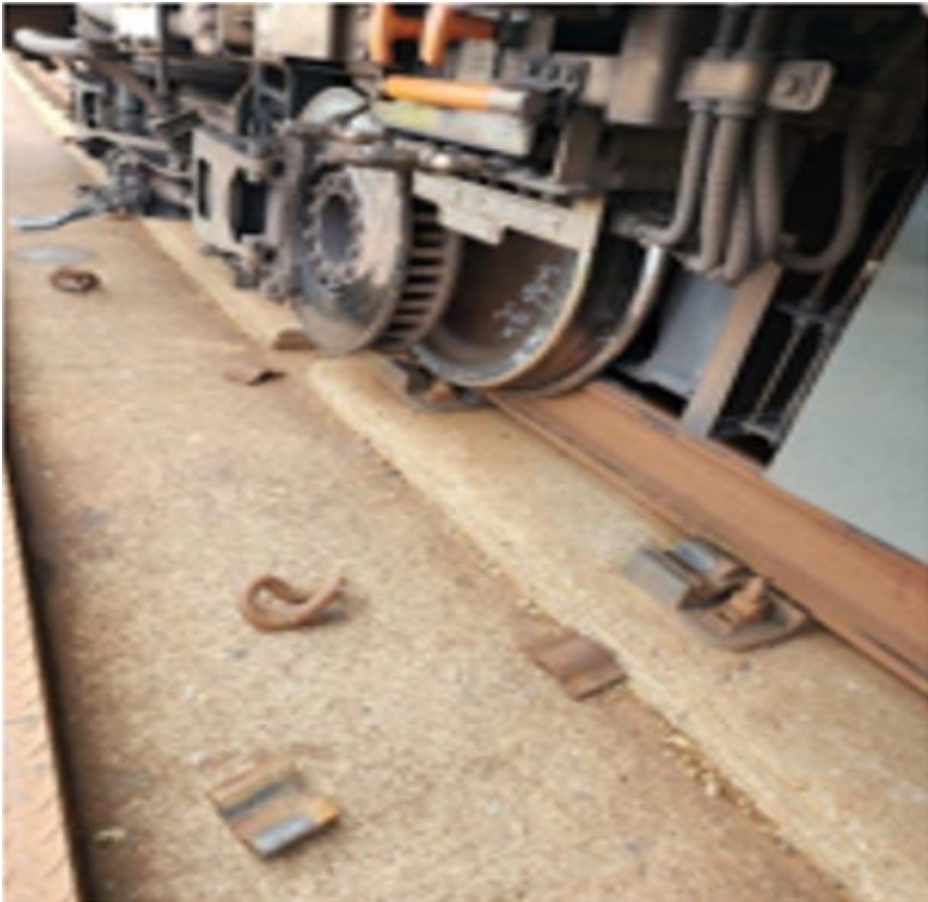
Image 3 - Derailment of Train ID 406 lead car

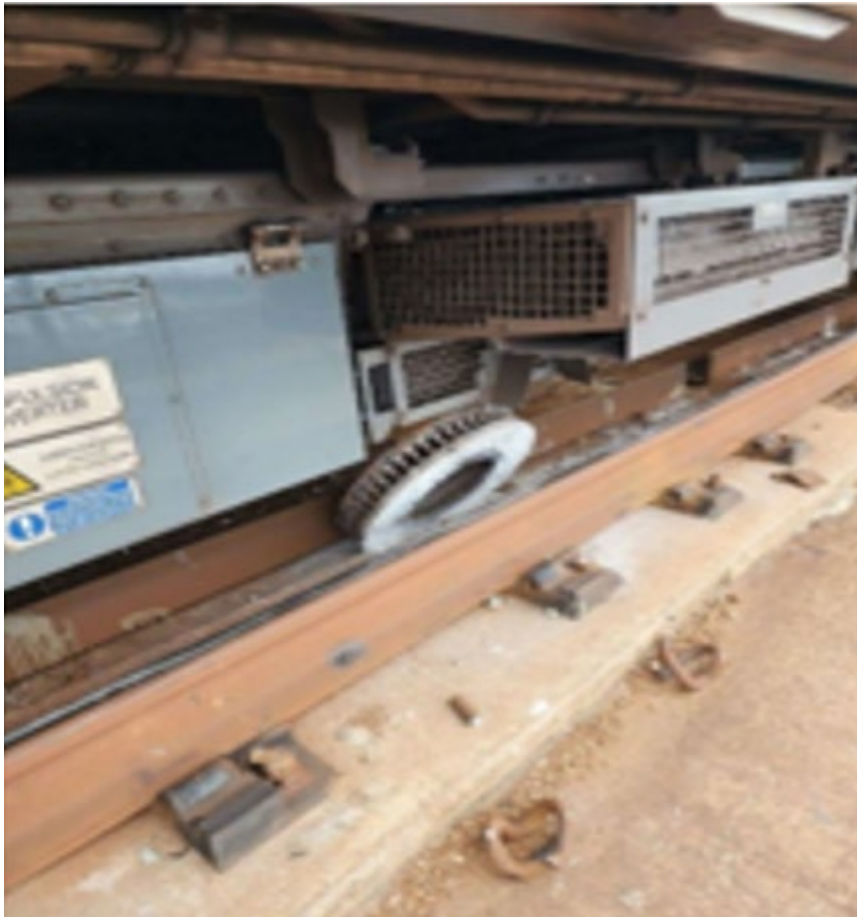
The probable cause of the Derailment event at National Airport Station on Friday, September 29, 2023, a hardware failure occurred on rail car 3069, specifically with the brake system. The #4 brake disc detached from the hub assembly, resulting in it dislodging from the train and coming to rest within the gauge of the left running rail due to fatigued bolts

Image 4 - Brake Disc that separated from Train ID 308, lodged under Train ID 406.

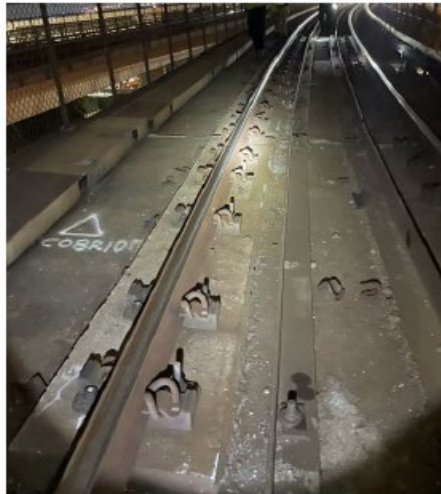
Figure 2: Multiple sheared studs on the field-side

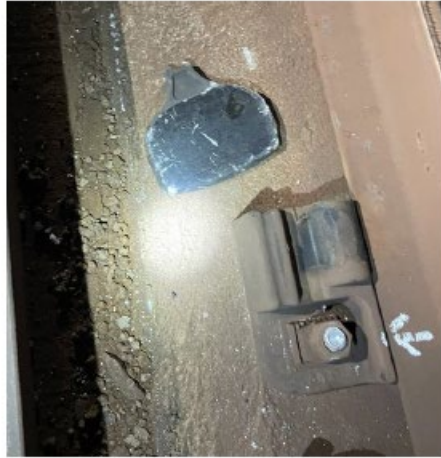
Figure 3: Sheared Field-Side Stud

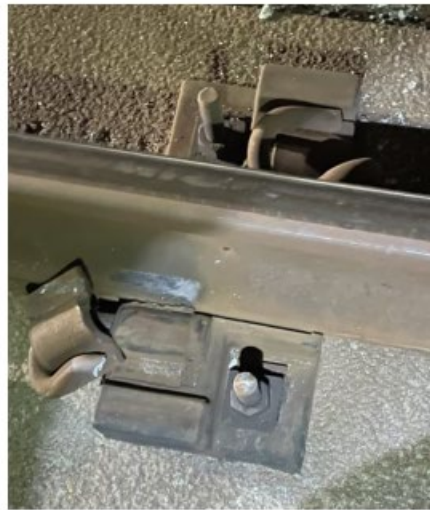
Figure 4: Damaged Fastener

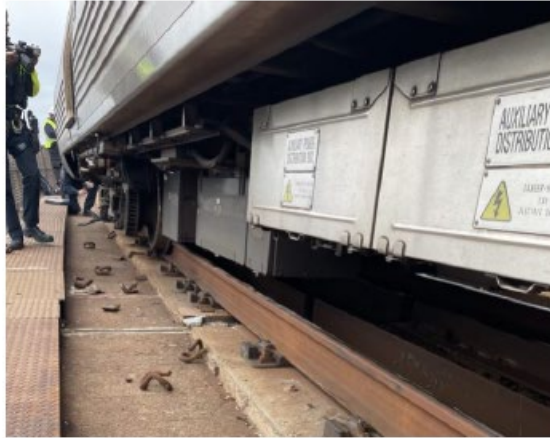
Figure 5: Derailed Left Wheel and Damaged fasteners & e-clips

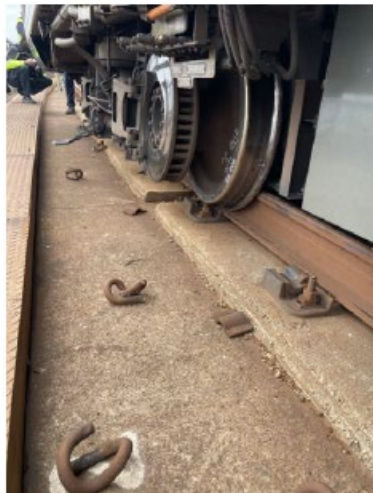
Figure 6: Derailed Left Wheel of Lead Axle

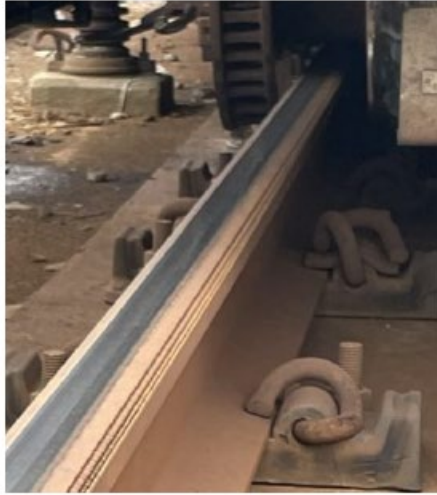
Figure 7: Derailed Right Wheel of Lead Axle

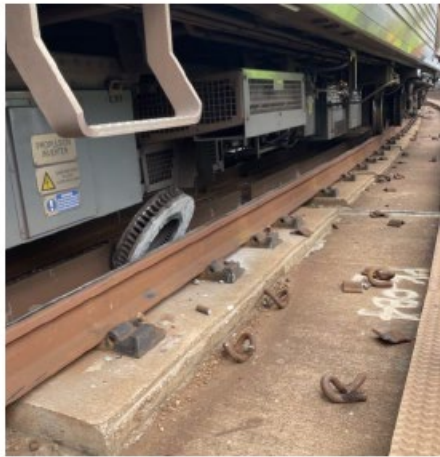
Figure 8: Damaged Fasteners and Detached 3K Disc Rotor

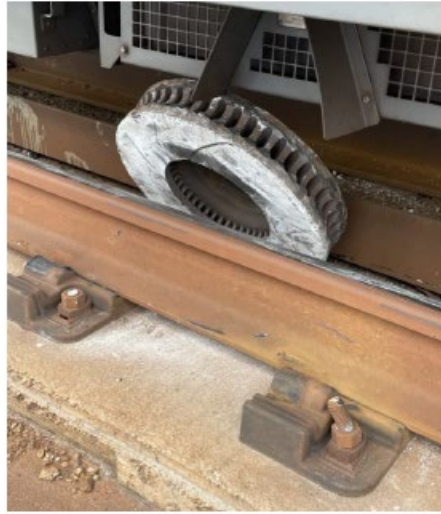
Figure 9: Detached 3K Disc Rotor

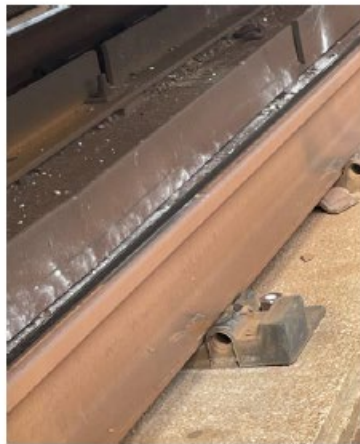
Figure 10: Debris around EGR

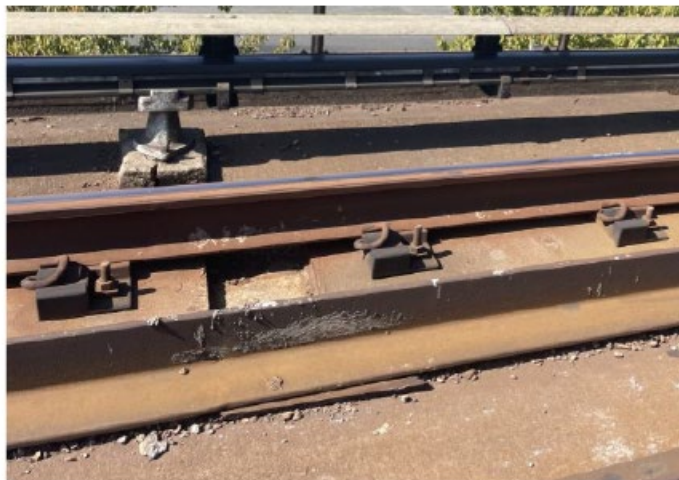
Figure 12: Damaged Insulator Grout Pad

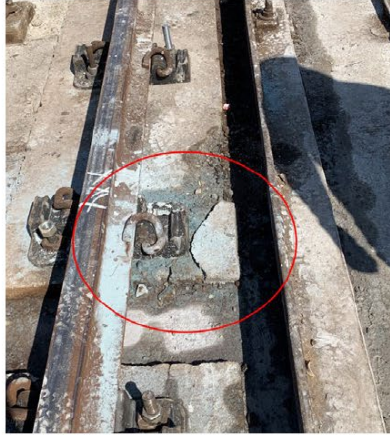
Figure 13: Damaged Grout Pad
