W-0305 Train Operator Removed for Fatigue, Drug and Alcohol – Orange Line – September 10, 2023

FINAL REPORT OF INVESTIGATION A&I E23636

Date of Event:	September 10, 2023
Type of Event:	Operator Removed from Service (Fatigue – Drug & Alcohol) - Failure to Service Stations
Incident Time:	07:50 Hours
Location:	Multiple Stations
Time and How received by SAFE:	09:30 Hours – SAFE/MAC
WMSC Notification Time:	11:12 Hours
Responding Safety Officers:	None
Rail Vehicle:	Train ID 909 (L7690/91x7639/38x7372/73x7399/98T)
Injuries:	None
Damage:	None
Emergency Responders:	MTPD (Metro Transit Police Department)
SMS I/A Number	20230910#111280

**Foggy Bottom Station – Operator Removed from Service
(Fatigue – Drug & Alcohol) - Failure to Service Stations**

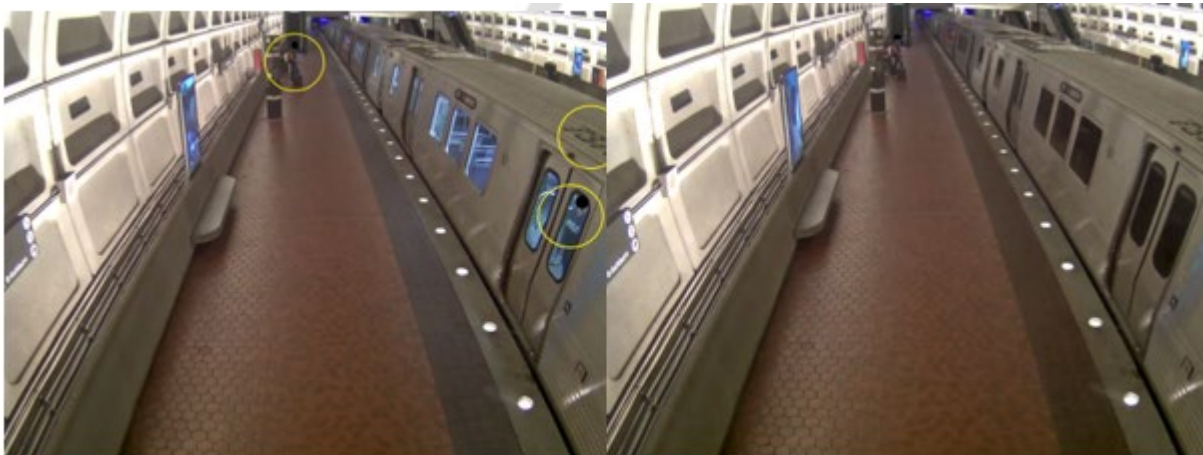
At 07:50 hours, Train ID 909 arrived at McPherson Square Station, stopped within the platform limits, did not service the station, and continued to Farragut West Station.

Image 1 - Train ID 909 stops at McPherson Square Station at 07:50 hours for approximately 90 seconds and fails to service the platform, track 2, dimming the lights and then moving towards Farragut West Station.

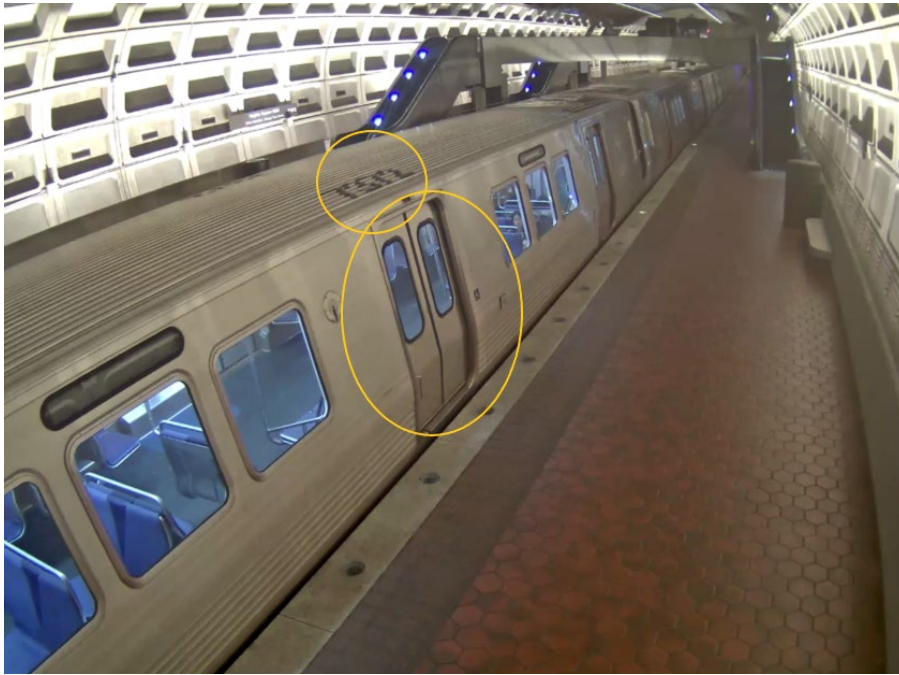
At 08:03 hours, Train ID 909 arrived at Virginia Square Station, stopped within the platform limits, did not service the station, and continued to Ballston Station.

Image 2 - Train ID 909 stops at Virginia Square Station at 08:03 hours for approximately two minutes and fails to service the platform, track 2.

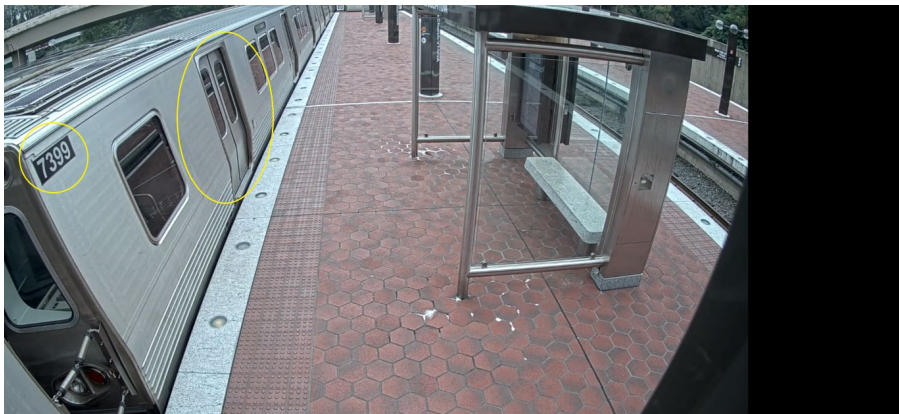
At 08:19 hours, Train ID 909 arrived at West Falls Church Station, stopped within the platform limits, did not service the station, and continued to Dunn Loring Station. The Vienna Terminal Supervisor contacted the AOM and advised that Train ID 909 was late arriving at Vienna Station. The AOM responded that Train ID 909 held at Eastern Market for six minutes.

Image 3 - Train ID 909 stops at West Falls Church Station at 08:19 hours for approximately two minutes and fails to service the platform, track 2.

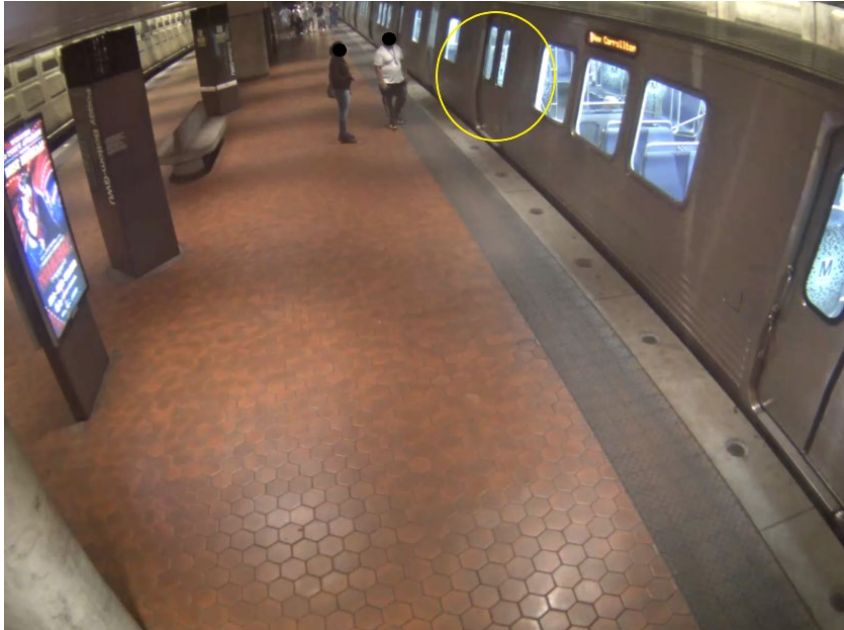
At 09:03 hours, Train ID 909 at Foggy Bottom Station stopped within the platform limits, did not service the station, and continued to Farragut West Station.

Image 4 - Train ID 909 stops at Foggy Bottom Station at 09:03 hours for approximately two minutes and fails to service the platform, track 1.

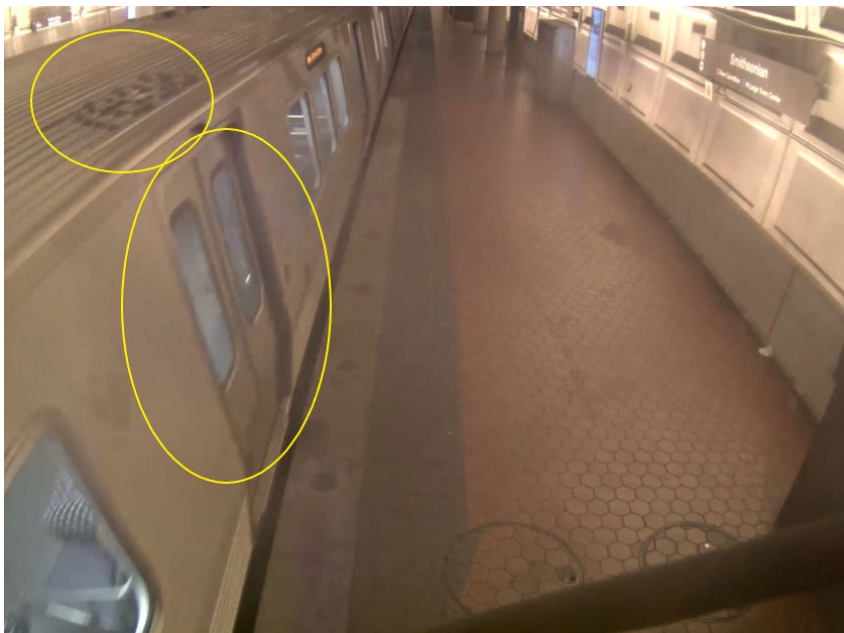
At 09:14 hours, Train ID 909 arrived at Smithsonian Station, stopped within the platform limits, did not service the station, and continued to L'Enfant Plaza Station.

Image 5 - Train ID 909 rolls through Smithsonian Station at 09:14 hours, failing to stop and failing to service the platform, track 1.

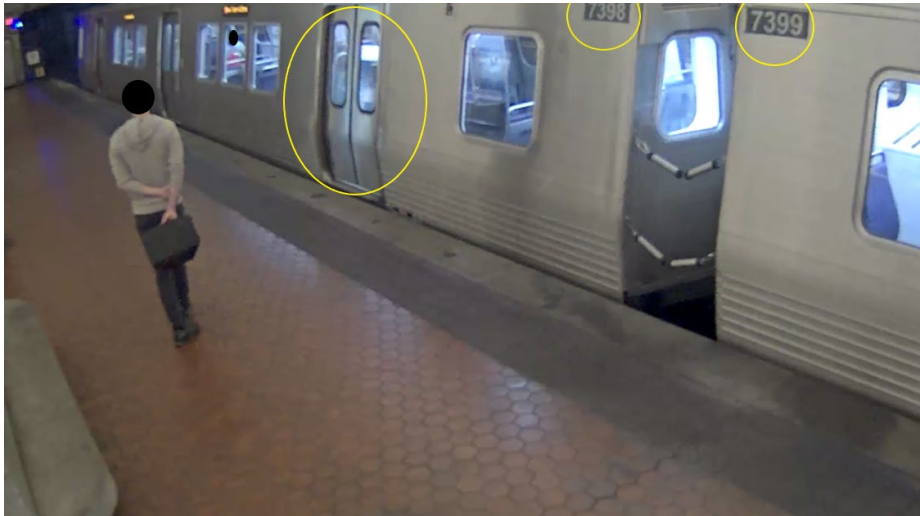
At 09:18 hours, Train ID 909 arrived at Federal Center Station, stopped within the platform limits, did not service the station, and continued to Capitol South Station.

Image 6 - Train ID 909 stops at Federal Center Station at 09:18 hours for approximately 90 seconds and fails to service the platform, track 1.

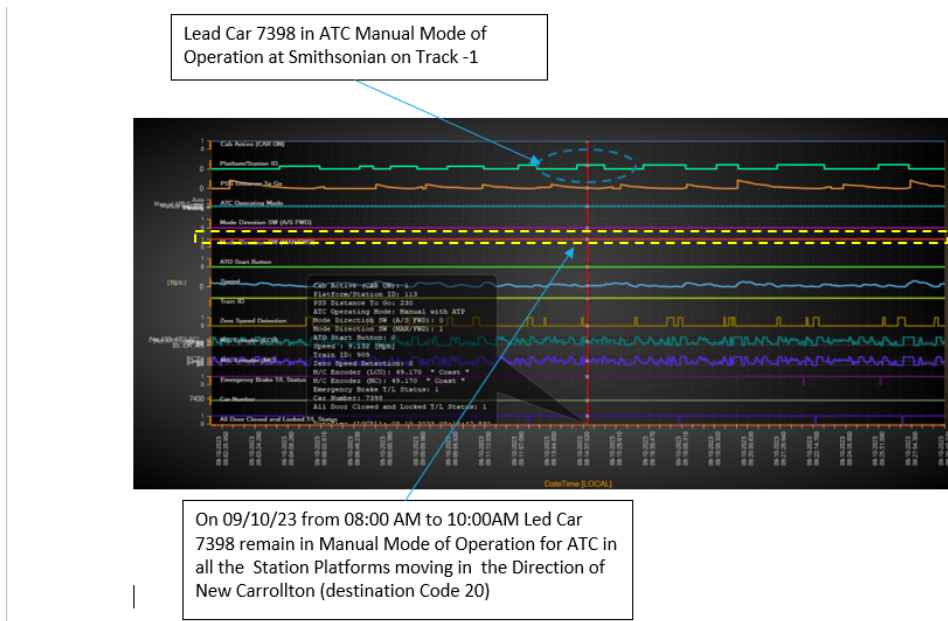
Lead Car 7398 ER Analysis Graph #1 / Lead Car 7398 remained in Manual Mode of operation before, after, and at Smithsonian on Track-1

"IIT reviewed the ER Data for this incident. The ATC Operation remained in Manual Mode before, during, and after the reported incident at 9:30 AM. IIT did not see any faults in the Logs that would have contributed to this incident. At no time was the ATO Start push button depressed, and at no time was the Lead Car 7398 operated or configured for ATO mode of operation."

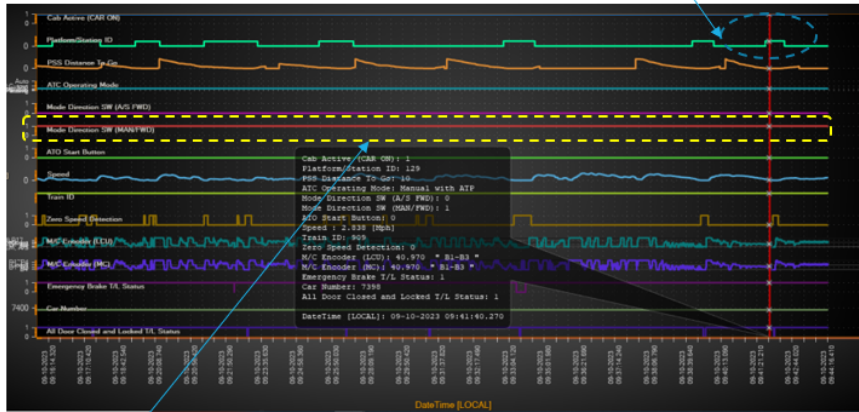
Lead Car 7398 ER Analysis up to Deanwood Station Platform (TWC (129) on Track-1 with Lead Car 7398 operating in Manual Mode

09:41:40 Train in Manual Mode of Operation at DeanDeanwood on Track-1

Train remained in Manual Mode of operation before, during and after the Incident reported Time

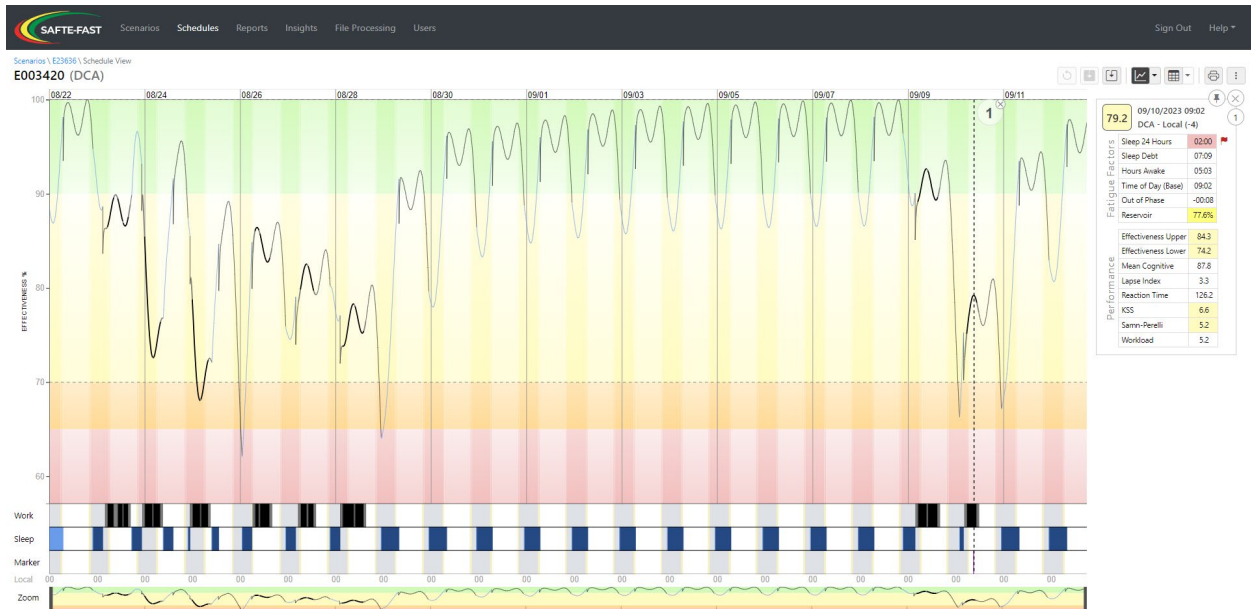
Incident data was evaluated for fatigue risk factors. Risk factors for fatigue were identified. The incident time of day does not suggest an increased risk of fatigue-related impairment. The employee worked day shift the day leading up to the incident. The employee reported a total of 2 hours of sleep in the last sleep period preceding the incident and was awake for 5 hours at the time of the incident. The off-duty period preceding the incident was 14.6 hours, which provided the opportunity for 7-8 hours of sleep. The employee reported usual workday sleep durations of 5 hours and issues with sleep, though these were unspecified.

A biomathematical fatigue modeling application (SAFTE-FAST WebSFC) was used to evaluate further fatigue risk factors that may have been present in the Train Operator's schedule. The analysis was based on the Train Operator's work schedule, reported sleep from the day before the incident, and reported habitual sleep durations. The estimated performance effectiveness at the time of the incident was 79.2%. Specifically, the analysis identified short sleep duration in the last 24 hours as a factor contributing to an increased risk of fatigue at the time of the incident.

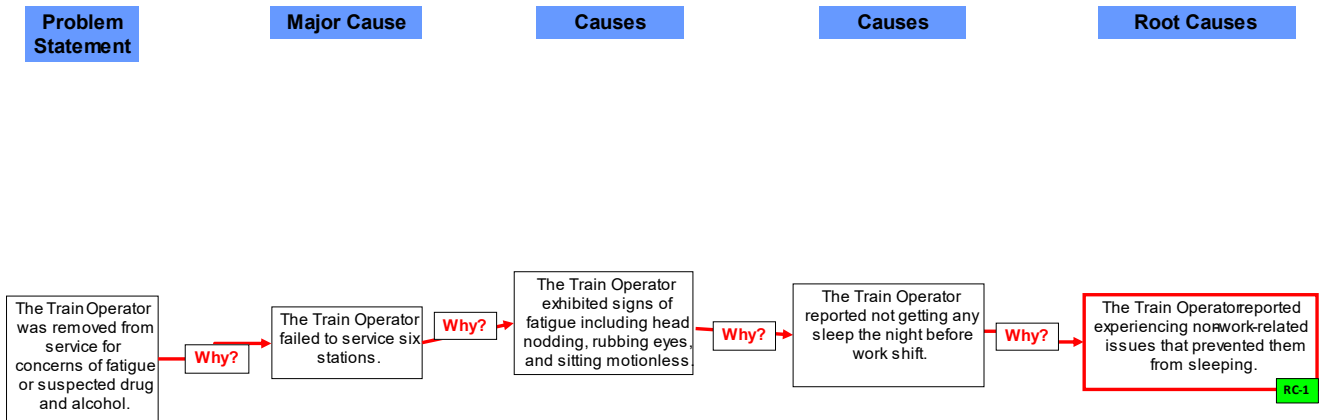
Appendix B – Why Tree

The probable cause of the Operator Removed from Service (Fatigue – Drug & Alcohol) – Failure to Service Stations event on September 10, 2023, was the Train Operator experienced non-work-related issues that prevented them from getting sleep the night before.
