## W-0325 & W-0326 Hazardous Materials Spills – Green Line, Red Line – August 9, 2023

#### **W-0325 – Track tamping machine hydraulic hose bursts while in use on Green Line (WMATA ID: E23550)**

#### **W-0326 – Hydraulic failure upon activation of RMM boom at Medical Center Station (WMATA ID: E23551)**

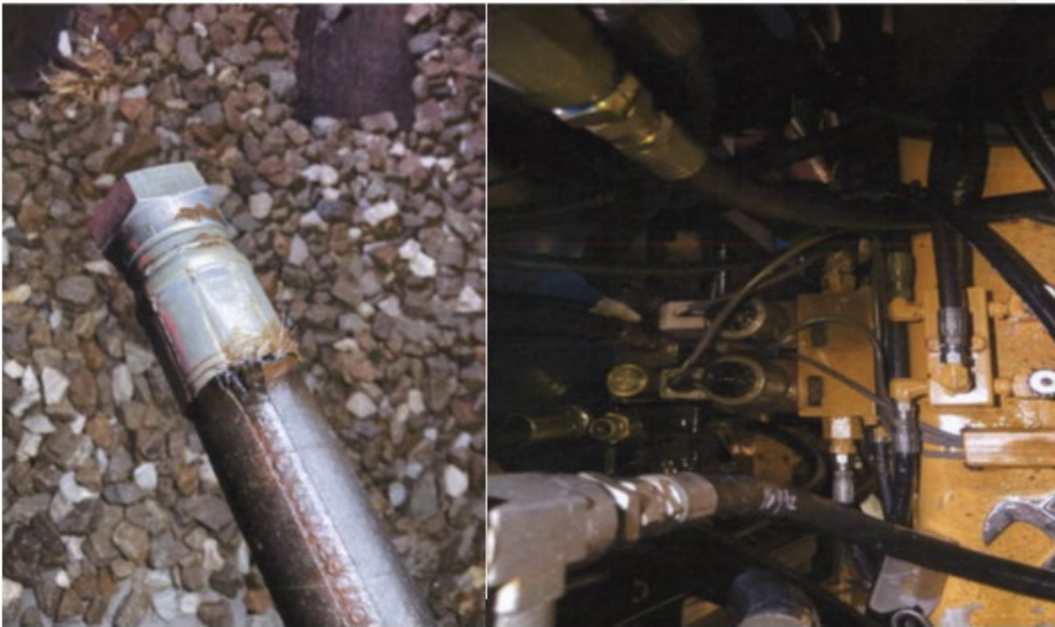
The probable cause was a broken hydraulic line. This is due to inadequate installation of the aftermarket hose where there was not enough slack in the hose. The industry standard recommendation for straight hose installation is to allow enough slack (+2% to -4%) in the hose line to provide for changes in length that will occur when pressure is applied. No precursors were noted during the pre-trip inspection. <sup>1</sup>

*Figure 1 – Tamping Unit T004 broken hydraulic fluid line and the repaired hydraulic fluid line.*

Email reports reflect that the pressure line on the left side vibrator failed. Due to the heat coming from the hose line, personnel were unable to cap the line. Spill Booms and absorbent pads were deployed to contain and clean up the hydraulic fluid. The fluid leaked into the ballasted area and down an embankment towards a concrete channel. The fluid did not enter the concrete channel.

Tamping Unit T004 hydraulic fluid line was repaired on the scene, the hydraulic tank was re-filled with 166 gallons, and the unit was returned to Greenbelt Rail Yard.

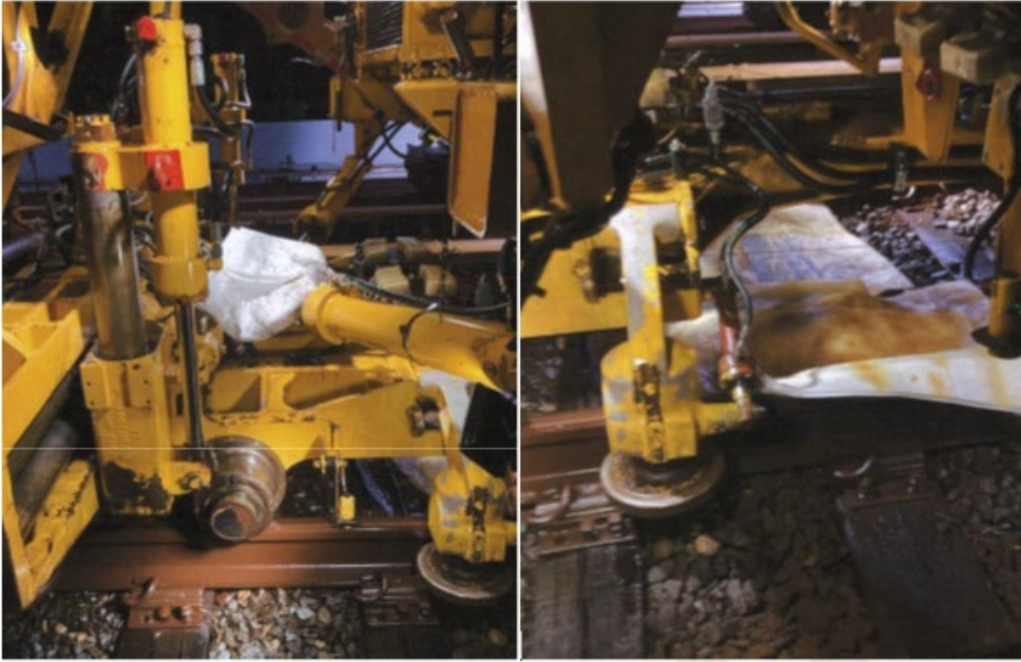
*Figure 2 - Tamping Unit T004 leaking hydraulic fluid onto Absorbent pads.*

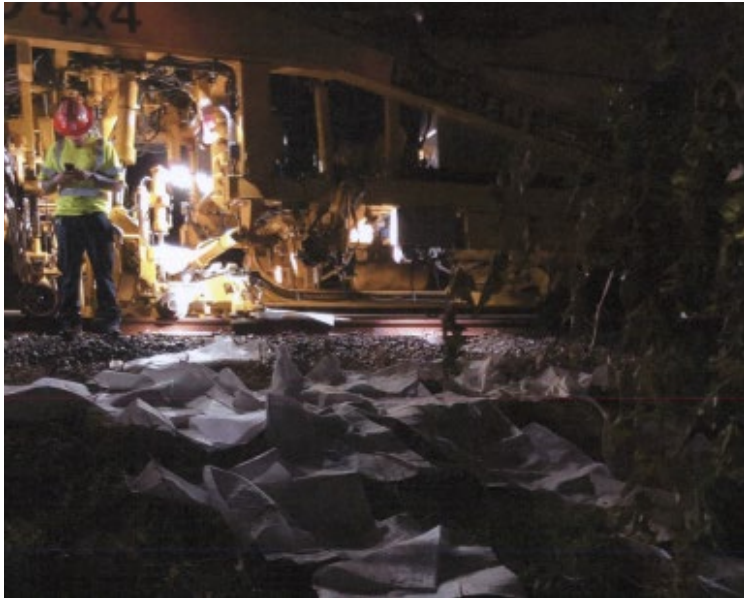
*Figure 3 - depicts absorbent pads leading down the embankment from Tamping Unit T004 containing the hydraulic fluid.*

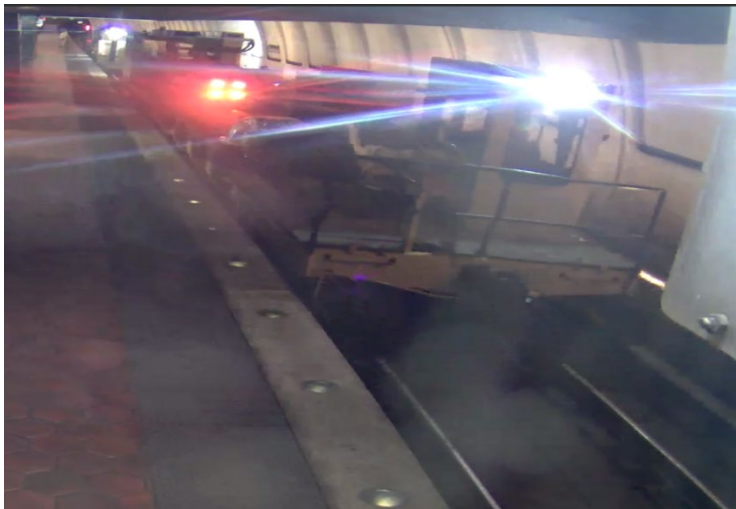
*Figure 4 – A10-P-19 CCTV camera captured PM-578 arriving on the platform of Medical Center Station (A10) track 1.*

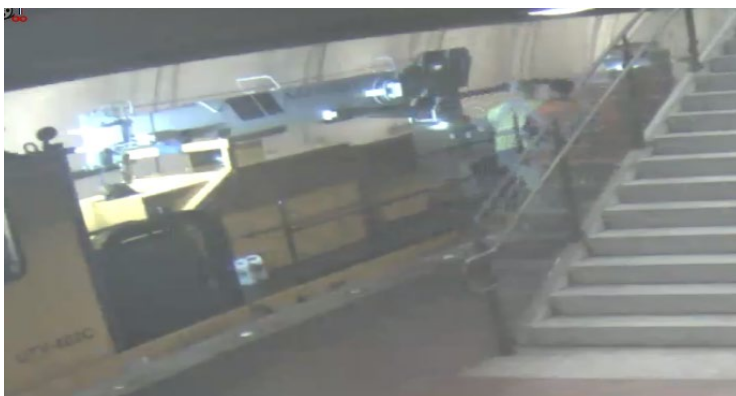
*Figure 5 – A10-P-022 CCTV camera captured TRST personnel discovering hydraulic fluid leaking from the boom of PM-578.*

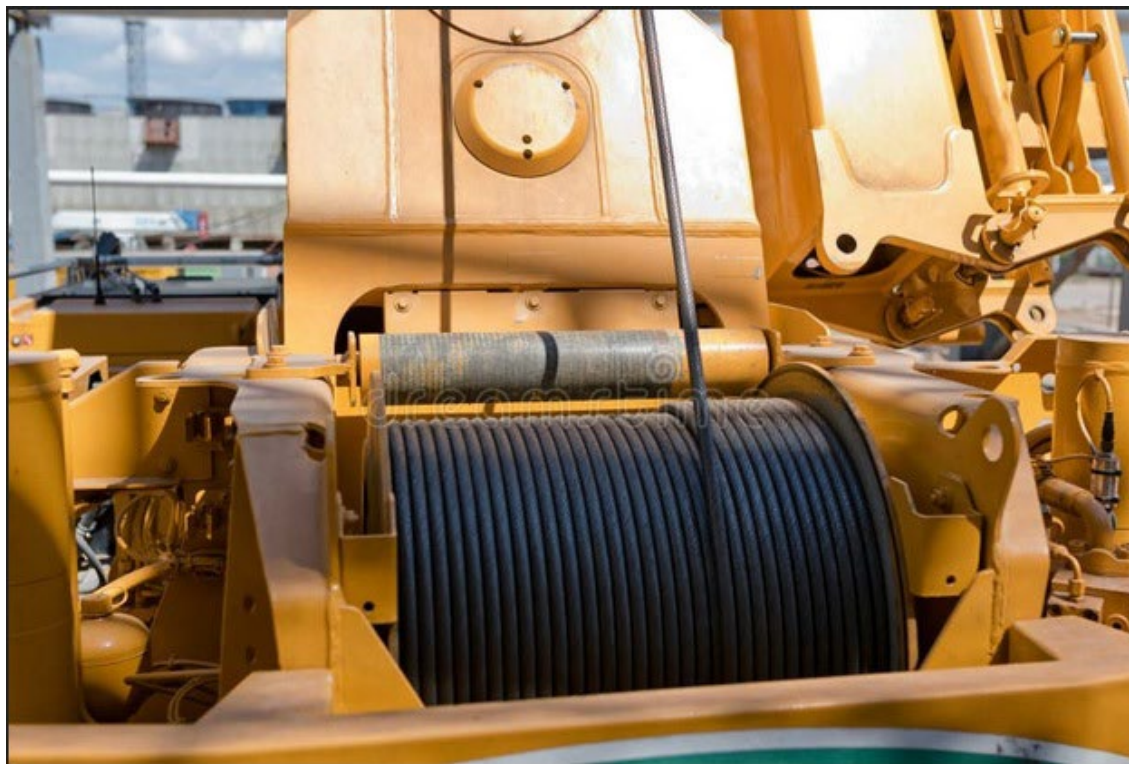
*Figure 6 – depicts the winch drum inside the boom near the hydraulic brake.*

The probable cause of the Hydraulic Fluid Leak event was the failure of a rubber seal on the brake actuator located inside the winch drum of the crane. The boom arm attached to the winch drum is inspected on a six-month basis and a part of that inspection the boom arm is cycled.

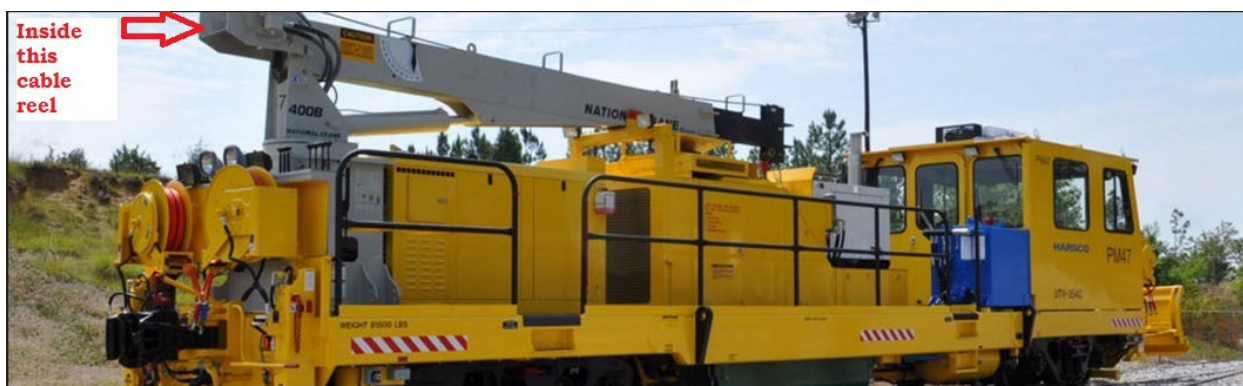
*Figure 7 – depicts a vehicle similar to PM-578 and the boom from which the hydraulic fluid leaked (see arrow).*

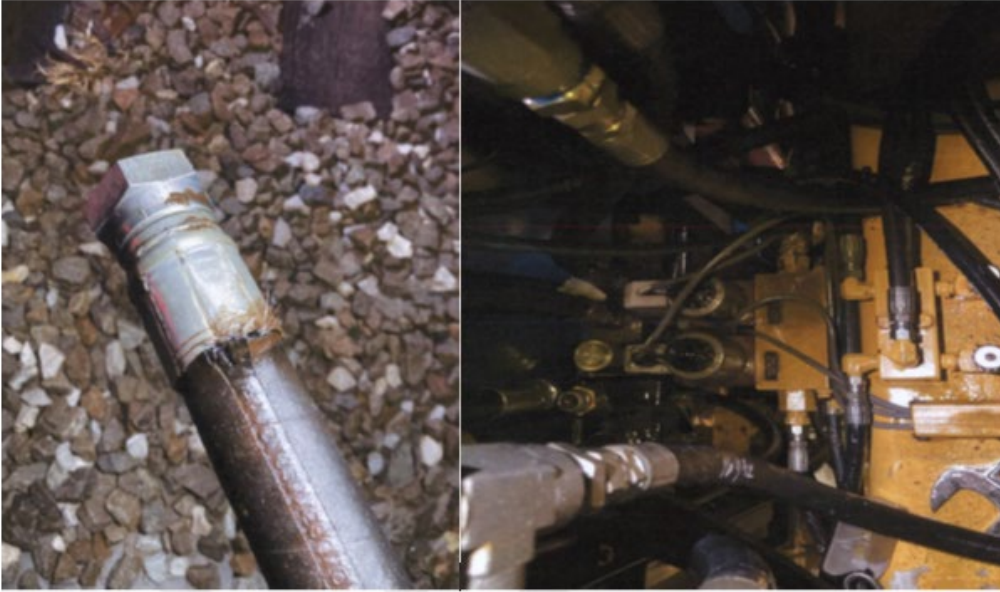
*Figure 8 - Tamping Unit T004 broken hydraulic fluid line and the repaired hydraulic fluid line.*

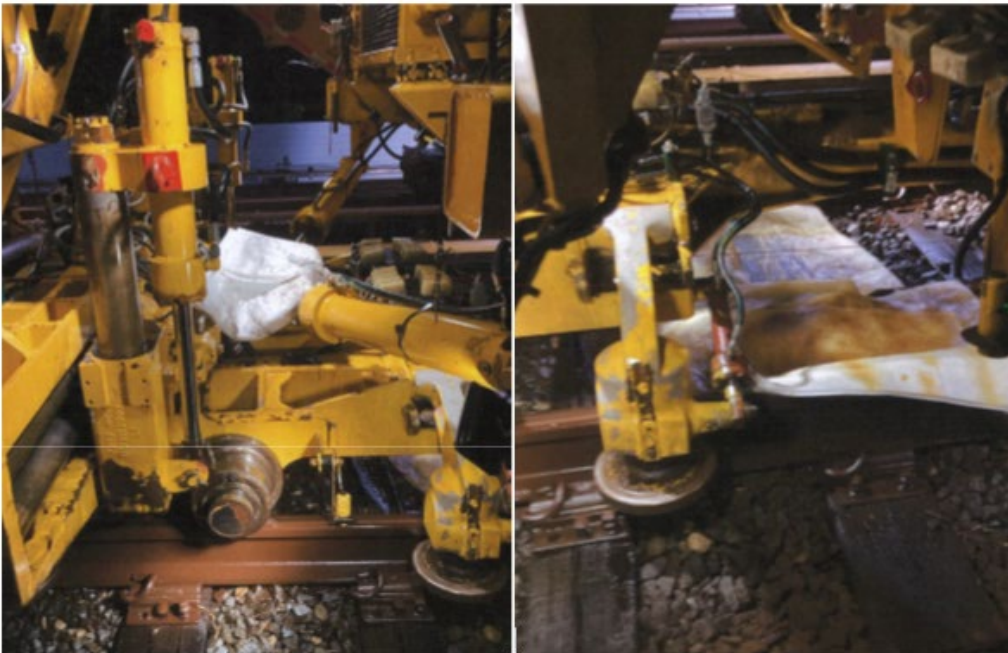
*Figure 9 - Tamping Unit T004 leaking hydraulic fluid onto Absorbent pads.*

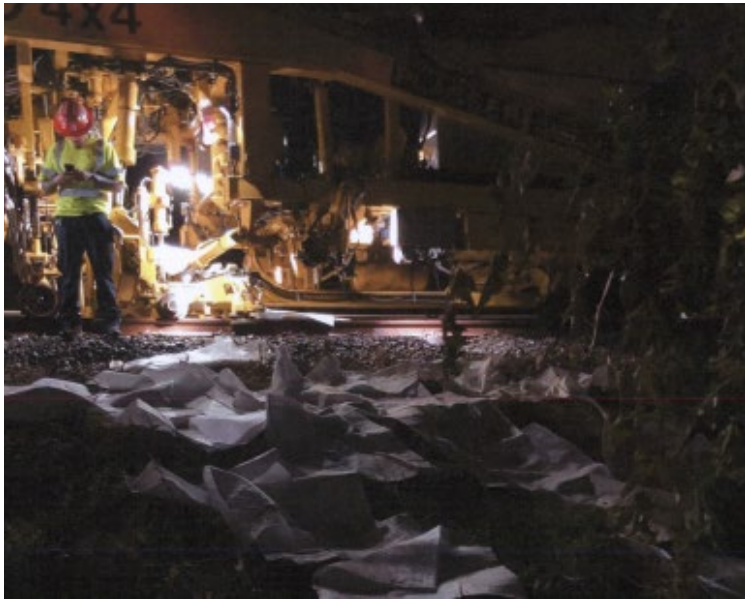
Figure 10 - depicts absorbent pads leading down the embankment from Tamping Unit T004 containing the hydraulic fluid.

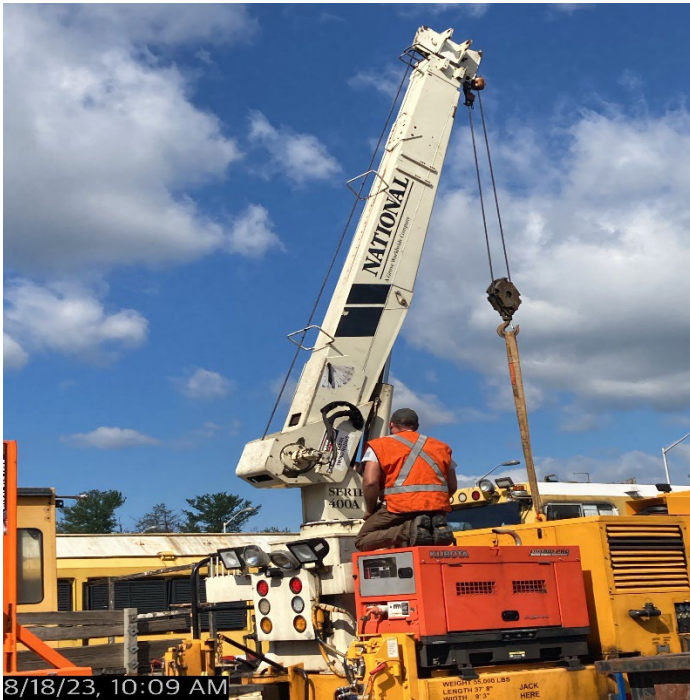
Figure 11 – Inspection of the winch brake on the boom of PM-578.

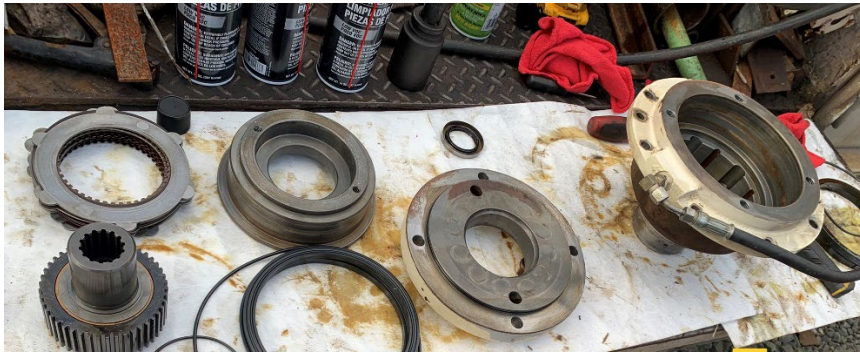
Figure 12 - Disassembled winch brake from PM-578.

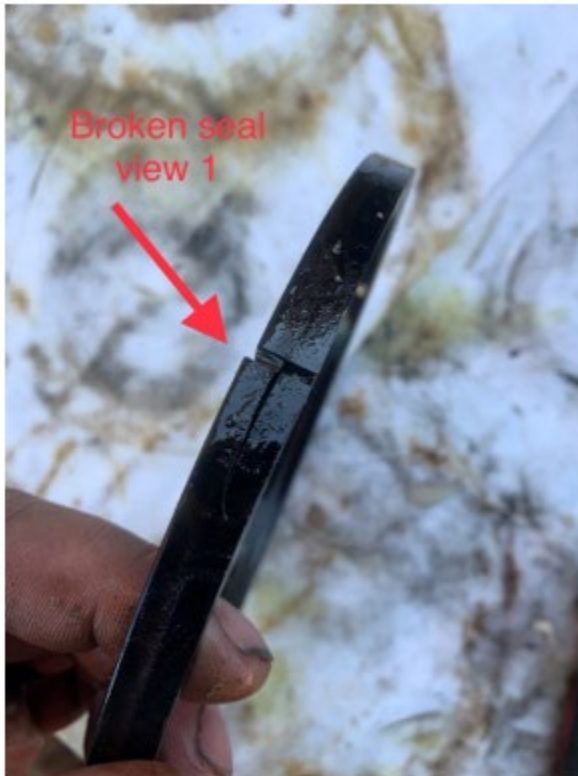
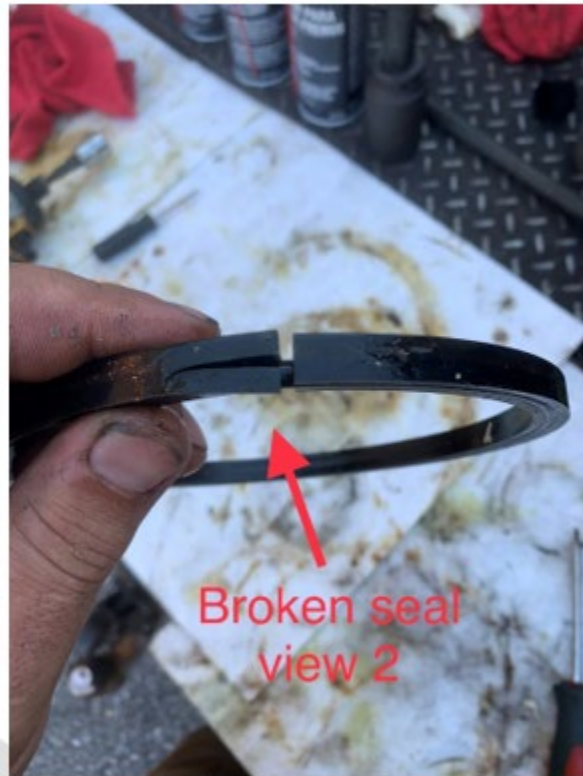
Figure 13 - Broken seal from winch brake from PM-578.

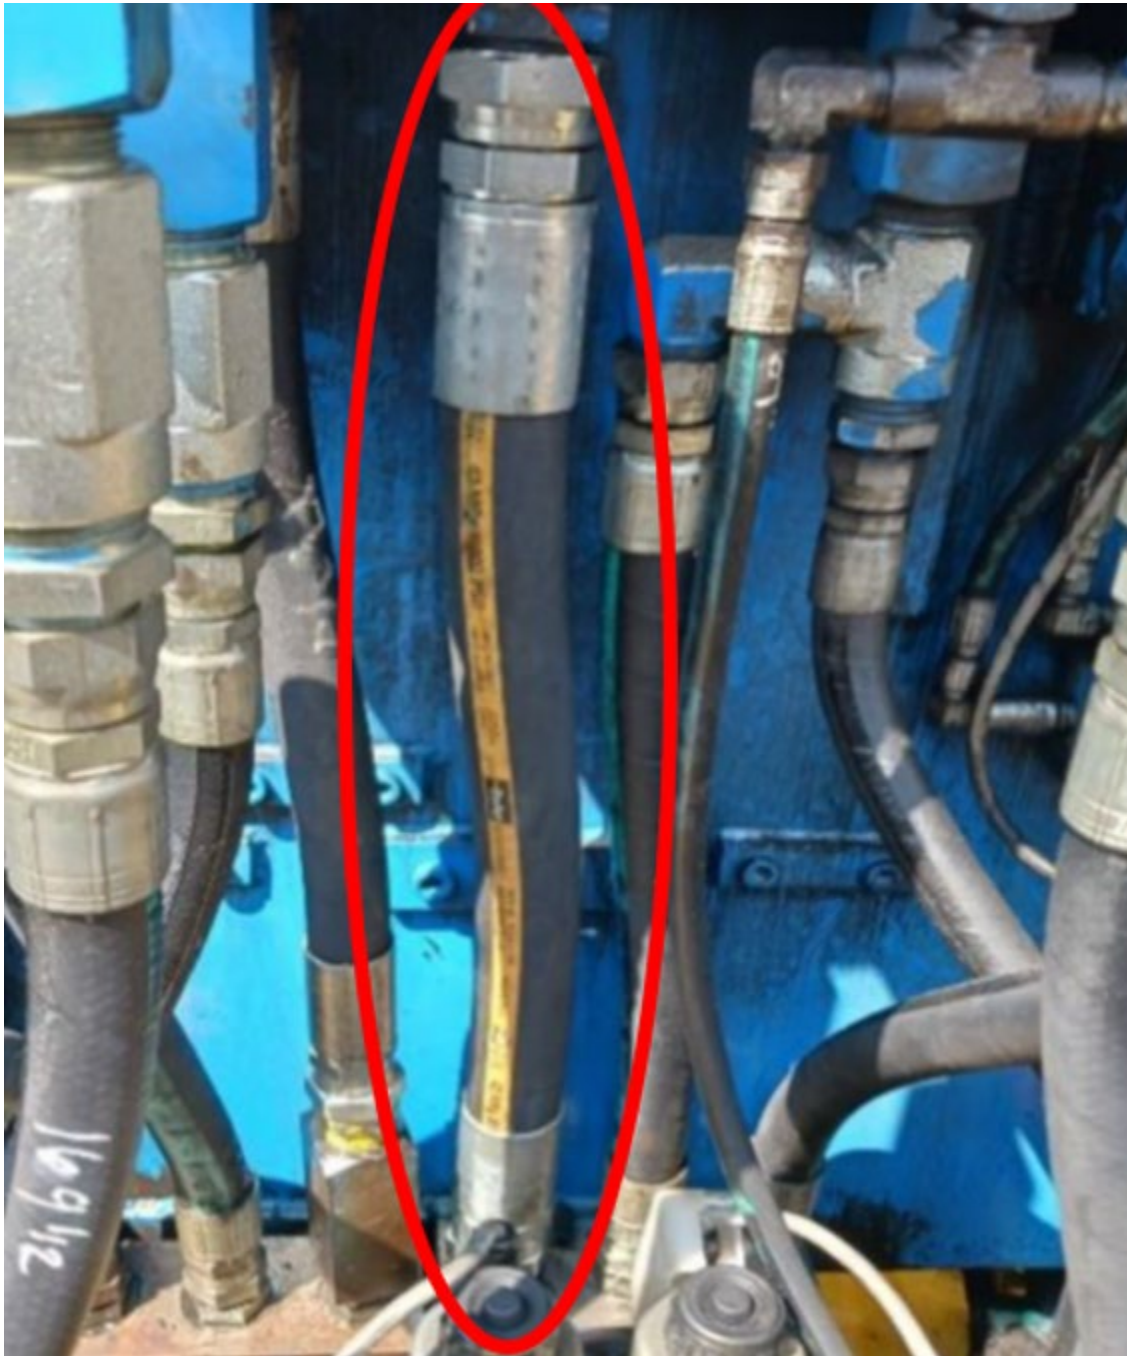
The probable cause was a broken hydraulic line. This is due to inadequate installation of the aftermarket hose where there was not enough slack in the hose. The industry standard recommendation for straight hose installation is to allow enough slack (+2% to -4%) in the hose line to provide for changes in length that will occur when pressure is applied. No precursors were noted during the pre-trip inspection.

Figure 24 – Depicting the improper straight hose length on a similar tamping unit.
