Red Signal Overruns

At or Near New Carrollton Rail Yard, Rhode Island Ave-Brentwood Station, and West Falls Church Station

January 3, 2024 – February 13, 2024 – February 15, 2024

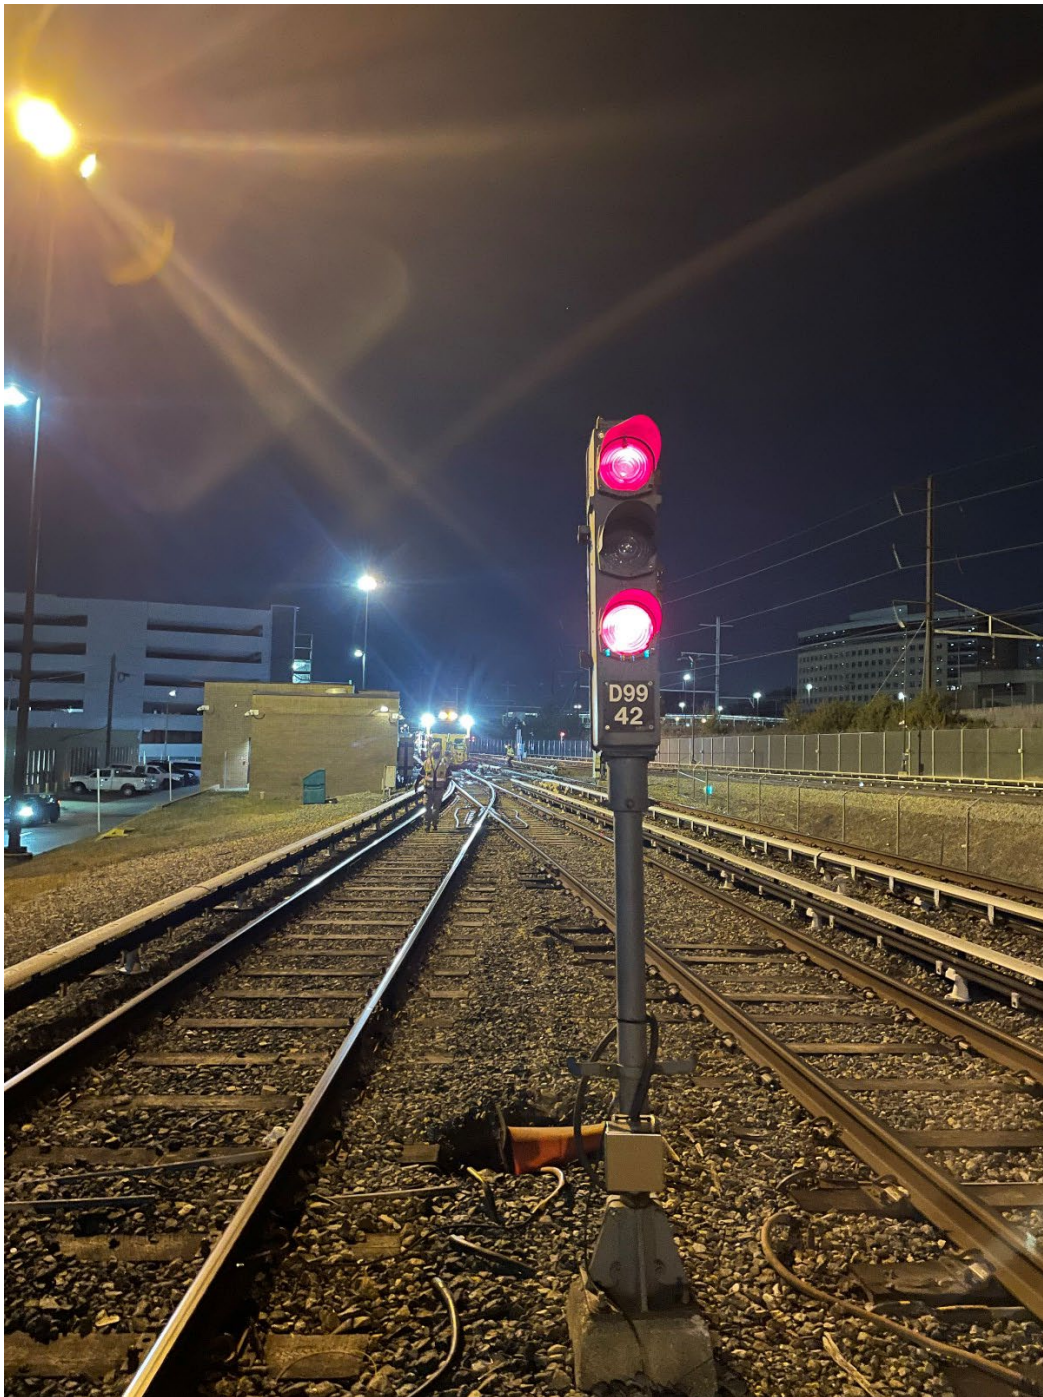
Image 5 – D99-42 Signal displaying a red aspect in the New Carrollton Yard.

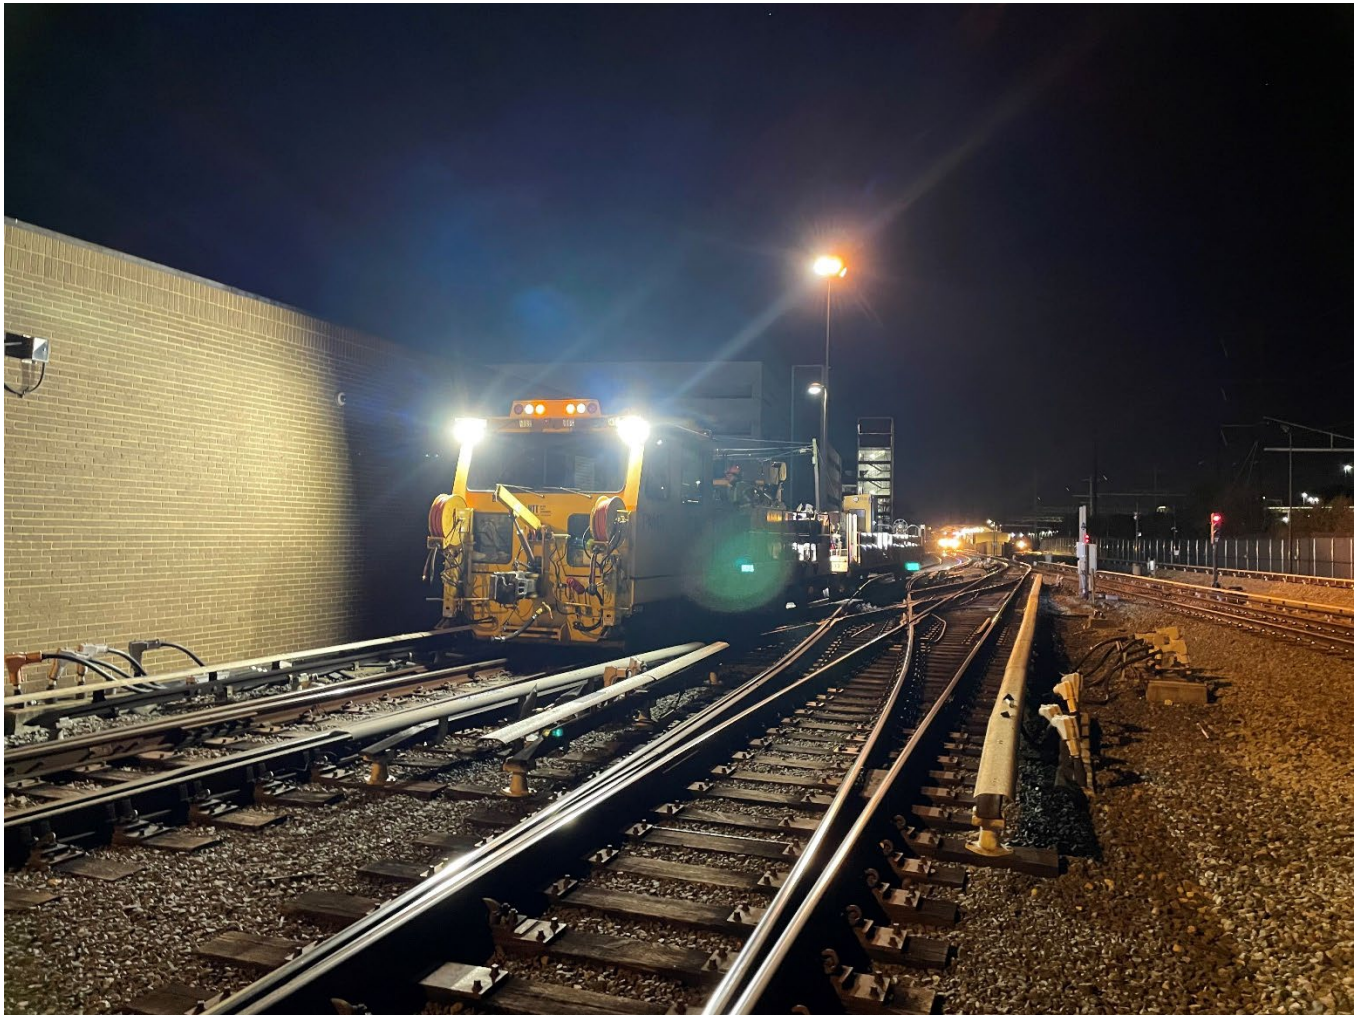
At 00:52 hours, the IO observed PM-43 with F-533 overrun signal D99-42 and directed them to stop movement. PM-43 with F-533 came to a complete stop 320 feet beyond signal D99-42. PM-43 with F-533 traversed switches 31, 29A, and 27A.

Image 7 – PM-43 stopped 320 feet beyond the D99-42 Signal.

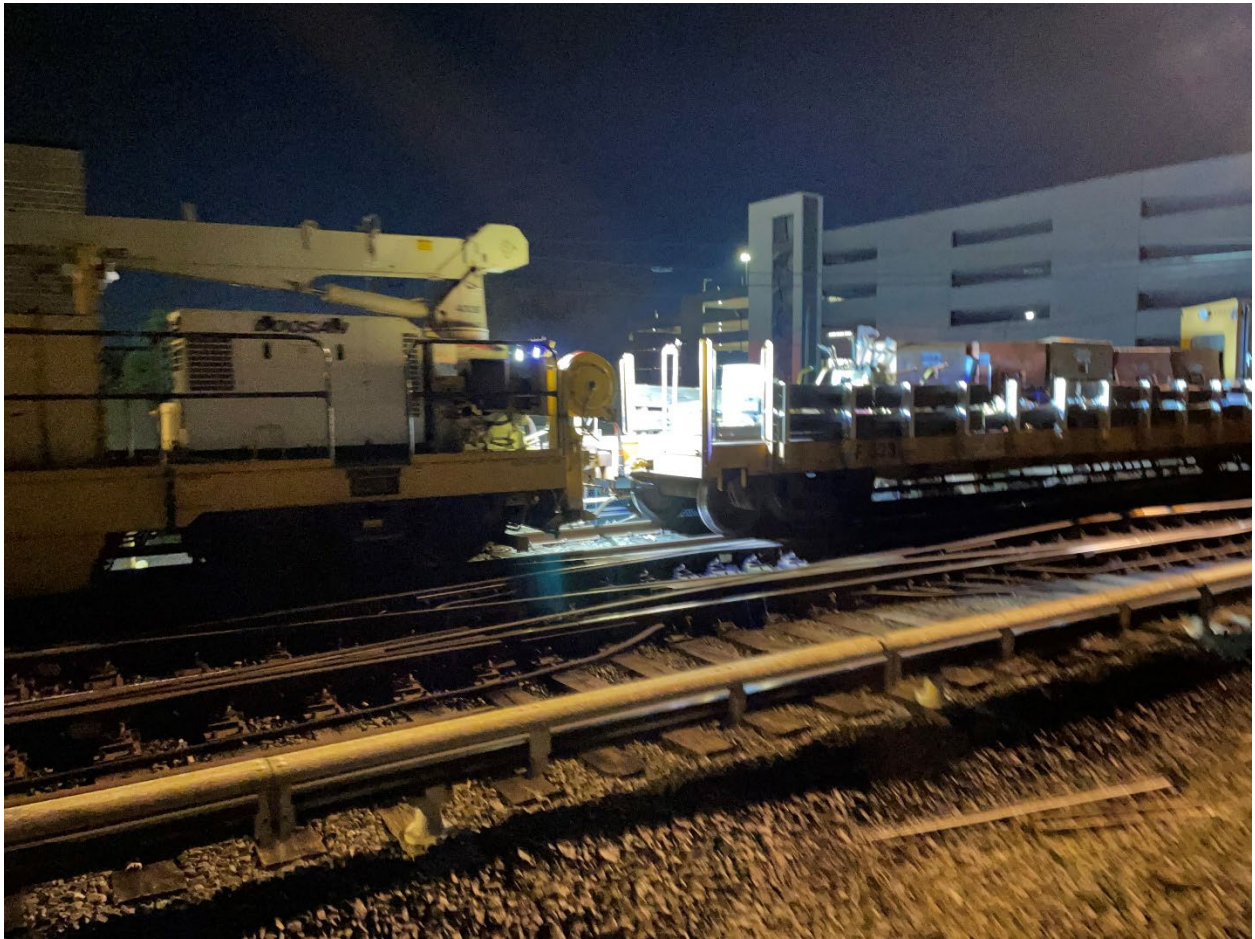
Image 8 – Photo illustrating PM-43 pushing Flatcar 533.

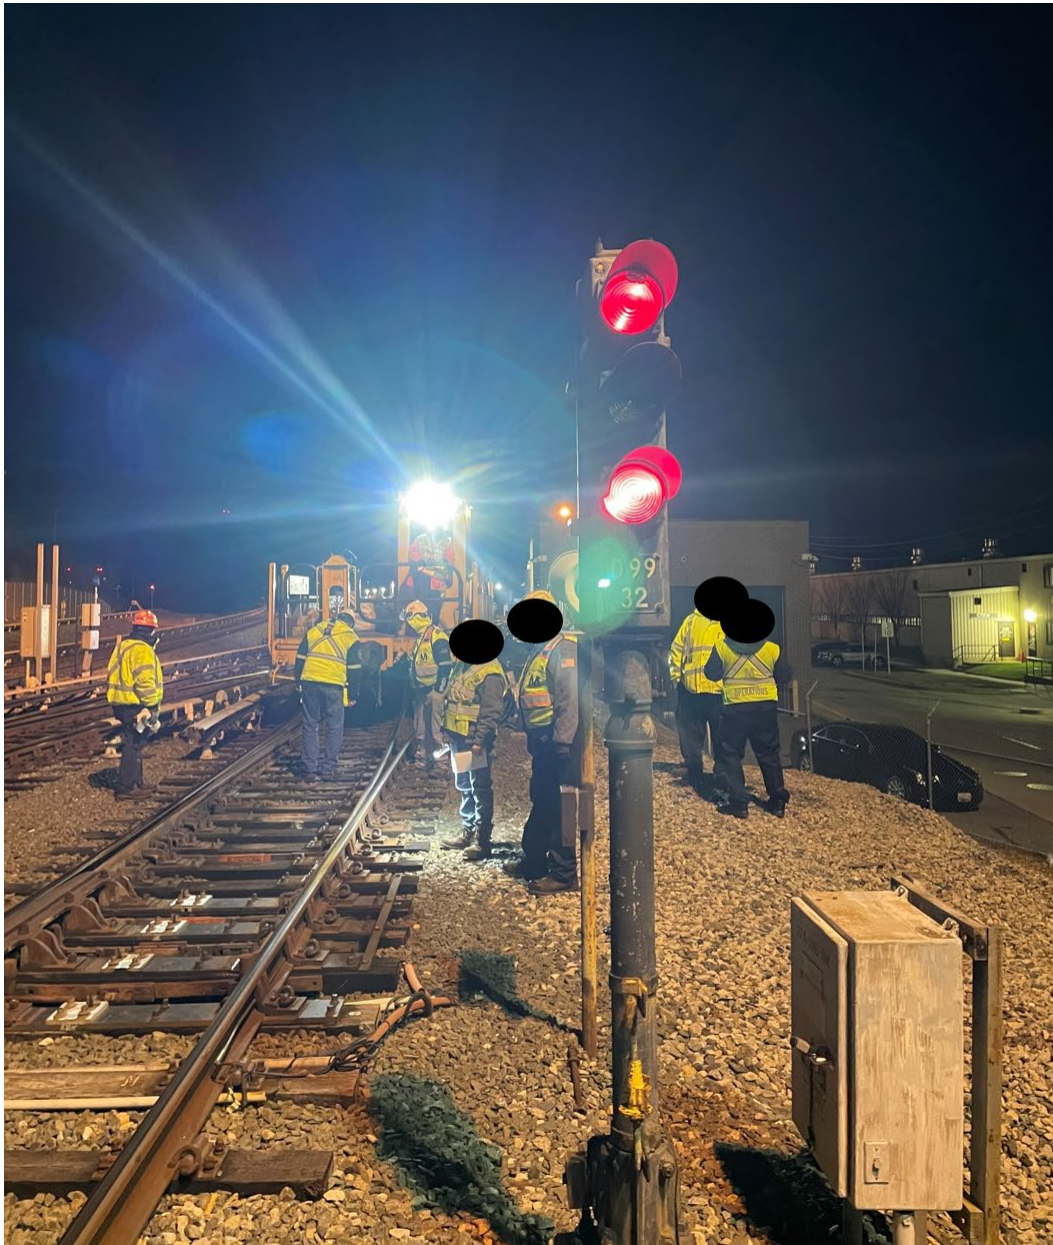
Image 9 – Photo of Flatcar 533 adjacent to D99-32 Signal.

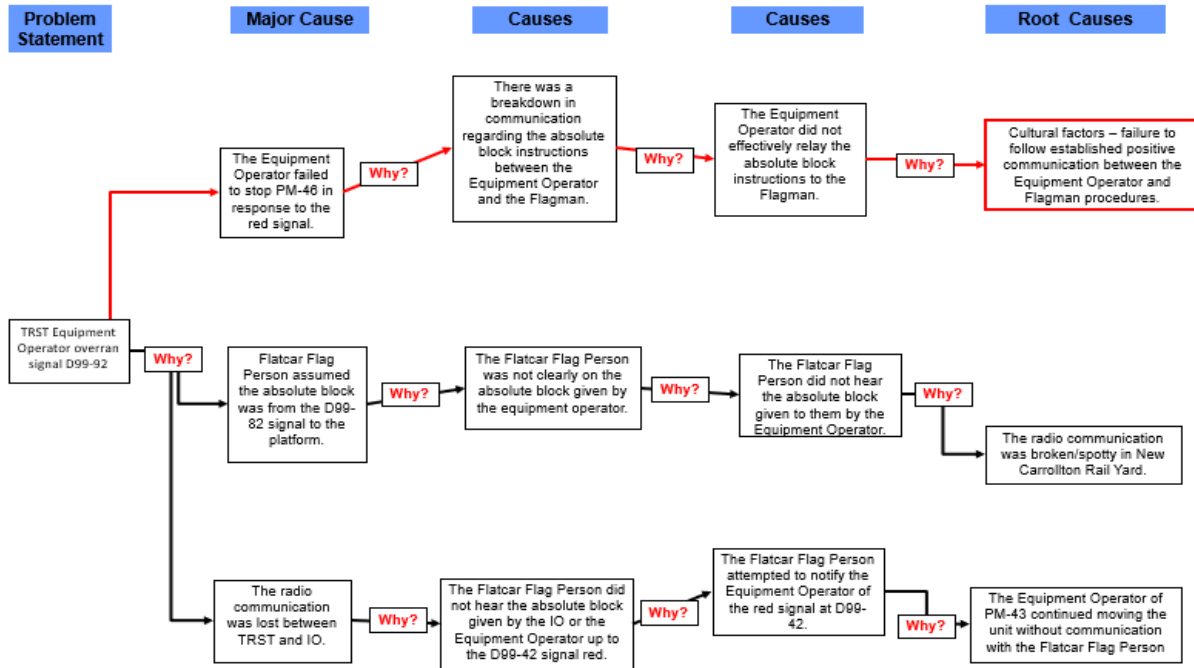
The probable cause of the Red Signal Overrun event at New Carrollton Yard on January 3, 2024, was that the Equipment Operator and the Flagman failed to adhere to verbal instructions and written procedures, resulting in the overrun of the signal D99-42. Another causal factor was radio communication issues, contributing to PM-43 failing to stop before the D99-42 signal (Red).

Corrective Action Code	Description	Responsible Party	Estimated Completion Date
113714_SAFE CAPS_RTRA_001	Develop a Lesson Learned – Loss of Communication actions and procedures to follow.	RTRA SRC	Completed
113714_SAFE CAPS_TRST_001	Develop and distribute re-instruction bulletin on broken communication and procedures.	TRST SRC	Completed
113714_SAFE CAPS_TRST_002	Re-instruct the Flagman on the loss of communication procedures (MOR 8.11.1.1 & 8.11.1.1)	TRST SRC	Completed
WMSC_21_C 0100	WMATA to replace the radio communications system in all rail yards and shops.	COMM	Ongoing

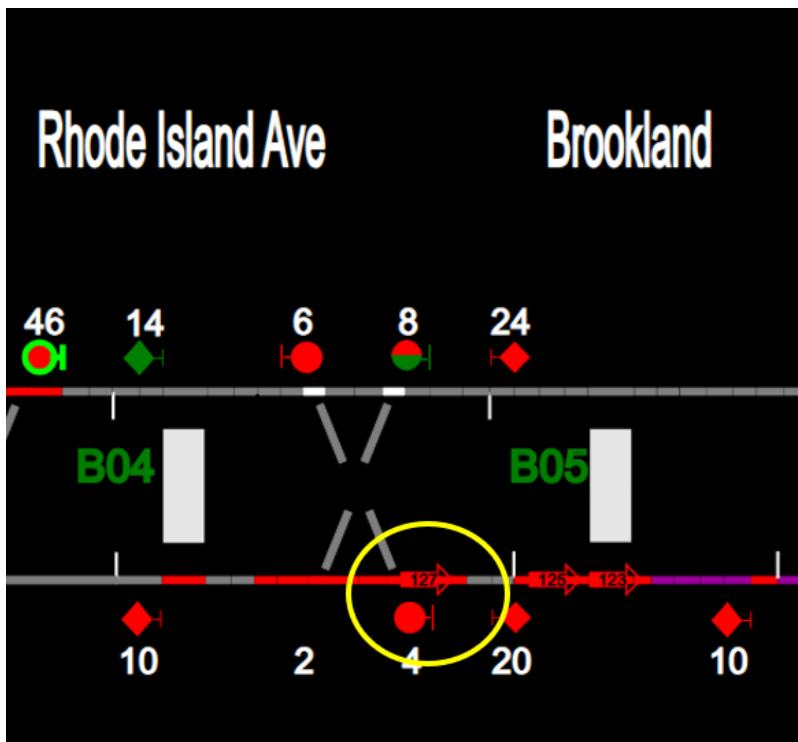
The train passes signal B04-02 at a speed of 13 MPH while moving to a P2 power position. Full-service brake applies a B4 Braking Rate, bringing the train to a complete stop 199 ft. beyond the B04-02 signal. There were no faults with the train that contributed to the cause of the red signal overrun incident; the train performed as commanded.

Image 2 - Depicts Train ID 127 passing the B04-02 signal.

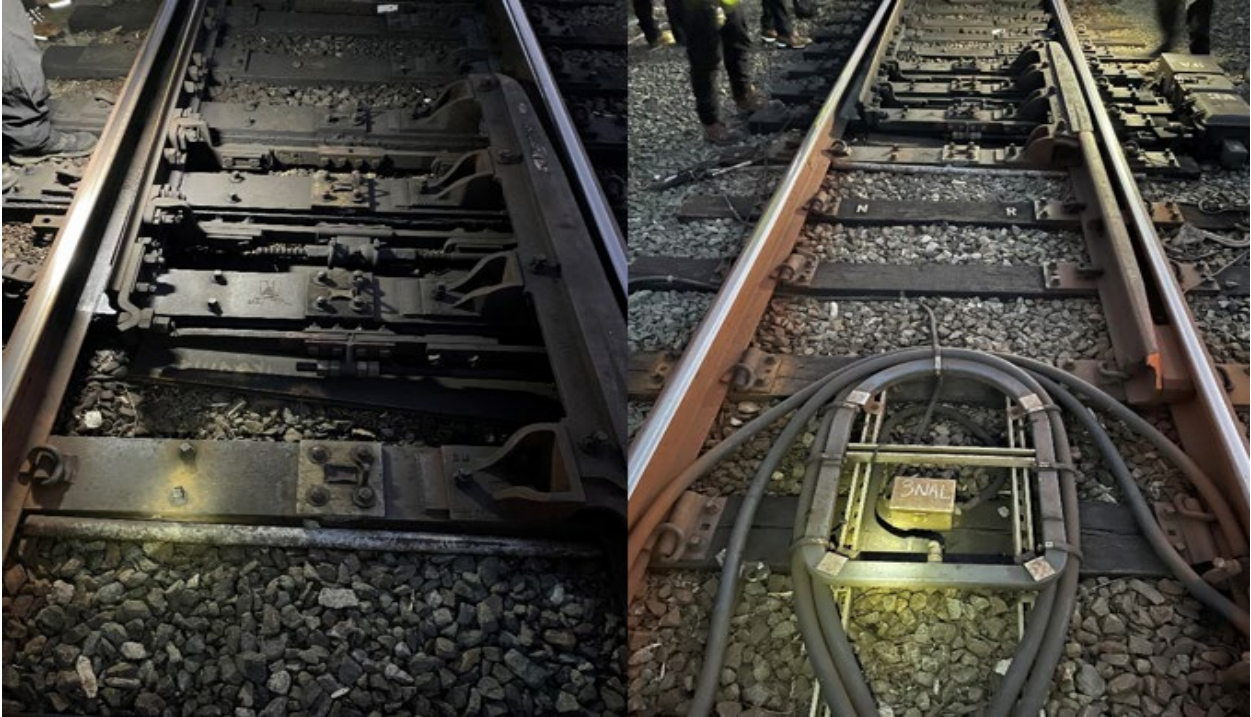
Figure 5 - depicts switch 3A with no damage to the switch or switch point.

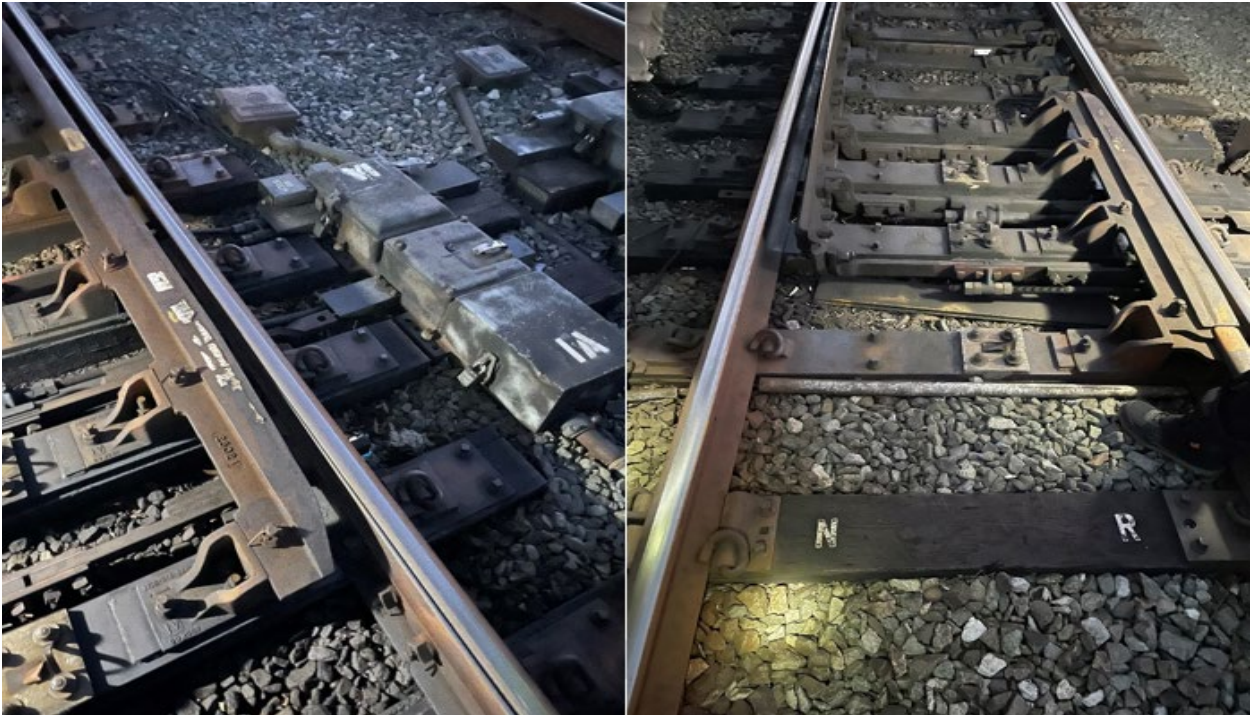
Figure 6 - depicts switch 1A with no damage to the switch or switch point.

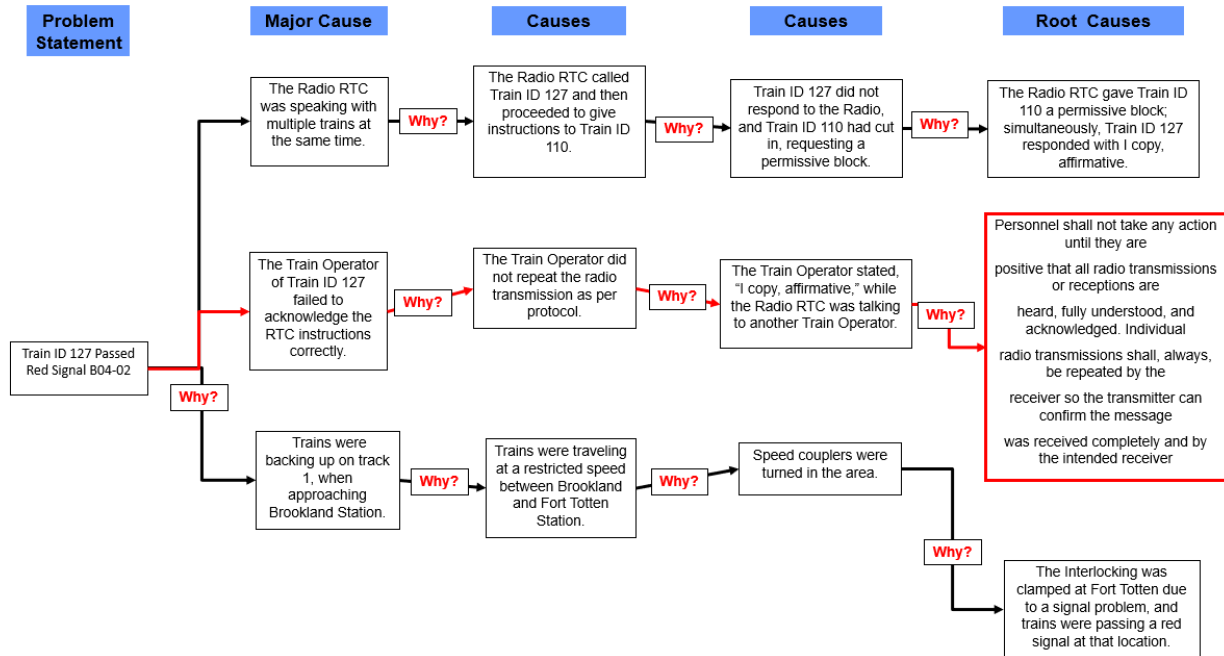
The probable cause of the Red Signal Overrun event on February 13, 2024, at Rhode Island Avenue Station was the Train Operators' lack of communication. Specifically, the Train Operator did not follow the established Radio Transmission & Reception Procedures, which required repeating radio transmissions to ensure that the intended receiver received the message completely. Additionally, Radio RTC #1 failed to establish communication between various Train IDs, as they failed to repeat the Train ID, location, and track number.

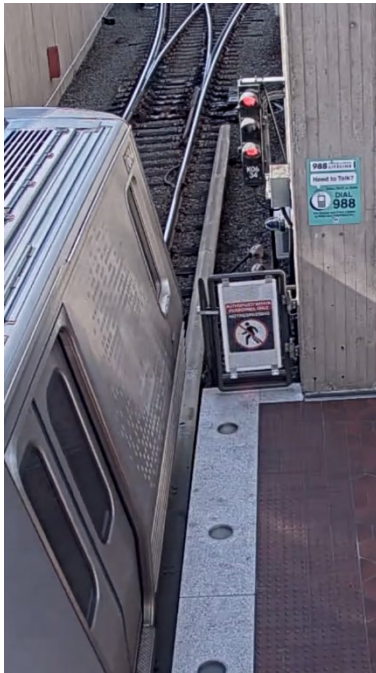
At 14:49 hours, CCTV showed the Train Operator closing the train doors and proceeded to operate the train past signal K06-34 displaying a red aspect. This is consistent with playback from the AIMS.

Figure 1 Train ID 918 moving past signal K06-34 displaying a red aspect at 14:49 hours

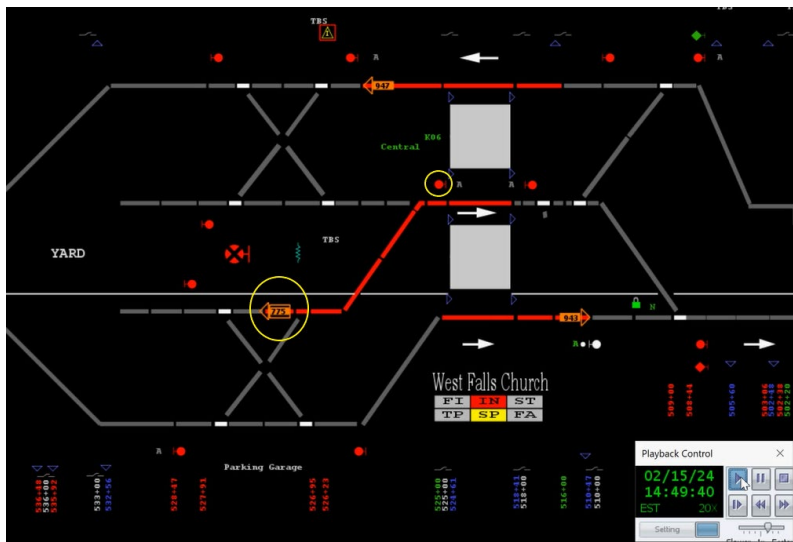
Figure 2 AIMS confirmed the red signal overrun at 14:49 hours
