Improper Roadway Worker Protection

At or Near Smithsonian, Spring Hill, Rhode Island Ave-Brentwood, College Park-UMD and Glenmont stations

March 14, 2023 – January 26, 2024 – February 27, 2024 – July 4, 2023 – January 18, 2024

Smithsonian Station – Improper Rail Vehicle Movement

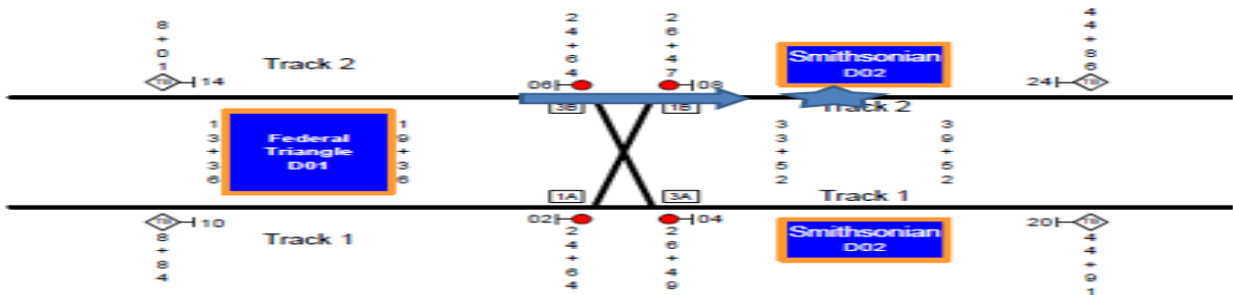
Smithsonian Station, track 2

On March 14, 2023, at 03:25 hours, PM-38 pushing Flatcar 531 collided with a WSAD within the platform limits at Smithsonian Station, track 2. A TRST Equipment Operator was operating PM-38 with a Flagman located on Flatcar 531 and was being utilized to work at the interlocking outside Smithsonian Station.

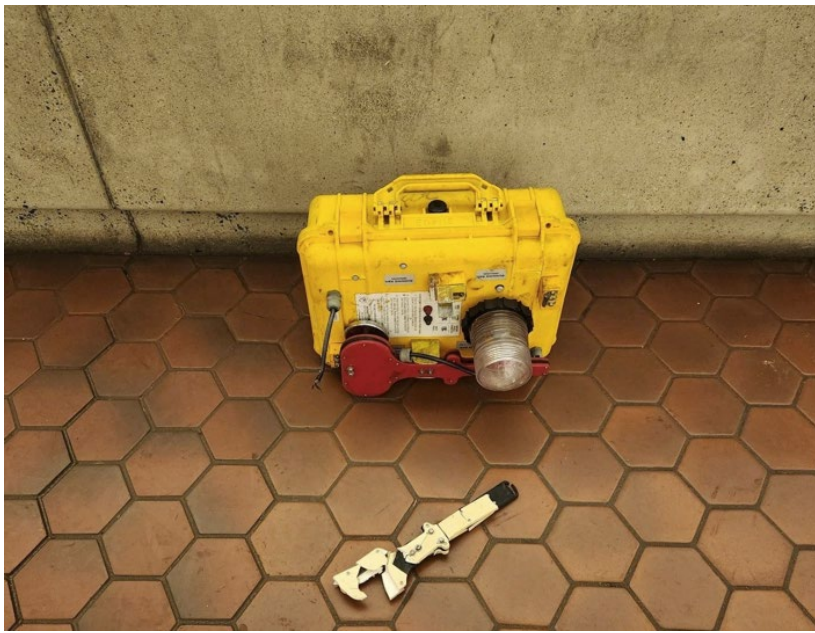
There were no injuries or damage to the vehicle, however the WSAD was damaged.

Image 1 – Damaged WSAD that was struck by Flatcar 531.

TRST performed an investigation for this event and determined that the incident could have been prevented had the Flagman observed the obstruction (WSAD) ahead on the roadway. The Flagman attended re-instruction training with an emphasis on MSRPH Rules 3.175.7 and 3.175.10.

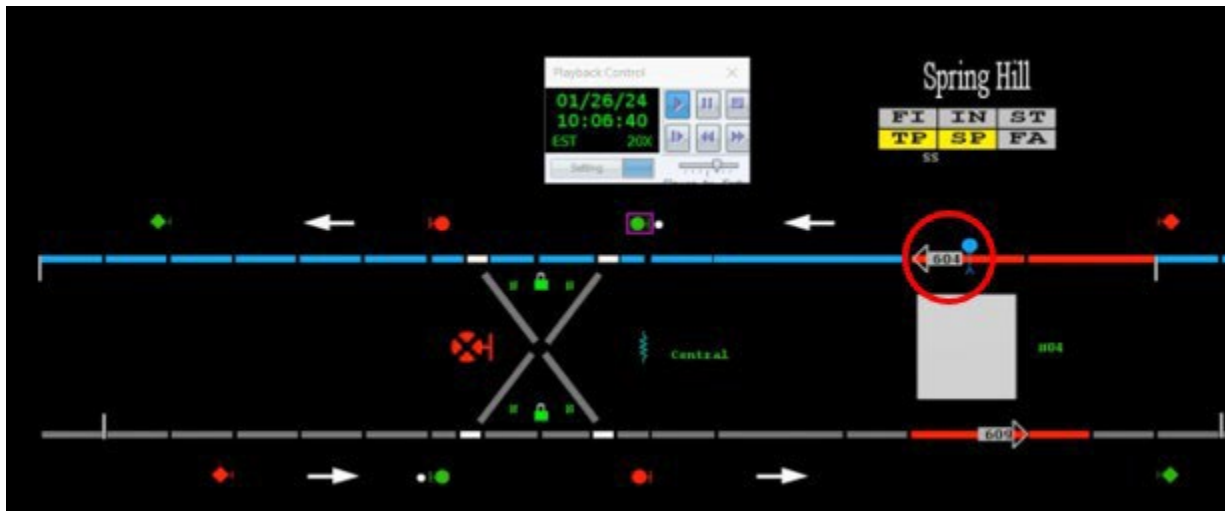
On Friday, January 26, 2024, at 10:06 hours, TRST RWIC was given permission to perform a track inspection between Spring Hill Station and Wiehle-Reston Station on track 2 by the Radio RTC when they advised the AMF located Spring Hill Station on track 2 at the 8-car marker that foul time was granted. The AMF acknowledged that the mobile work crew was under foul time protection. At 10:07 hours, Train ID 604 (L7240-41x7199-98x7618-19x7589-88T) departed Spring Hill Station on track 2 towards Wiehle-Reston Station without receiving a briefing from the AMF.

Figure 1 – Train ID 604 at Spring Hill Station, track 2 at 10:06 hours.

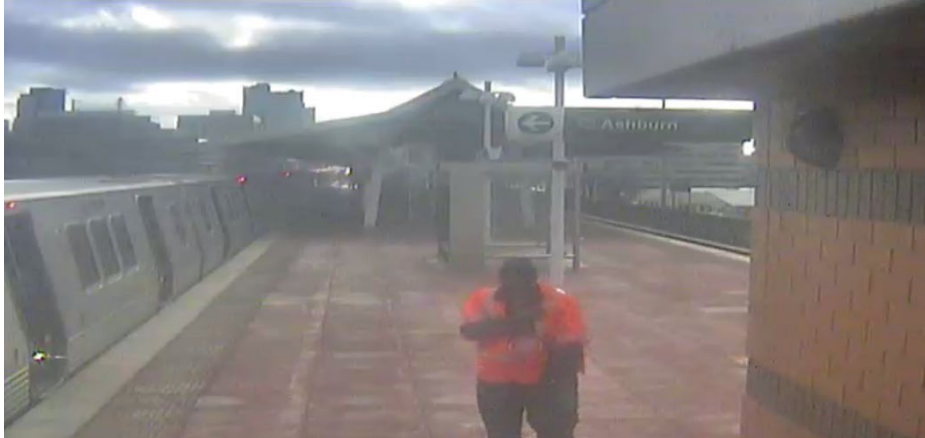
At 10:07 hours, the AMF acknowledged, and then advised, “Got one on the platform that just left.” The RWIC did not respond to the transmission. The AMF appeared to be speaking into the mic on their chest as Train ID 604 was stopped on the platform at Spring Hill Station with the train doors open. The AMF did not instruct the Train Operator to remain on the platform as the work crew was under foul time.

Image 1 - AMF at Spring Hill Station on track 2 talking into a mic, with Train ID 604 stopped on the platform with the train doors open at 10:07:07 hours.

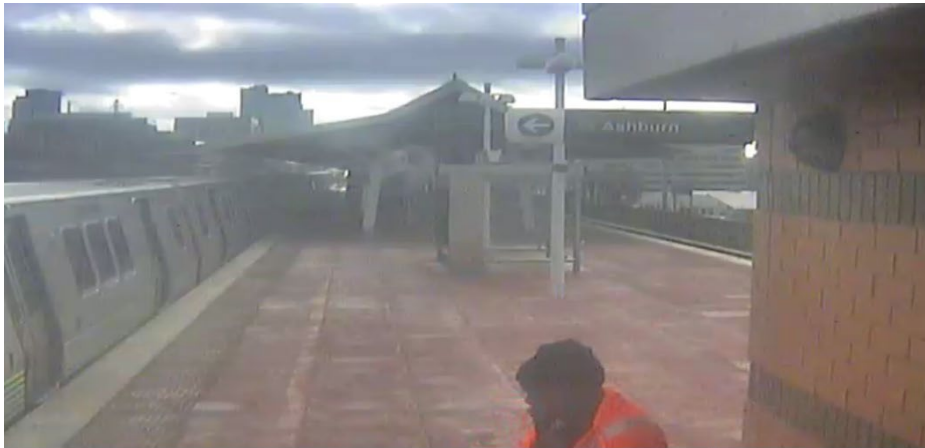
Image 2 - AMF positioned facing the train with the train doors closed at 10:07:13 hours.

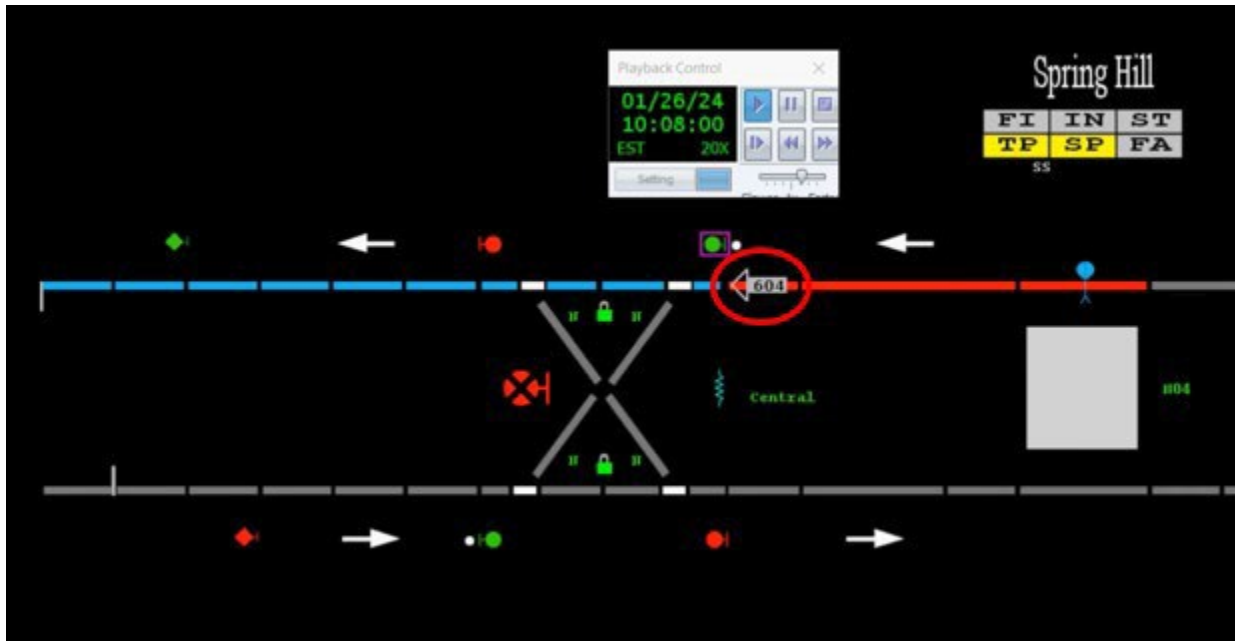
Figure 2 - Train ID 604 en route to Wiehle-Reston East Station at 10:08 hours.

The Office of Chief Mechanical Officer/Incident Investigation Team (CMOR/IIT) Analysis revealed that at 10:13 hours, Train ID 604 train speed was 57MPH when the master controller was placed in a B5 braking mode, then to the emergency position initiating emergency braking. The train passed the mobile work crew at 45MPH¹.

TRST determined that the RWIC and AMF would receive discipline in accordance with the Disciplinary Administration Program. The AMF received refresher training on the AMF procedures.

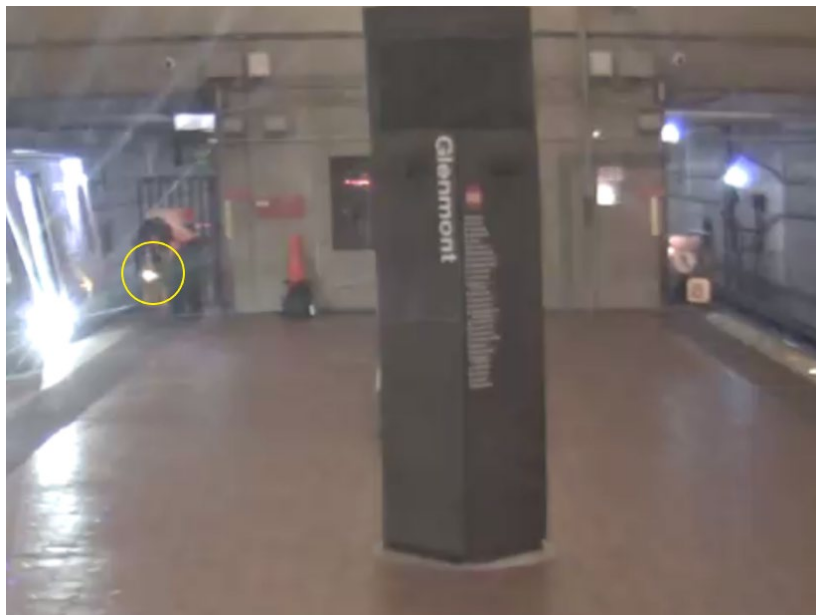
Image 1: AMF is observed deploying their amber lantern on the track 1 side at 10:05 hours.

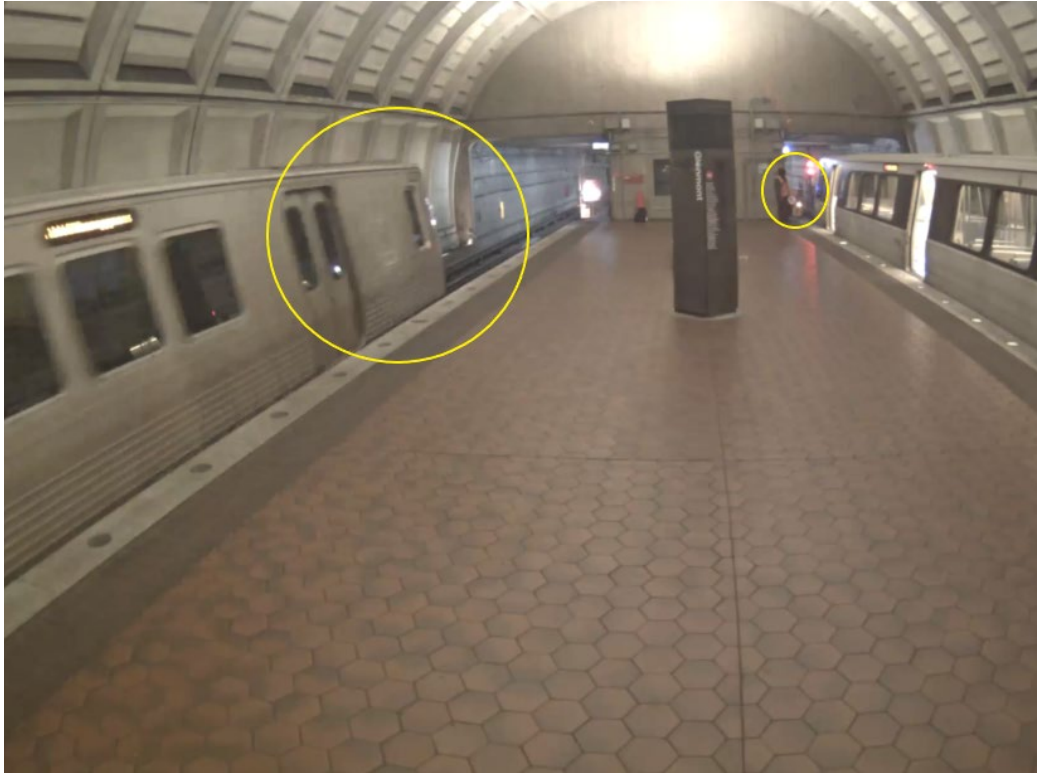
At 10:16 hours, CCTV determined that Train ID 891 failed to stop for the AMF at the eight-car marker of Glenmont Station, track 1.

Image 2: Train ID 891 on approach to the AMF on the track 1 side at 10:16 hours. Note the AMF addressing Train ID 118 on track 2. Train ID 118 departed Glenmont Terminal at 10:19 hours.

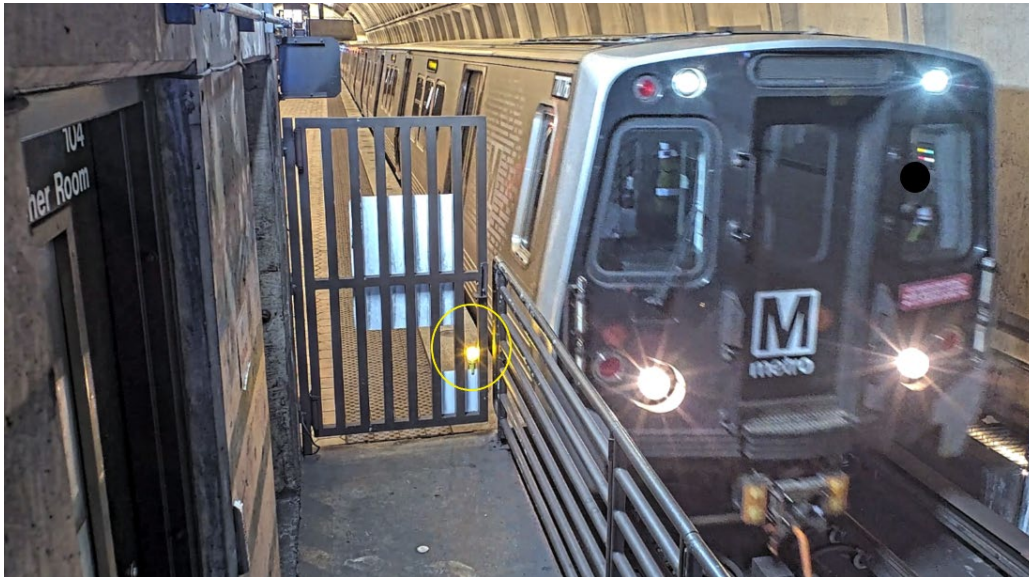
Image 3: Train ID 891, 2 seconds later, having not stopped for the AMF's flashing amber lantern.

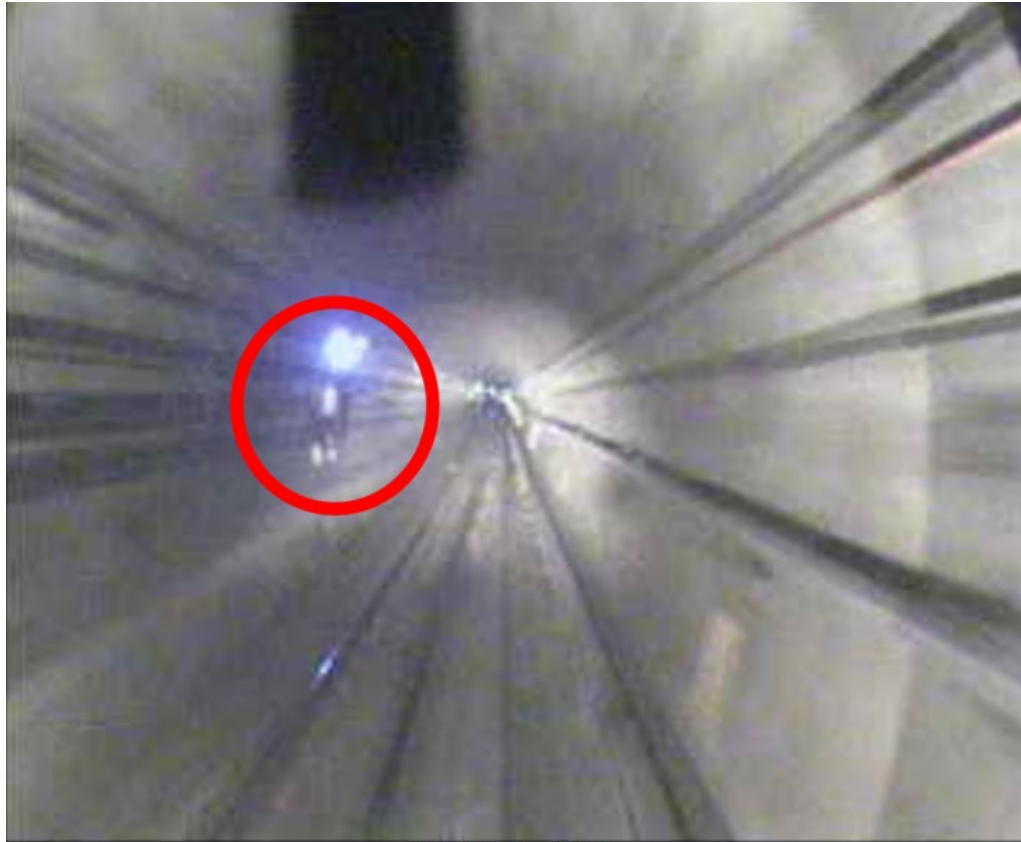
01/18/2024 10:18:59.353

At 10:18 hours, forward-facing camera footage of Train ID 891 captured one of the members of the work crew in a place of safety, within the roadway.

Image 4: A silhouette of personnel on the catwalk in the roadway at 10:18 hours.

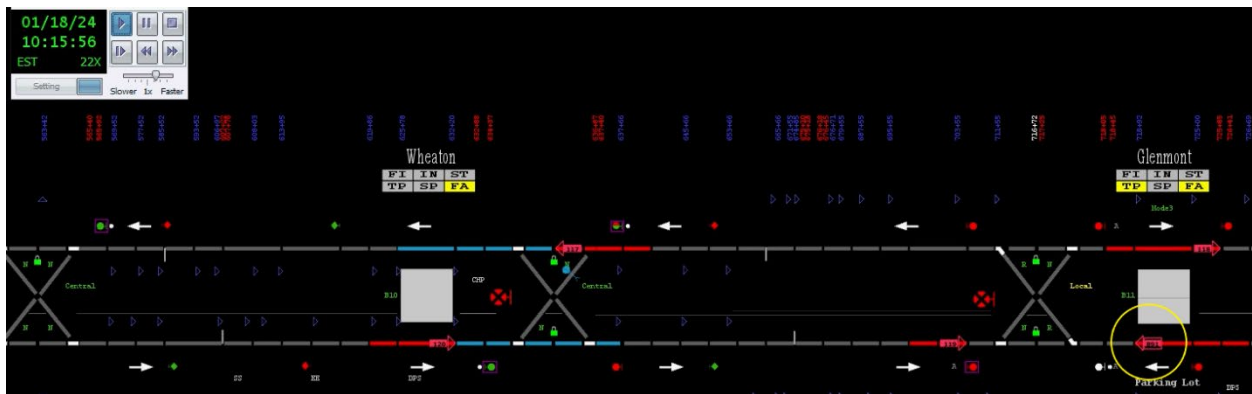
Figure 2 – Train ID 891 arrived at Glenmont Station, track 1 at 10:16 hours.

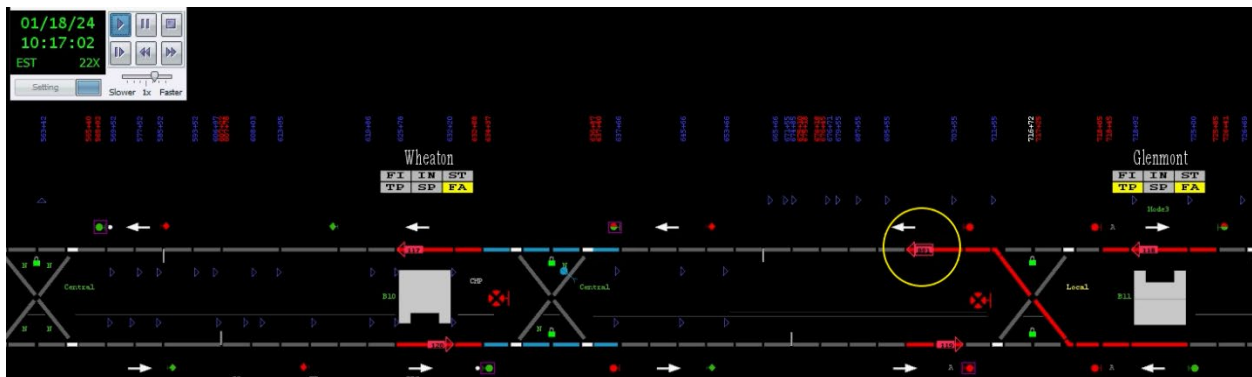
Figure 3 – Train ID 891 crossed over to track 2 while en route to Wheaton Station at 10:17 hours. Note Train ID 119 is facing Train ID 891 with lights engaged.

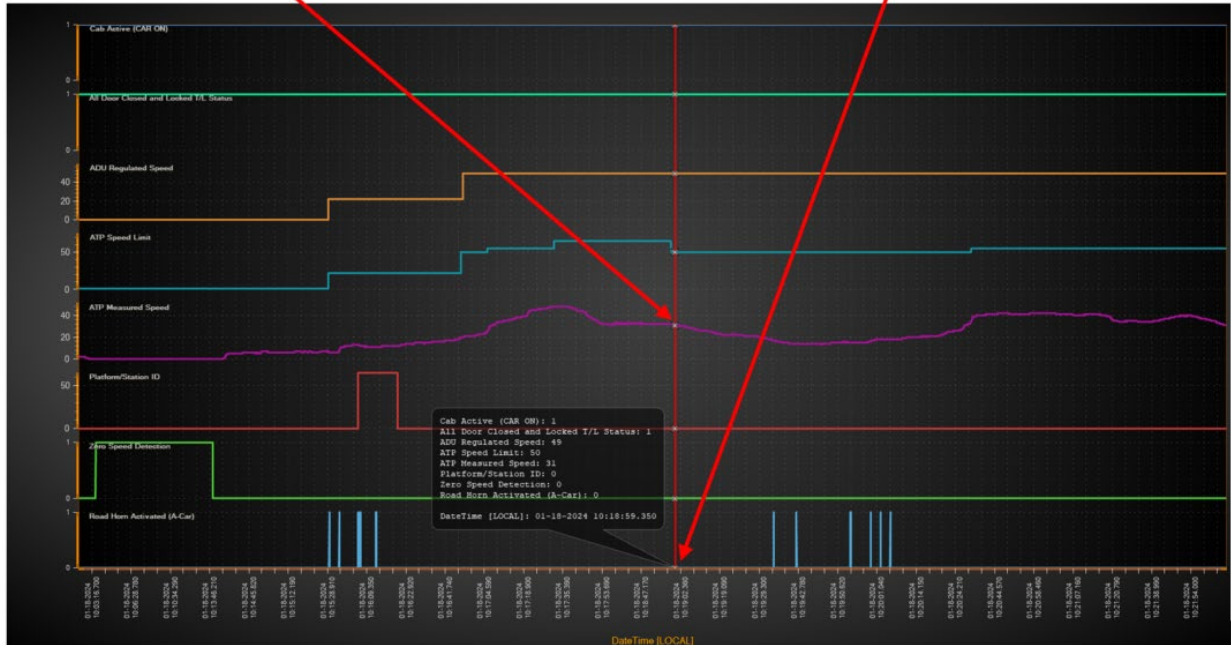
10:18:59 The Speed Limit was 50mph, Regulated Speed was 49 and train was traveling at 31 mph.

10:18:59 The Road Horn was not activated during this time.

Figure 3 –Train ID 891 speed and horn activations.
