Improper Door Operation

Columbia Heights, Federal Center SW, and Rhode Island Ave-Brentwood stations

November 28, 2023 – January 11, 2024 – February 17, 2024

Columbia Heights Station – Improper Door Operation

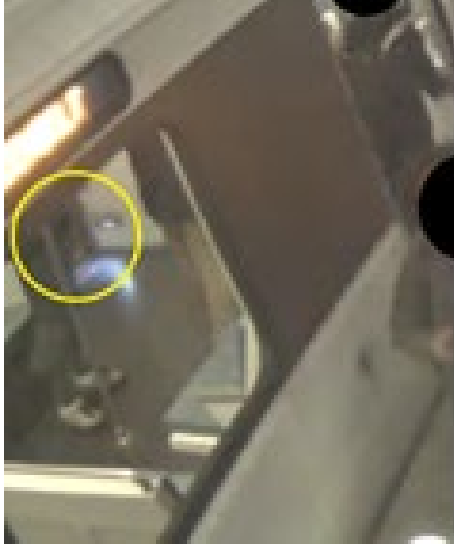
At 20:39 hours, Train ID 515's non-platform side doors could be observed opening after multiple cycles of the interior lights could be observed. The non-platform side doors then closed approximately nine seconds after opening.

Image 2 - Train ID 515's non-platform side doors can be observed open at 20:39 hours after the interior lights were rapidly turned off and then back on again.

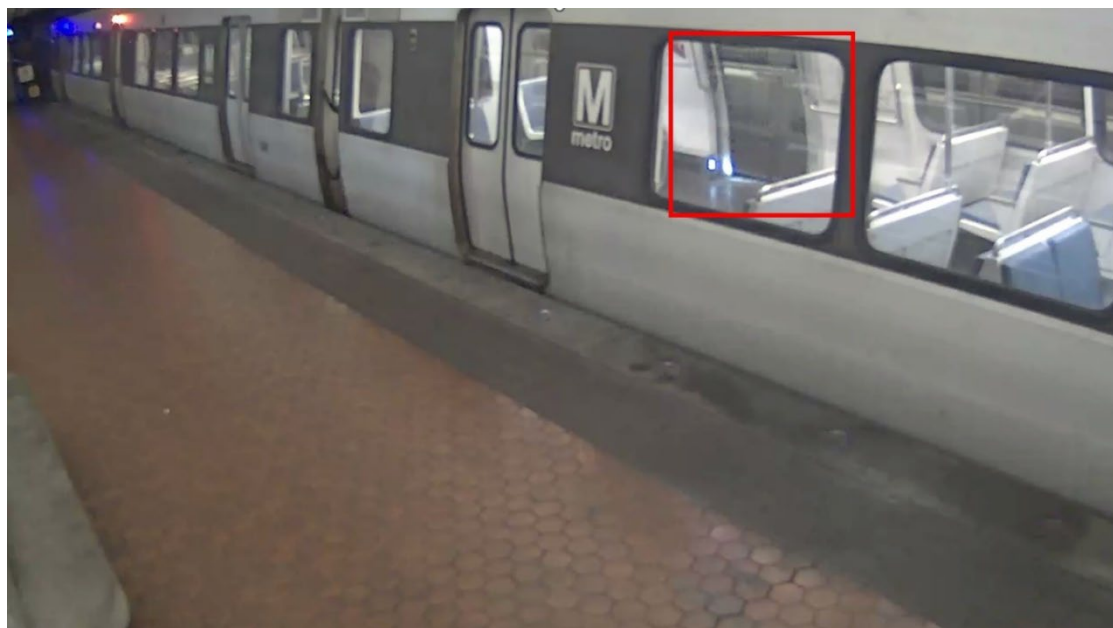
Image 1 - Train ID 411 doors open the doors on the non-platform side (right side) at Federal Center SW Station, Track 1, at 23:26:01 hours.

The probable cause of the Improper Door Operation event on January 11, 2024, at Federal Center SW Station was an incorrect application of the procedures that resulted in the Train Operator mistakenly commanding the non-platform side doors to open. The Train Operator activated the non-platform side open door button prior to verifying the platform side of the station. This action led to the right-side doors being opened off the platform.

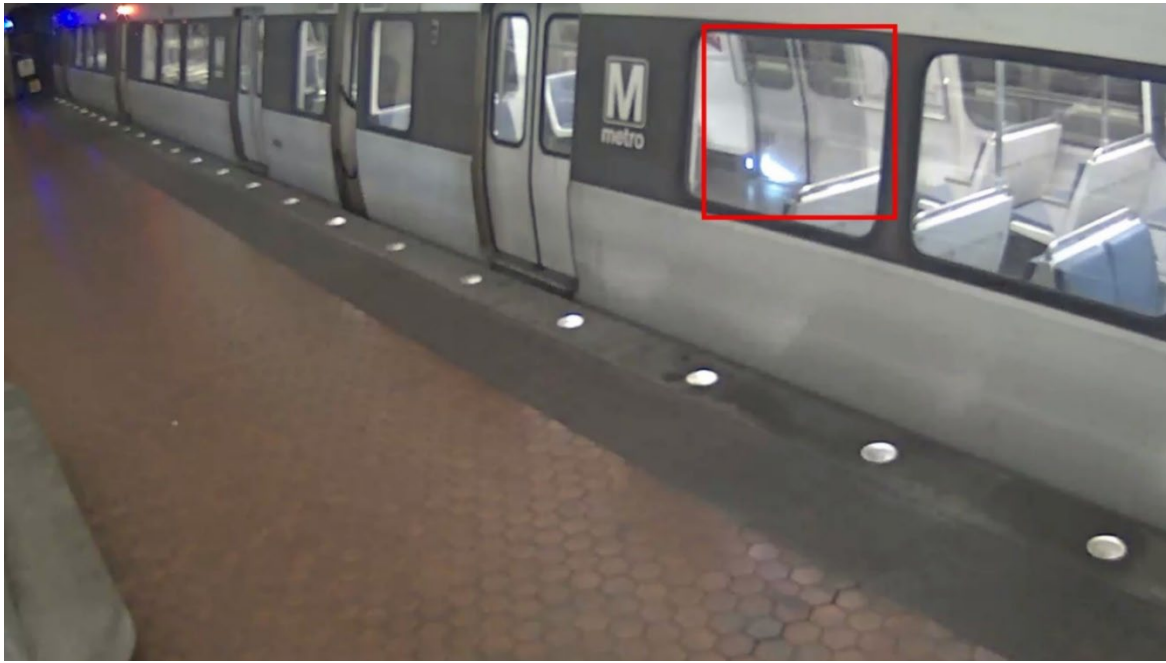
Image 2 - Train ID 411 doors were closed the non-platform side (right side) at 23:26:03 hours.

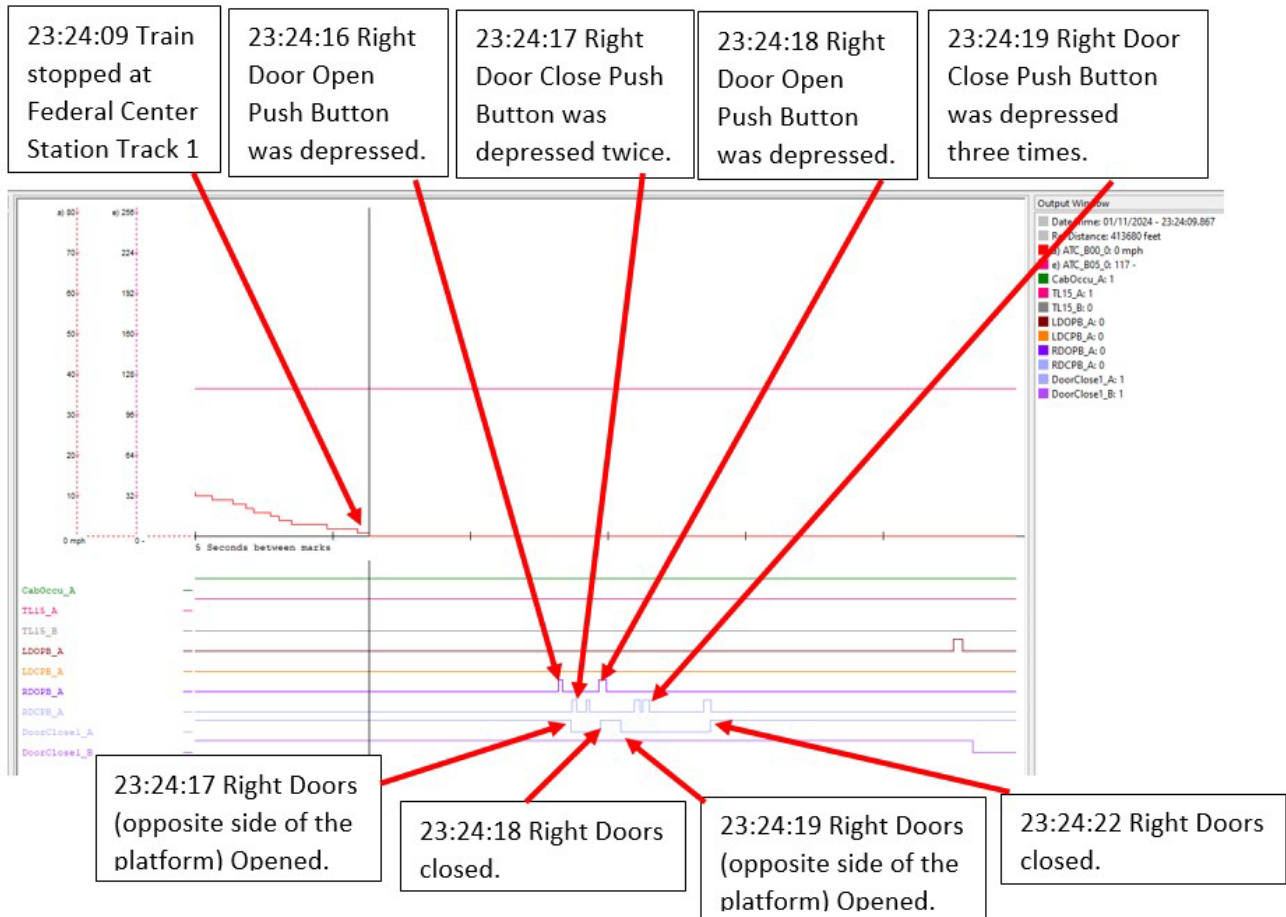
“Based on Vehicle Monitoring System (VMS) data, the IIT determined that no mechanical failure could have contributed to this incident. In summary, the right doors (opposite side of the platform) were manually operated twice while the train was stopped at Federal Center SW Station. The right signals that monitor the right-side door control push buttons confirmed the door push button was manually operated, and the analysis is provided. See the timeline of events below.”

Graph 1 – Data analysis of Lead Car 6052 door operations.

CMNT personnel performed door operational checks and inspections as recommended by CMOR IIT. CMNT inspected all Door Push Buttons, microswitches, and associated wiring. All door pushbuttons were depressed without sticking, and CMNT cleared the train for service. (See Appendix E).

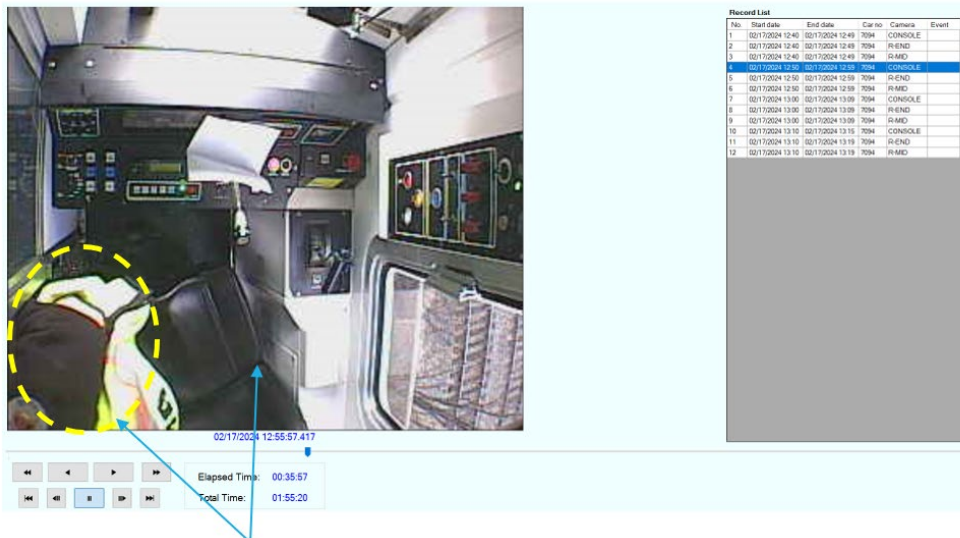
02/17/24 12:55:57.41 Operator left his Seat for Door close operation on the Left hand side as seen in the NVR Video Cab Video

Figure 1: Car 7094 NVR Video Screenshots for Operator reaching out to the Left side Door Control Panel for Door operation.

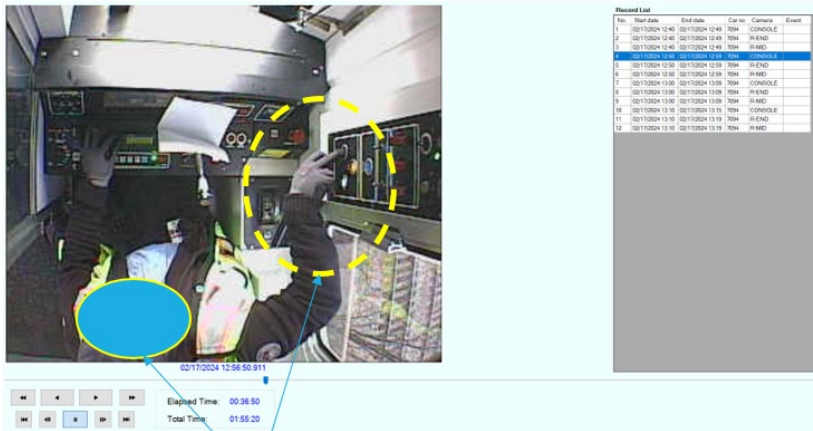
02/17/2024 12:56:50.91 Operator is seeing depressing the Right Door open push button on the Right Door Controller Panel and both NVR Video and ER confirmed Door opening on the Right Hand side also

Figure 2: Car 7094 Cab video screenshot showing the Operator's finger depressing the Right Door open push button on the Right Door Controller panel.
