Improper Door Operation
Farragut West and Vienna stations
February 26, 2024 – March 12, 2024

FINAL REPORT OF INVESTIGATION A&I E24155

Farragut West Station – Improper Door Operation

Vienna Station – Improper Door Operation

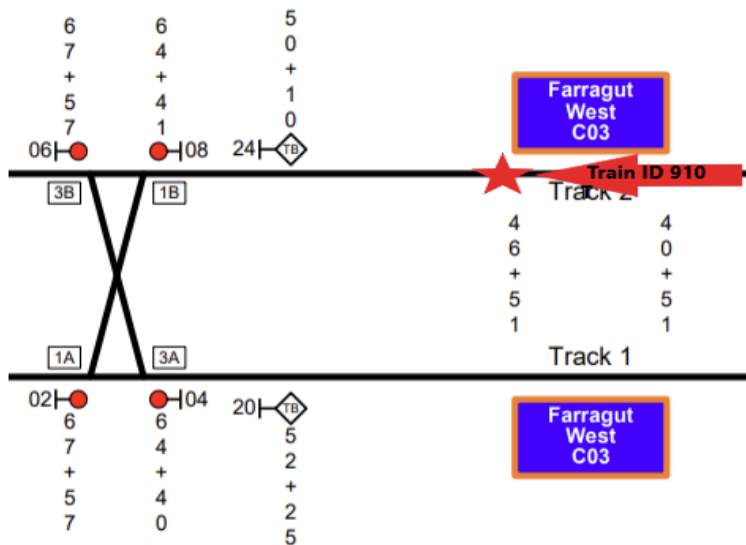
Field Sketch/Schematics

Farragut West Station, track 2

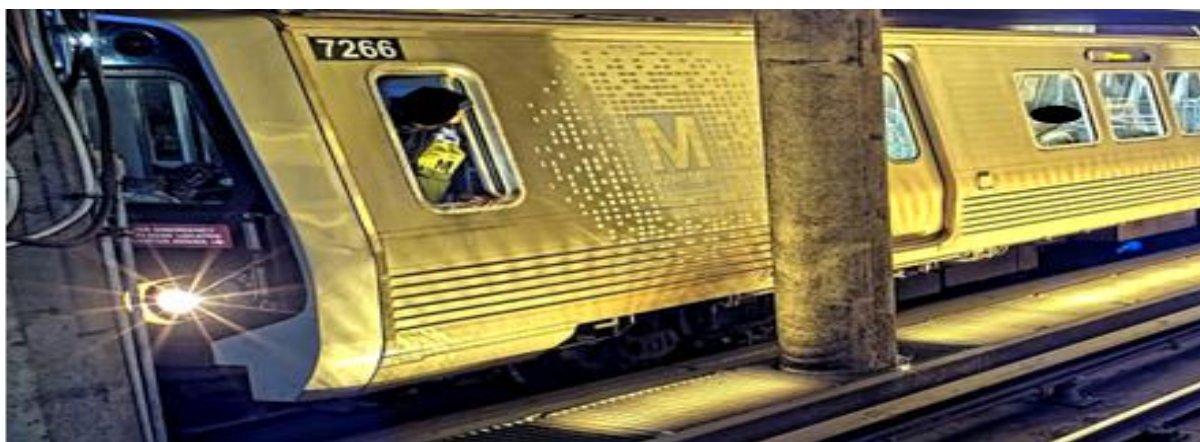
The Closed-Circuit Television (CCTV) revealed that at 08:16 hours, Train ID 910 (L7266/67x7144/45x7260/61T) arrived at Farragut West Station on track two. As the train was coming to a stop, Student Train Operator #2 knocked on the Operator’s Cab door; the LPI left the observation seat and then opened the Operator’s Cab door to address Student Train Operator #2. The train stopped at the 8-car marker; the platform was on the right of the train. As the LPI was talking to Student Train Operator #2, Student Train Operator #1 stood up and walked to the left side door control panel, opened, and looked out of the window on the non-platform side of the train, then walked back to the train console and acknowledged the alarm that confirmed that the train doors should open on the left side. Student Train Operator #1 walked back to the left side door control panel, opened, and looked out of the window on the non-platform side of the train and then opened the train doors on the non-platform side.

Image 1 – Image of Student Train Operator #1 at the left side cab window at 08:15 hours.

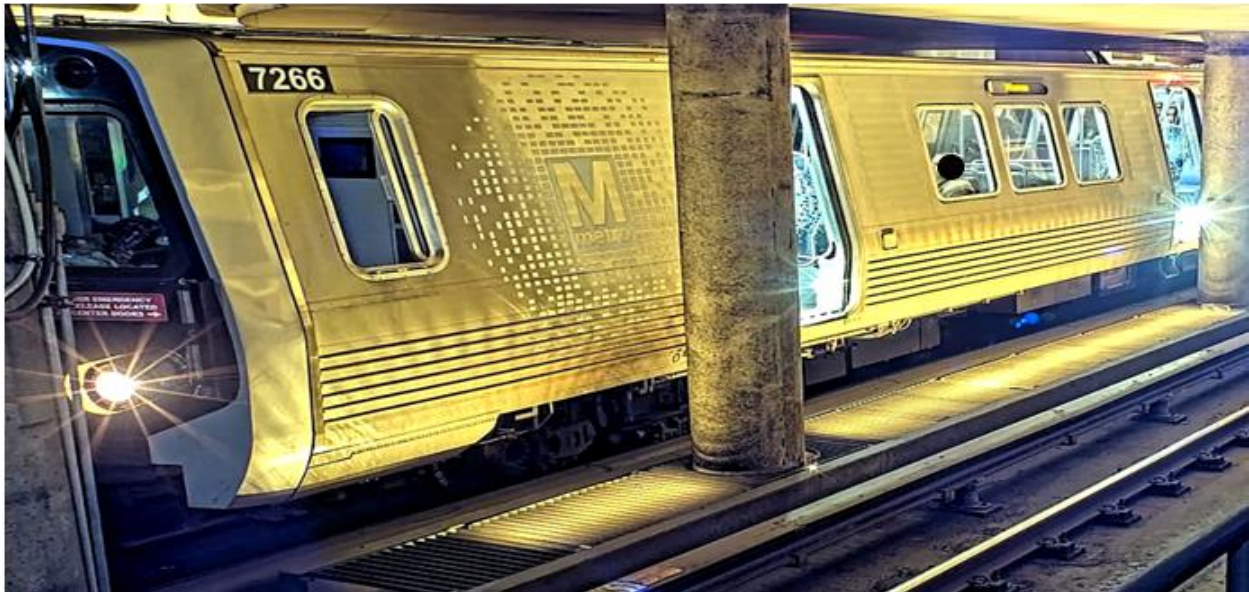
Image 2 - Image of Train ID 910 with the train doors open on the non-platform side at 08:16 hours.

The System Performance on Time Summary (SPOTS) revealed that the non-platform side doors were opened at 08:16:04 hours and were closed at 08:16:09 hours. The platform side doors were opened at 08:16:32 hours and were closed at 08:21:40 hours.

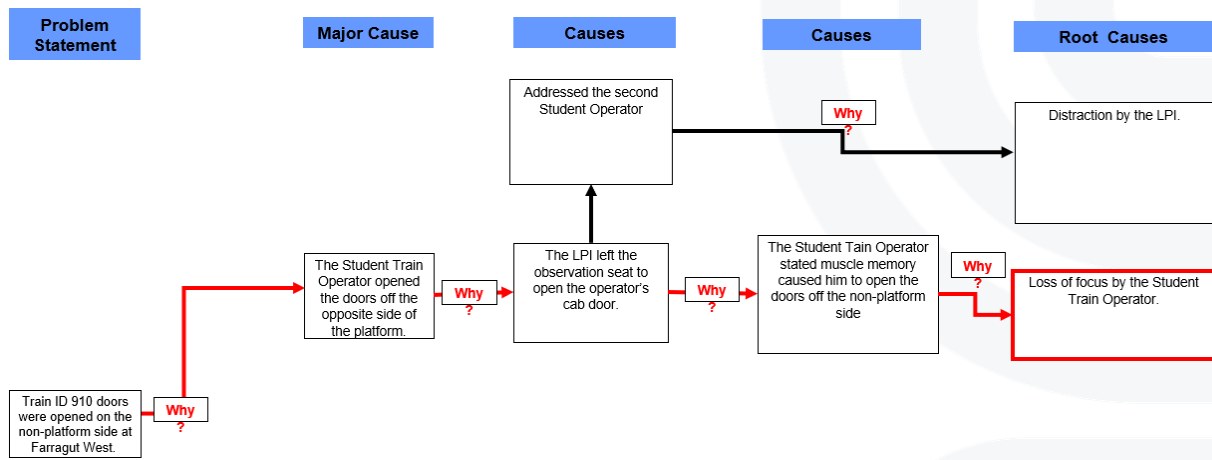
Appendix D – Why-Tree Analysis

The probable cause of the Improper Door Operation event on February 26, 2024, at Farragut West Station was the distraction of Student Train Operator #1 and the LPI when Student Train Operator #2 requested the attention of the LPI while the train was stopping on the platform. The contributing human factors of Student Train Operator #1 were a loss of situational awareness and a lack of experience that caused them to approach the left side of the Operator's Cab when the LPI moved from the observation seat.

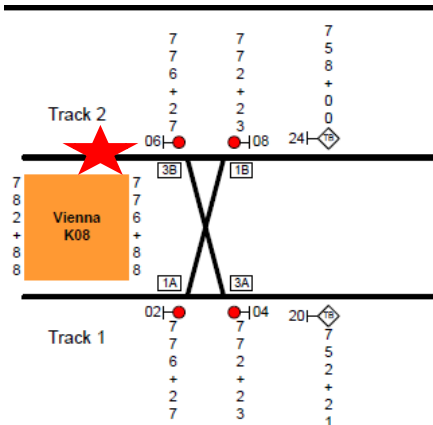
Field Sketch/Schematics

Vienna Station, track 2

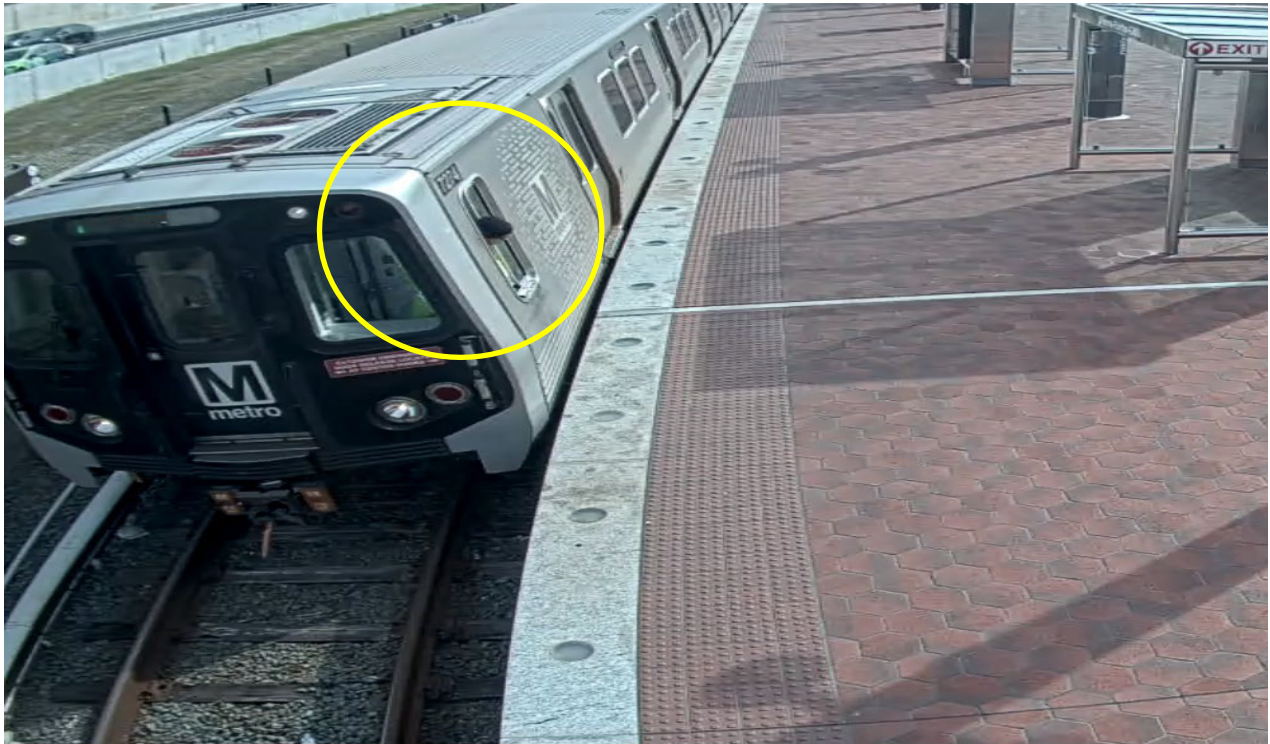
On Tuesday, March 12, 2024, at 10:38 hours, Train ID 914 [L7274/75x7279/78x7462/63x7417-16T] arrived at Vienna Station on track 2 and stopped with one door of the trailing car outside of the platform limits. The Train Operator opened the train doors, keyed down, and exited the train. A second Train Operator, who was in the trailing car, notified the Terminal Supervisor that the train door was opened outside of the platform limits.

Image 1 – Train Operator looked out cab window second time prior to opening doors while the train doors were outside the platform limits.

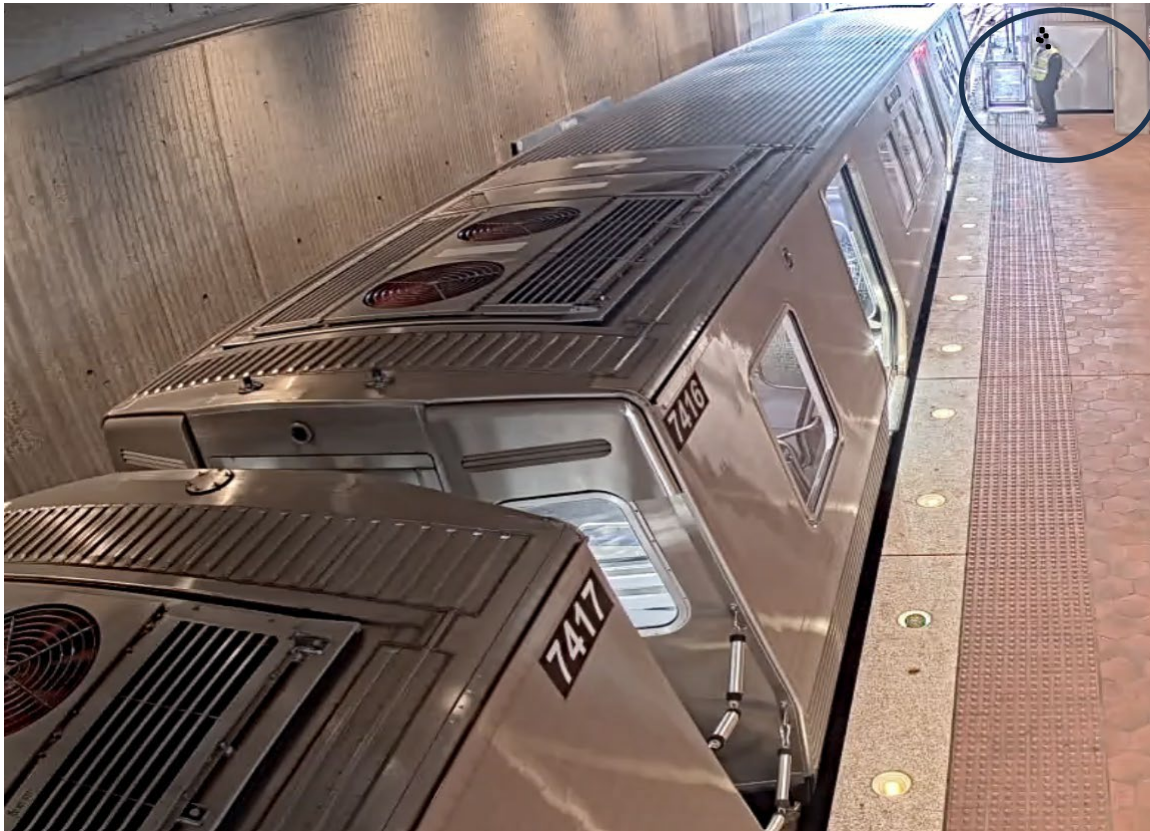
Image 2 - RTRA Supervisor verifying the train doors open outside the platform limits.

The Closed-Circuit Television (CCTV) revealed that at 10:40 hours, the Terminal Supervisor verified the Improper Door Operation, boarded the trailing car, closed the train doors, and placed the train out of service. The Audio Recording System (ARS) revealed that at 10:44 hours, the Terminal Supervisor contacted the MICC to report the event.
