# WMSC Inspection Report 20241121

Title: Deanwood Track Inspection

Location: Track 1 Deanwood Metrorail Station to Minnesota Ave; and Track 1 Minnesota Ave.

Date: 11/21/24

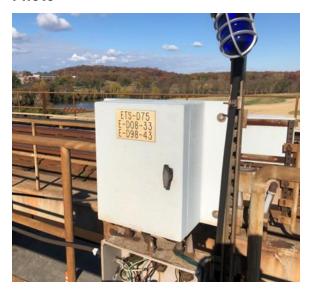
Defect 2

Damaged or disassembled ETS Box ETS-075

**Hazard Rating: 3D**

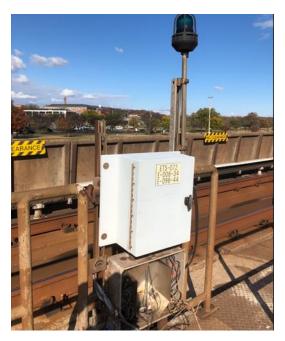
## Defect 4

Damaged or disassembled ETS Box ETS-072

**Hazard Rating: 3**

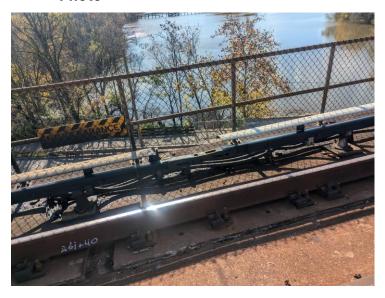
**Additional Observation**

Worn third rail expansion joint 261+40

**Hazard Rating: 3C**
