# WMSC Inspection Report 20241205B

ISSUED 12/9/2024

Train Control Room (TCR) Inspection

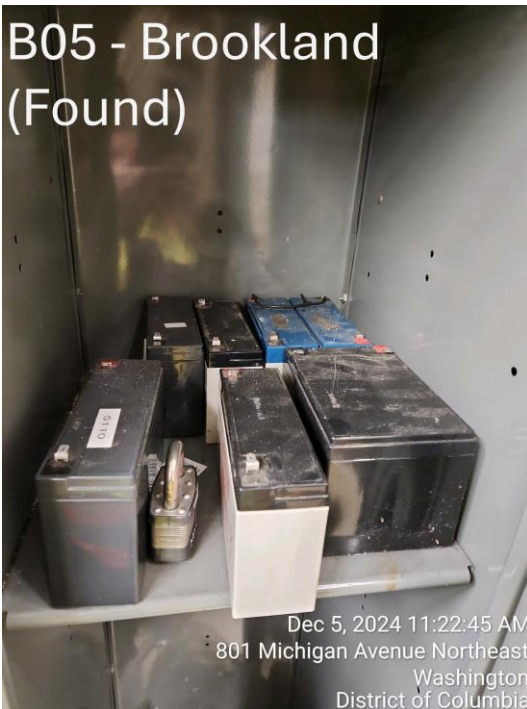
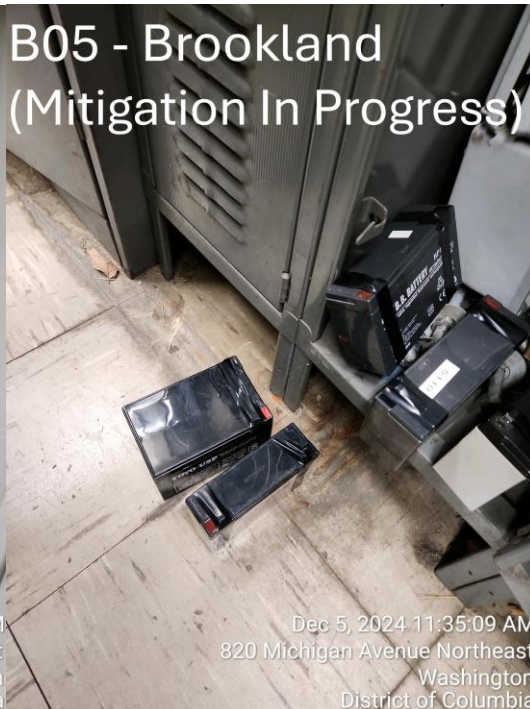
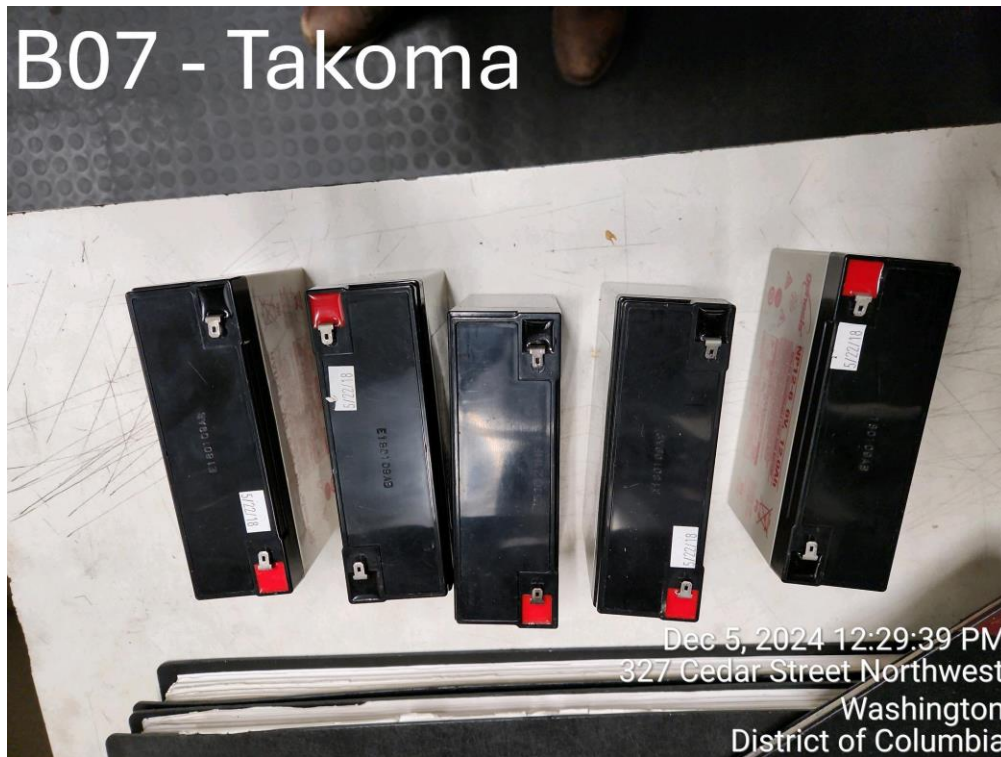
**Defect 1**

During inspection, lead acid batteries were found that did not have their metallic leads guarded and that were stored within metal lockers often neighboring accelerants such as paper and chemicals. Such batteries encountering other metals can cause sparks which could lead to a fire. These conditions were observed at B05 Brookland and immediately reported to ATCM Assistant Director Kelvin Murphy who was on site during the inspection and who contacted the local area supervisor for mitigation. This condition was also observed at B07 Takoma and was pending mitigation by the Assistant Director’s designee after discovery. As a temporary mitigation the batteries were removed from their metal cabinet to an open-air space until they could be taped and removed for proper disposal.

**Hazard Rating: 3B**

During the inspection, this potentially hazardous condition was identified as an Immediate Safety Concern that was immediately conveyed to ATCM Assistant Director Kelvin Murphy and, as noted above, was mitigated on-site during the inspection.

Additionally, WMSC notified WMATA of the Immediate Safety Concern again via email on Friday, December 6, 2024, in accordance with Program Standard Section 6.F.2.a. In response to the WMSC’s emailed Immediate Safety Concern, Automatic Train Control Maintenance advised that the batteries had been retrieved and relocated to the Car Maintenance shop at Brentwood Yard for proper disposal.

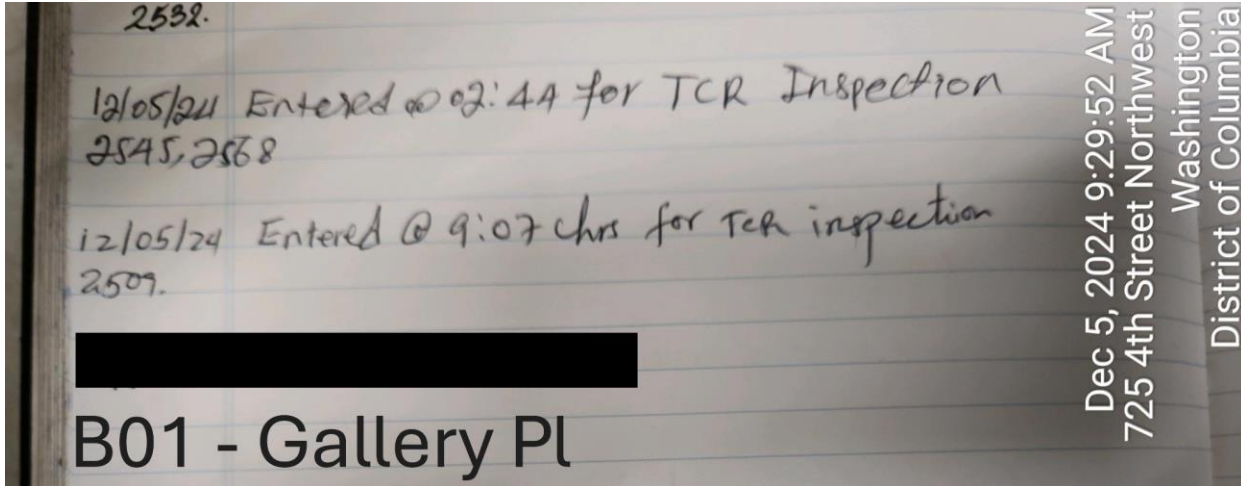
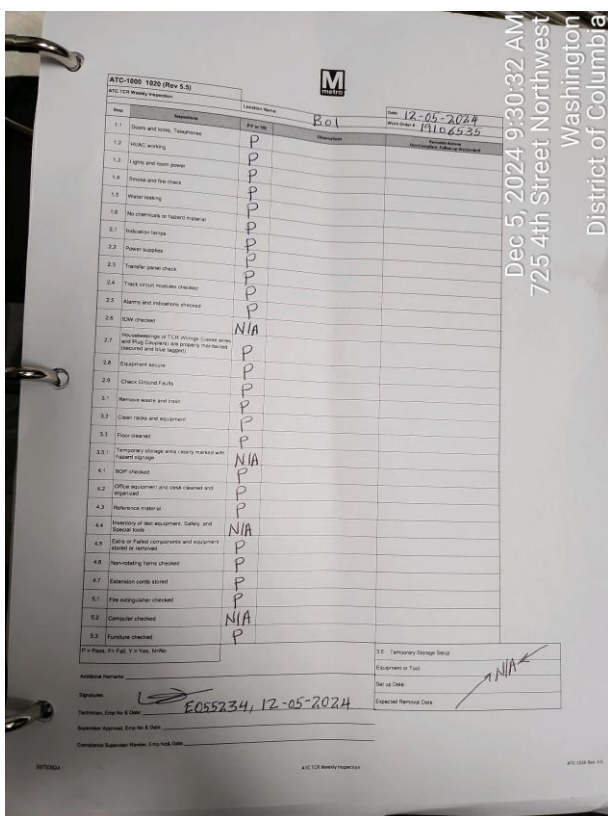
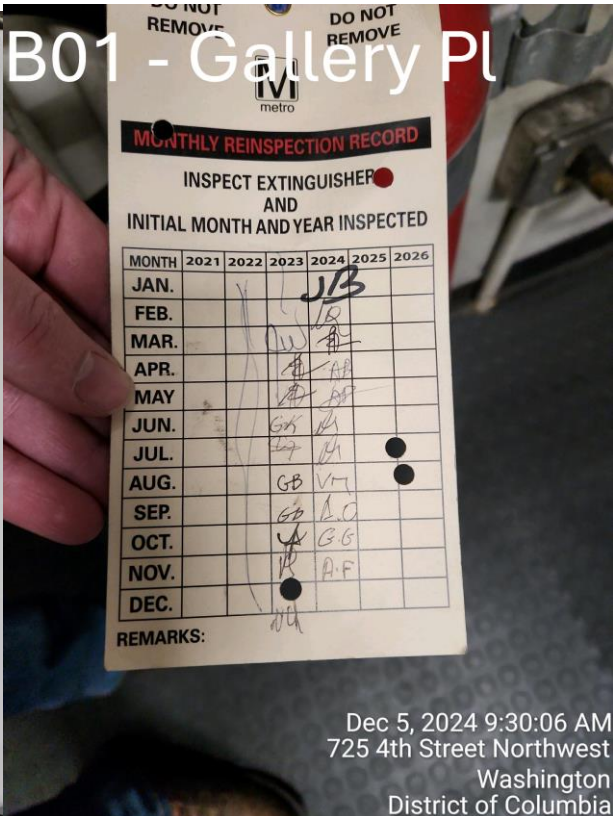
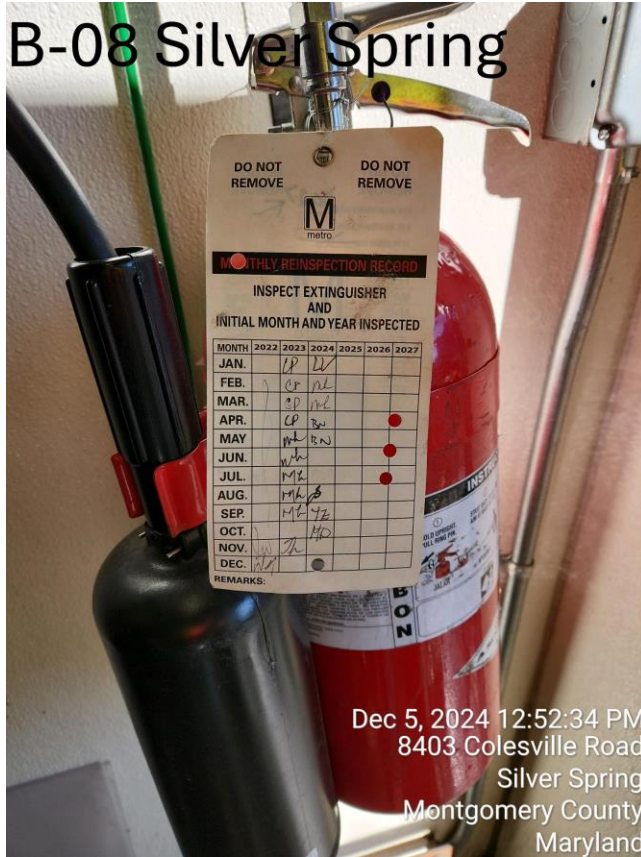
**Defect 2**

As outlined in the ATC-1000 Instructions for Testing and Inspection of ATC Apparatus and System the 1020 Procedure for Train Control Room (TCR) Weekly Inspections Procedure, Step 5.1.4 instructs that WMATA mechanics performing this preventative maintenance must “verify the extinguishers has an inspection tag and that tag has been initialed by a WMATA Approved Fire Personnel for the current or previous month of the inspection.”

Each visited TCR had an extinguisher available in the room. At two TCR locations, the present fire extinguishers had not been signed off as having their condition checked/confirmed. The locations in question were Gallery Pl - Chinatown (TCR Inspection 1020 Data Sheet completed 12/5/2024 with “Fire Extinguisher checked” as “P” passing, but the extinguisher’s tag had not been signed off for the month of December) and Silver Spring North Train Control Room (November Maintenance Check Missing - December check not completed yet).

**Hazard Rating: 3B**

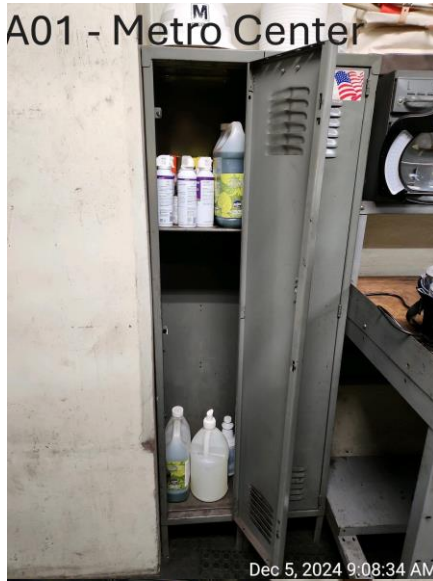
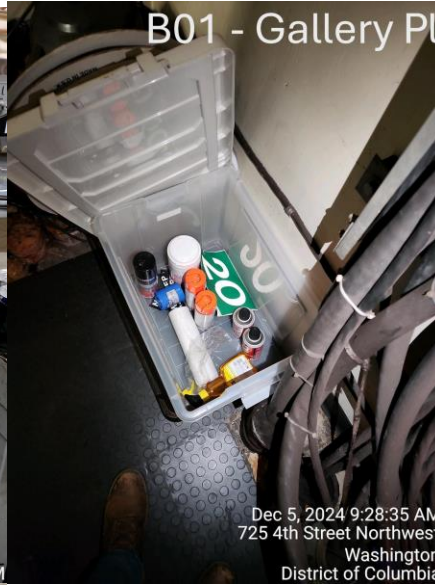
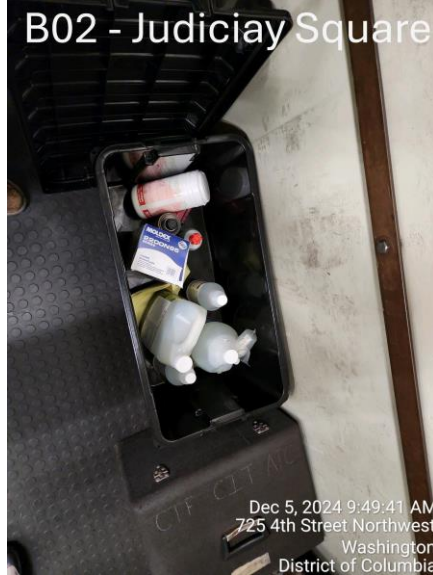
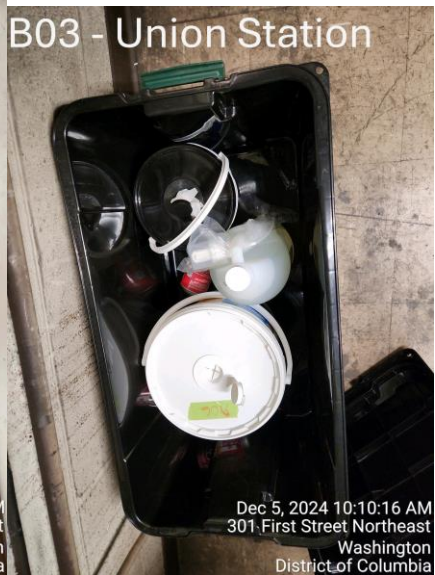
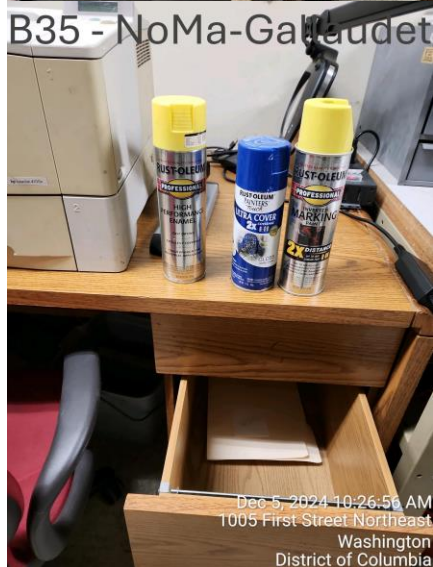
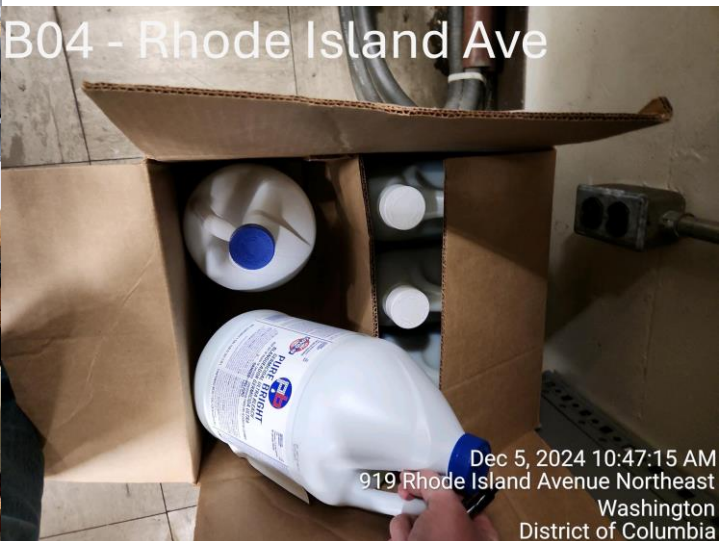
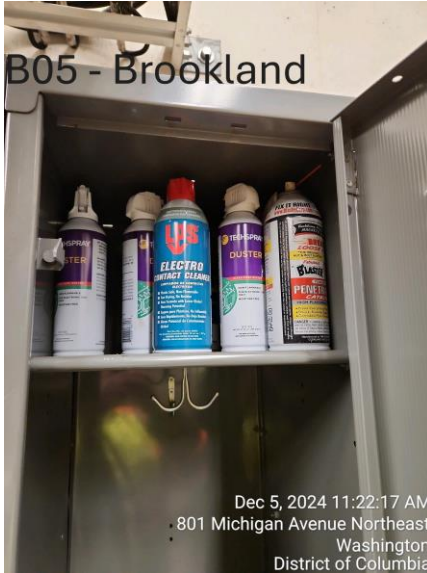
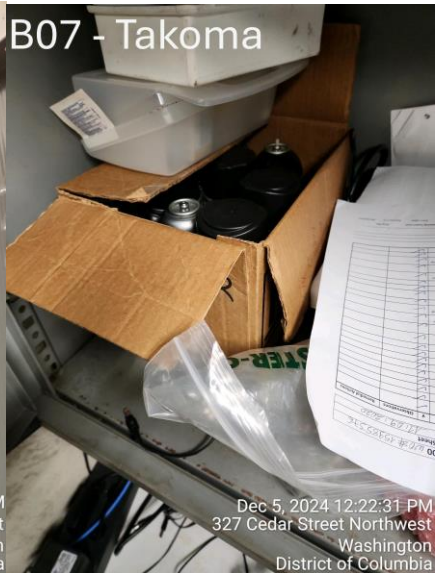
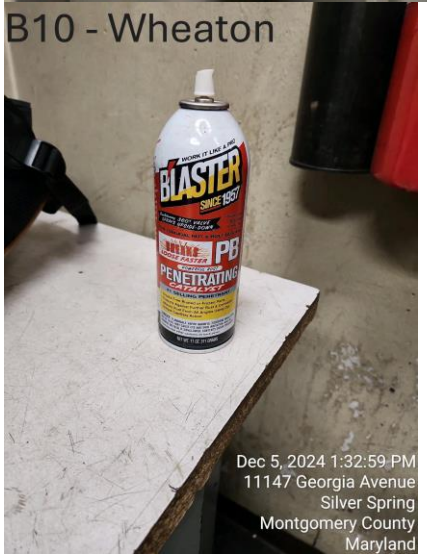
### Defect 3

As outlined in the ATC-1000 (Instructions for Testing and Inspection of ATC Apparatus and System) the 1020 Procedure for Train Control Room (TCR) Weekly Inspections Procedure, Step 1.6 instructs that WMATA mechanics performing this preventative maintenance must “ensure that no hazardous material or any type of chemicals are stored in the TCR.”

In 9 of the 13 TCRs (A01, B01, B02, B03, B35, B04, B05, B07, and B10) hazardous material or chemicals were observed in the room that included combustibles, flammables, and corrosives.

**Hazard Rating: 3B**

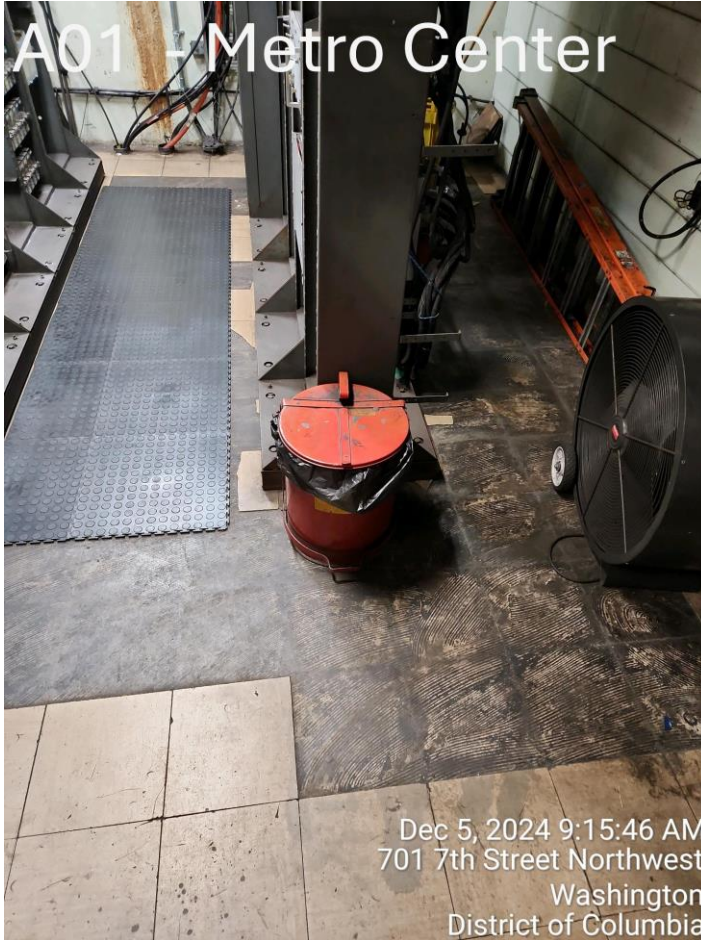
**Defect 4**

Damaged or missing flooring was identified at A01 Metro Center TCR. Some plastic flooring material was added in front of equipment racks. As presented, the floor poses a slip or trip hazard.

**Hazard Rating: 3B**

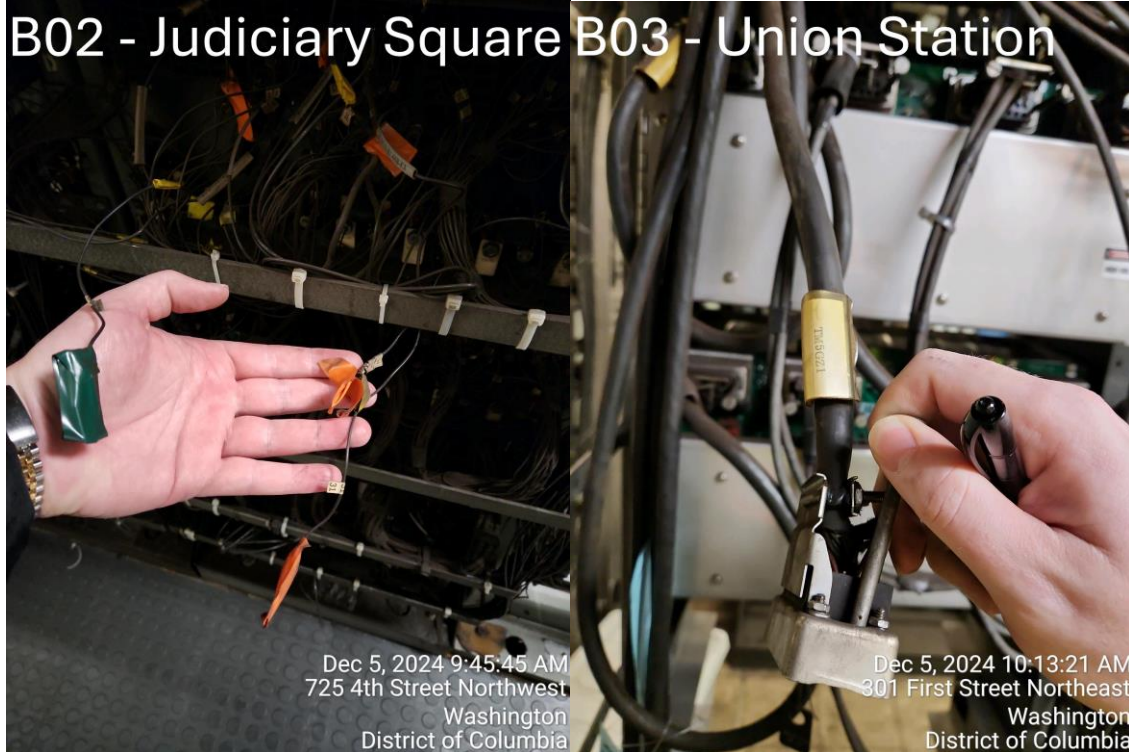
### **Defect 5**

At several TCR, cable jumpers and various copper interconnect cable heads were observed hanging from racks that were not blue tagged to indicate their status at B02, B03, B04, B05, B06, and B07. Stations B04, B05, B06, and B07 appeared to be undergoing work so it is possible these four locations will be resolved by those efforts.

As outlined in the ATC-1000 (Instructions for Testing and Inspection of ATC Apparatus and System) the 1020 Procedure for Train Control Room (TCR) Weekly Inspections Procedure, Step 2.7.2 instructs that WMATA mechanics performing this preventative maintenance ensure the following: “Unterminated loose wires must be properly secured, and blue tagged. The blue tag should be properly filled out. Unterminated Loose wires without blue tags must be reported to the ATC Supervisor for investigation and documentation. Any deficiency must be corrected as soon as possible.”

**Hazard Rating: 3B**

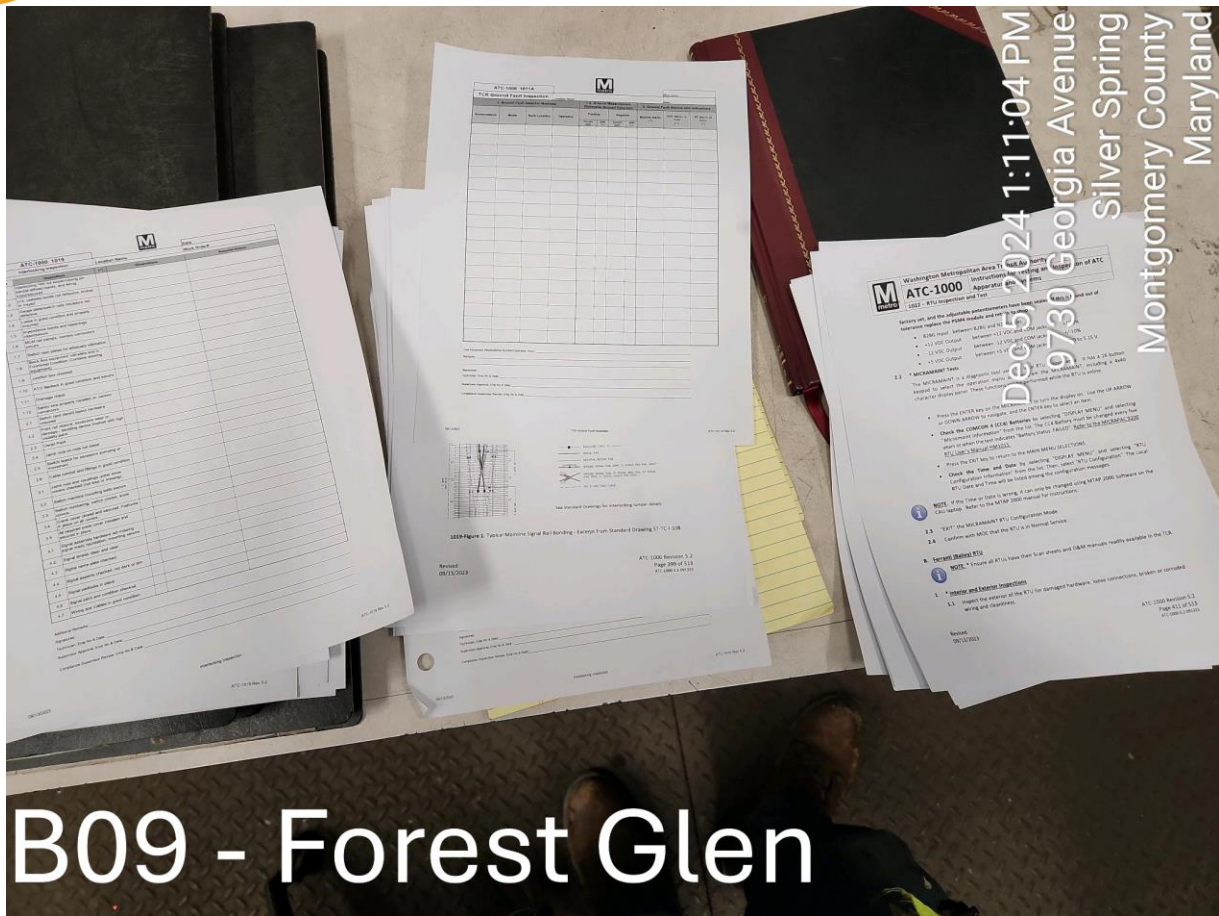
**Defect 6**

A spot check was conducted at the A01, B01, and B09 Train Control Rooms checking for maintenance data sheets. In each room there were instances where there were copies of pre-printed data sheets that were from various revisions of the ATC 1000 Instructions for Testing and Inspection of ATC Apparatus and System. To ensure proper document control, the outdated forms should be removed and only printed prior to performing work to ensure the current version of data sheets are used with up-to-date measurements, tolerances, and specifications. At A01 and B01 ATCM mechanics were in the TCR engaged in the 1020 Procedure for Train Control Room (TCR) Weekly Inspections Procedure activities and immediately remedied the finding of the outdated paperwork at the time of the observation. Assistant Director Murphy was advised at B09 of the condition needing intervention.

**Hazard Rating: 3B**

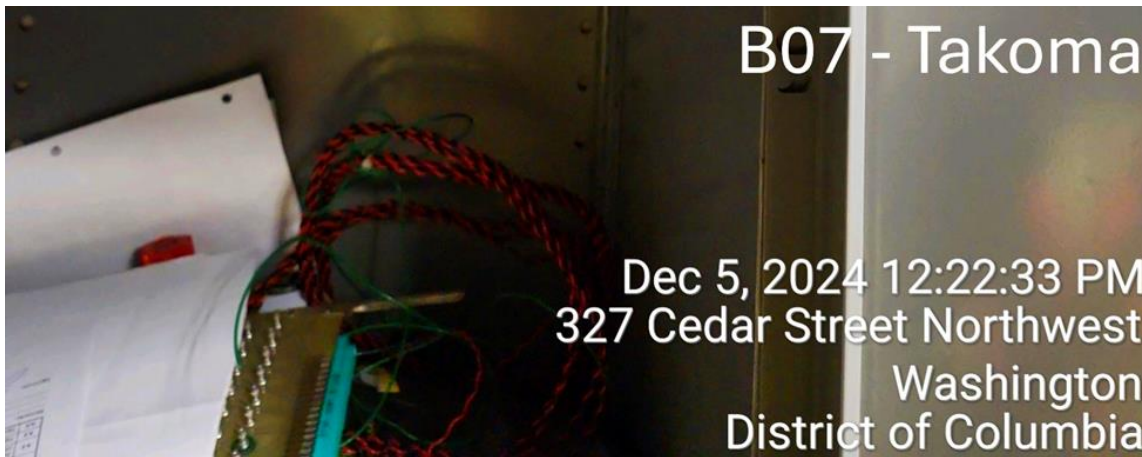
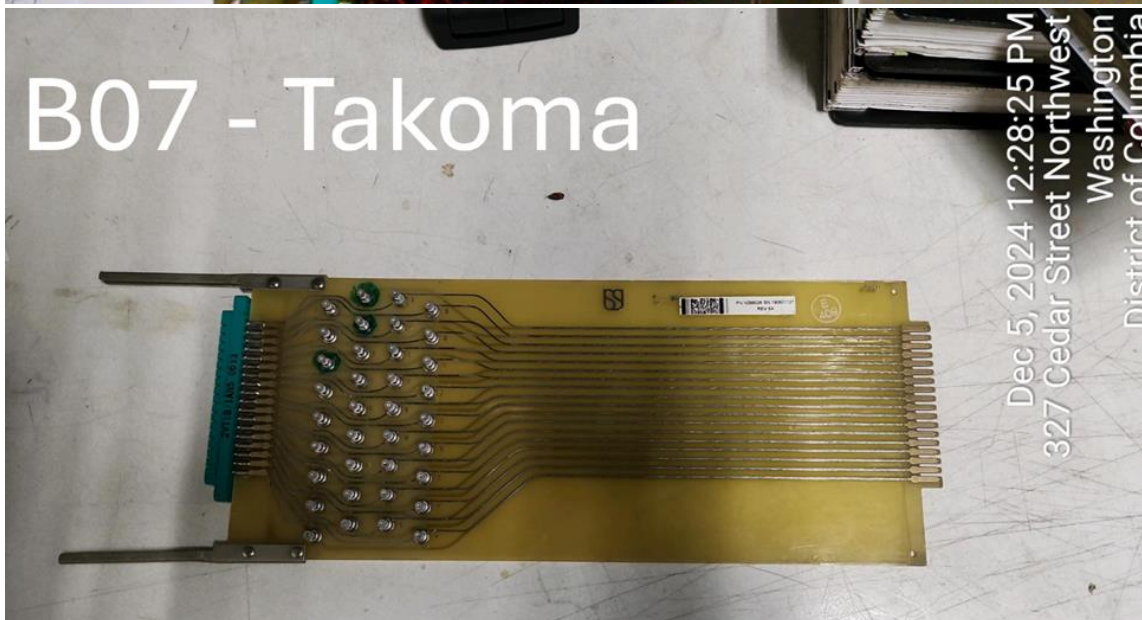
**Defect 7**

An extender board was found at the B07 Takoma Train Control Room sitting atop a box of improperly stored cans and other various discarded equipment inside a cabinet. This extended printed circuit board (PCB) is a piece of equipment that is used to pass current during sensitive testing procedures. The board found during this inspection was removed by ATCM Assistant Director Kelvin Murphy.

1) The observed type of storage of such a piece of equipment is against the ATC-2000 System Integrity Maintenance Practices, which states:

Electronic modules or sensitive components must be completely enclosed in suitable conductive anti-static jackets during storage or transportation.

2) The board observed at this location was modified and marked with what appears to be green permanent marker highlighting specific pins. Such modifications without an approval are prohibited in the ATC-2000 System Integrity Maintenance Practices, which states:

2005.8 Changes and Modifications Modification must not be made to any apparatus or circuits without the proper authority. Changes and modifications must be approved by the Senior Director ATC Engineering or designated Employee through release of an Engineering Modification Instruction (EMI), Engineering Bulletin (EAB/EIB) or a Temporary Configuration Plan (TCP).

**Hazard Rating: 3B**
