Evacuation for Life Safety Reasons

Farragut West, Dupont Circle and Stadium-Armory stations

October 14, 2023 – December 18, 2023 – February 19, 2024

FINAL REPORT OF INVESTIGATION A&I E23717

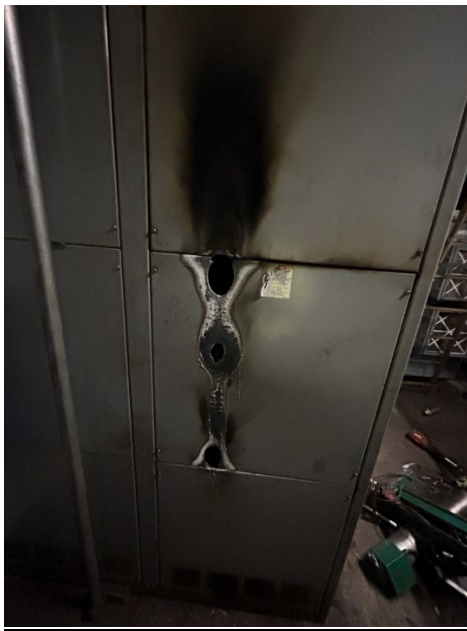
On Monday, February 19, 2024, at 06:50 hours, an explosion occurred at Stadium-Armory Station within the UPS gear located in the AC Switch Gear Room 104, which resulted in a loss of power at the station. When the explosion occurred Electrical Personnel #1 fell from a ladder, which resulted in a fractured ankle. All personnel exited the AC Switchgear Room after the incident.

Image 1 – UPS Gear after the explosion.

WMATA Power Department personnel replaced the UPS gear with the new UPS as originally planned. Repairs to the gearswitch panels involved extraction of damaged copper, the fitting of new insulators and the overhaul of the cables and bus bars.

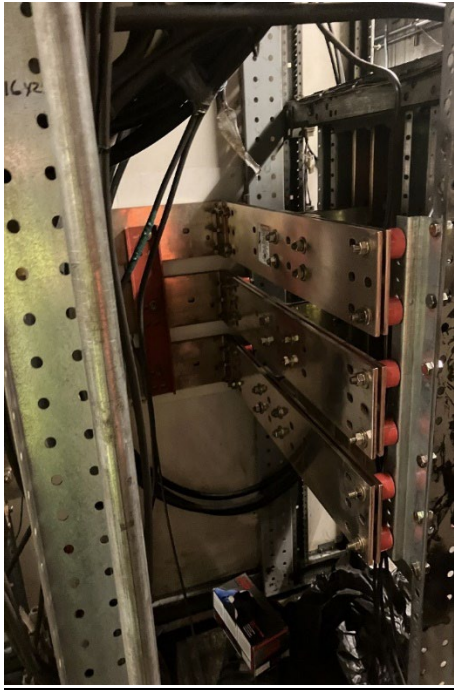
At 07:27 hours, Power Department personnel arrived at that station and conducted an inspection, then reported that the panel, switch board and breaker were melted. The switchgear has two breakers which supply the normal and reserve feed to the UPS. The UPS does not feed into the switchgear.

Image 2 – Inside view of the UPS Gear after the explosion.

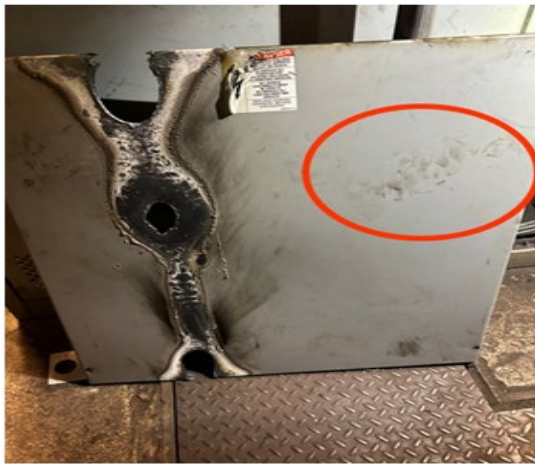
The cause of the explosion was due to inadvertent pressure applied to the side of the switchgear by personnel as evidenced by a footprint left on the panel of the switchgear, which caused the unit to contact energized components within the bus bar, leading to a direct arc. The switchgear was not deenergized because it was not in the scope of the contractor's work.

Image 3 – Footprint on the UPS Gear Panel Cover discovered after being removed.

The probable cause of the Evacuation for Life Safety Reasons event at Stadium-Armory Station on February 19, 2024, was inadvertent pressure applied to the side of the switchgear located near the bus bars. This action caused the unit to contact energized components within leading to a direct arc.

The existing design of the panel cover provided minimal protection of the equipment but were designed not to have pressure applied. The bus panels were replaced and further recessed into the housing.

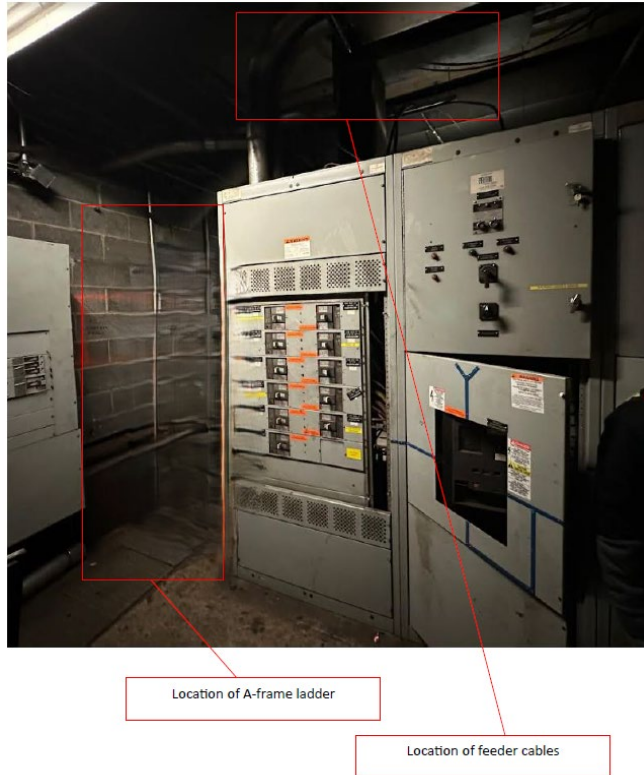
Image 4 - AC Room 1 Switch Room 1 -Side C

Three burn marks were identified on the outside section of the panel guarding the buses. At some point in removing the feeder cables the inside phasing bus encountered the outside metal skin creating a direct ground fault/phase to phase short causing an explosion. The internal distance from the live bus to the switchgear side panel was observed after the incident to be very close and was believed to have contributed to the incident.

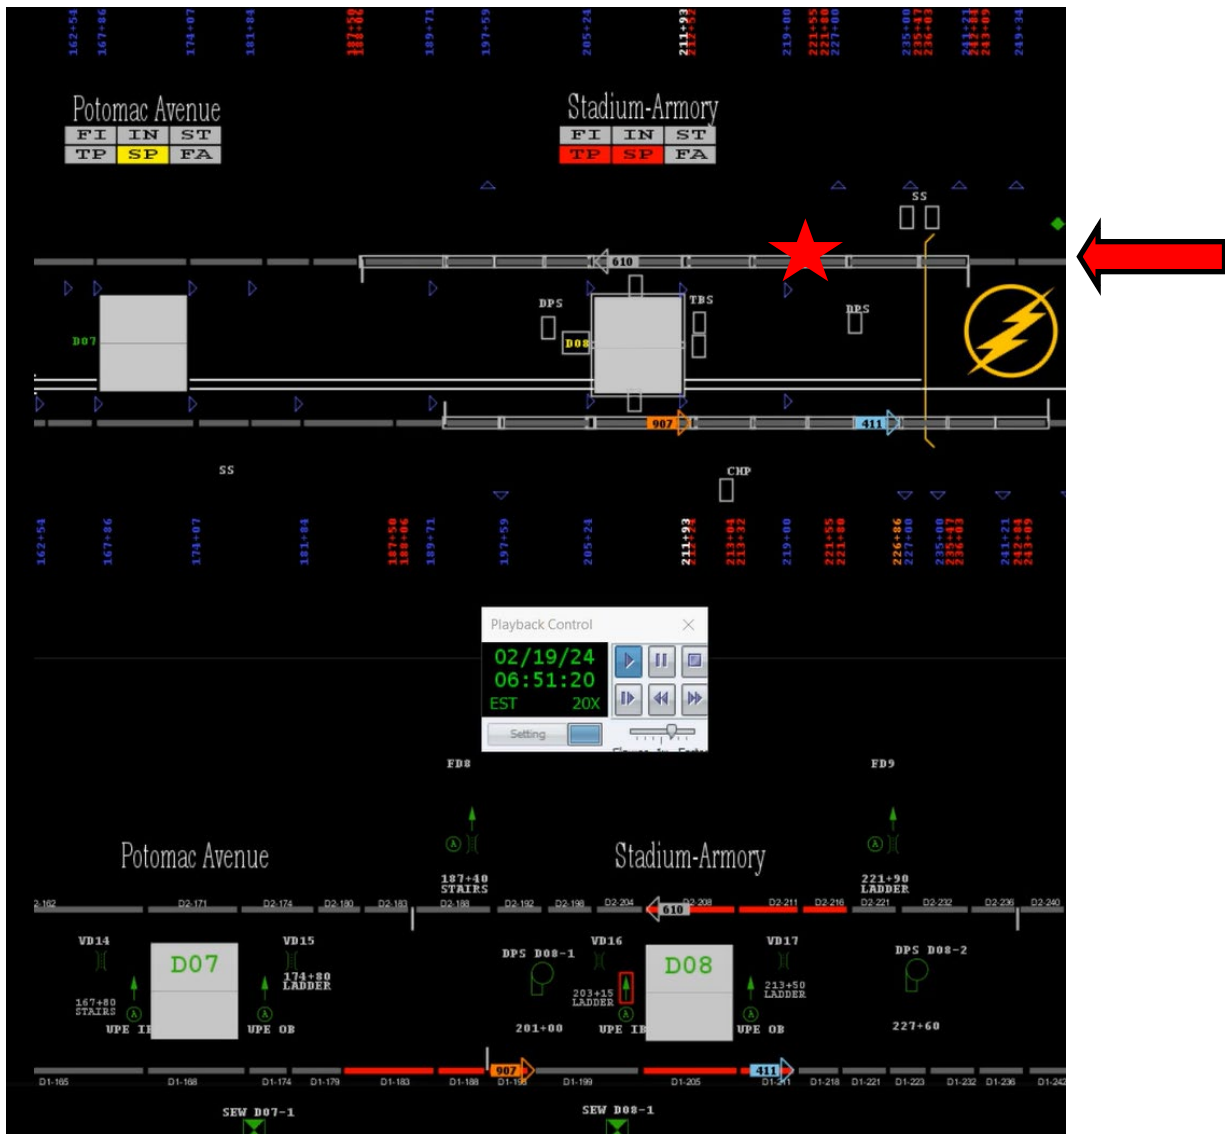
Figure 1 – Star on the AIMS Playback indicates a loss of station and 3rd rail power.
