**Red Signal Overruns**  
**At or Near Brentwood Rail Yard and Anacostia Station**  
**April 11, 2024 – April 19, 2024**

Washington Metropolitan Area Transit Authority  
Department of Safety  
Office of Safety Investigations  
**FINAL REPORT OF INVESTIGATION A&I E24287**

**B99-06 Signal, CM B1 114 + 60 – Red Signal Overrun**

<b>Date of Event:</b>	April 19, 2024
<b>Type of Event:</b>	O-8: Red Signal Overrun
<b>Incident Time:</b>	22:05 hours
<b>Location:</b>	Anacostia Station, track 2 - Signal F06-08
<b>Time and How received by SAFE:</b>	22:11 hours, Mission Assurance Coordinator (MAC)
<b>WMSC Notification Time:</b>	22:49 hours
<b>Responding Safety Officers:</b>	WMATA: Office of Safety Investigations (OSI) WMSC: Other:
<b>Rail Vehicle:</b>	Train ID 528 (L7678-7679x7511-7510x7386-7387x7519-7518T)
<b>Injuries:</b>	None
<b>Damage:</b>	None
<b>Emergency Responders:</b>	None
<b>SMS I/A Number</b>	20240420#116295MX

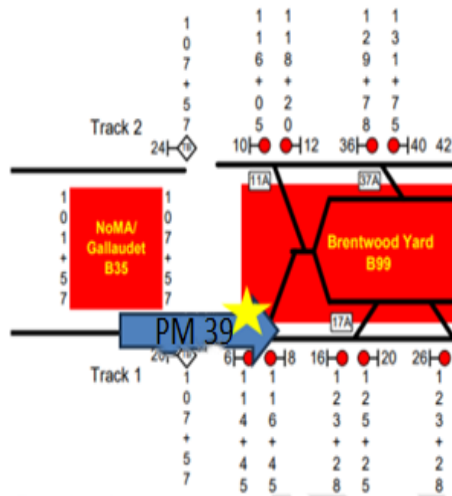
### **Field Sketch/Schematics**

B99-06 signal, Chain Marker 114+60

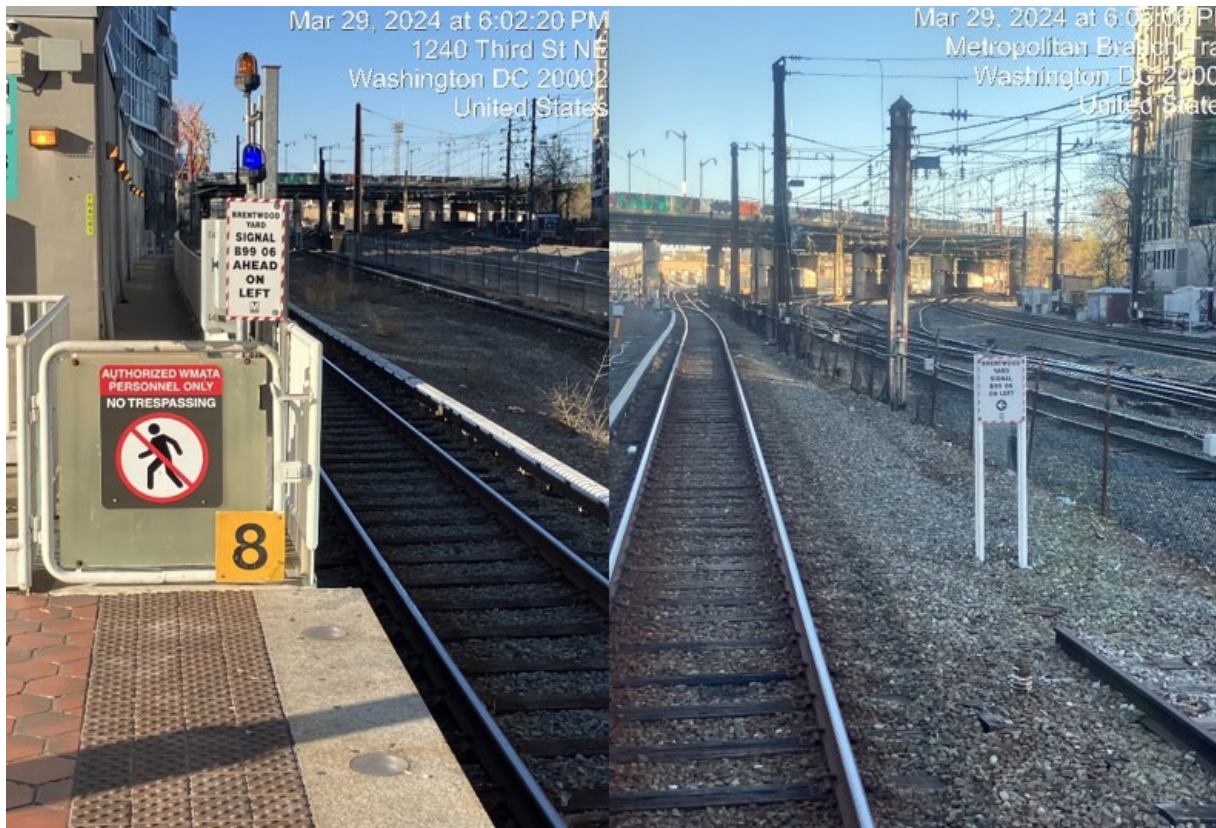
The probable cause of the Red Signal Overrun event on April 11, 2024, at Brentwood Yard was the Equipment Operator's lack of situational awareness and unfamiliarity with the Redline. The Equipment Operator failed to notice the signage located at the 8-car marker on the platform of

This sign was meant to alert the operator that B99-06 was ahead on the left side of the track. Additionally, a second warning sign was located at Chain Marker B1 114+00, which was 60 feet before the signal and interlocking. This sign was also intended to alert operators that the B99-06 signal is located on the left side of the track.

Image 1 (left) signal alert signage on the platform of NoMa-Gallaudet Station, (right) signal alert signage at CM B1 114+00.

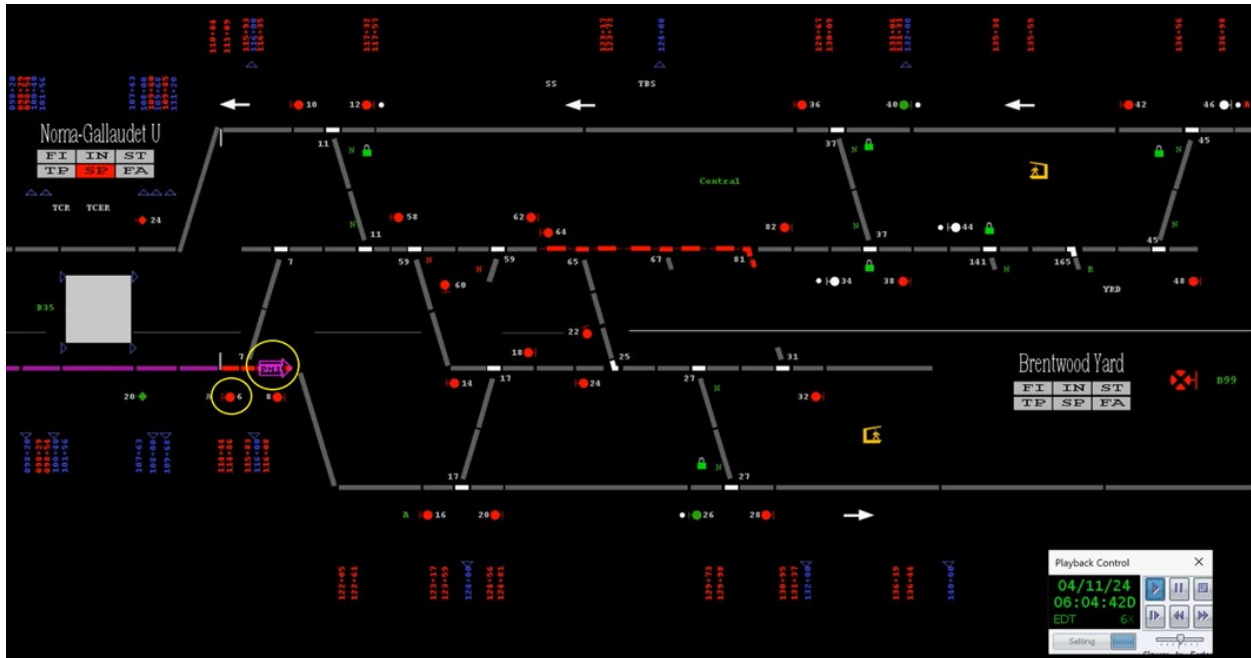
The Interlocking Operator stated, no PM 39 was holding at signal B99-06. The Button RTC explained they observed via the AIMS, that PM 39 was holding at signal B99-16 which indicated overran signal B99-06, which displayed a red aspect.

Figure 1 - Depicts PM 39 passing B99-06 signal red at 06:04 hours and continuing to a stop at B99-16.

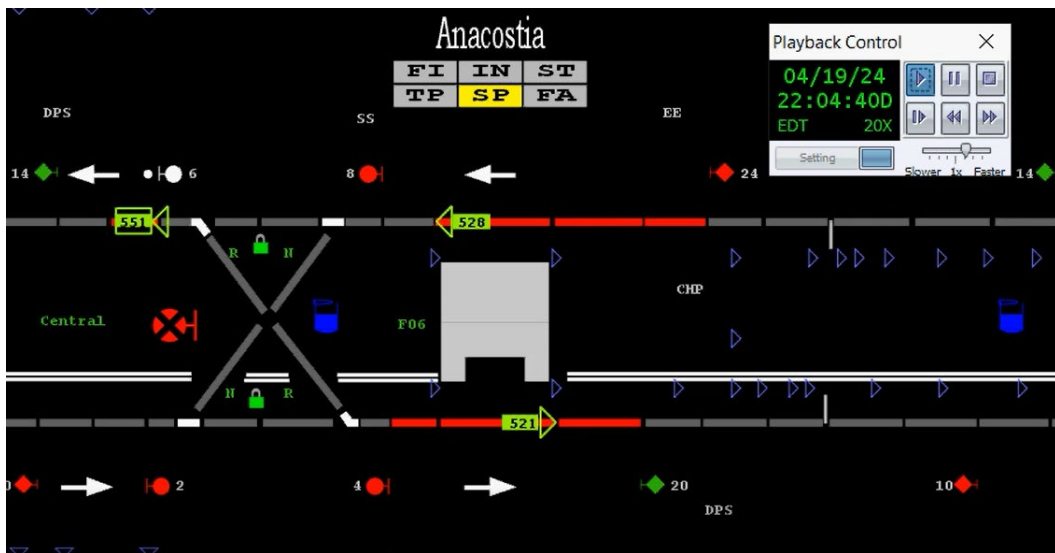
Image 1 – AIMS depicts the event Train ID 551 crossing over from track 2 to track 1 at signal F06-06 at 22:04 hours.

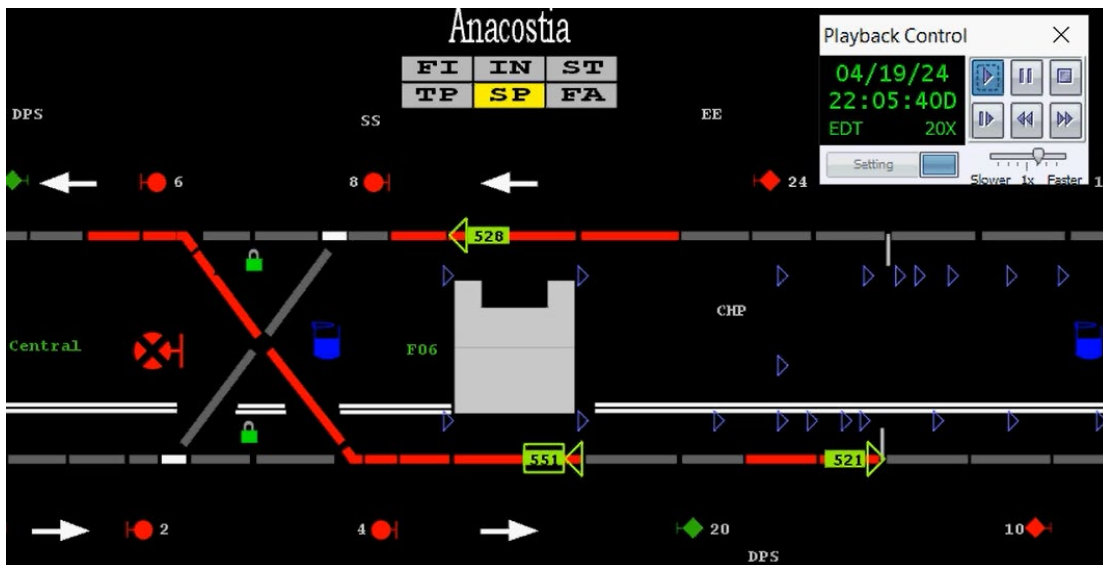
Image 2 – Depicts Train ID 551 on the platform at Anacostia Track 1 at 22:05 hours.

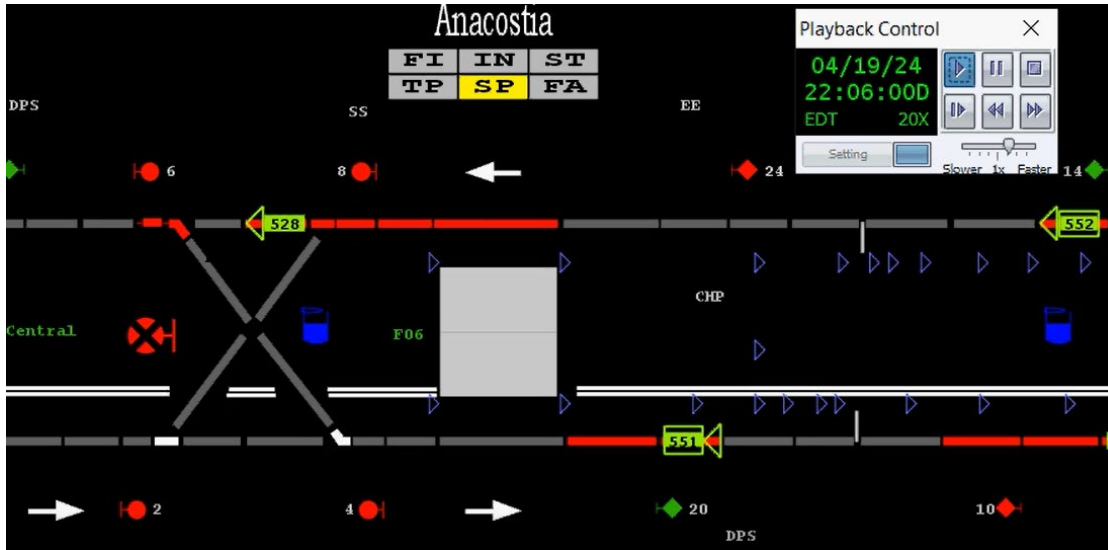
Image 3 – Depicts Train ID 528 passing signal F06-08 red at 22:06 hours.

The train passes signal F06-08 red at a speed of 12.9 MPH with the Master Controller in “B5” position, coming to a complete stop 48 feet beyond the signal F06-08. The emergency brake was not initiated. There were no faults with the train that contributed to the cause of this incident, the train performed as designed.

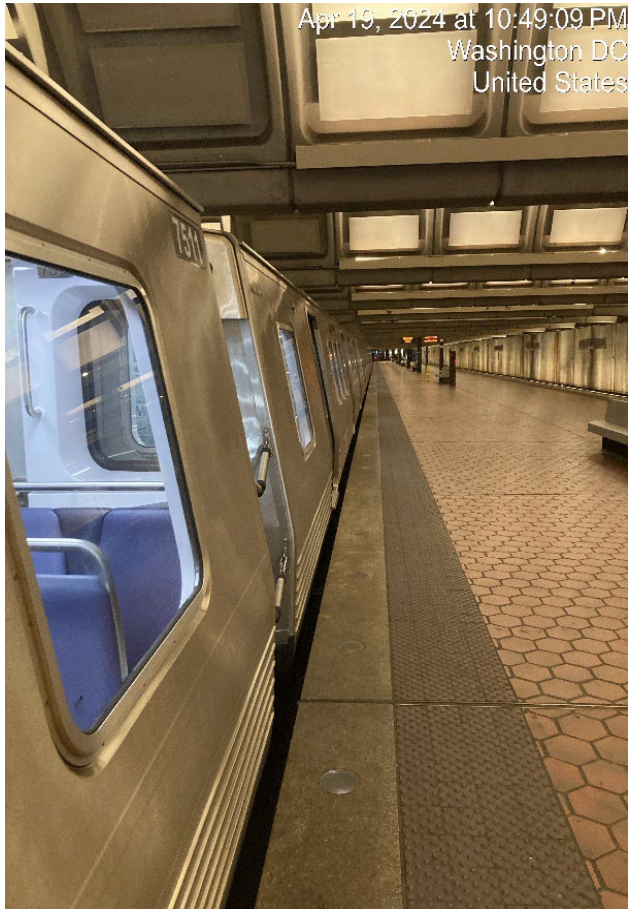
Figure 1 – Incident train partially on platform

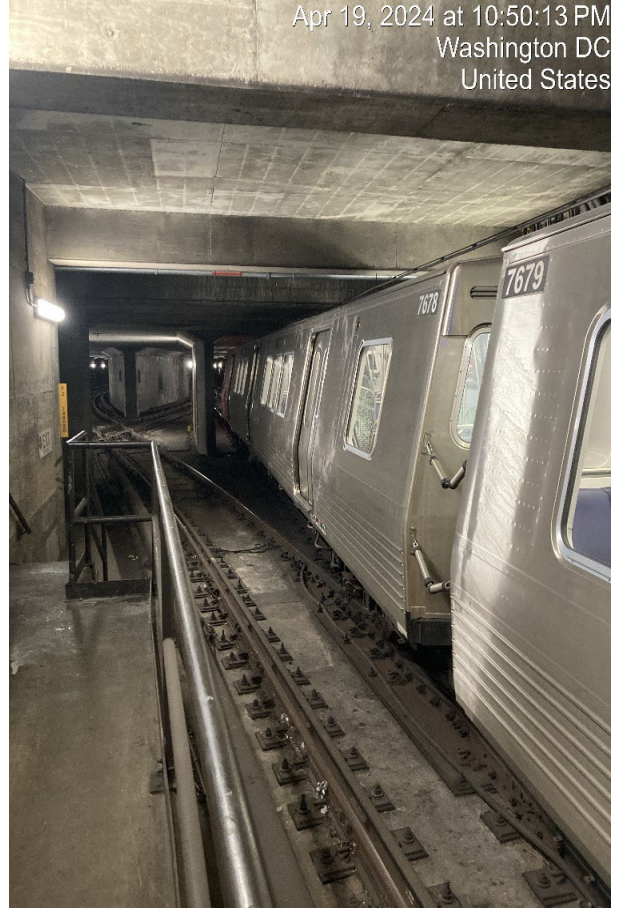
Figure 2 – Incident train 2 cars in the tunnel

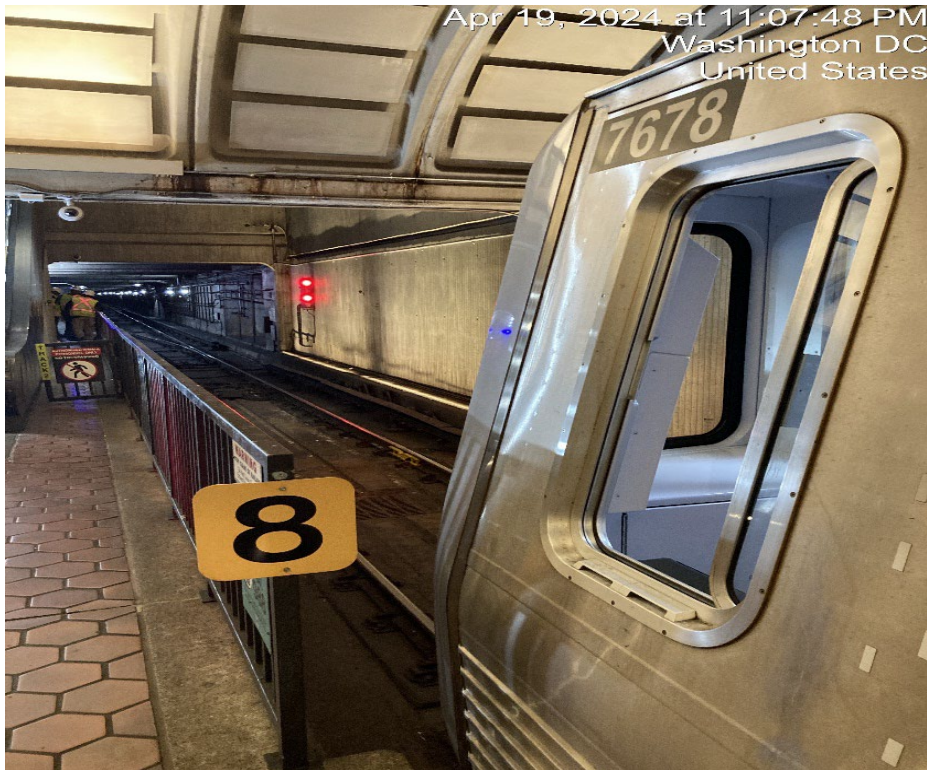
Figure 3 – View of Train ID 528 after the train was repositioned.

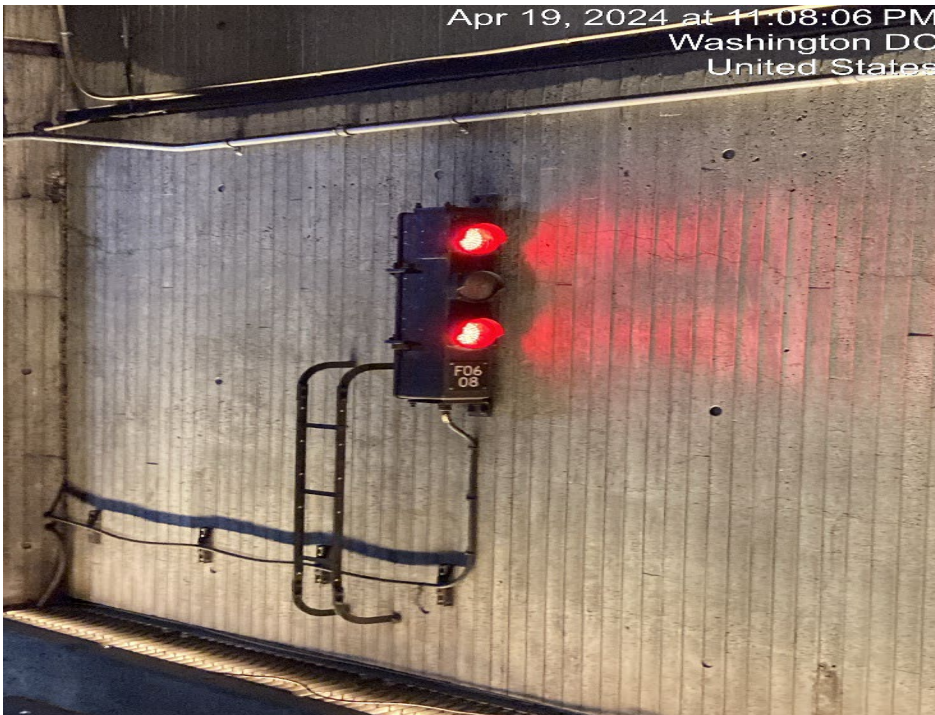
- The RTC advised the Train Operator that signal F06-08 was red.
- The Train Operator reported entering the stop and proceed method prior to stopping at the 8-car marker.
- The Train Operator failed to verify a lunar signal at F06-08 after servicing Anacostia Station.

Figure 4 – F06-08 signal red

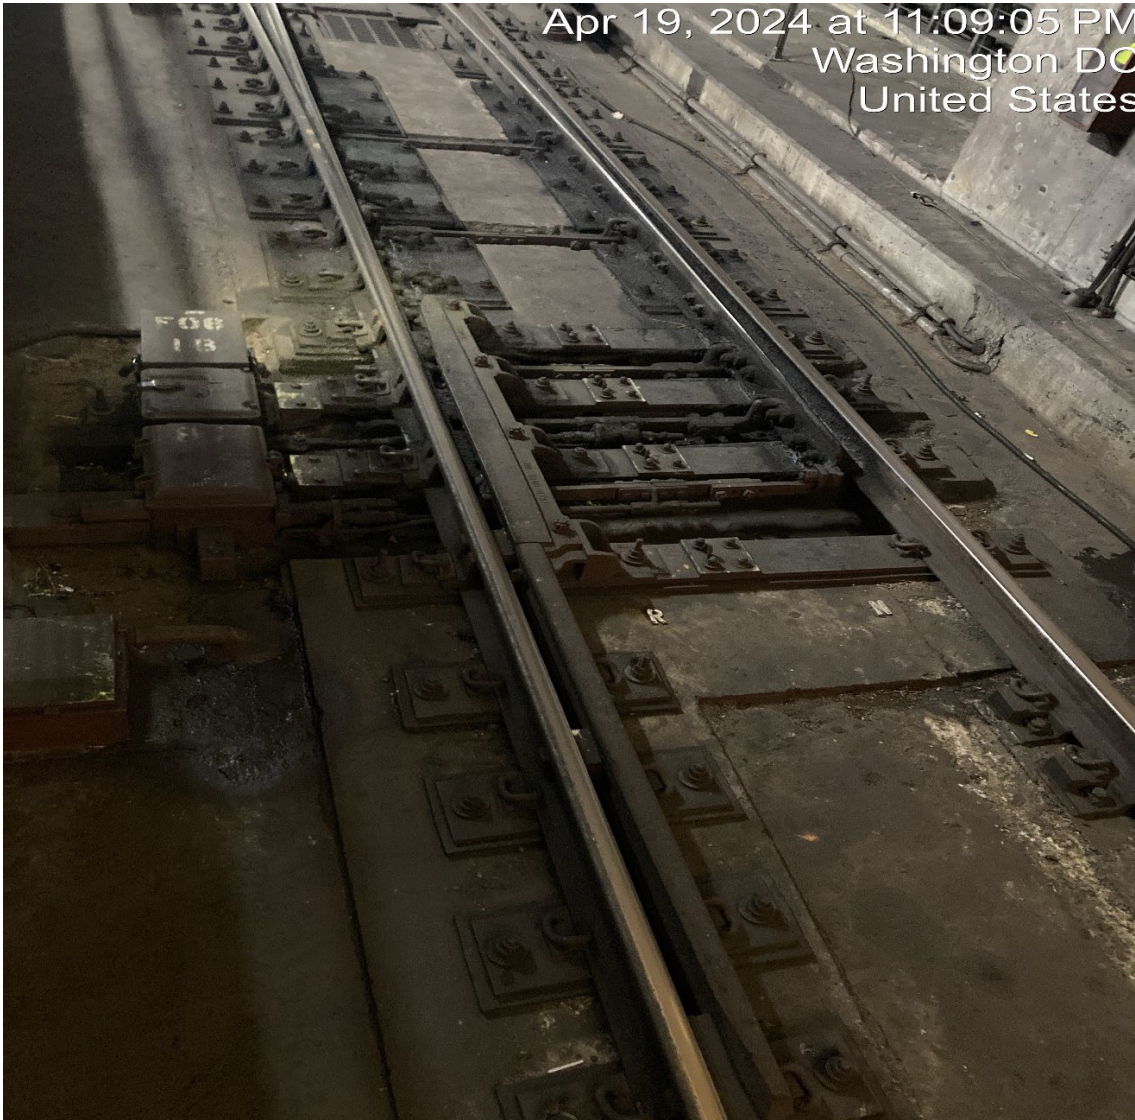
At 22:50 hours, ATCM personnel arrived at Anacostia Station. At 23:05 hours, the ATCM personnel inspected and verified that Train ID 528 did pass switch 1B and did not pass switch 3B, and there was no damage to switch 1B. Train ID 528 was returned to the platform at Anacostia Station.

*Figure 5- Switch 1B in normal position. (no damage)*

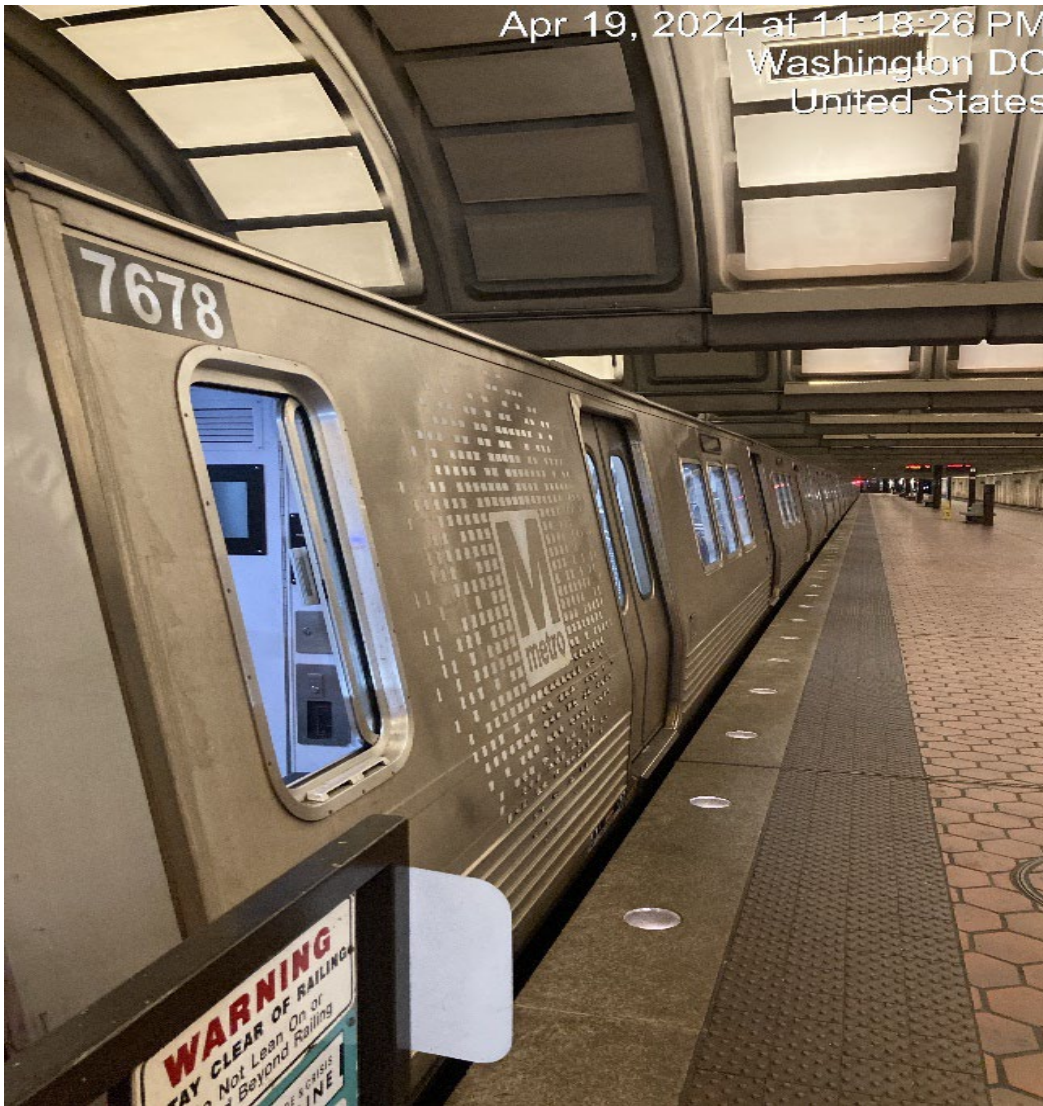
Figure 6 – Train ID 528 secured on track 2, Anacostia.
