W-0353 – Derailment – near Stadium-Armory Station – December 16, 2023

FINAL REPORT OF INVESTIGATION A&I E23892

Stadium-Armory Station - Derailment

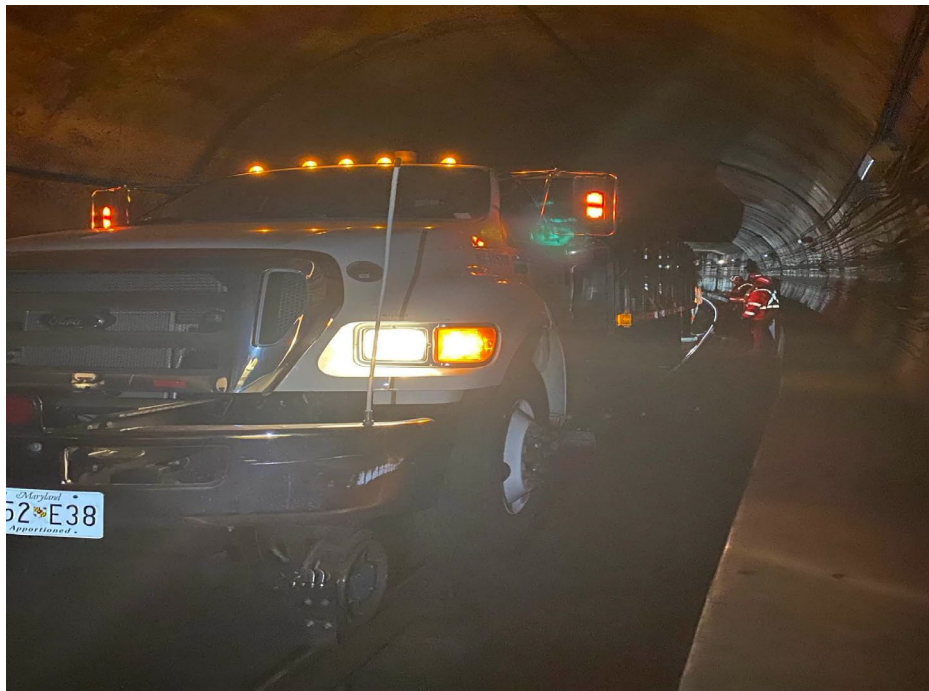
Image 1 – Hi-Rail Vehicle 9042 post-derailment position CM D1 215+00. (Front view)

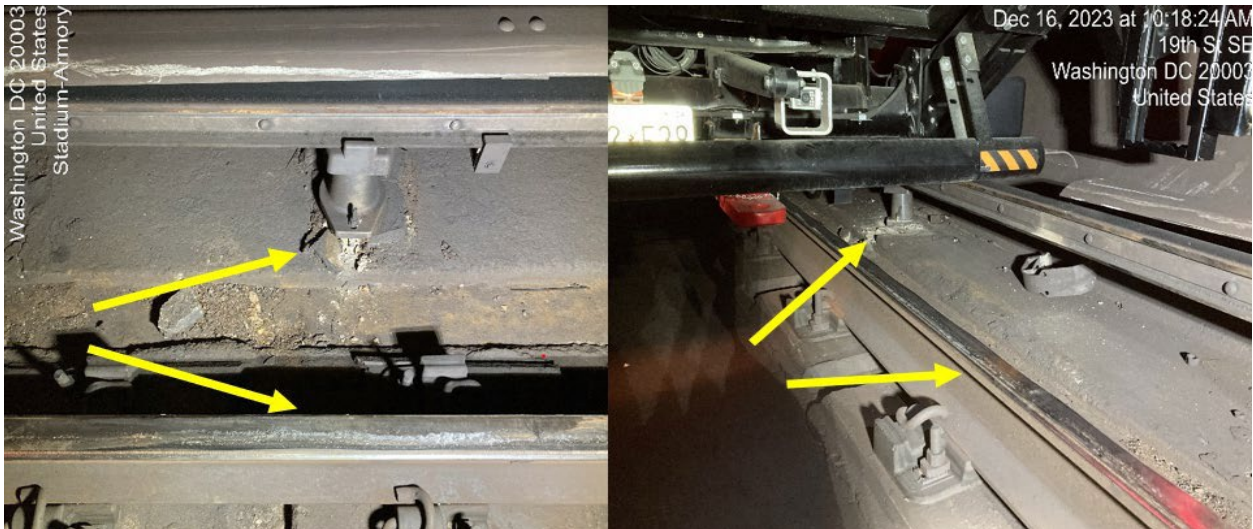
TRST personnel performed loaded gauge measurements³ in front and at the rear of the derailed unit. Both were reported within tolerance (D1 215+00 – 216+00). The inspection of the area identified scratches on the running rails, damage to an insulator, and a third rail cover was knocked over.

Image 3 & 4 – Images depict damage to running rails and insulators.

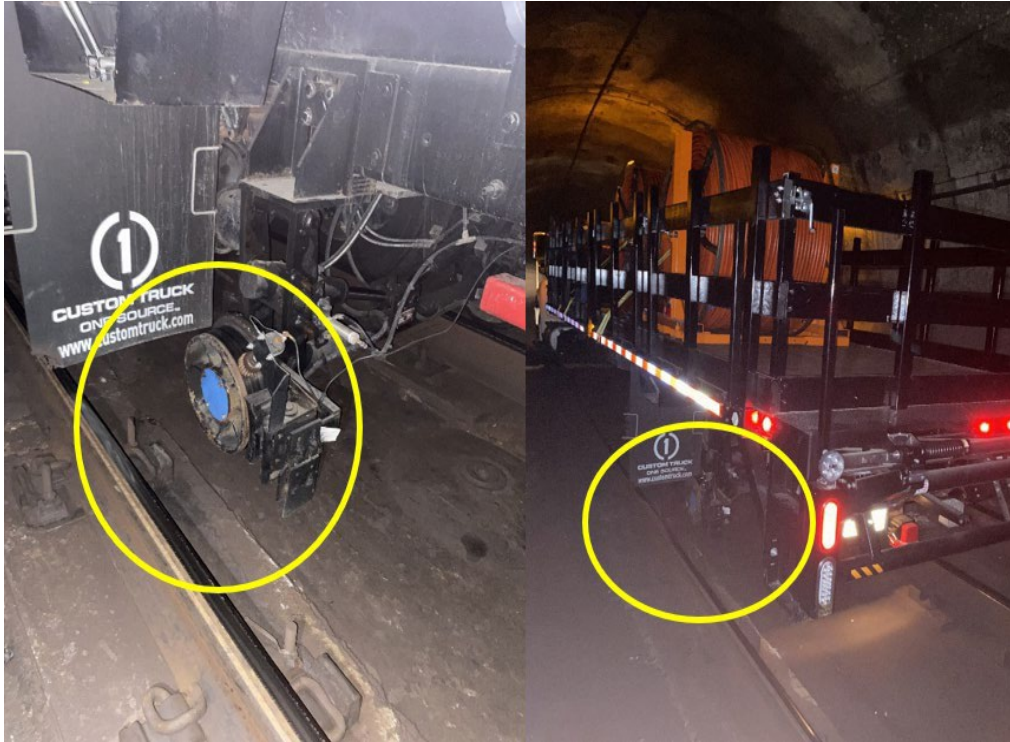
The cause of the derailment was determined to be the mechanical locks⁴ for the rear hi-rail gear set to an unlocked position. The hi-rail gear was unsecured at the time of the derailment. Without the rear hi-rail gear set to a locked position, the hydraulic cylinders' holding valves could not provide enough resistance, leading to the rear hi-rail gear drifting over time. This allowed the rail wheels to unload, resulting in a flange climb.

Images 5 and 6 - Depicts the derailed left rear wheel of Hi- Rail Vehicle 9042. (Rear view)

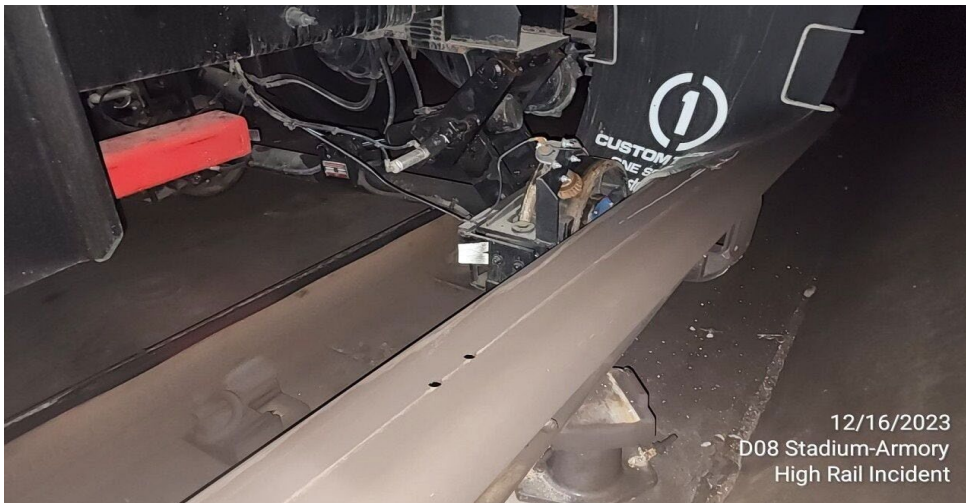
Image 7 - Right axle of Hi-Rail Vehicle 9042. (Rear view)

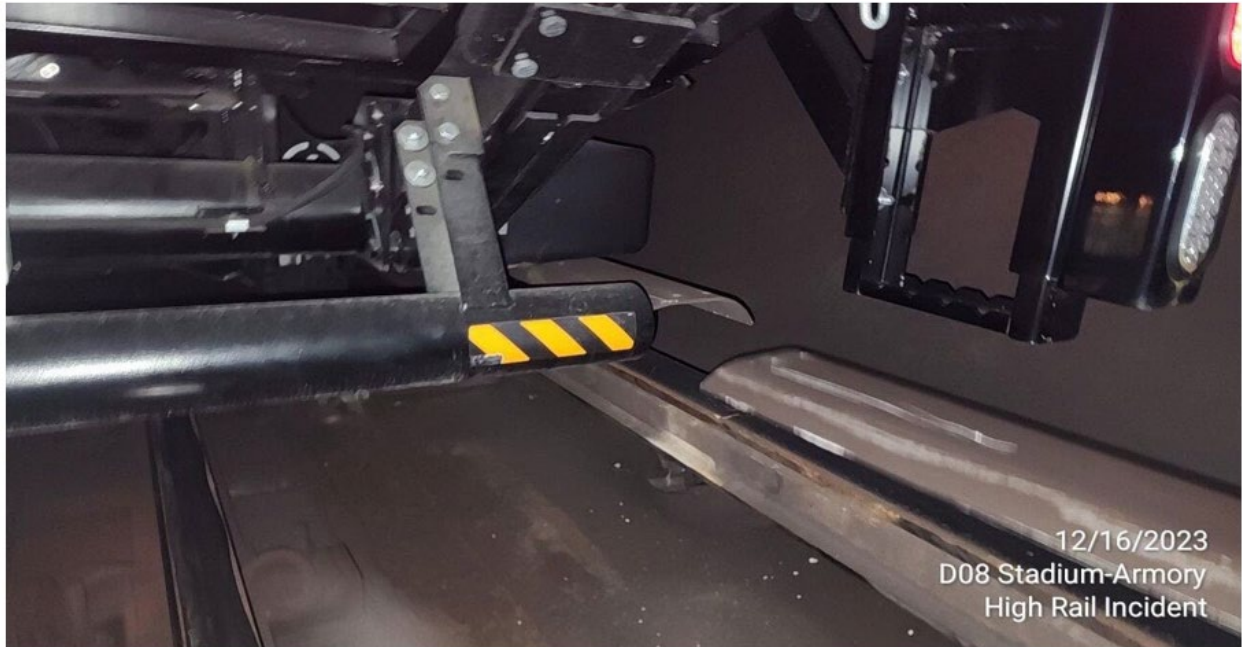
Image 8 - Right axle of Hi-Rail Vehicle 9042. (Rear Center View)

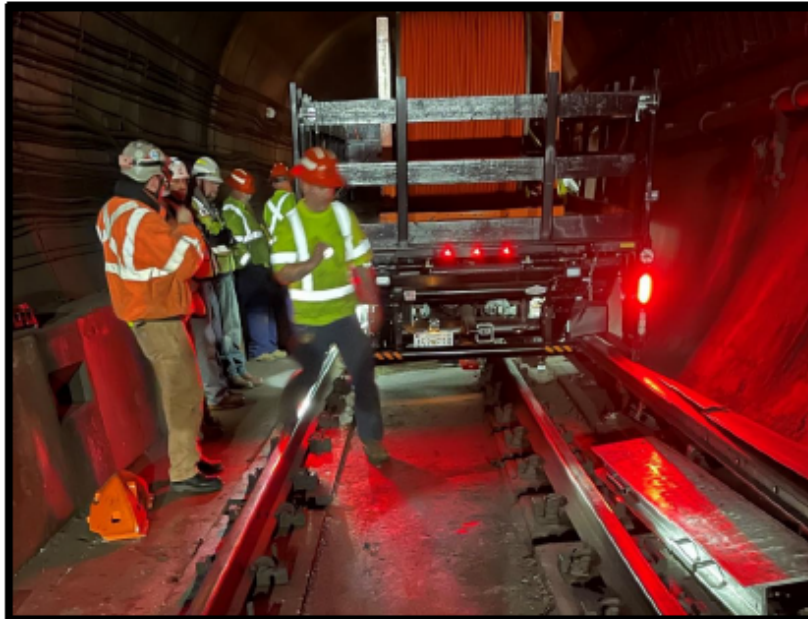
On the morning of December 16, 2023, at approximately 0815 hours, contractor hi-rail unit CR9042 derailed within the work zone on D-line Track 1 at chain marker 215+00 (Figure 1). ROCC was notified and CTEM mechanics were dispatched. At 1730 hours, the unit was rerailed and moved to the East end of the work limits. No injuries were reported. Revenue service was not disrupted.

Figure 1. CR9042 derailment

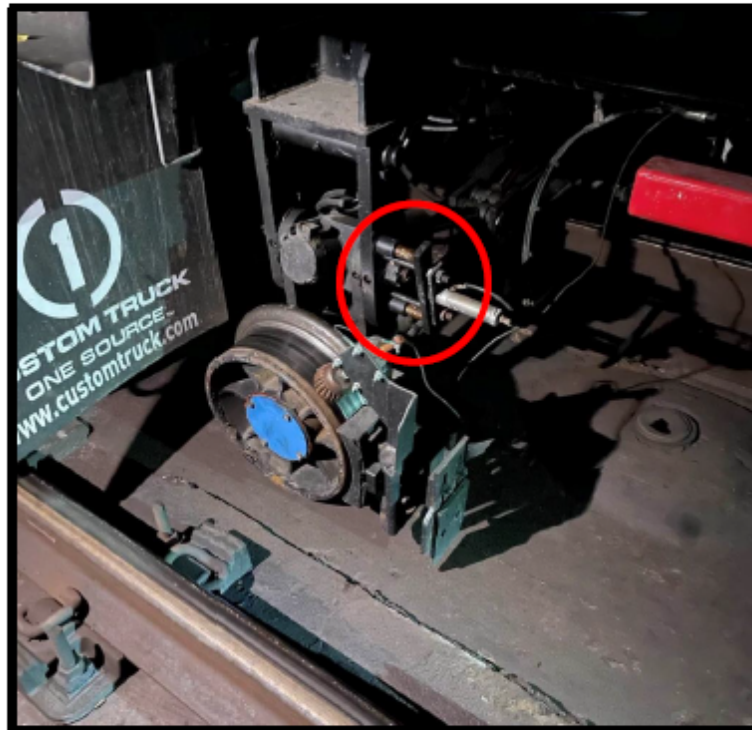
Reviewing photographs from the incident scene show the mechanical locks for the rear hi-rail gear in an unlocked position (Figure 2 and Figure 3). If the hi-rail gear was unsecured at the time of derailment, this would be a contributing factor to the derailment. The hydraulic cylinders have holding valves to provide some resistance to drift, but over time, will allow the rail wheels to unload, resulting in flange climb.

Figure 2. Left locks not engaged

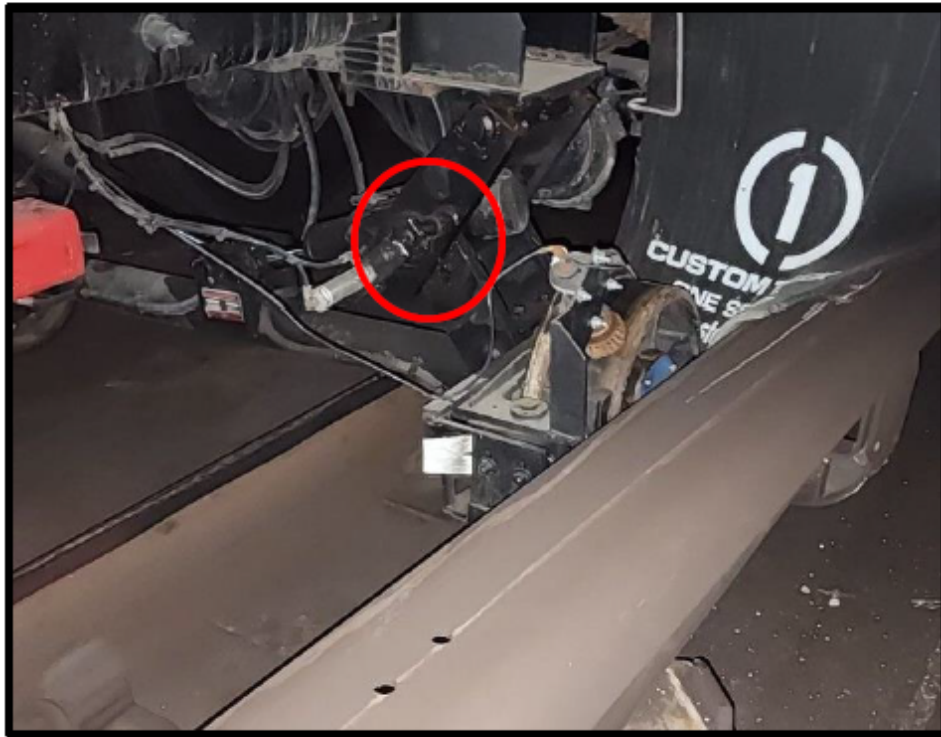
Figure 3. Right locks not engaged

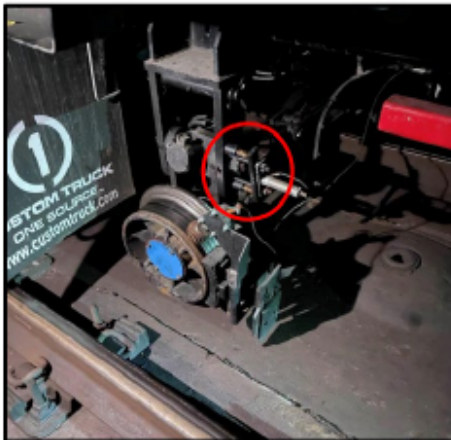
1. HR CR9042 rear hi-rail gear appear to be in an unlock position. (Figure 1 & 2)
2. Track stud bolts possibly extending above track level. (Figure 3)
3. Existing joint on the running rail. (Figure 4)
4. Incomplete pre-trip inspection prior to embarking on the roadway. (No clearance to passenger side of vehicle due to where unit was staged at in the yard).

Figure 1. Left rear locking mechanism not engaged

1. Prior to operating a Hi-Rail a complete pre-trip inspection must be performed
2. Prior to embarking a Hi-Rail onto the roadway ensure all switches and locking mechanisms are locked and in place.
3. While operating Hi-Rail be vigilant in recognizing any roadway hazards.
4. Adhere to all regulated speed.

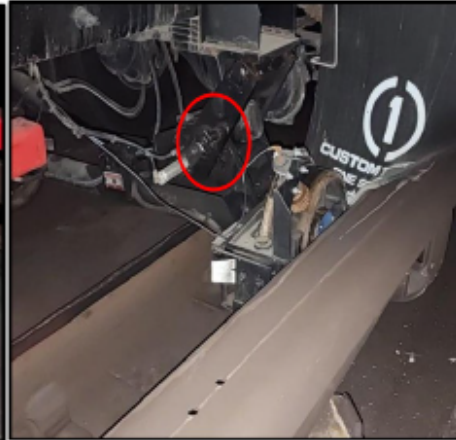
Figure 2. Right rear Locking mechanism not engaged

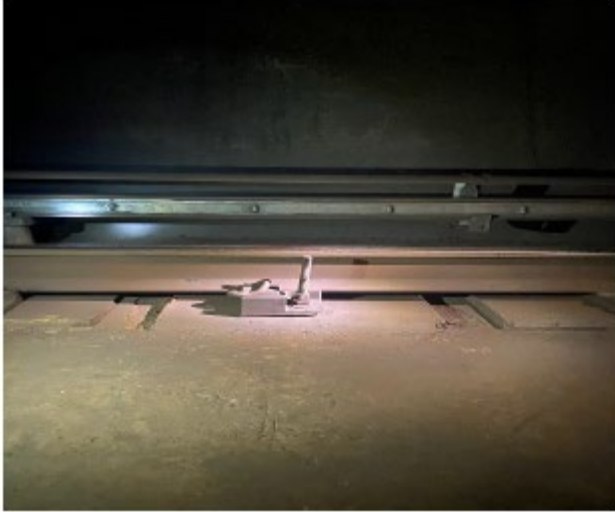
Figure 3. Track Stud Bolt

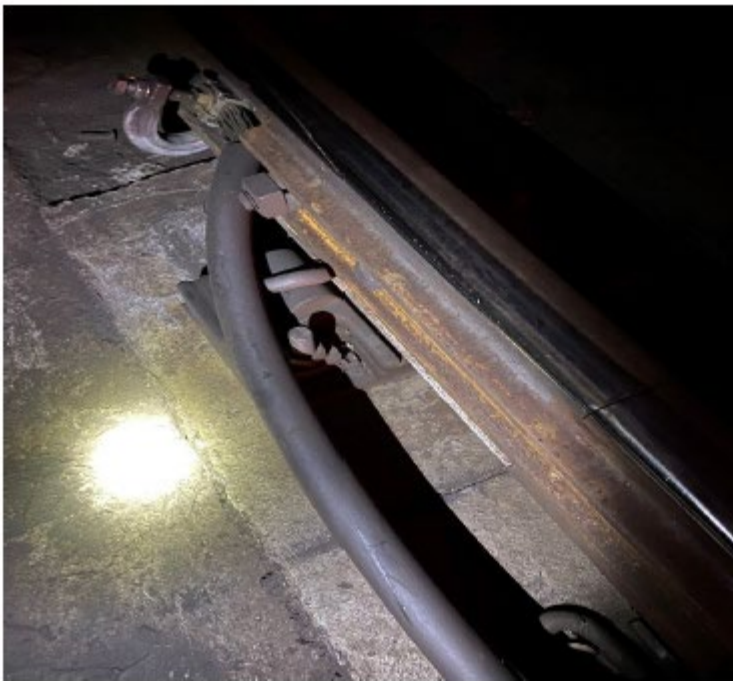
Figure 4. Cut Rail
