WMSC Inspection Report 20250113B

Title: ATO Operation, Train Operations, and Station Berthing

Location: Union Station (B03)

Date: 01/13/2025

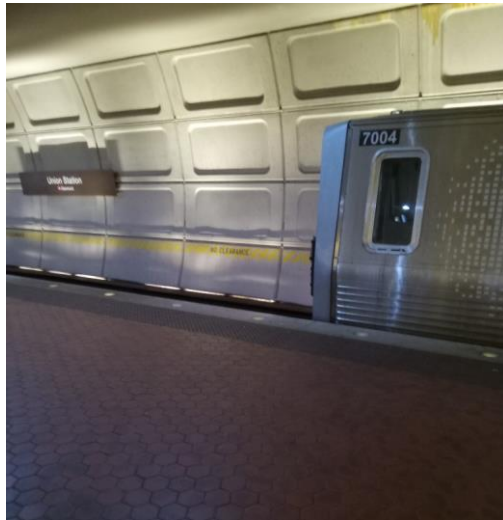
Photo

Procedure or Instruction Number: SOP 40 section 3.11 states “Properly Berthed – Precise positioning and stopping of Class 1 rail vehicles with the front of the train aligned with the eight (8)-car marker position.” The inspector observed a train service Union Station on track one that stopped short of the 8-car marker. When this occurs, Procedure or Instruction Number: SOP 40 states that the rail vehicle operator must do the following:

From the inspector's vantage point (from the platform), the rail vehicle operator did not announce over public address (PA) system, "Your attention please, this train will move forward" (section 6.3.1.1.4) or sound the horn (section 6.3.1.1.5).

Subsequent to the field portion of this inspection, a review of the radio (Ops 1) was able to confirm that this was train ID 125 with lead car 7004 (pictured below). Train ID 125 was confirmed to be operating in ATO. The rail vehicle operator contacted the control center but did not request to change modes as required by section 6.3.1.1.2 "Contact RTC for permission to change operating mode from Mode 1 to Mode 2 Level 1". The rail vehicle operator also did not report the misalignment to the control center.

Hazard Rating: 2E
