## WMSC Inspection Report 20250115A

Title: N01, McLean Station, 3 Month, 1012 B-1 Preventive Maintenance

Location McLean Station, Train Control Room

Date of Inspection: 1/15/2025

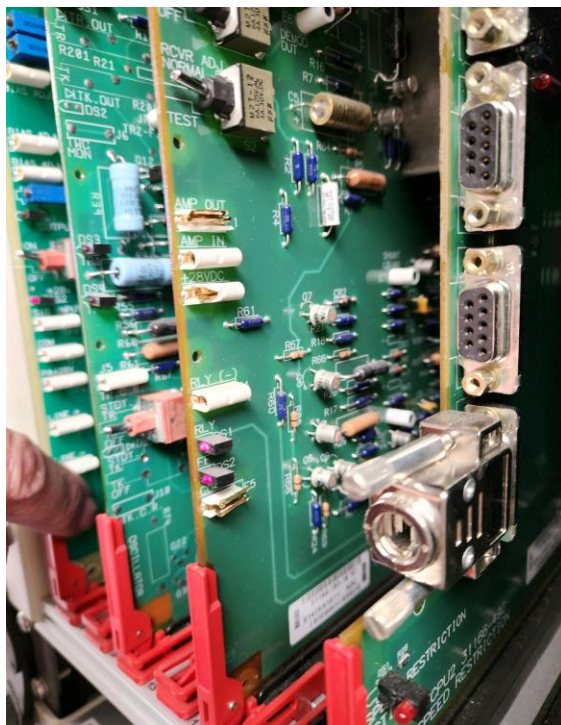
Fig. 1 Test lead termination points

Inspector noticed that the test lead termination points on one of the boards was damaged (see photo below). Although the defect did not prevent the measurements from being gathered, continued deterioration could affect the validity and ability of the data to be collected in the future. This concern was raised to the onsite supervisor for remediation (replacing the card).

#### Hazard Rating: 4D
