W-0344 – Evacuation for Life Safety Reasons at Eastern Market Station – February 15, 2024

Document Purpose

Safety event summary:

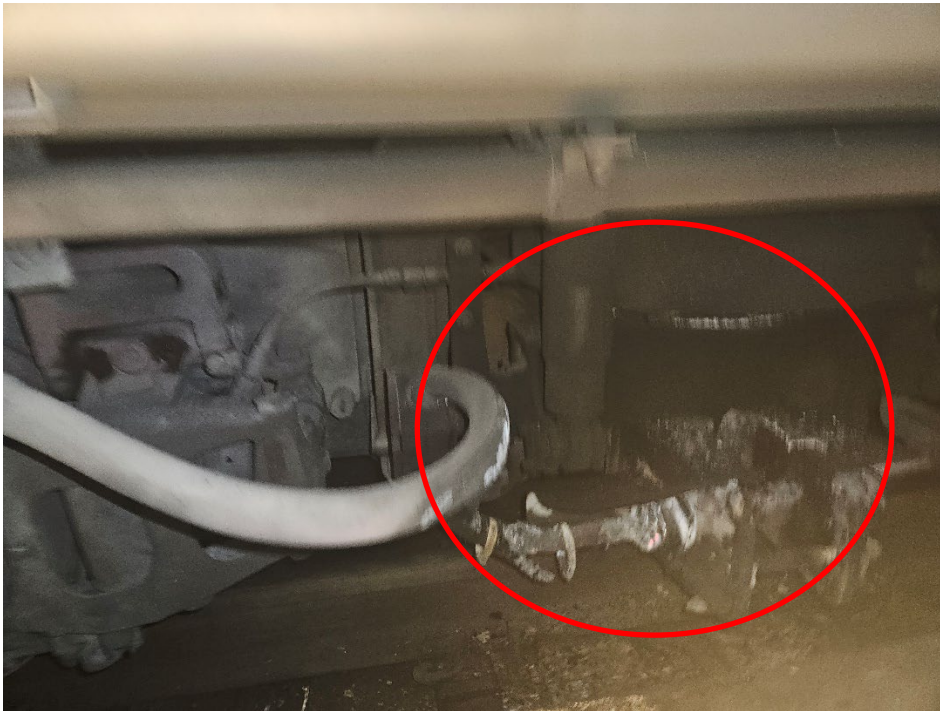
Image 11 - The photo above depicts the #2 collector shoe assembly on Car 7663 primary power cable and mounted collector shoe assembly affected by the arcing event.

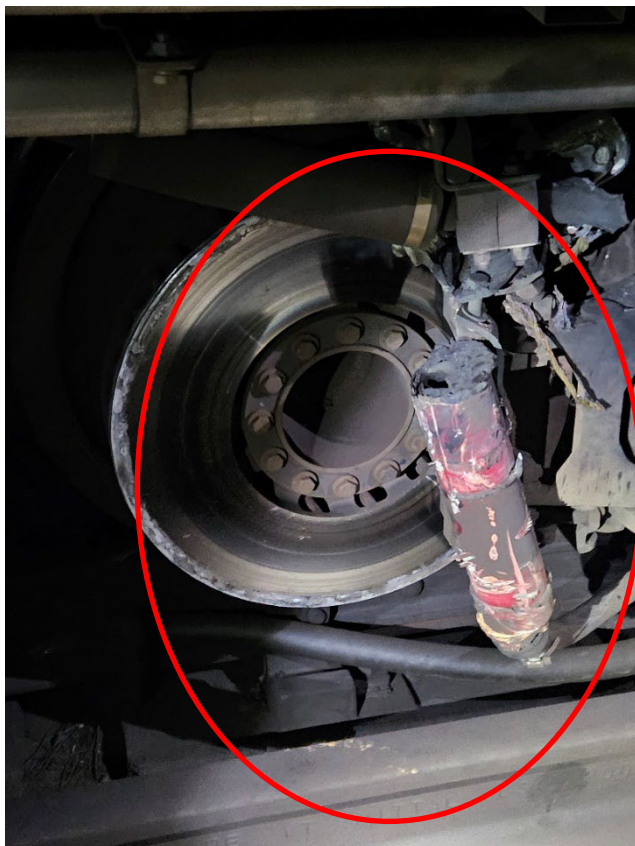
Image 12 - The above photo depicts a different angle of damage assessment of the #2 collector shoe assembly and power cable positioned on the front truck of Car 7663.

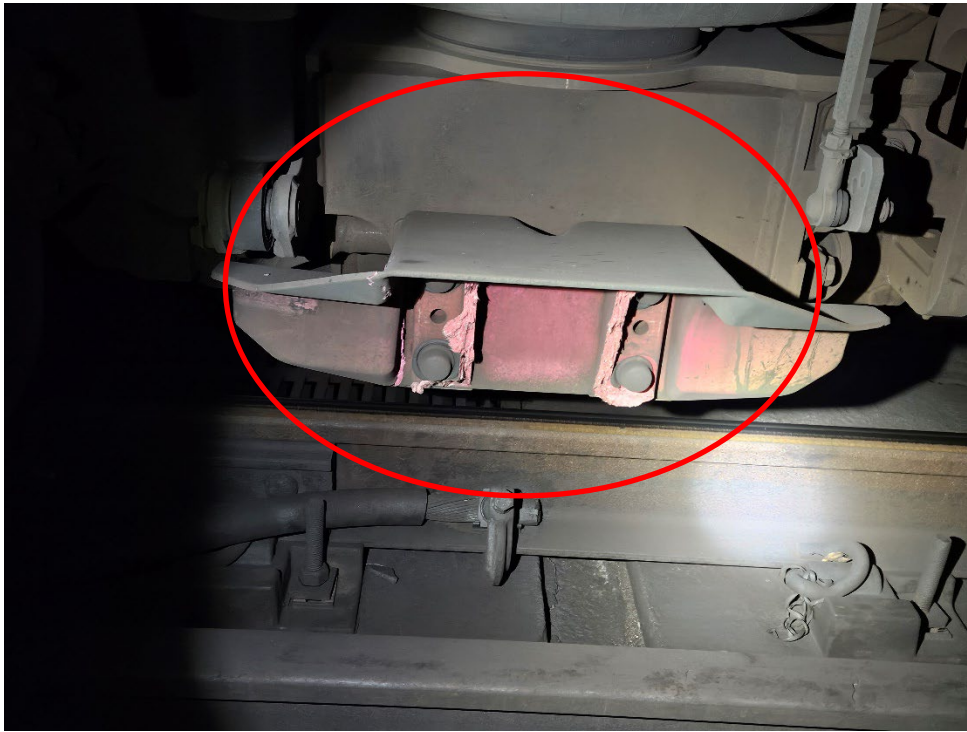
Image 13 - The above photo shows the collector shoe fuse dislodged from the missing collector shoe assembly and damage to the #6 brake disc on car 7663.

The #4 Collector Shoe Assembly was found to be missing with the shoe fuse dangling, still attached to an approx. A 3-foot section of the primary cable, which was flashed open, separated from the remainder of the primary cable. There is evidence of flashing of the primary cable to the #6 brake disc.

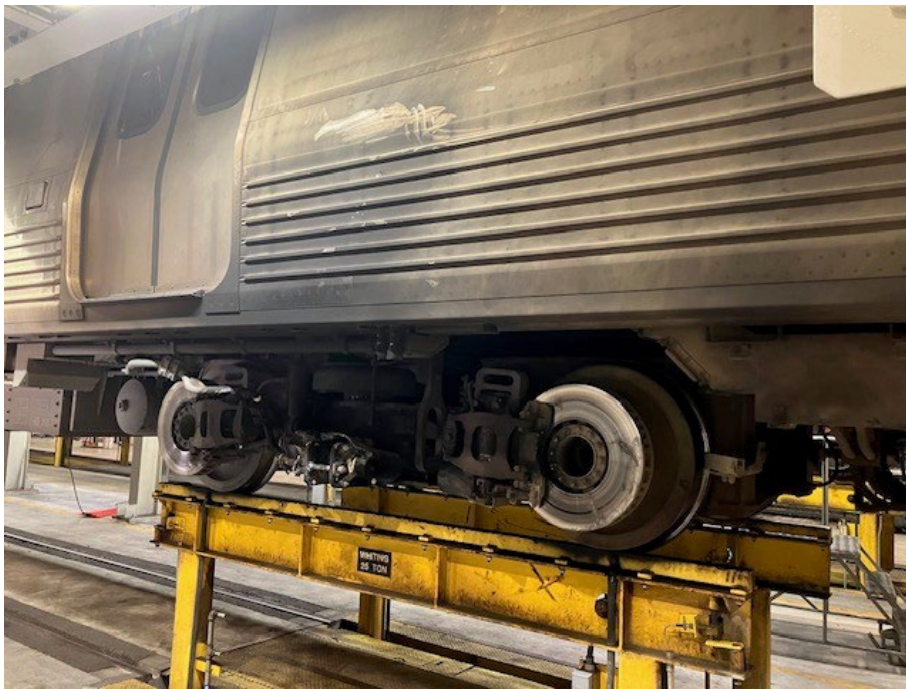
Image 14 - The above photo shows Car 7663 mounting bolts, fiberglass arc shield, and clean break, indicating Foreign Object Damage on the rear truck at the #4 collector shoe assembly position.

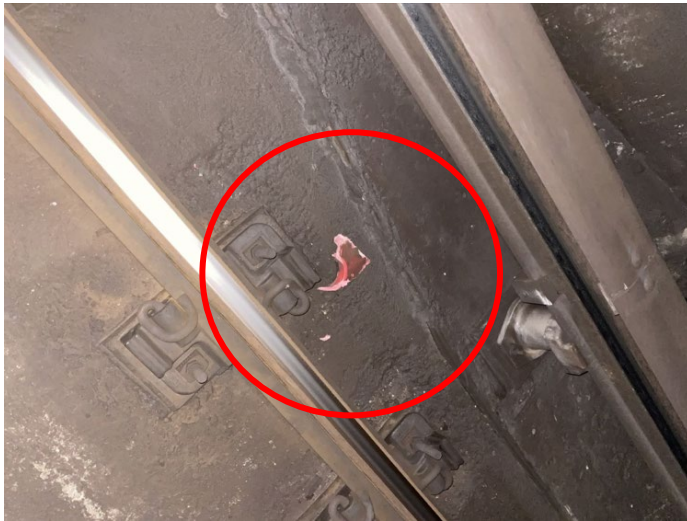
- The inspection team observed one (1) recently broken insulator at C1 75+20.
- Fractured pieces of plastic from what appeared to be off a collector shoe assembly between the 3rd rail and the right running rail between C1 76+00 to 77+00.

Image 16 – Image of the first fragments of the broken collector shoe assembly at CM C1 76+00 – 77+00.

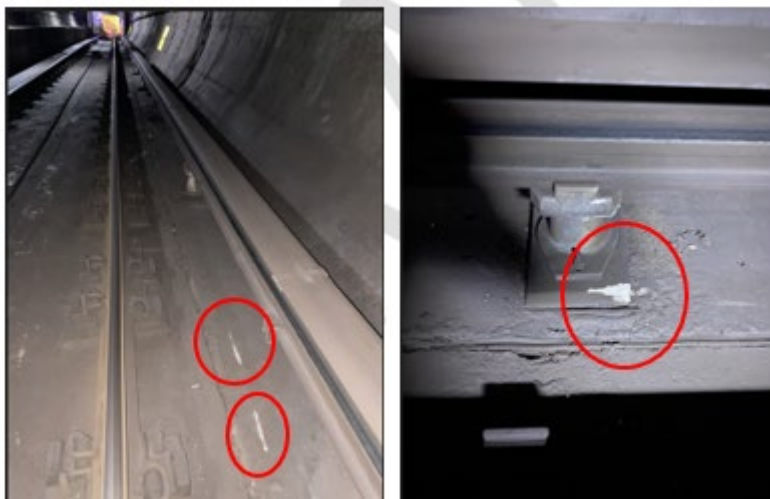
- From C1 76+00 to 79+00 the team discovered scuffs on the invert and several chipped 3rd rail insulator grout pads from equipment being dragged recently.

Image 17 – Image of the scuffs along the invert and third rail grout pad.

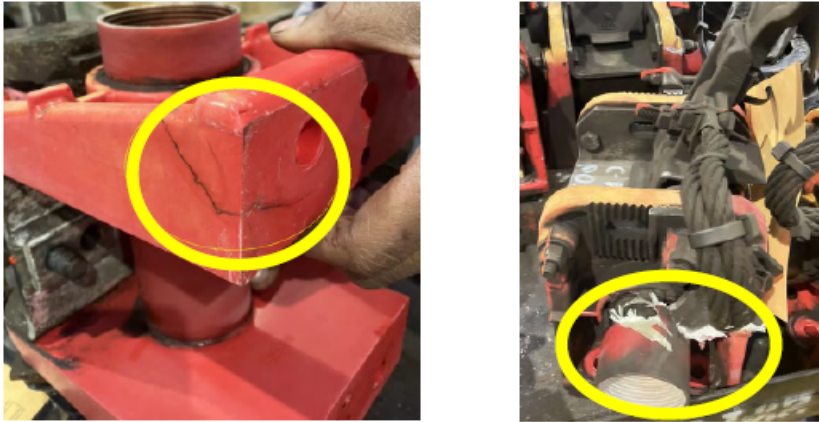
Figure 3. Examples of condemning defects for collector shoe assembly.

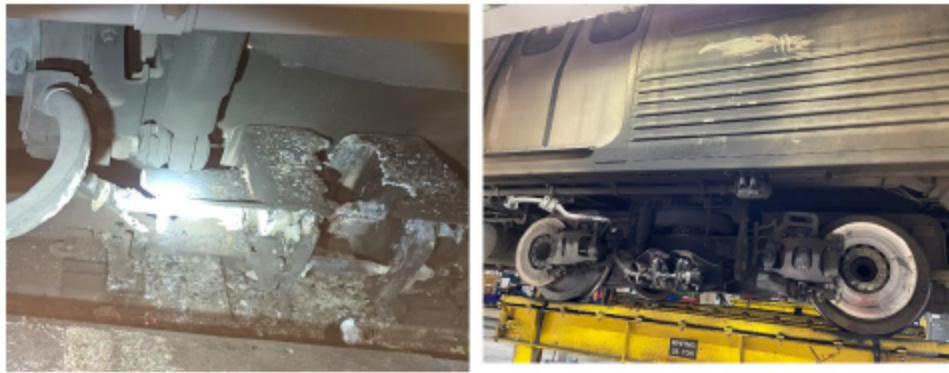
During the undercar inspection, the shoe fuse assembly for current collector #1, on B-Car 7663, was found to be mostly disintegrated, likely due to excessive arcing. Figure 2 below depicts the condition of the current collector assembly at time of inspection.

Figure 2, Car 7663 Current Collector Assembly # 1 and Fire Location

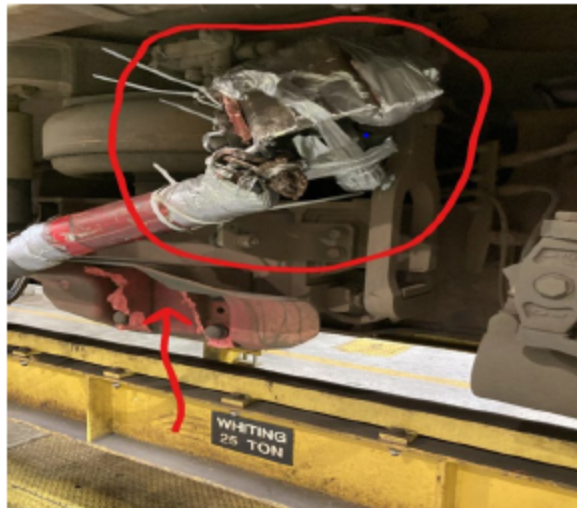
Current collector assembly #4 was completely broken, with the majority of the assembly components missing. NOTE: TRST found fractured pieces of a collector shoe assembly between the Third Rail and Running Rail, located between chain markers C1 76+100 and C1 77+00. Based on the location, it is believed, those were remnants of collector assembly #4. Figure 3 below shows the collector fuse (which was flashed open) & the mounting channel, which remained hanging from an approximately 3 ft. section of the primary cable.

Figure 3, Car 7663 Current Collector Assembly # 4

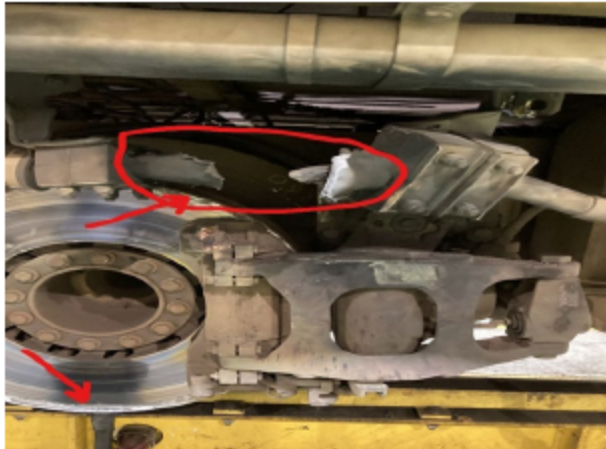
Figure 4 below depicts evidence of flashing of the primary cable to the #6 brake disc. Additionally, circular scrapes were found on the back of the collector assembly mounting channel #4, indicating it was lodged against the brake disc as shown in Figure 5.

Figure 4, Car 7663 Primary Cable, and Brake Disc # 6

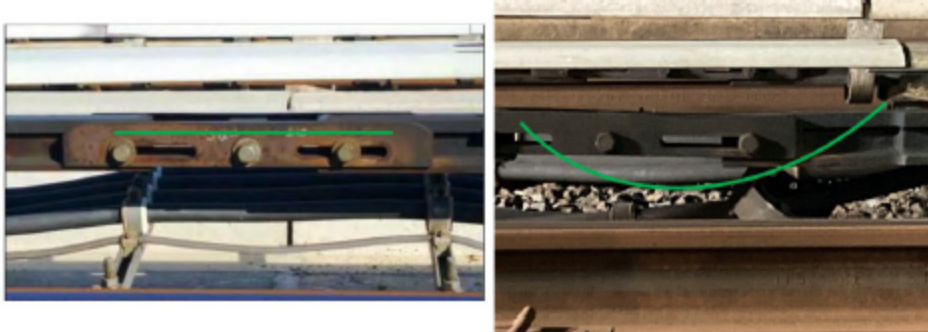
Figure 10 below illustrates an example of an expansion joint area with no dip (left) and a location identified on the Orange Line with an expansion joint that significantly impacts collector shoes due to the "dip" (right).

Figure 10, Expansion Joints

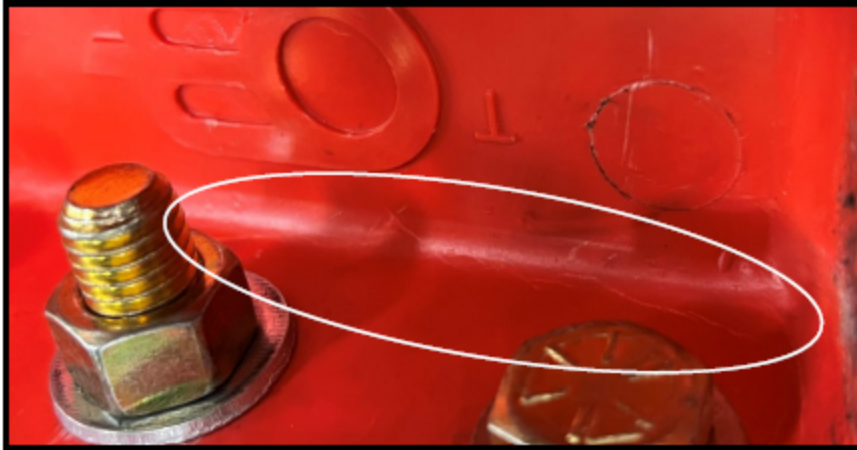
Figure 7: Crack propagation observed after static loading on a new assembly

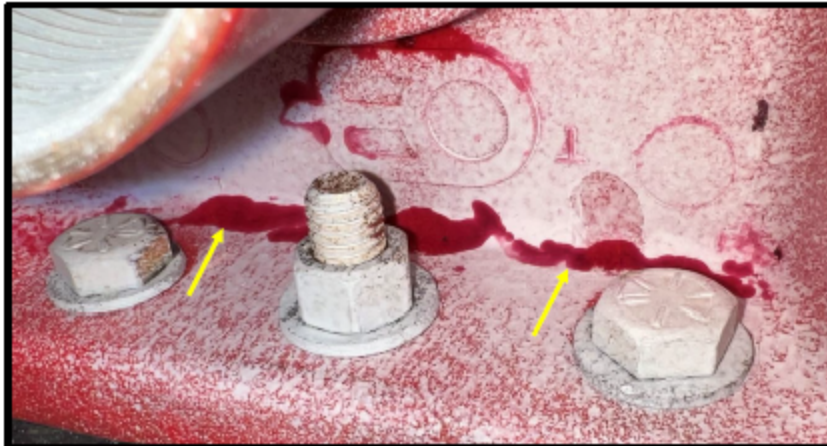
Figure 8: Dye penetrant testing after static loading on a new assembly

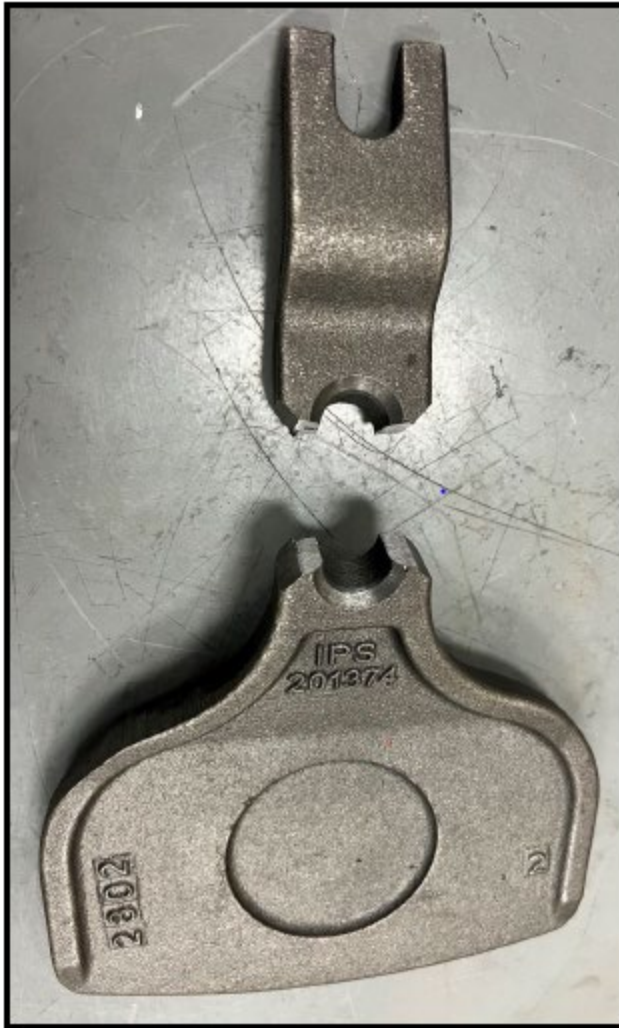
Figure 9: Typical failure mode for static loading of the shoes

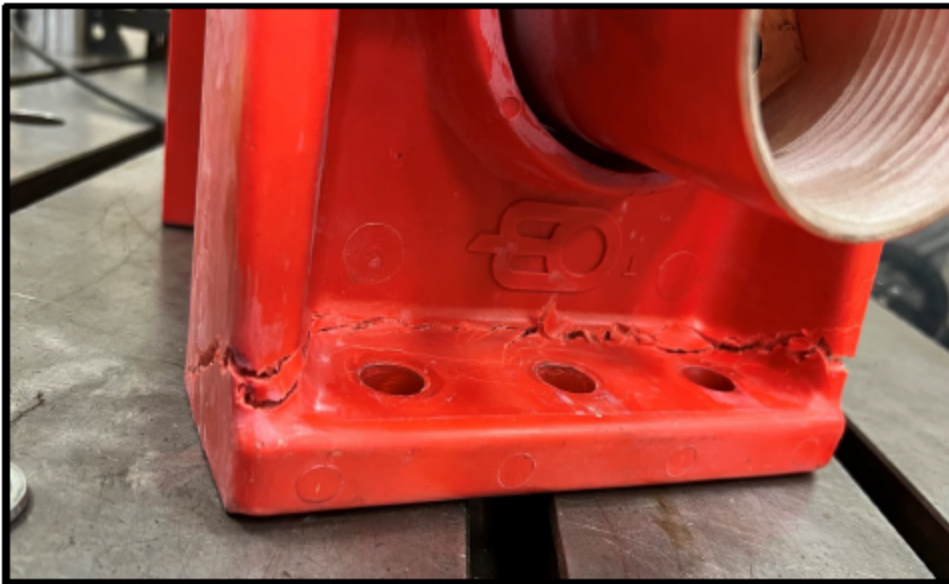
Sample #	Maximum Load (lbf)	Remarks
1	3,035	The assembly deformed and split along the base. See Figures 10 & 12.

Figure 10: Failure at the base of the assembly during the assembly ultimate strength load test

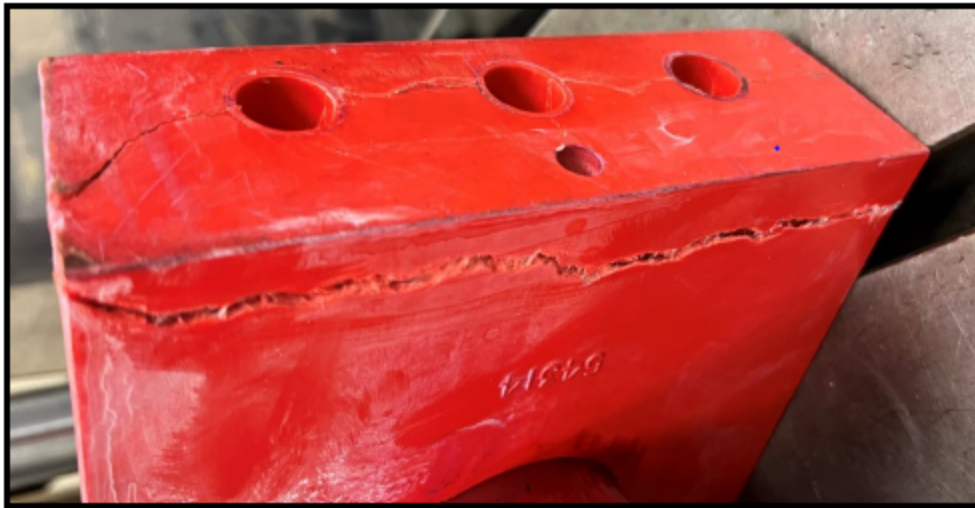
Figure 12: Failure at the base of the assembly during the ultimate strength load test

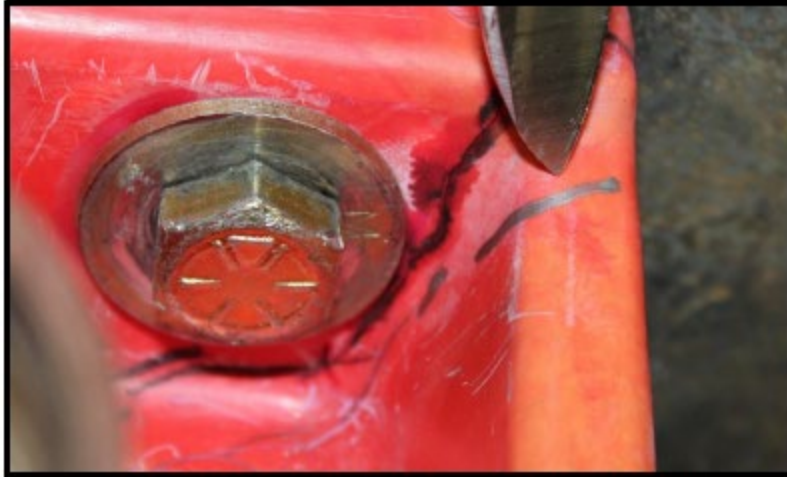
Figure 13: Crack growth on the used assembly during drop tests

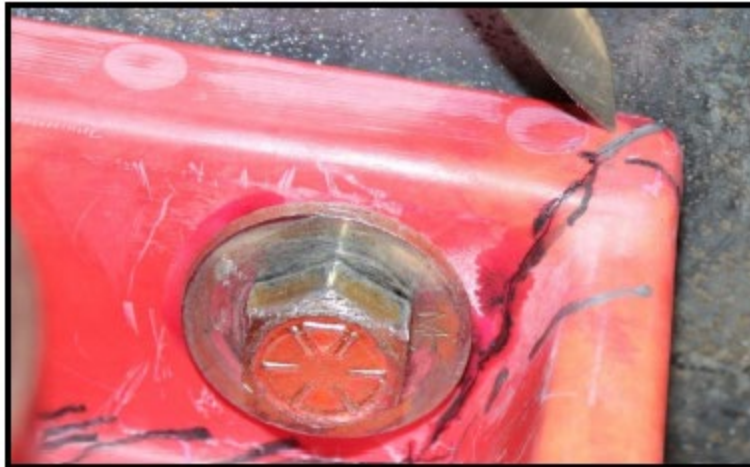
Figure 14: Separation of the surface because of crack propagation from the drop tests on the used unit

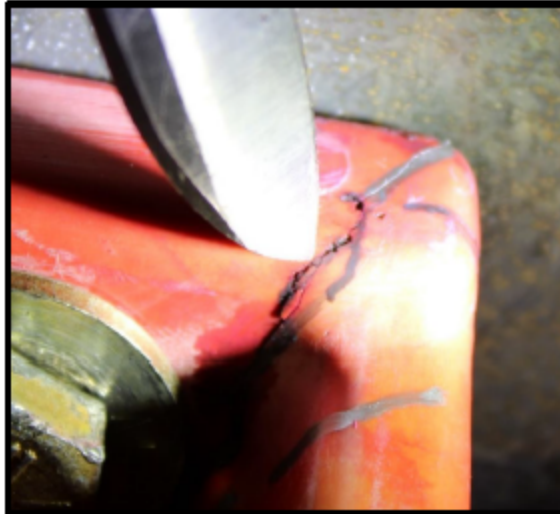
Figure 15: More crack propagation on the used assembly during the drop tests

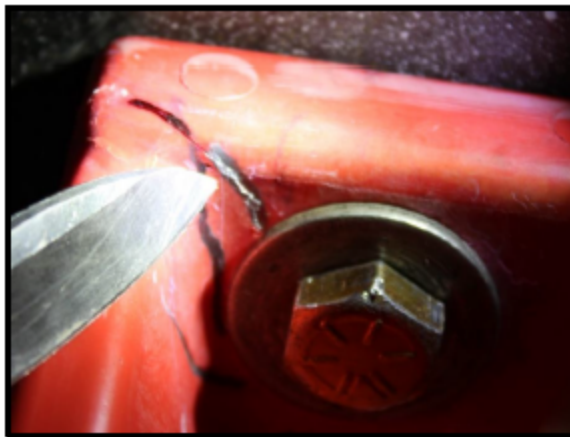
Figure 16: Additional separation observed on the used assembly during drop tests

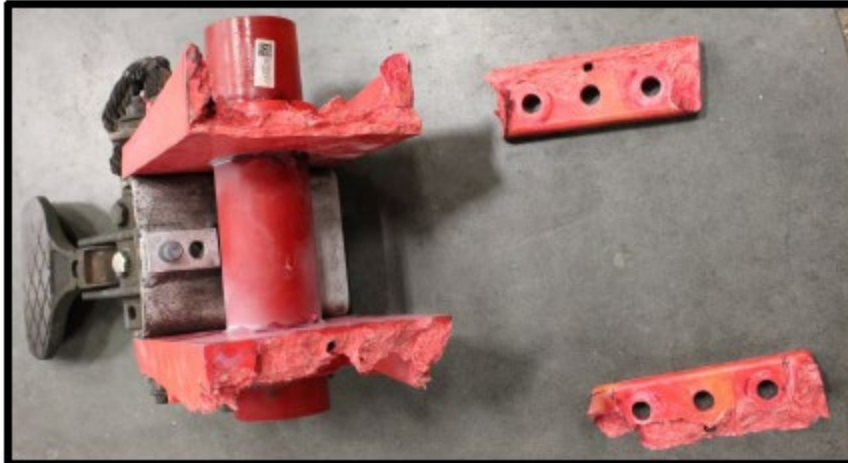
Figure 17: Used assembly failure from drop tests

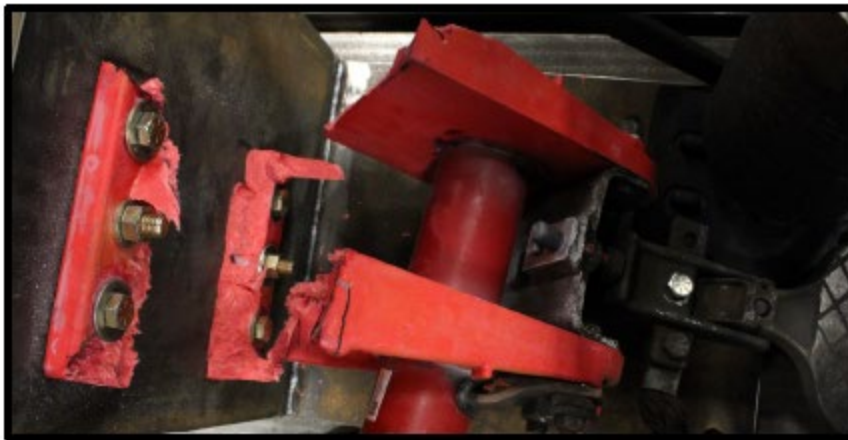
Figure 18: Top view of used assembly failure while mounted during the drop tests

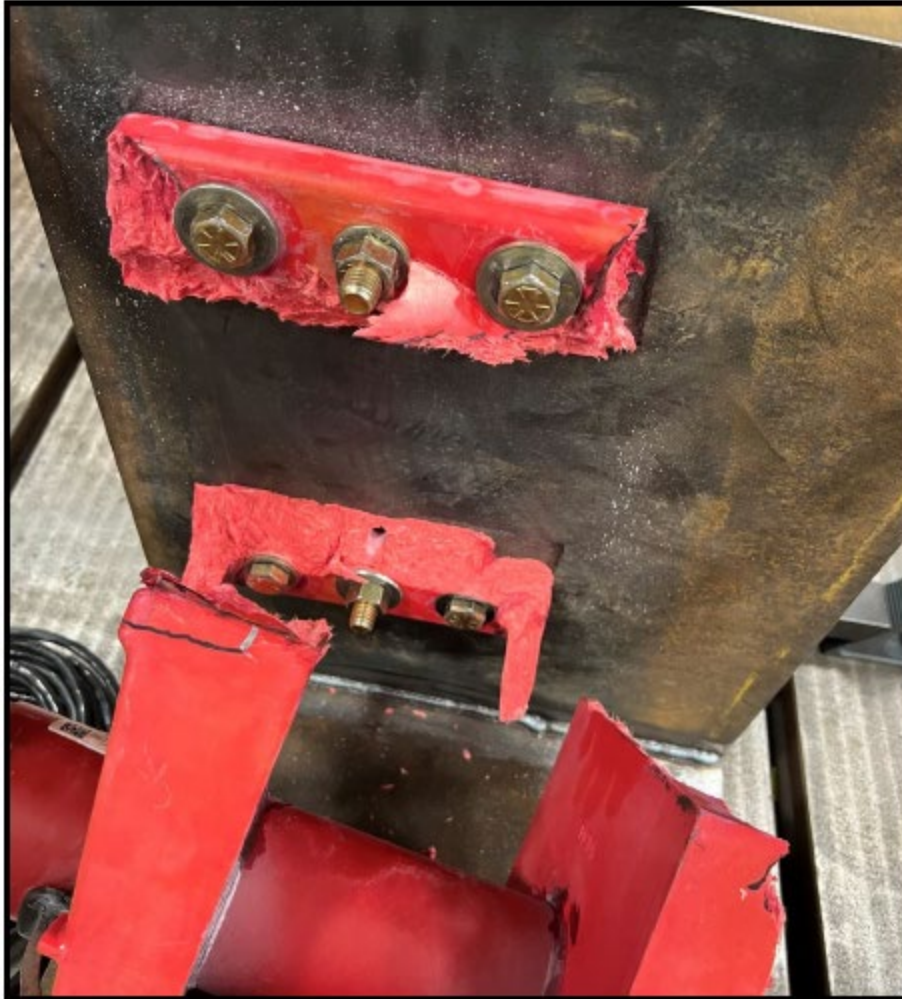
Figure 19: Additional view of the used unit failure from drop tests

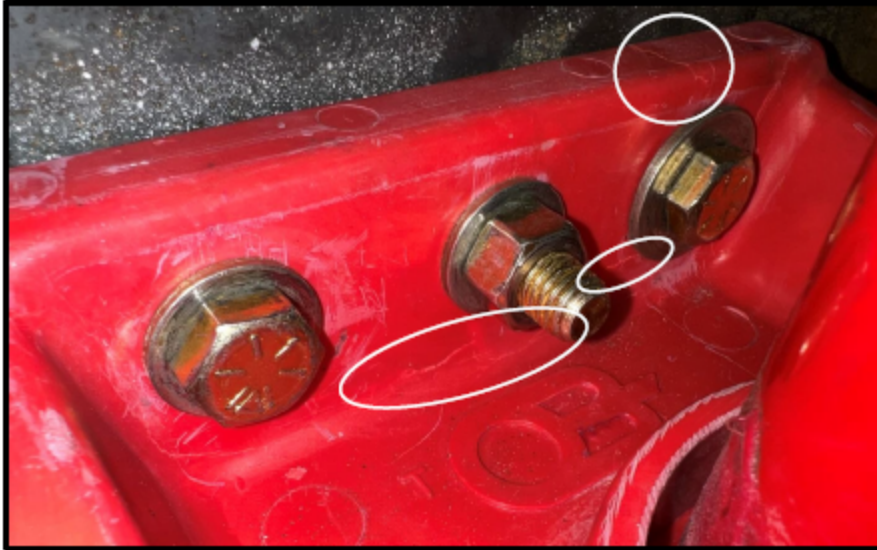
Figure 20: Crack propagation observed on the new collector assembly from drop tests

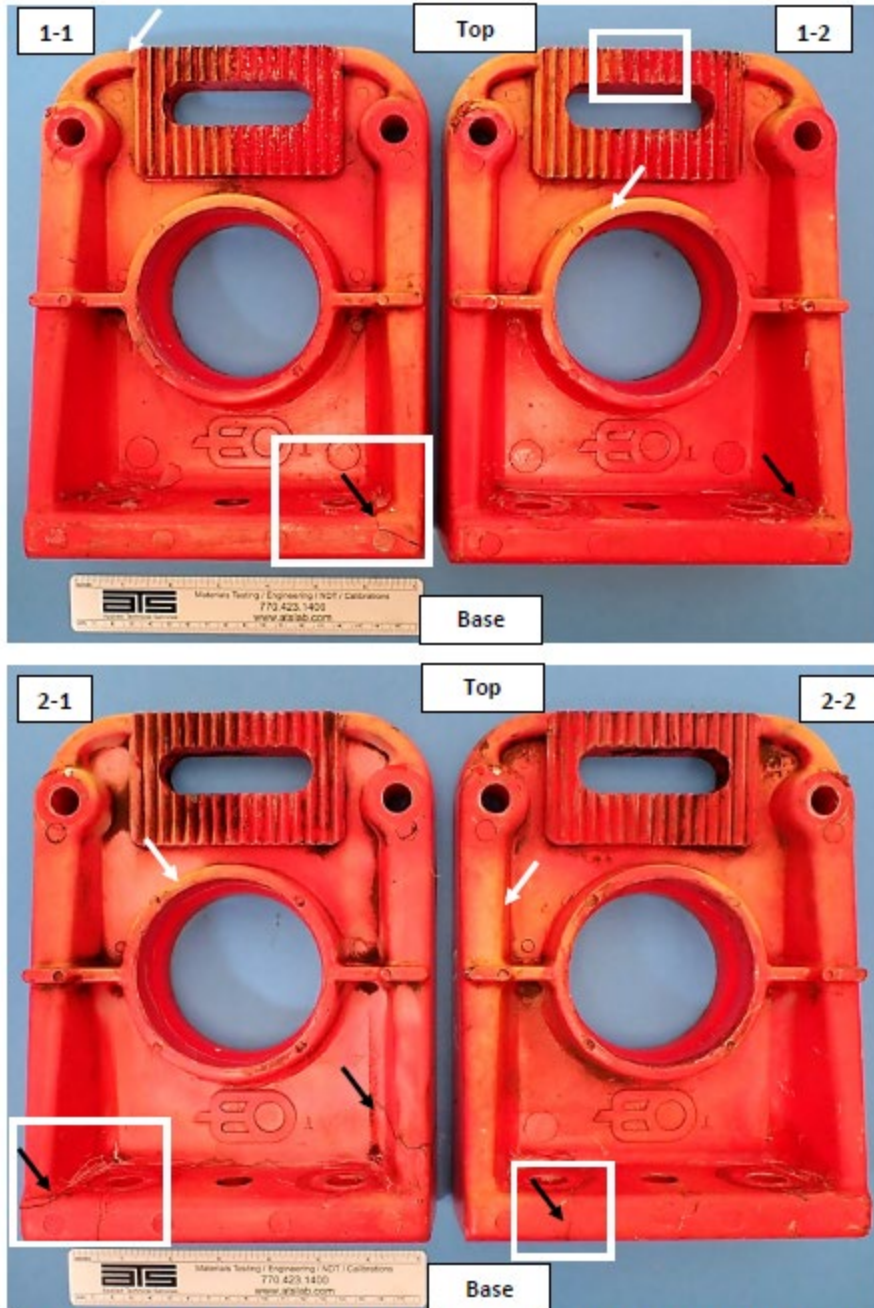
Figure 2: Photographs of the outer facing surfaces, or front, of the collector assembly brackets from Bundle 1 (top) and Bundle 2 (bottom) exhibiting a yellow discoloration (white arrows) and cracking predominantly at the base of the brackets (black arrows). A cracked area from each sample was further examined (white rectangles)

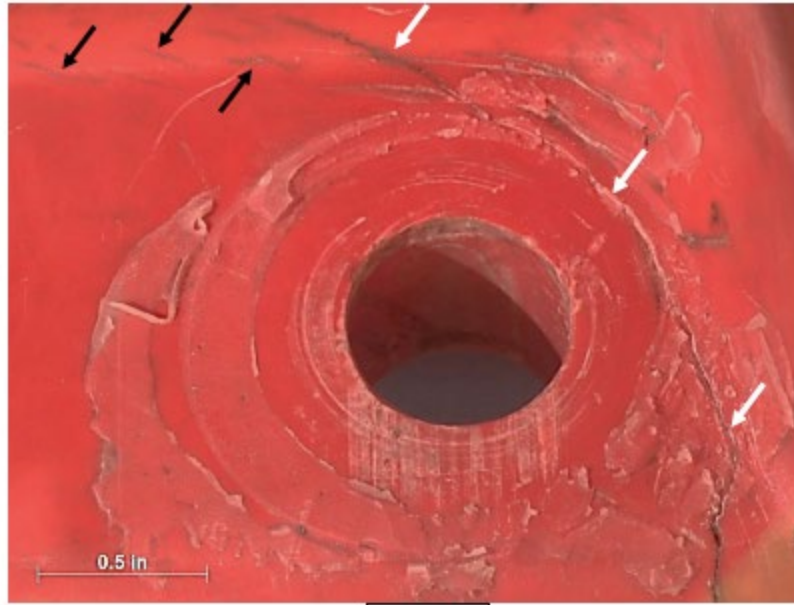
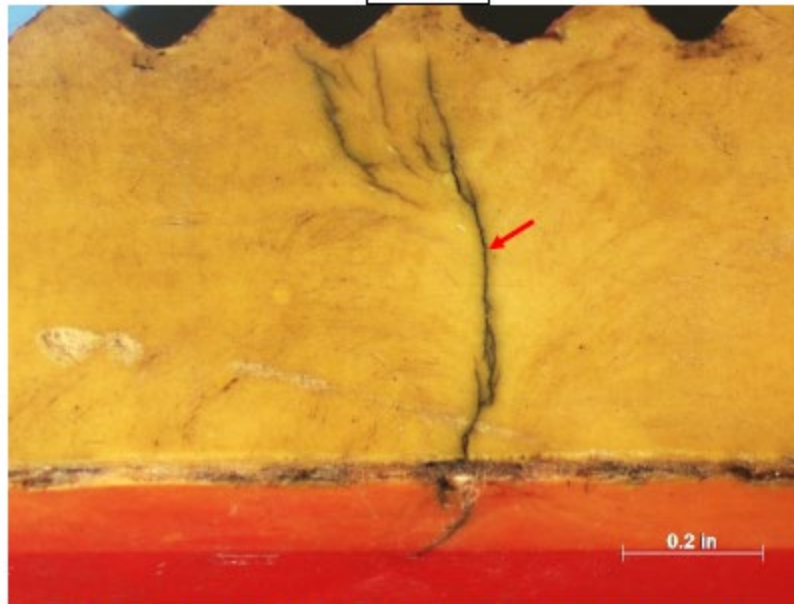
Figure 3: Macrograph of the base of Sample 1-1 showing cracking along the circumference of a washer indentation (white arrows) and dispersed secondary cracks along the radius of the bracket base (black arrows). Cracking was also observed in the yellow material at the top of Sample 1-2 (bottom).

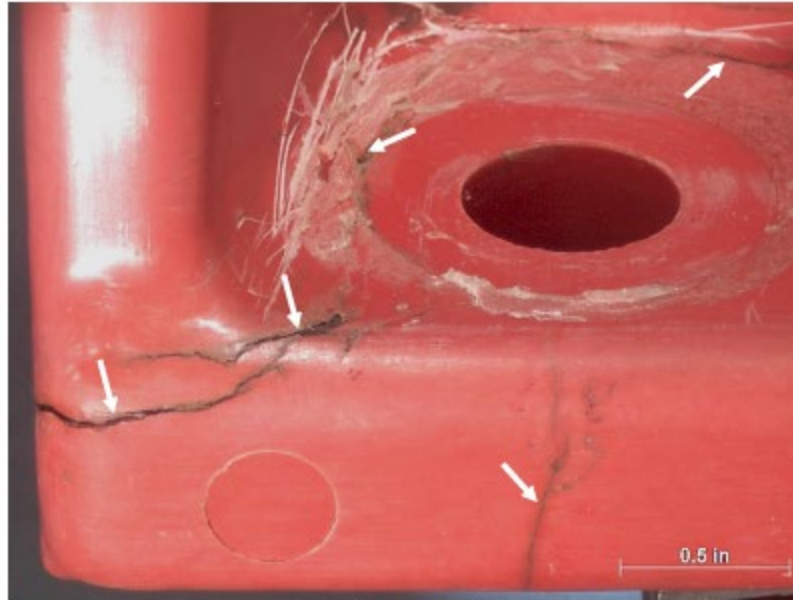
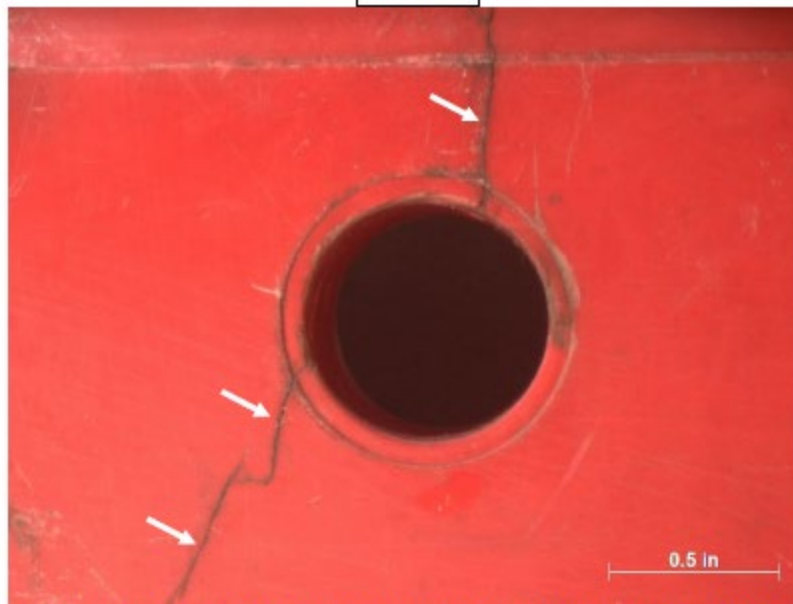
Figure 4: Macrographs showing cracking (white arrows) along the circumference of a washer indentation, along the radius of the bracket base, and in the bracket base in plane with a bolt hole of Sample 2-1 (top). Sample 2-2 also exhibited cracking from the front of the bracket base to one of the bolt holes and further within the material along the bottom of the bracket base (bottom).

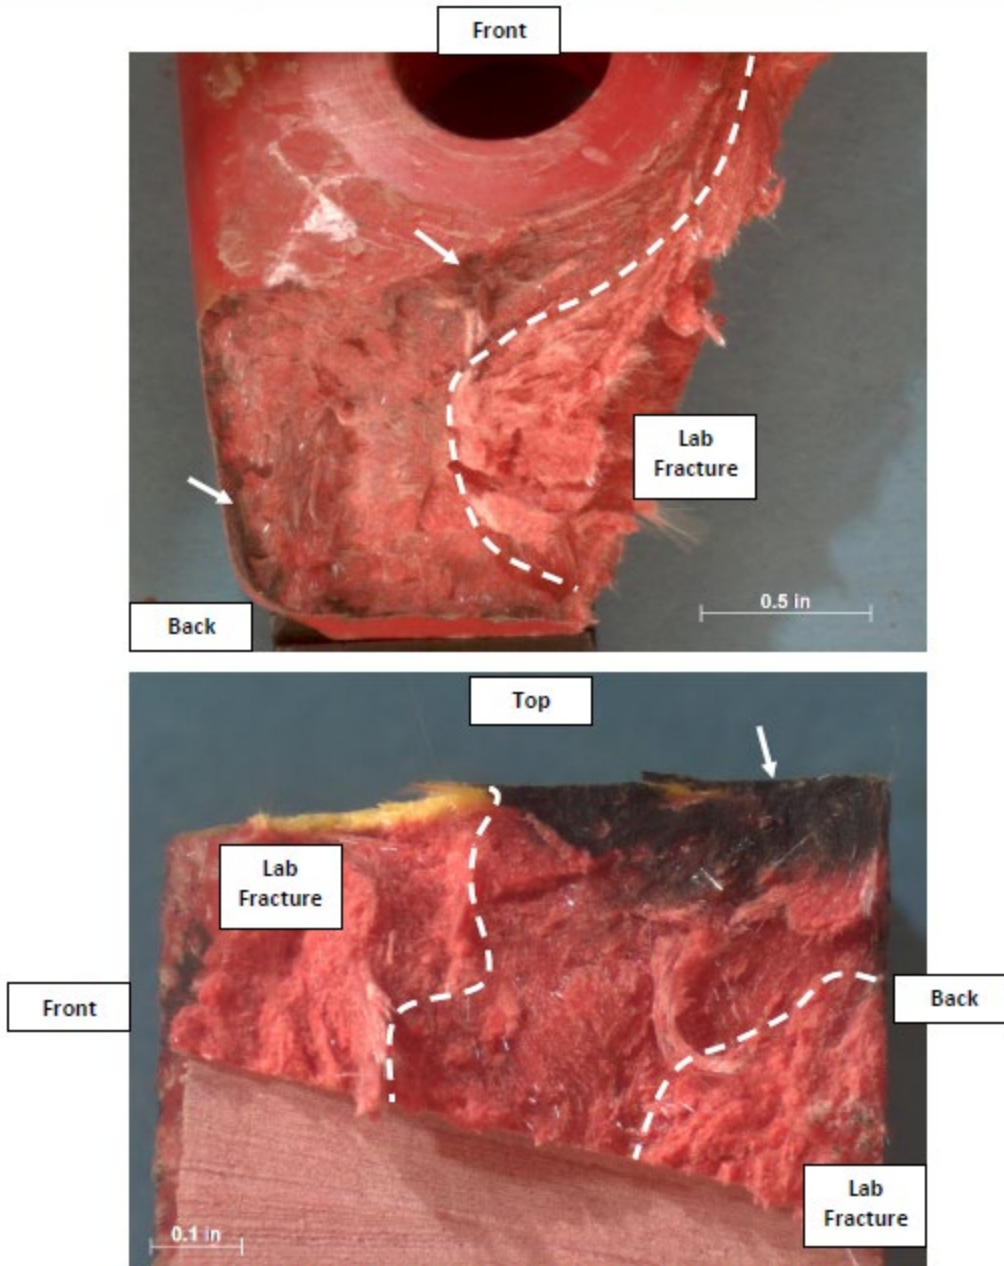
Figure 5: Macrographs of the opened fracture surfaces from the base of Sample 1-1 (top) and the yellow material at the top of Sample 1-2 (bottom). The service fracture of Sample 1-1 follows the circumference of the washer indentation and leads down the back of the bracket base at an angle. Both service fracture surfaces were smoother and exhibited a duller appearance compared to the lab fractures. A dark discoloration was observed on the fracture surfaces along the exposed surfaces (white arrows).

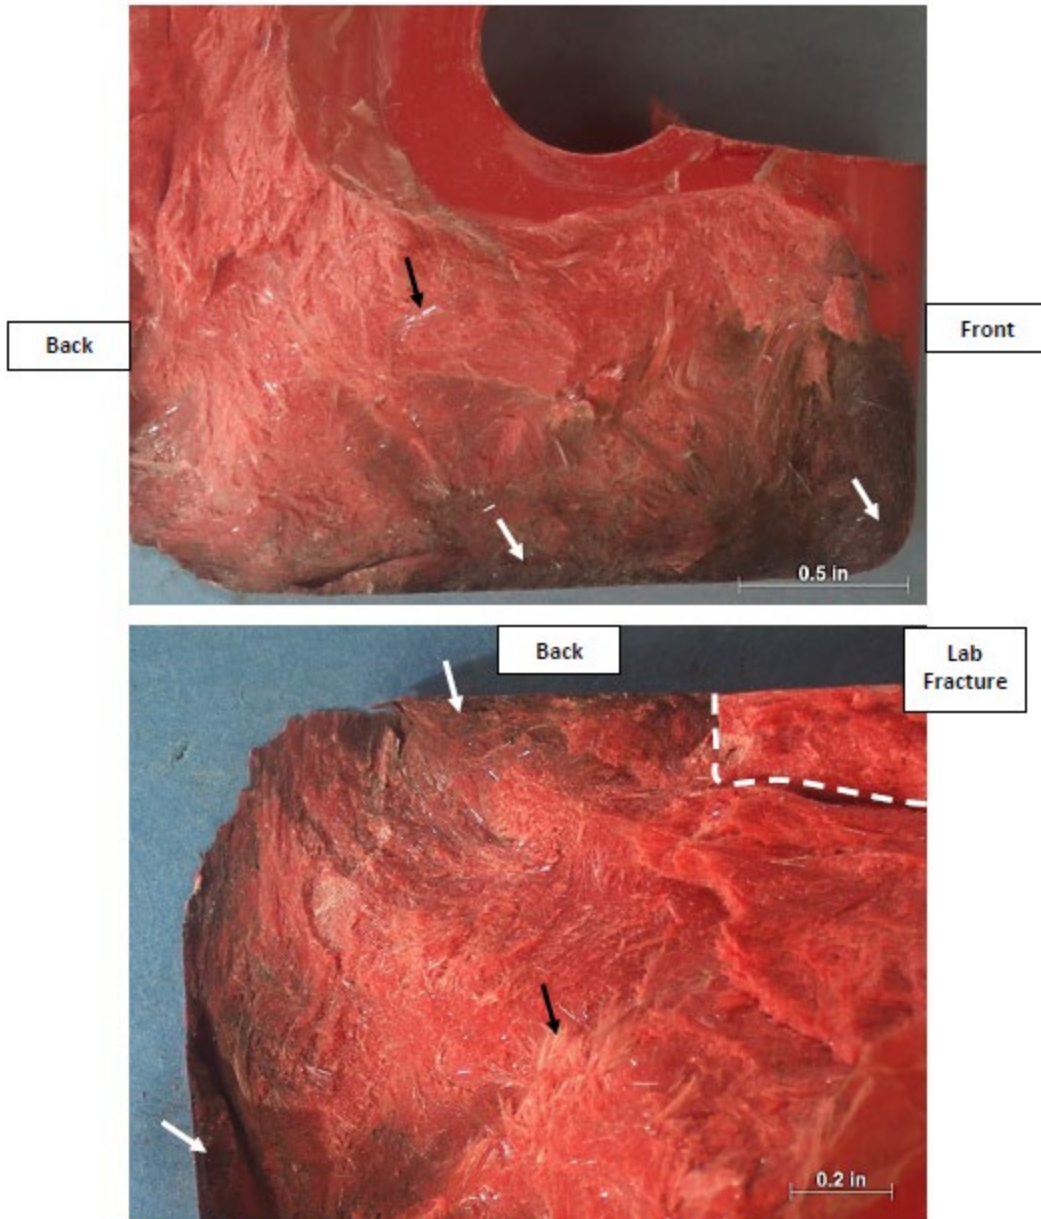
Figure 6: Macrographs of the opened fracture surface from the base of Sample 2-1 showing a smooth fracture surface with dispersed exposed fibers (black arrows). A dark discoloration was observed along the exposed surfaces of the sample (white arrows). The service fracture of Sample 2-1 follows the circumference of the washer indentation and leads down the back of the bracket base at an angle.

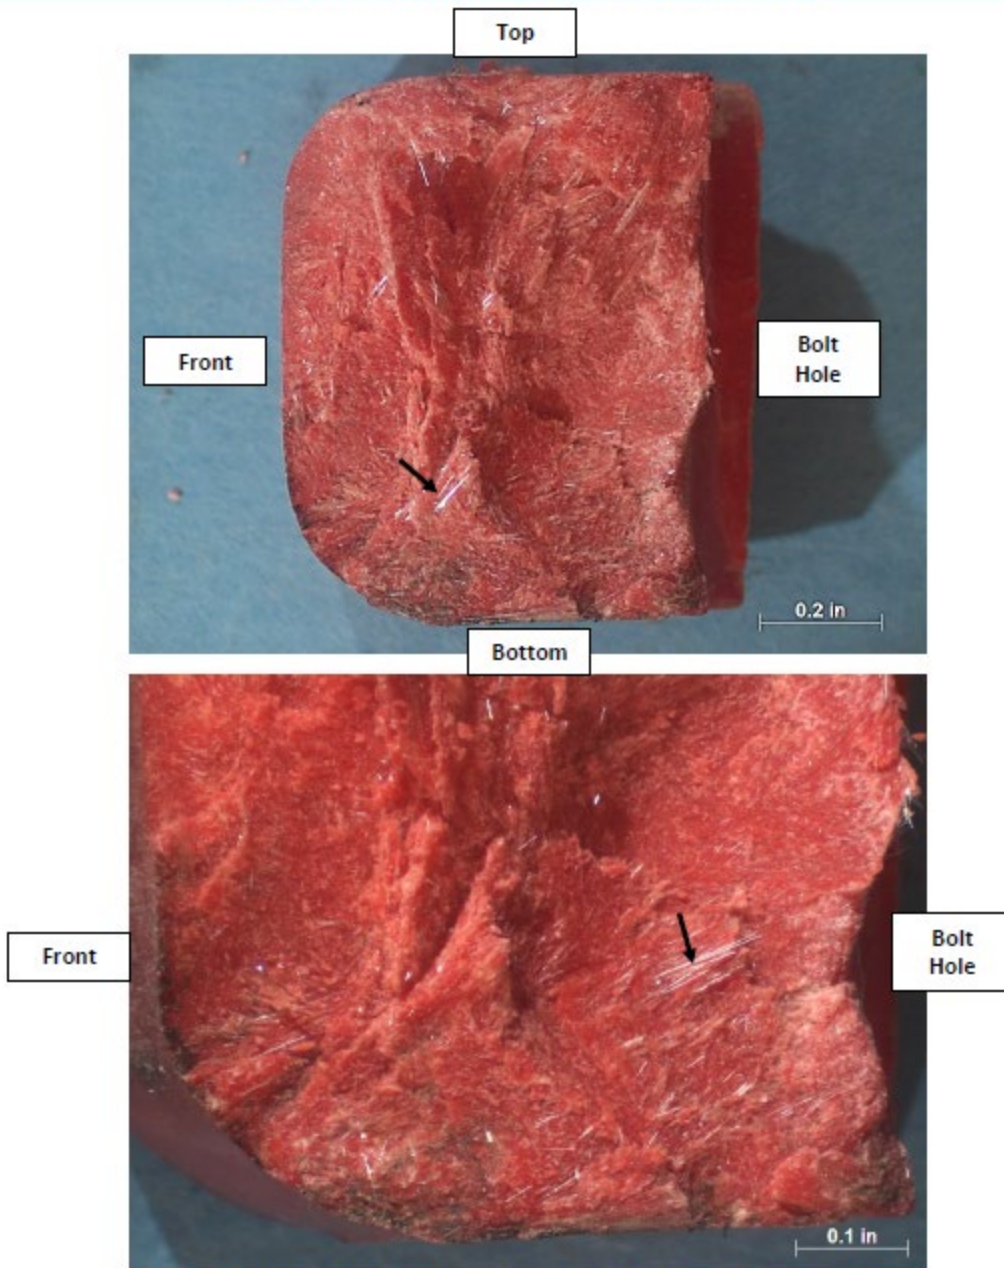
Figure 7: Macrographs of the opened fracture surface from Sample 2-2 showing a smooth and relatively flat fracture surface with areas of exposed fibers (black arrows).

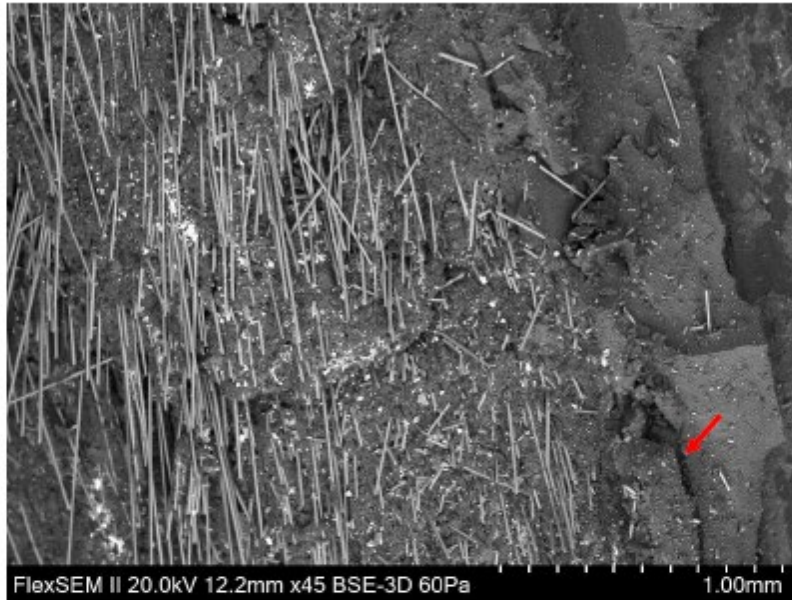
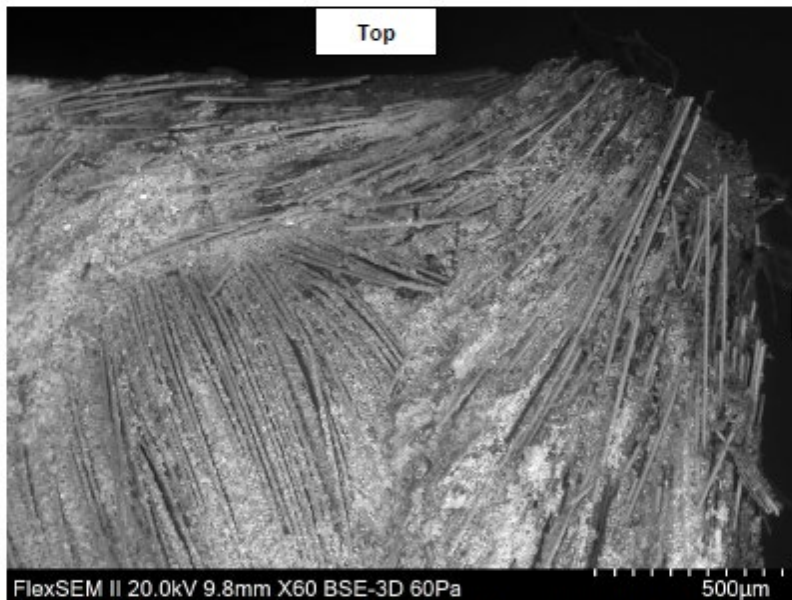
Figure 8: SEM image of the fracture surface from Sample 1-1 (top) showing exposed fibers all along the circumference of the washer indentation (red arrow) at the top of the bracket base. An SEM image of the fracture surface from Sample 1-2 shows exposed fibers along the fracture surface covered in contamination (bright) (bottom)

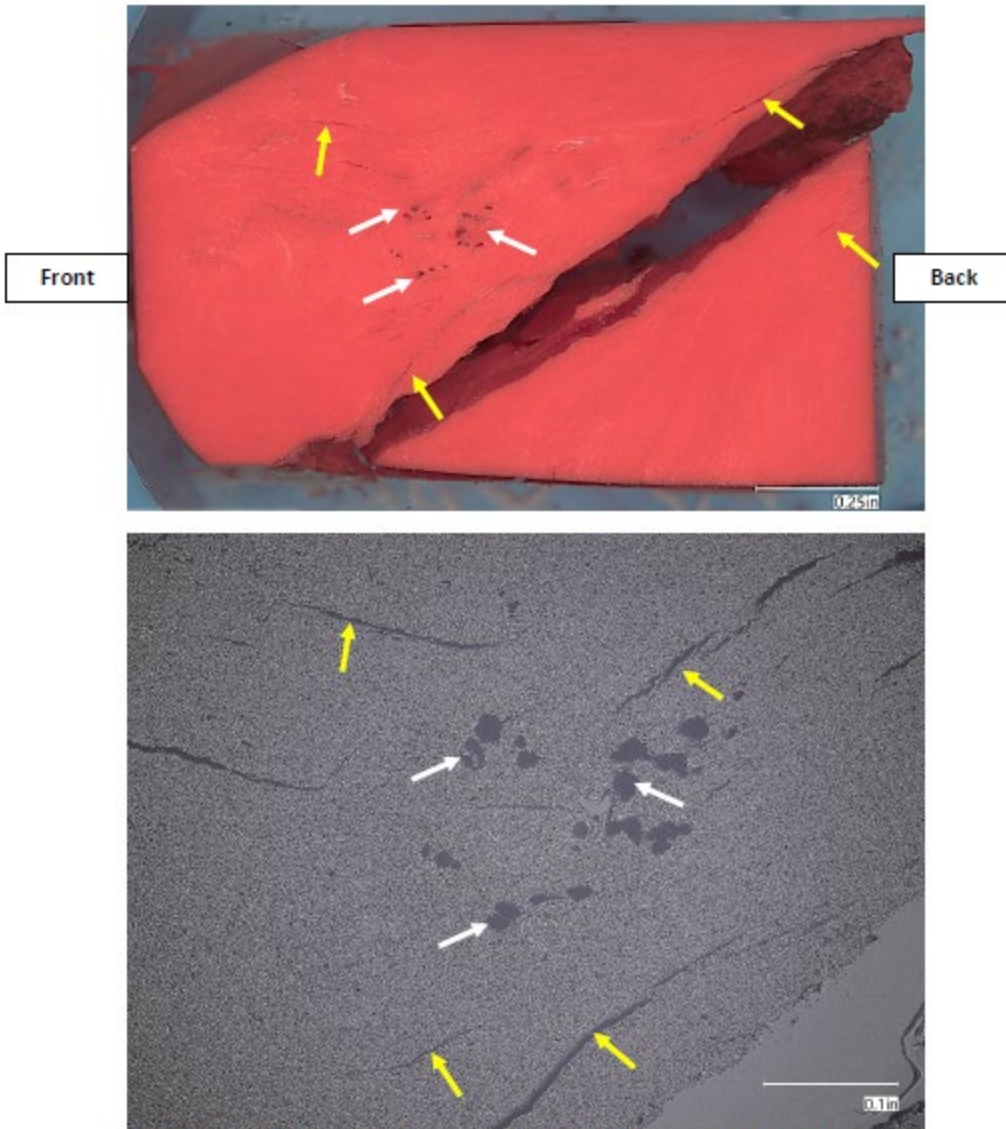
Figure 13: Optical images of a transverse cross section taken through the fracture surface of Sample 2-1 (top) showing voids (white arrows) and cracks (yellow arrows) throughout the material (bottom).

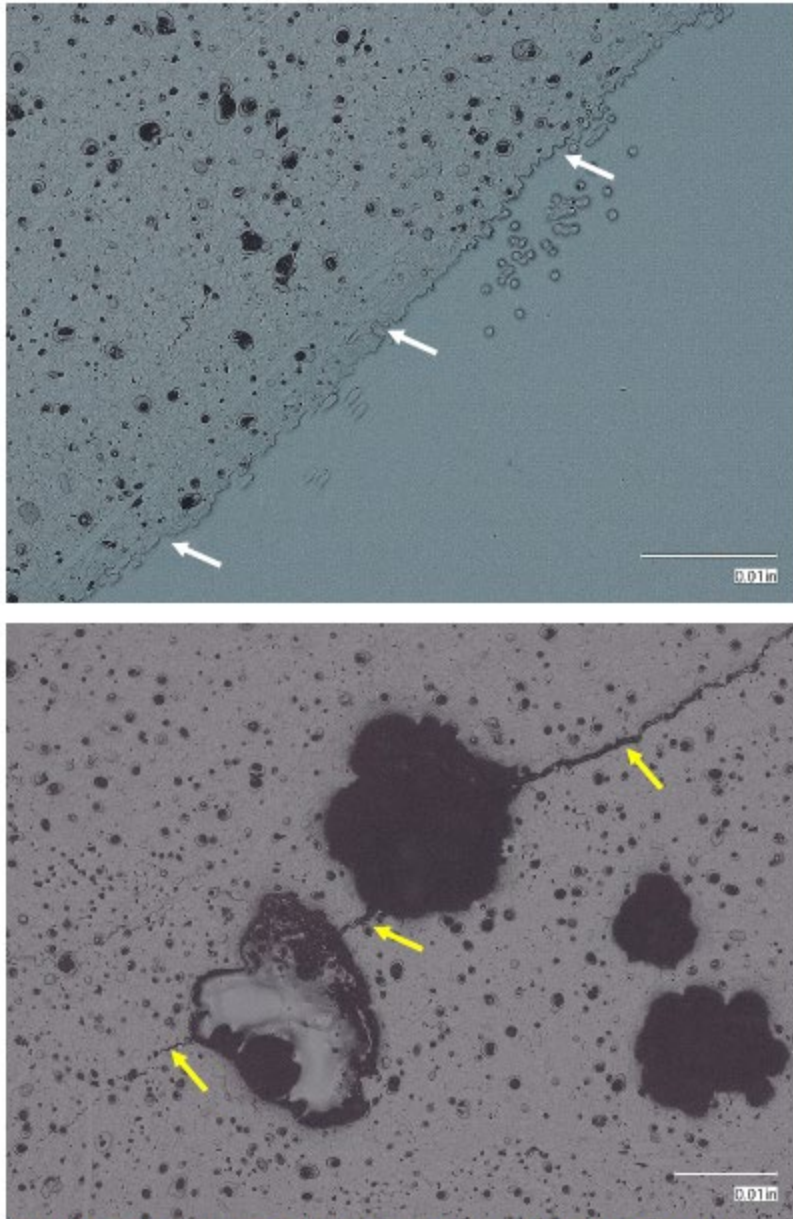
Figure 14: Optical images of a transverse cross section taken through the fracture surface of Sample 2-1 showing the fracture surface (top) and the large voids observed within the material (bottom). The fracture surface was predominantly flat and exhibited grooves (white arrows) where fibers used to be. Cracks (yellow arrows) were observed connecting and emanating from the large voids within the material.
