W-0344 – Evacuation for Life Safety Reasons at Eastern Market Station – February 15, 2024

Document Purpose

Safety event summary:

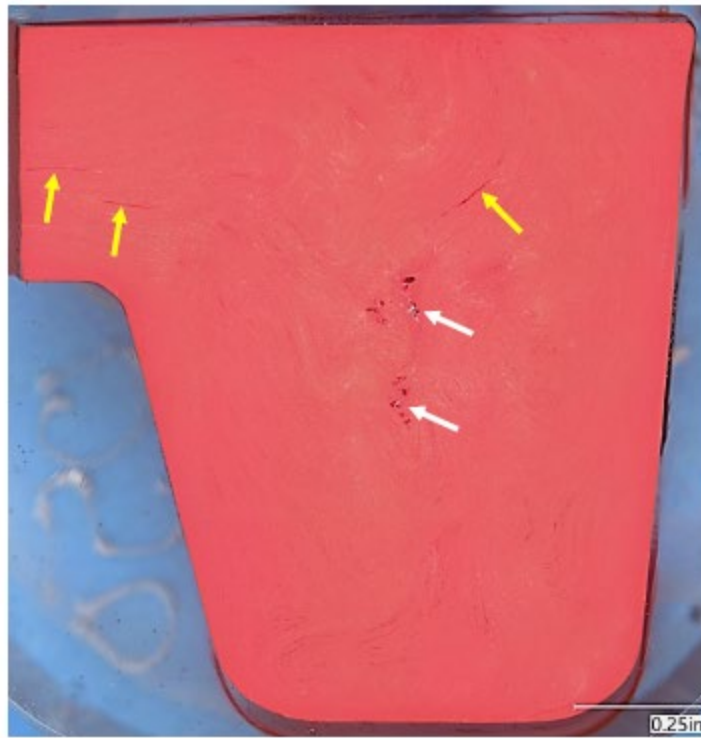
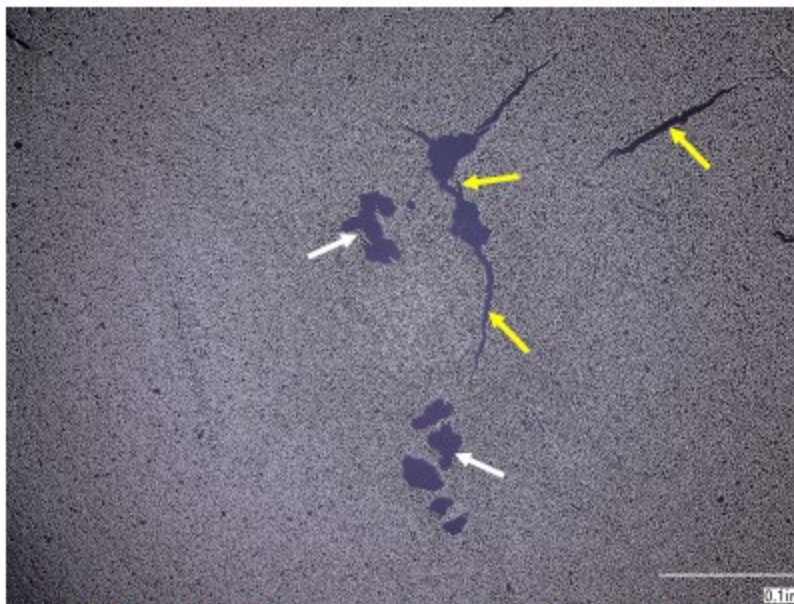
Figure 15: Optical images of a transverse cross section from Sample 2-1 taken remote from any cracks (top) exhibiting voids (white arrows) and internal cracking (yellow arrows). Cracks were also observed connecting and emanating from the large voids within the material (bottom).

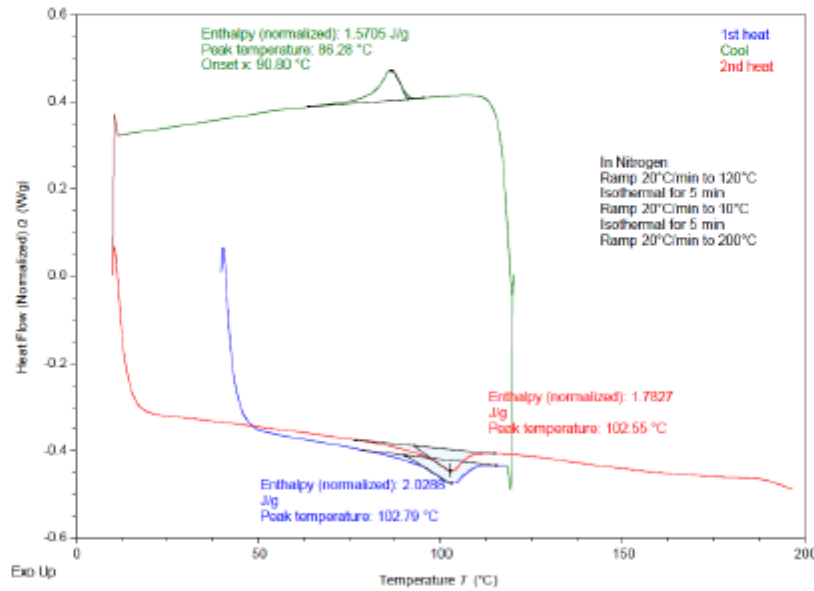
Figure 16: FT-IR spectra (top) collected from the exemplar sample (blue), a cracked sample (Sample 2-1, purple), and the black contamination observed on many of the fracture surfaces (green) compared to library spectra of polyester resin (pink), organophilic clay (indigo), and fiberglass (red). A DSC thermogram from material taken from Sample 2-1 exhibited no exothermic peaks that would indicate an incomplete cure of the resin (bottom).
