W-0355 – Improper Roadway Worker Protection – Anacostia Station – May 7, 2024

FINAL REPORT OF INVESTIGATION A&I E24355

Anacostia Station – Improper Roadway Worker Protection (RWP)

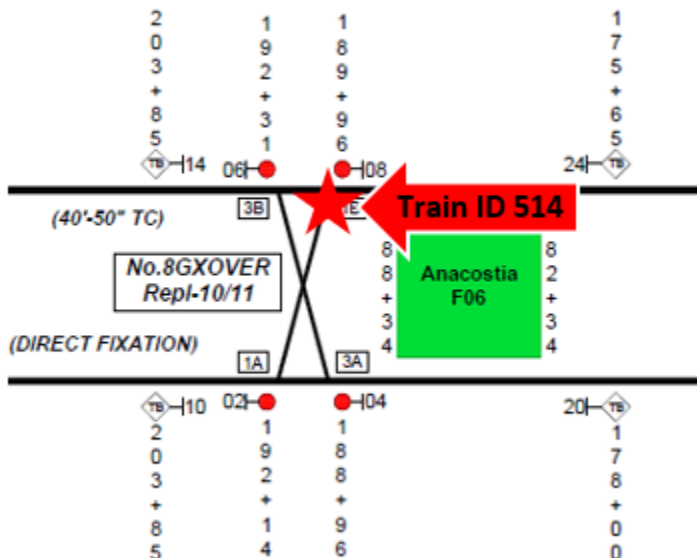
Field Sketch/Schematics

Anacostia Station, track 2.

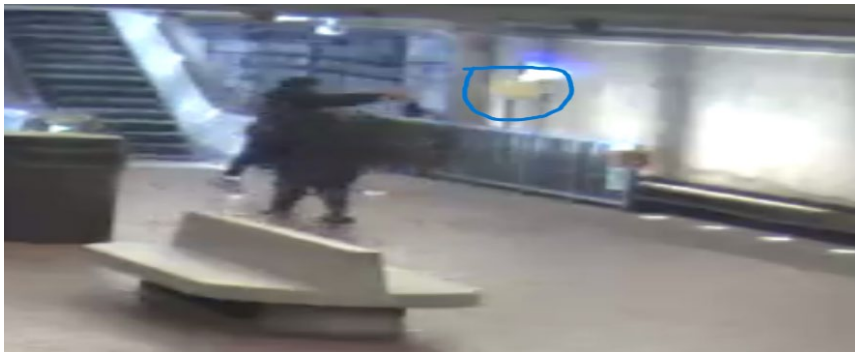
CCTV revealed that the wet floor sign was tossed into the roadway by a customer on Monday, May 6, 2024, at 00:07 hours.

Image 1 – Image of a customer throwing the wet floor sign onto the roadway at Anacostia Station on track 2 on May 6, 2024, at 00:07:00 hours.

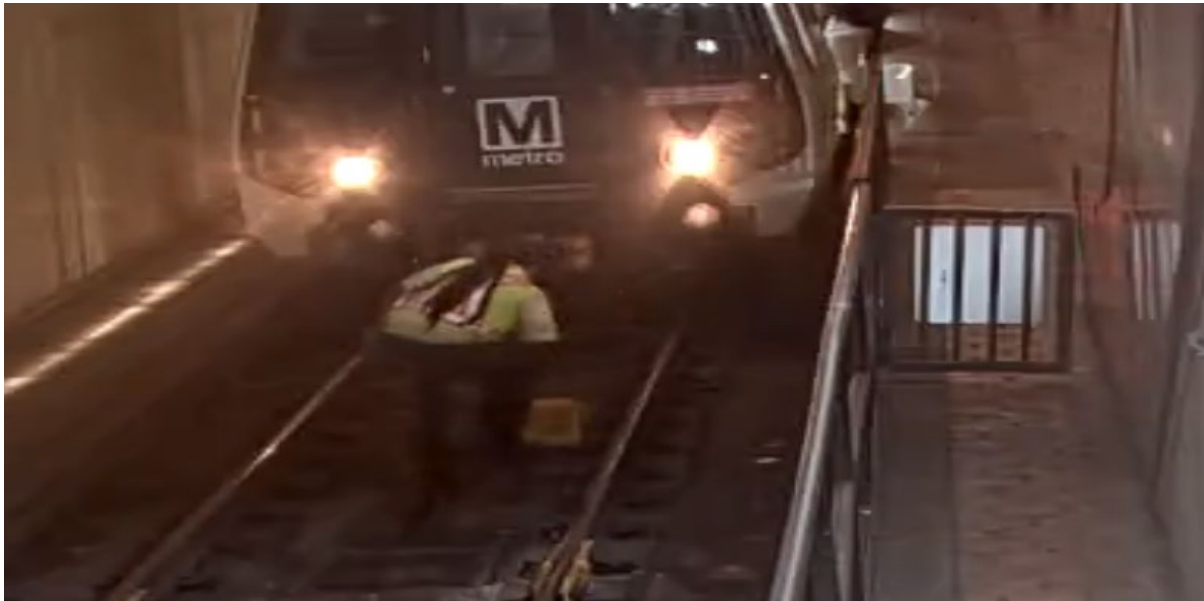
At 15:33 hours, the Station Manager walked past the 8-car marker, continued onto the catwalk, and into the roadway to retrieve the wet floor sign before returning to the platform. Train ID 514 was stopped at the platform and was not keyed down at the time.

Image 2 – Image of the Station Manager on the roadway in front of Train ID 514 removing the wet floor sign.

The probable cause of the Improper Roadway Worker Protection (RWP) event was a misapplication of established rules and procedures. The Station Manager entered the roadway and retrieved the wet floor sign while it was in close proximity to the energized third rail, without permission which was a violation of established procedures. The possibility of incidental contact existed, and to minimize this risk, the third rail power should have been de-energized or other preventive measures enacted.

Corrective Action Code	Description	Responsible Party	Estimated Completion Date
116705_SAF ECAPS_RT RA_001	(RC-1) The Station Manager is to attend re-instruction on entering the roadway without permission and proper methods to retrieve items in close proximity of the third rail and the required PPE.	RTRA SRC	Completed
