## W-0358 – Derailment – West Falls Church Rail Yard Lead – July 1, 2023

<b>Date of Event:</b>	July 1, 2023
<b>Type of Event:</b>	Derailment
<b>Incident Time:</b>	03:10 hours
<b>Location:</b>	West Falls Church Yard (K99) Yard Lead (YL) 015+00
<b>Time and How received by SAFE:</b>	04:37 hours/MAC Call
<b>WMSC Notification Time:</b>	04:35 hours
<b>Responding Safety Officers:</b>	Office of Emergency Preparedness (OEP) Office of Safety Investigations (OSI)
<b>Rail Vehicle:</b>	Hi-Rail Vehicle Unit ID CR5971
<b>Injuries:</b>	None
<b>Damage:</b>	Minor infrastructure damage
<b>Emergency Responders:</b>	The Office of Track and Structures (TRST) Metro Transit Police (MTPD) The Office of Rail Transportation (RTRA) The Office of Capital Delivery (CAPD) The Office of Safety and Readiness (SAFE) The Office of Vehicle Program Services (CENV)
<b>SMS I/A Number</b>	20230701#109604

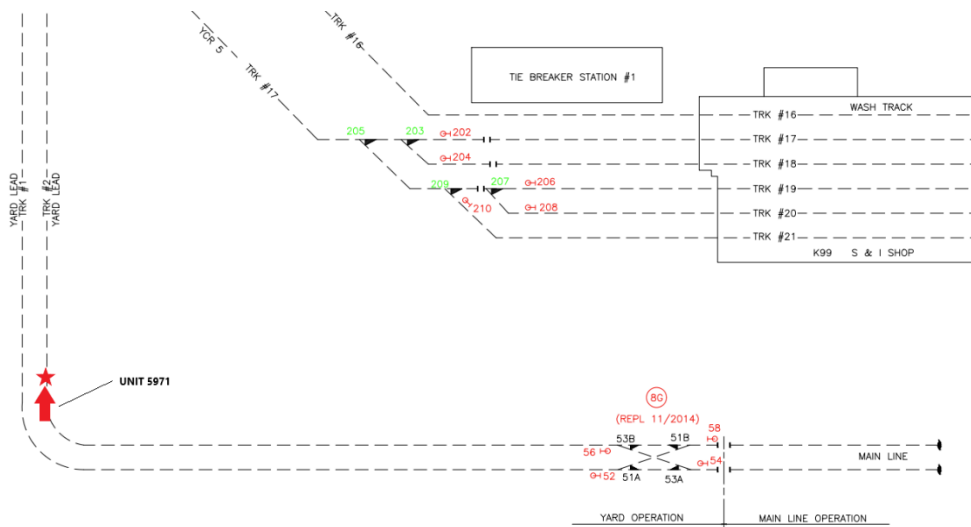
Approximate incident site and location of derailment marked with a "red star." The above depiction is not to scale.

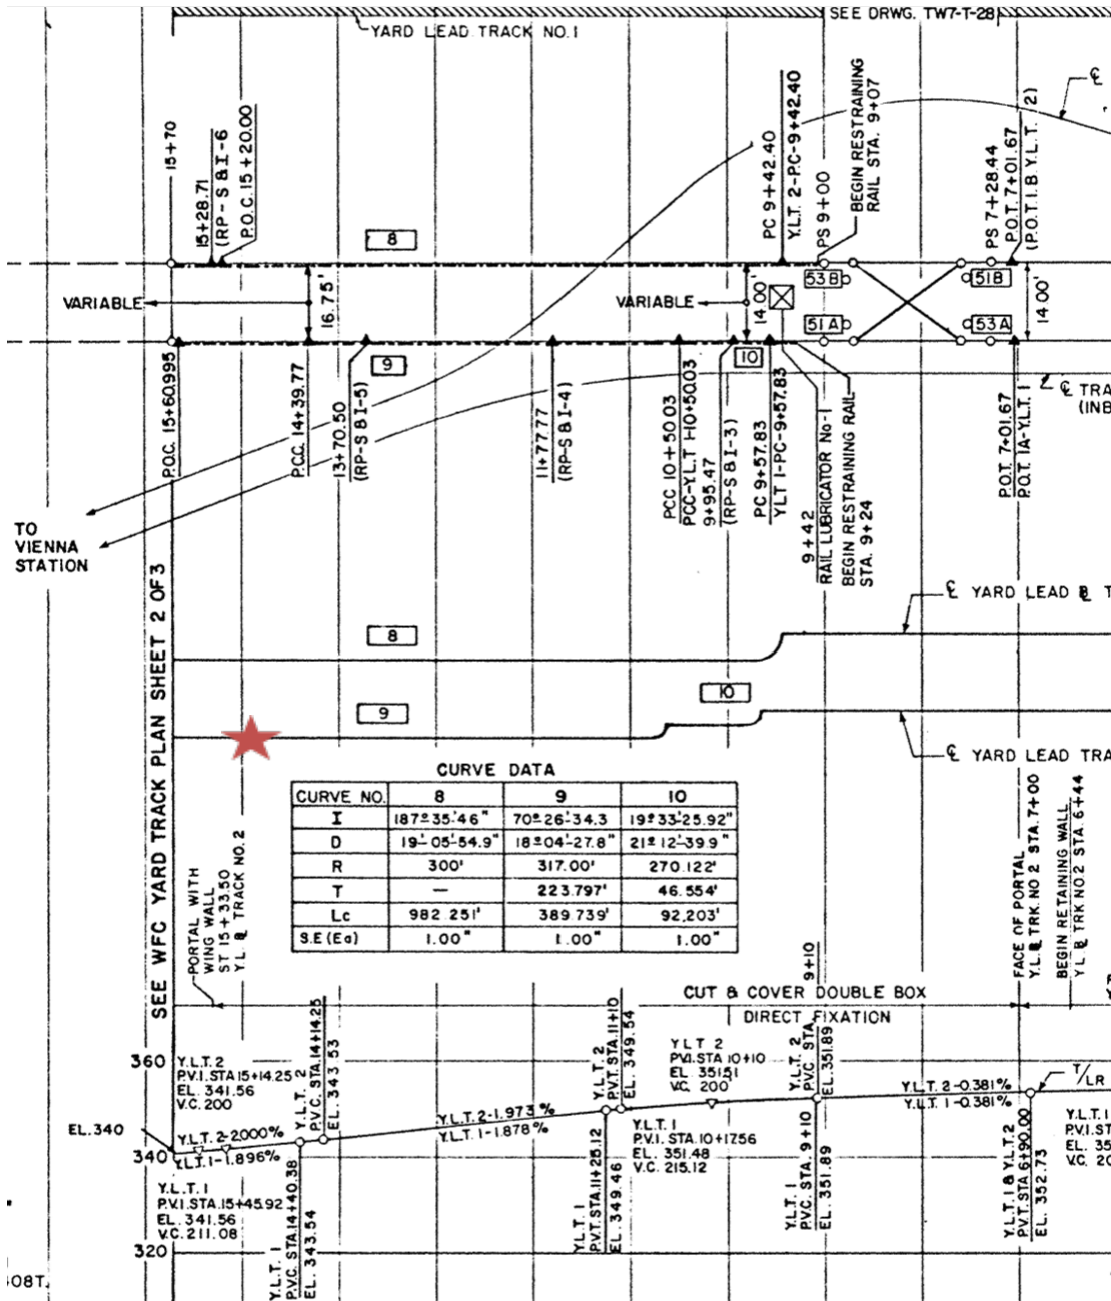
Approximate incident site and location of derailment marked with a "red star" on Track Drawing. Not to scale.

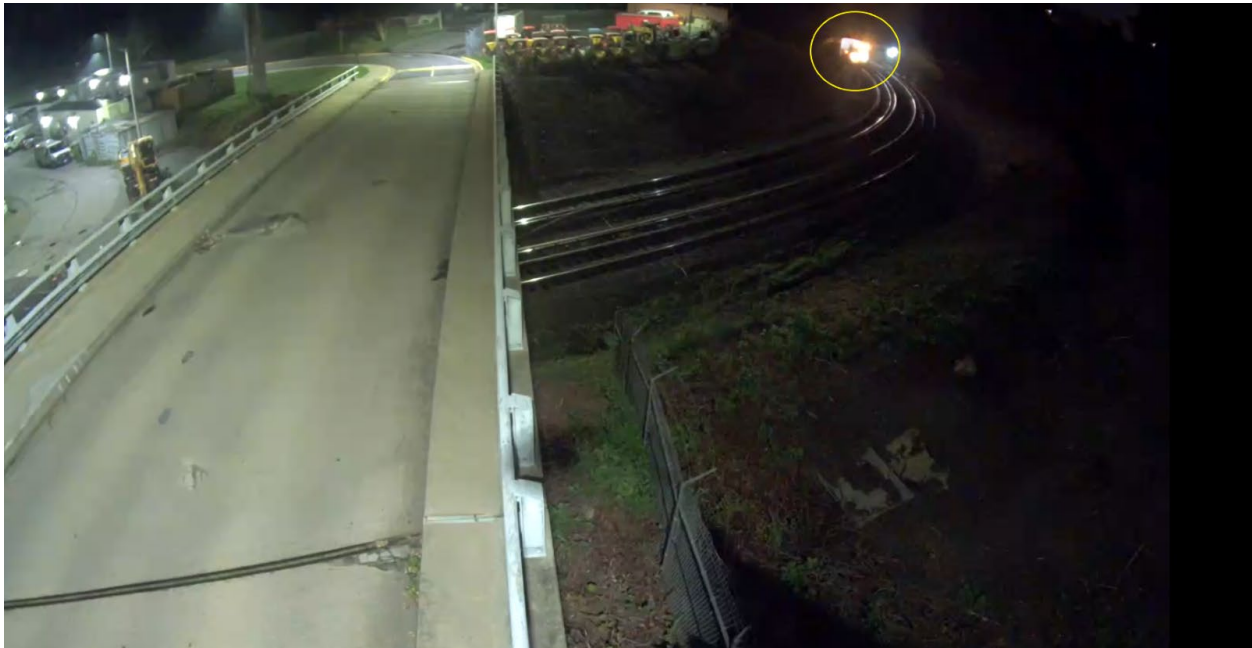
Figure 1 – Hi-Rail Vehicle CR5971 comes into view as it exited the portal on YL 2 and stops moving at 03:10 hours.

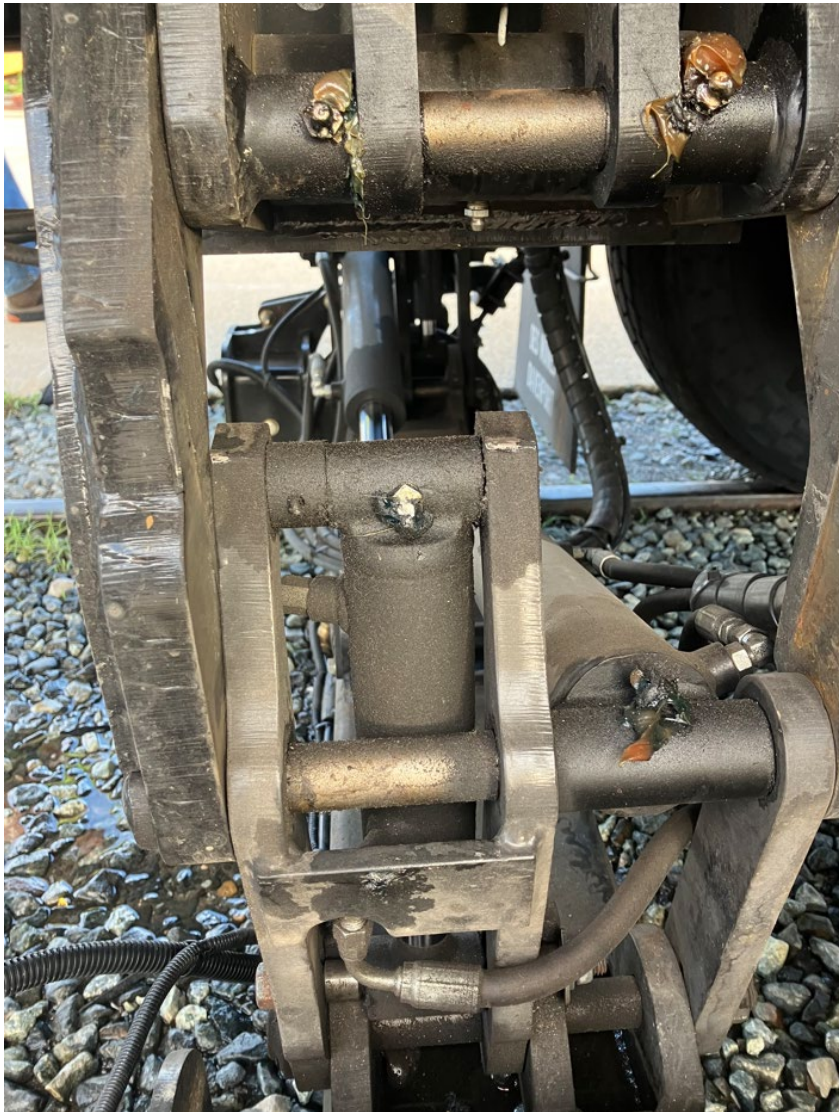
*Figure 9 –Hi-Rail Unit during inspection at Greenbelt Yard had multiple defects including a shorn-off grease nipple to the rear right shock-absorber.*

“This incident is likely the result of insufficient down force on the right rear rail wheel. Without sufficient downforce, wheel climb can occur. Once on the ball of the rail, derailment was inevitable from the righthand lateral forces noted above. The insufficient down force appears to be due to a twisted vehicle frame. The reason for the frame twist is unknown but occurred sometime between the last inspection and the July 1 derailment.”

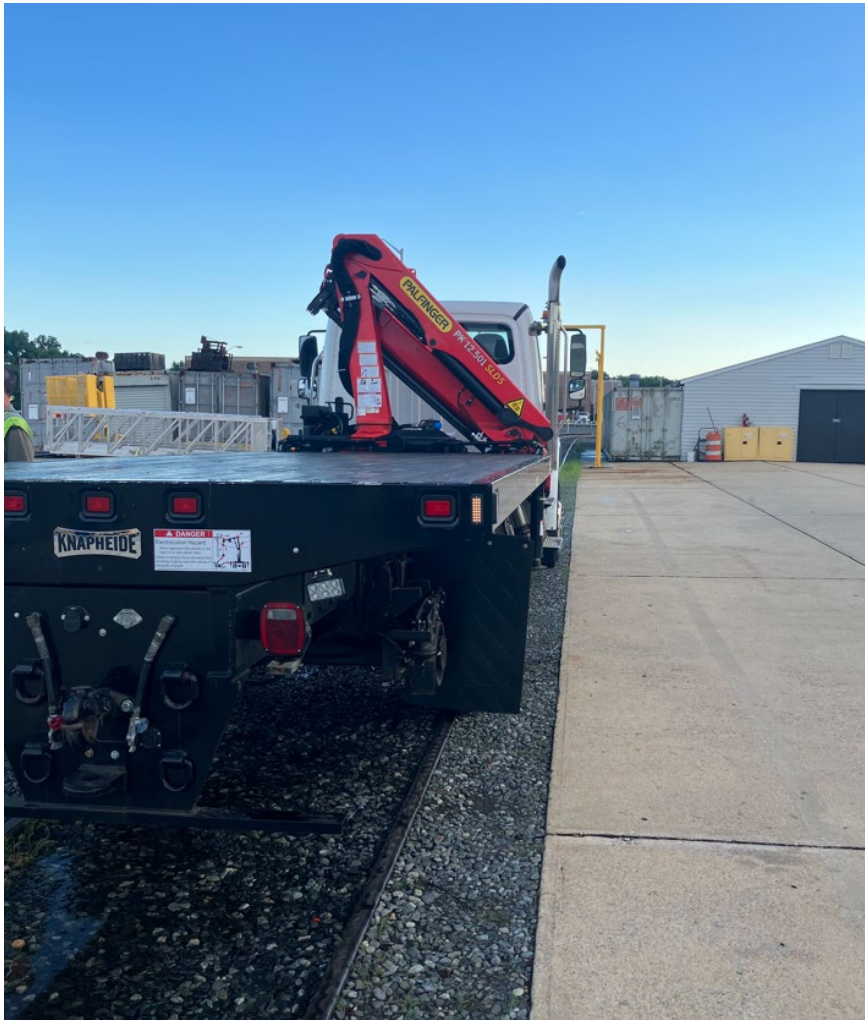
A post-incident inspection of the curve and restraining rail found minor deficiencies, which did not require immediate mitigation. WMATA Subject Matter Experts (SME) examined the vehicle after the event and noted a bend in the vehicle frame that would contribute to the uneven loading of the vehicle. The origin of the defect was not able to be identified but was not observed during the contractor vehicle's certification conducted on April 04, 2023.

The probable cause of the Derailment event on July 1, 2023, at West Falls Church Rail Yard was wheel climb at the point of derailment due to a bend in the vehicle frame that resulted in uneven weight distribution on the road wheels and a lack of rail wheel interface with the right (low) running rail.

Figure 10 –Hi-Rail Unit during inspection at Greenbelt Yard can be observed with a visible lean to the left-hand side indicating uneven weight distribution.

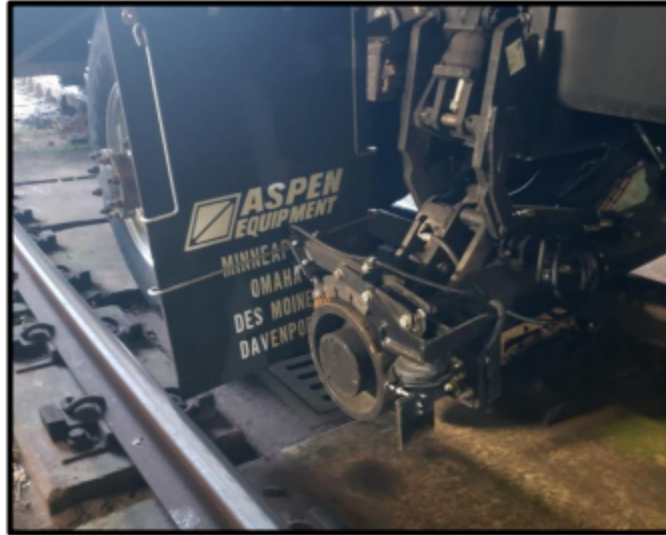
**Figure 1.** CR5971 derailment

Inspection of CR5971 on August 8, 2023, revealed an imbalance in the rear hi-rail gear causing insufficient loading on the right rear rail wheel and is the likely cause of this derailment. The truck frame height measured a one-inch difference between left and right from the ball-of-rail. The insufficient downforce would allow for wheel-climb leading to derailment in the direction of lateral forces.

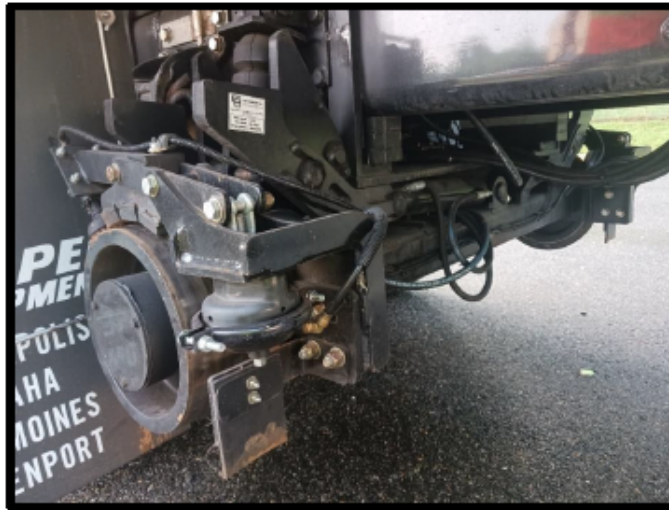
Figure 2. Continental hi-rail gear

- CR5971 hi-rail gear should be reinspected by a certified third-party familiar with Continental hi-rail gear, correcting for any anomalies in the truck frame.
- Hi-rail gear installation should include the recommended rear tire pressure when rail-bound.
- Moving forward, preserve hi-rail incident scenes until hi-rail inspectors arrive.

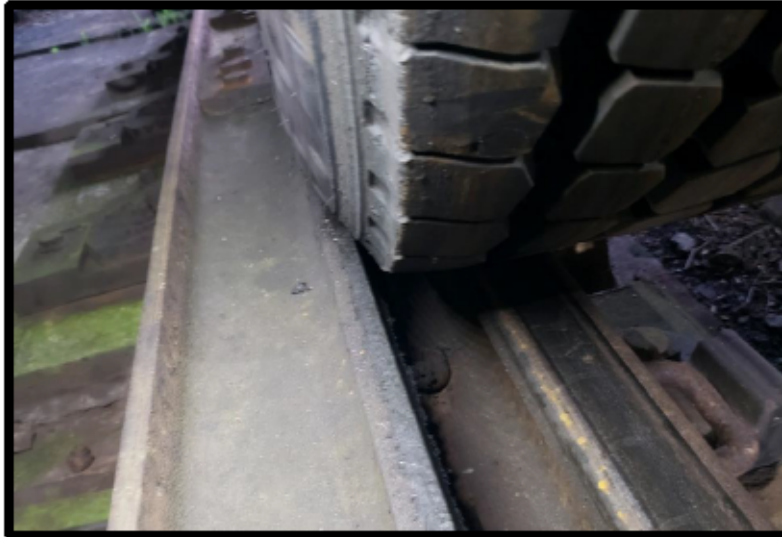
In this condition, the vehicle is not able to offer the necessary resistance to righthand lateral forces. At the incident location there were two sources of righthand lateral forces. One inch of super elevation is present in the radius and the rear tires were in contact the restraining rail (Figure 3). Both of these would cause a right bias in tracking and with less than the needed down force, the flange is able to climb the rail.

Figure 3. Lateral tire forces
