WMSC Inspection Report 20250204

Title: Shady Grove Yard (A99) Service and Inspection Shop Negative Return Cables

Location: Shady Grove Yard (A99) Tracks 2 and 3

Date of Inspection: 2/4/2025

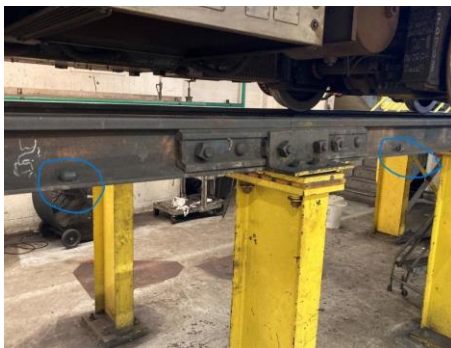
Defect 1

Track 2N, missing negative return cable.

Hazard Rating: 2D

Photo 1: Track 2N showing missing negative return cable.

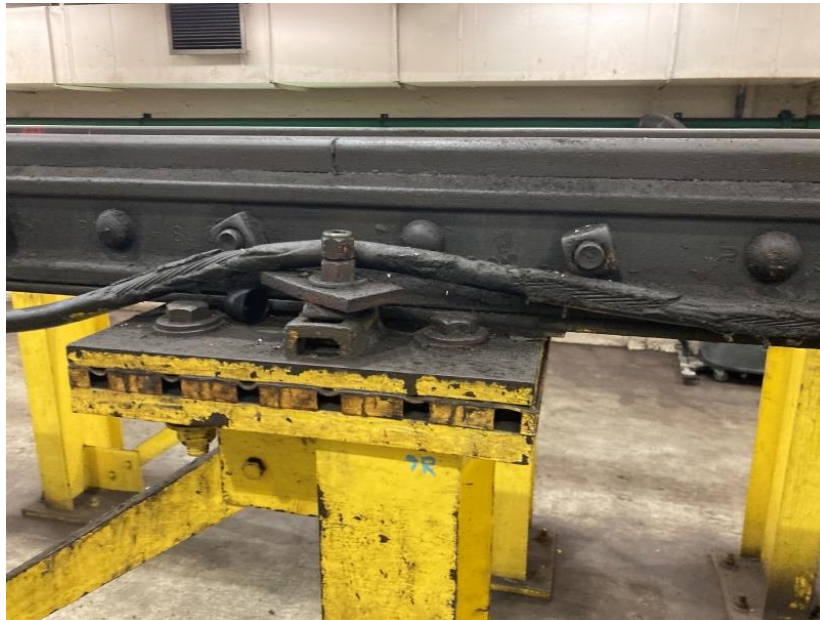
Defect 4

On Track 3N, a negative return cable showed deterioration on the insulated cover.

Hazard Rating: 2D

Photo 2: Negative return cable with insulated cover showing deterioration.

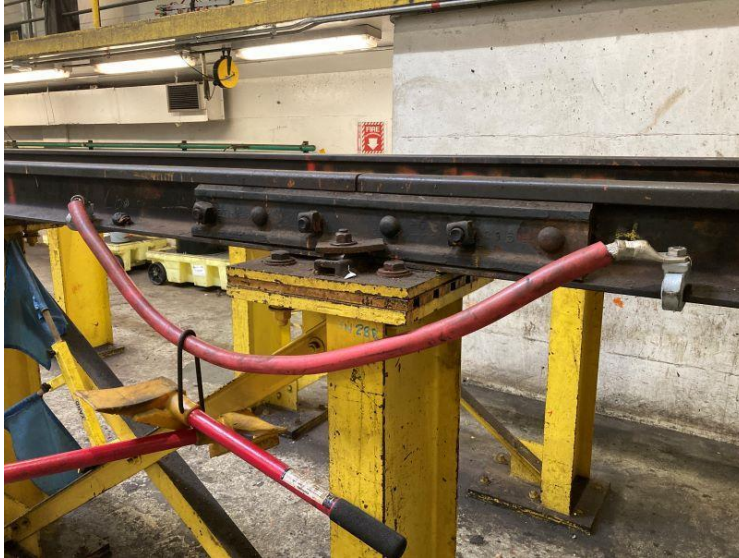
Defect 5

On track 3N, negative return cable with temporary clamps being used to support a wheel chock and otherwise presenting slack in the cable.

Hazard Rating: 3D

Photo 5: Negative return cable with temporary clamps being used to support a chock and presenting slack in the cable.
