# WMSC Inspection Report 20250210

Title: A-Line piers south of Grosvenor-Strathmore Station (A11)

Location: 10201 Rockville Pike (south of A11 Grosvenor-Strathmore Station)

Date of Inspection: 2/10/2025

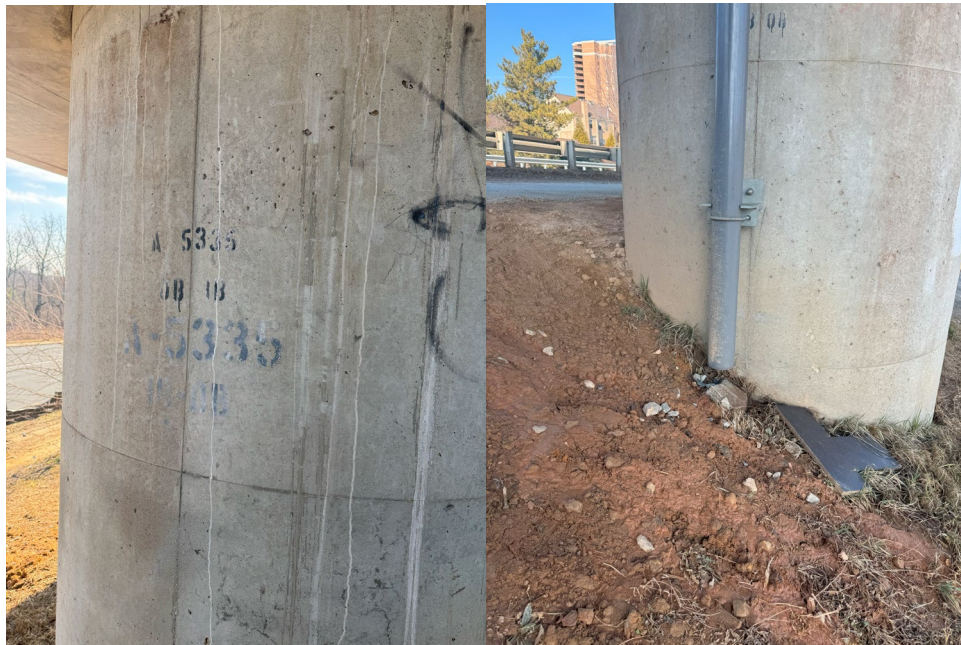
Pier A-5335 exhibiting erosion around base. WMATA's Structural Inspection Manual (TRST-SMI-SIM-REV-2.0, dated 9/27/2021) directs personnel to inspect for erosion around walls and piers (Appendix B, Forms 7 and 8).

**Hazard Rating: 2D**

Photo 1 (left) faded pier identification at pier A-5335. Photo 2 (right) signs of erosion near downspout at pier A-5335.

The pier identifying numbers of 9 other piers that were inspected are nearly unreadable either due to the number disappearing over time, due to graffiti, or both. (Piers: A-5324, A-5335, A-5356, A-5367, A-5376, A-5392, A-5403, A-5419, and A-5435.) For examples, see photos 1 and 7 above.

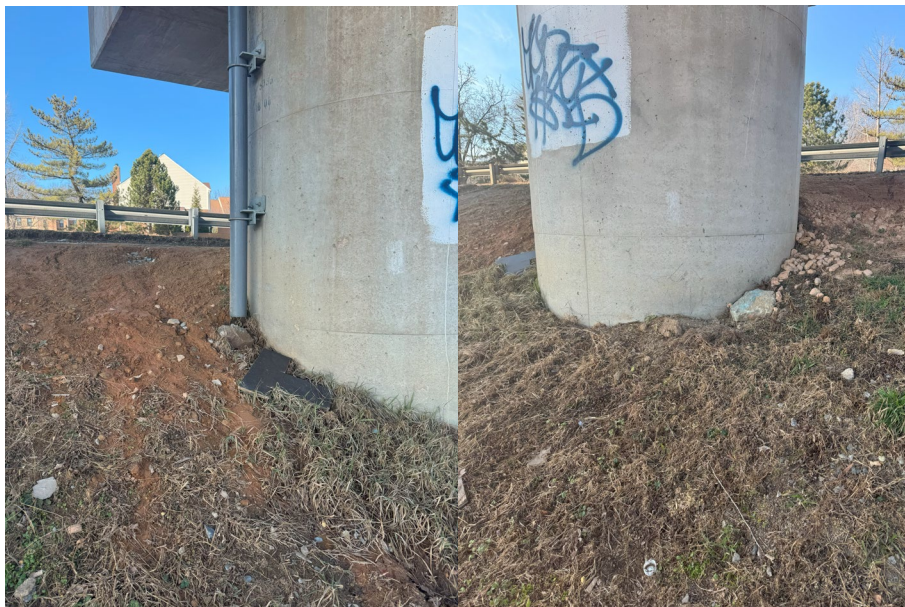
Photo 3 (left) Signs of erosion and exposed soil near base of pier A-5335. Photo 4 (right) opposite side of the same pier (A-5335).

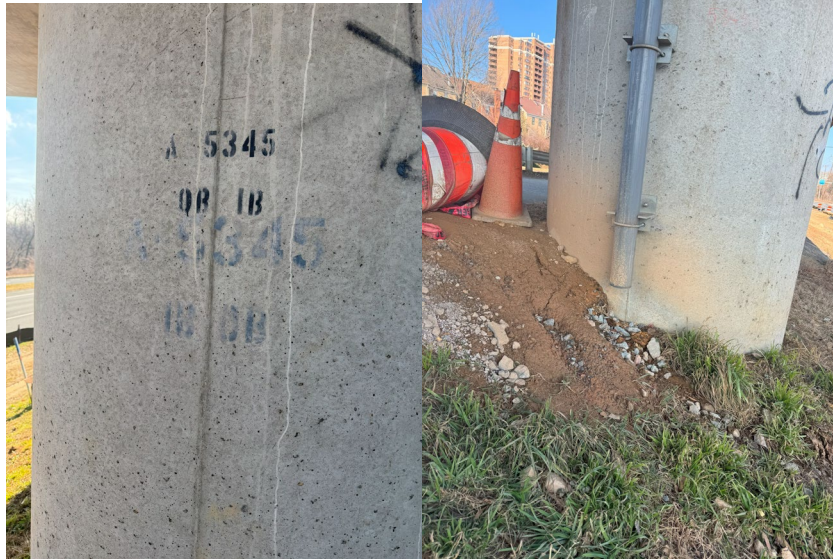
Pier A-5345 exhibiting erosion around base. WMATA's Structural Inspection Manual (TRST-SMI-SIM-REV-2.0, dated 9/27/2021) directs personnel to inspect for erosion around walls and piers (Appendix B, Forms 7 and 8).

**Hazard Rating: 2D**

Photo 5 (left) faded pier identification. Photo 6 (right) exposed soil near base.

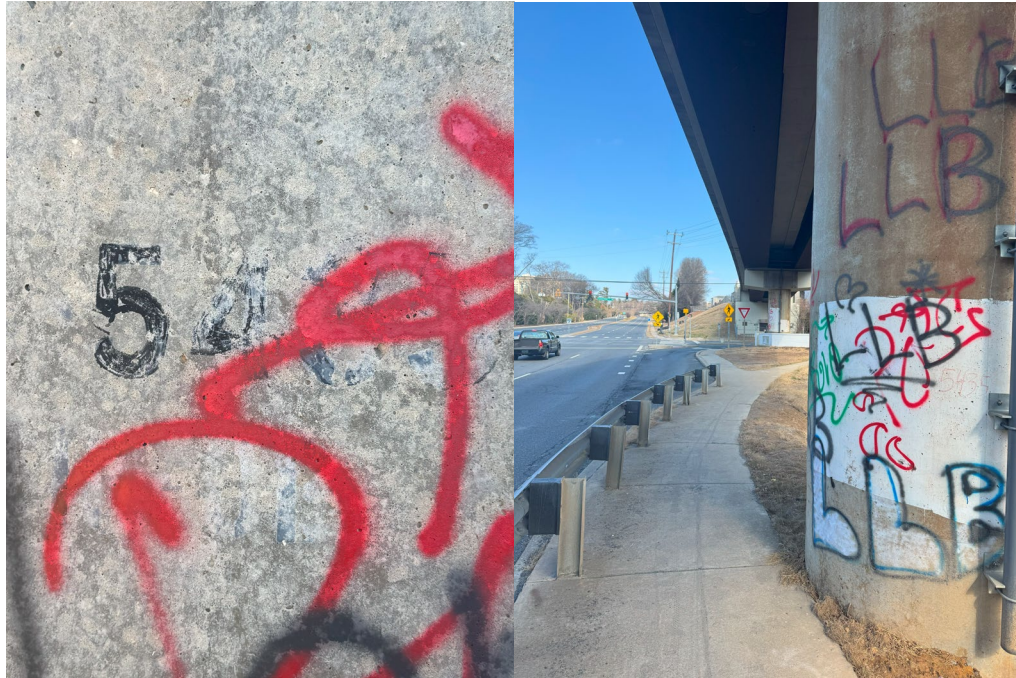
Pier A-5435 exhibiting erosion around base. WMATA's Structural Inspection Manual (TRST-SMI-SIM-REV-2.0, dated 9/27/2021) directs personnel to inspect for erosion around walls and piers (Appendix B, Forms 7 and 8).

**Hazard Rating: 2D**

Photo 7 (left) graffiti and faded pier identification at pier A-5435. Photo 8 (right) pier A-5435 from sidewalk.

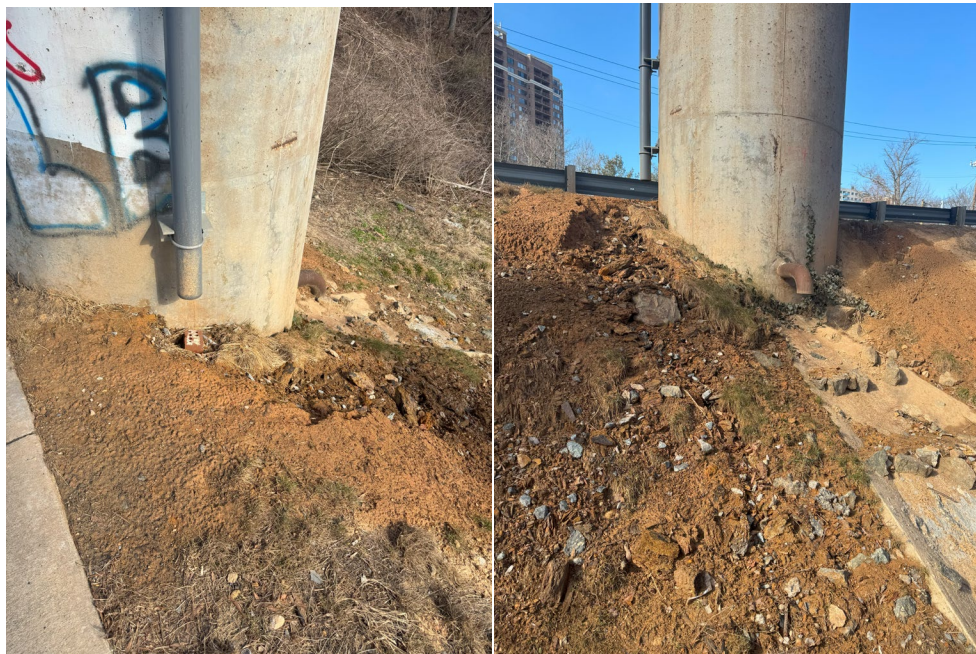
Photo 8 (left) soil erosion at pier A-5435. Photo 9 (right) soil erosion from a different angle at pier A-5435.

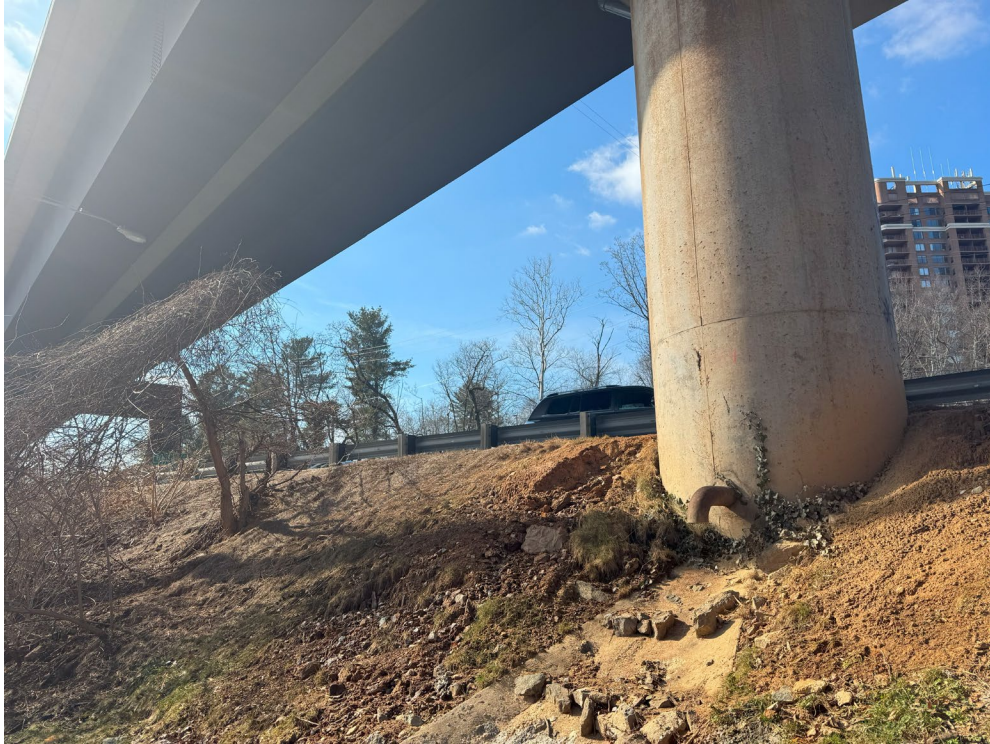
Photo 10 wider angle of pier A-5435 erosion on grade side.

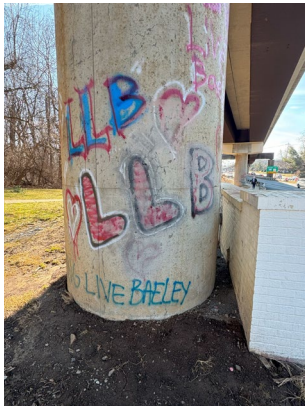
There is no observable identifying number on the pier just north of A-5435.

**Hazard Rating: 4D**

Photo 11 shows an unidentifiable pier north of A-5435.
