Inspection Form

Washington Metrorail Safety Commission

Inspection Date	YYYY/MM/DD 2024/03/08	Report Number	20240308-WMSC-DLB-2
Rail Agency Name	Washington Metropolitan Area Transit Authority	Rail Agency Department	Name
Rail Agency Department	RTRA	Contact Information	
Inspection Location	B09 Forest Glen Georgia Ave. Forest Glen Road

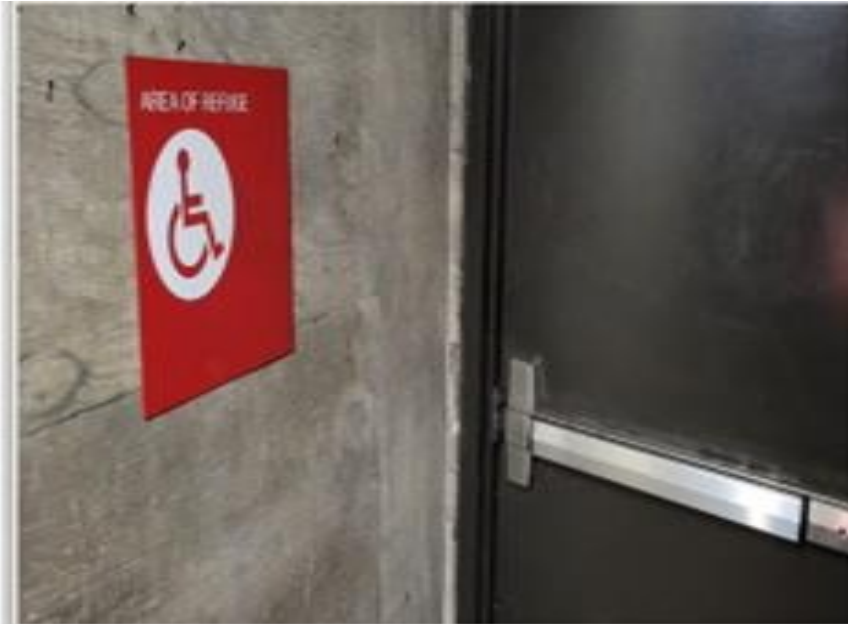
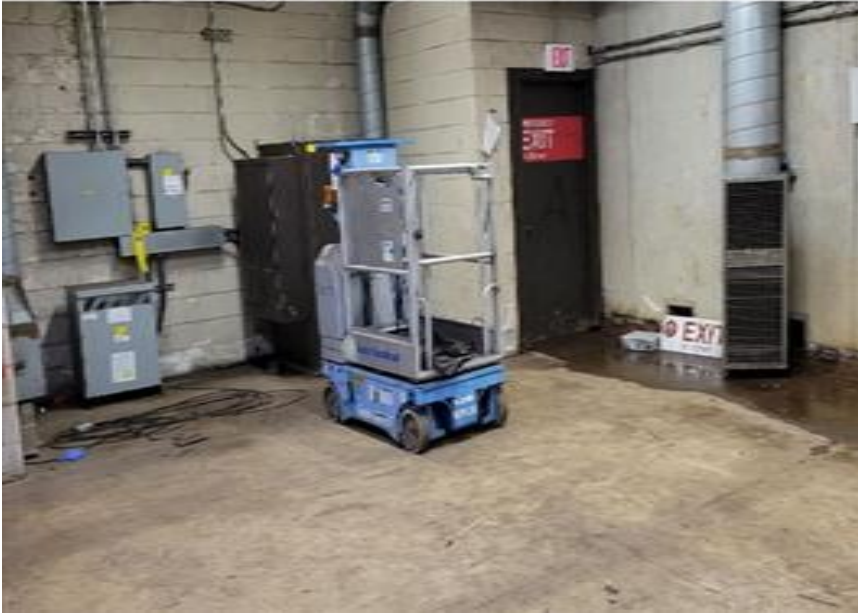
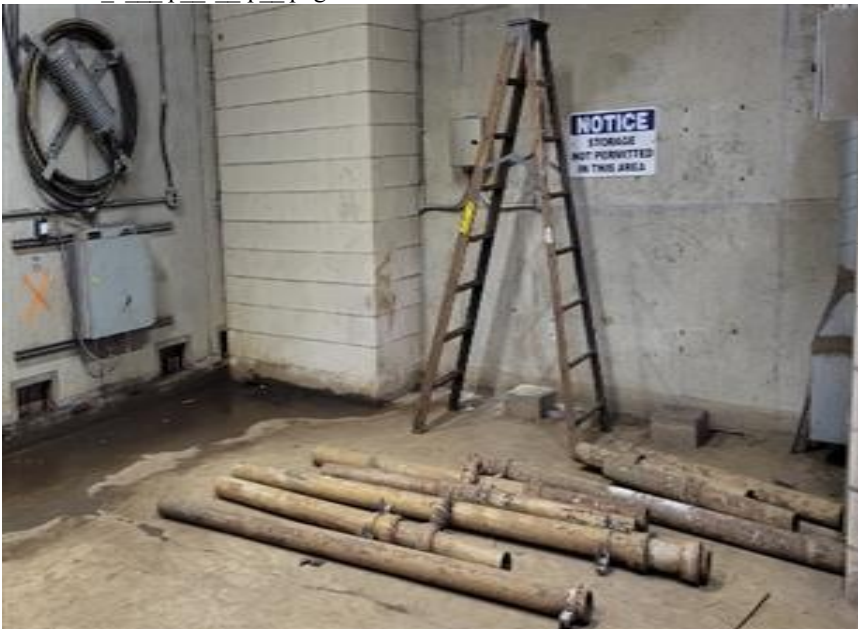
Picture_Set 4 lp_a_rp.png

Inspection Activity #	1	Inspection Subject	Station Fire Life Safety EMGT			Activity Code	PI-EMGT-WT				
Job Briefing Employee Name/Title	N/A.	Accompanied Inspector?	No	Out Brief Conducted	Yes	Time	06:00 AM	Outside Shift	No		
Related Reports	N/A.	Related CAPS / Findings			N/A.						
Related Rules, SOPs, Standards, or Other	Ref	Rule or SOP			Standard	Other / Title			Checklist Reference		
	N/A.	N/A.			N/A.	N/A.			N/A.		
Inspection Location	Main Track	Yard	Station	OCC	RTA Facility	WMSC Office	Track Type	At-grade	Tunnel	Elevated	N/A
	X		X								X
Line(s) & Track Number	B09 Forest Glen Georgia Ave. Forest Glen Road				Chain Marker and/or Station(s)	From			To		
						CM 546 + 00			CM 540 + 00		
Vehicles	Head Car Number		Number of Cars		Equipment	N/A.					
	N/A.		N/A.								
Description	<p>BACKGROUND: The WMSC became aware of several life safety concerns on March 8, 2024, during an inspection of the Forest Glen Station. The life safety concerns require Metrorail to evaluate the conditions and immediately mitigate the identified safety hazards.</p> <p>OBSERVATIONS/FINDINGS: The Forest Glen Station inspection identified 4 safety concerns that require Metrorail's immediate attention. 1. C625 Emergency Use Only (Access Door) on the platform level has Low/dim Lighting which introduces Slip, Trip, Fall Hazards to the evacuating public during an emergency. See Picture Set 1. 2. The hazard identified in number one above is further compounded by items inside the emergency access room C625 (Bucket and gate obstacle). These items introduce a tripping hazard in an emergency evacuation situation. See Picture Set 2. 3. Fan Room 612 adjacent to the area of refuge - Unsecured door. The door is malfunctioning and will not lock or remain closed. Fan controls are exposed to trespassers for potential tampering. See Picture Set 3. 4. Area Of Refuge It is currently being used for storage of construction material, a man lift and a ladder. This diminishes the capacity of the Area of Refuge for holding people during an emergency condition. See Picture Set 4.</p>							Number of Defects		4

Recommended Finding?		Yes	
								Remedial Action Required?		Yes	
								Recommended Reinspection?		Yes	
Remedial Action	Implement all of the corrective actions required in this report. Refer to the conclusion section for the necessary mitigations..
