WMSC Inspection Report 20250228

Title: Station Emergency Egress Routes and Areas of Refuge

Location: Green Line, F01 to E08

Date of Inspection: 2/28/2025

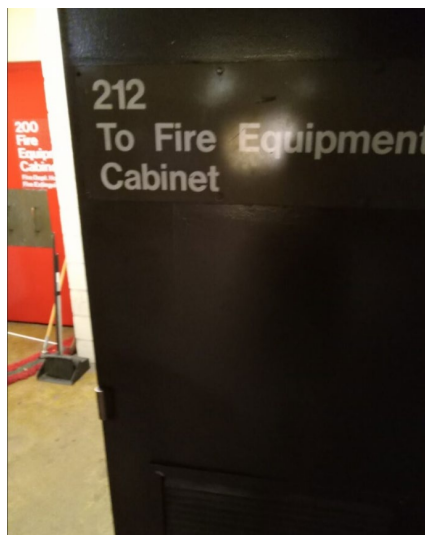
Defect 1

At Shaw-Howard U Station (E02), items are stored in front of emergency cabinet 200.

Hazard Rating: 4D

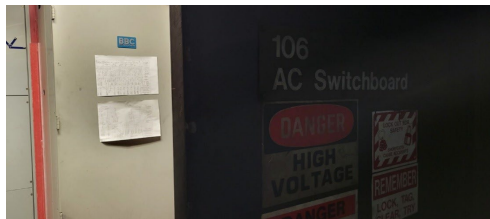
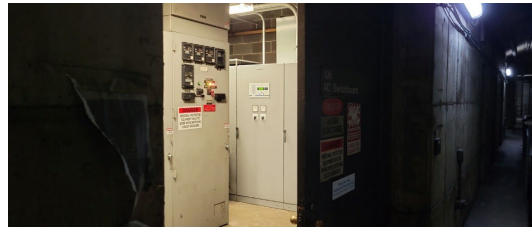
U St AC Room 106 open

At U Street Station (E03) AC Switchboard room 106 was open.

During the inspection, this potentially hazardous condition was identified as an Immediate Safety Concern that was immediately conveyed to the Power Desk at the Maintenance Operations Center (MOC). The MOC told the inspectors they were sending a crew to mitigate the safety issue.

Hazard Rating: 1D

Additionally, WMSC notified WMATA of the Immediate Safety Concern again via email on Friday, February 28, 2025, in accordance with Program Standard Section 6.F.2.a. In response to the WMSC's email, WMATA emailed WMSC back on February 28, 2025, showing photographic evidence of the mitigated open U Street Station (E03) AC Switchboard room 106.

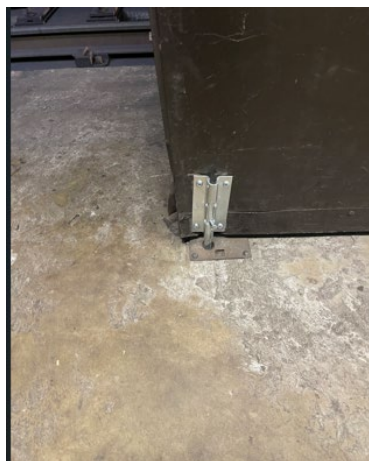
U St AC Room 106 – Door Repaired (picture provided by Metrorail)

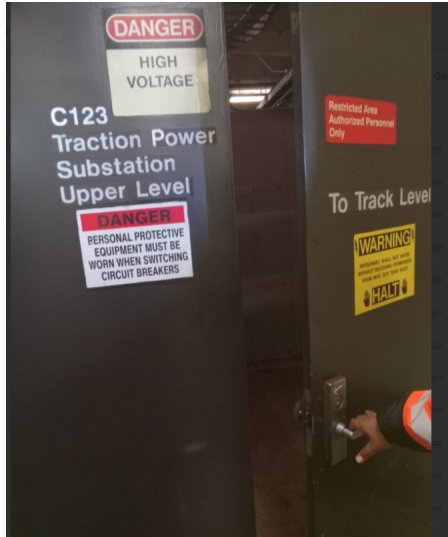
Defect 3

At Columbia Heights (E04), Traction Power room C123 was open and not secured. Door was closed and secured by WMSC inspectors.

Hazard Rating: 1E

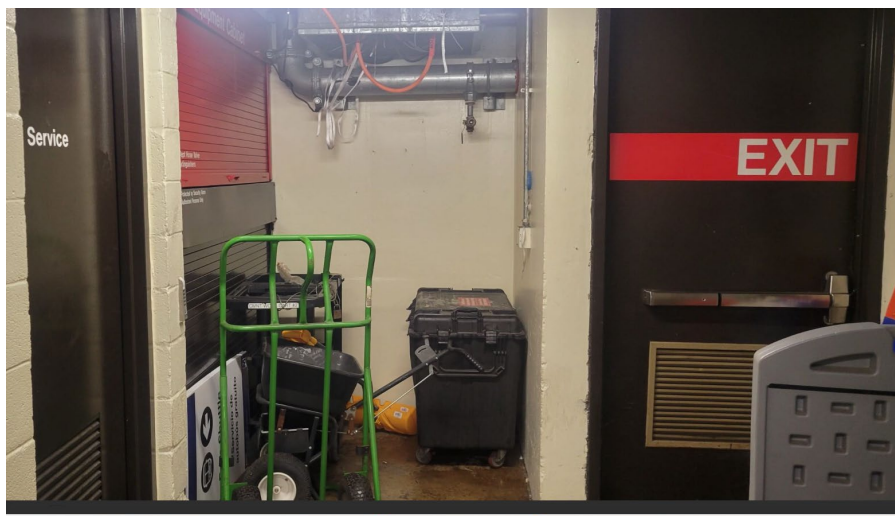
At Fort Totten (E06), emergency cabinet C104 was blocked. This was mitigated by the station manager.

Hazard Rating: 2E

Cabinet C104 was blocked

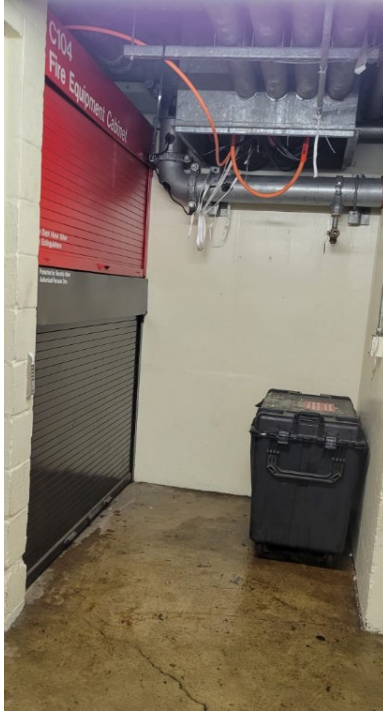
Fort Totten emergency Cabinet C104 corrected by Station Manager

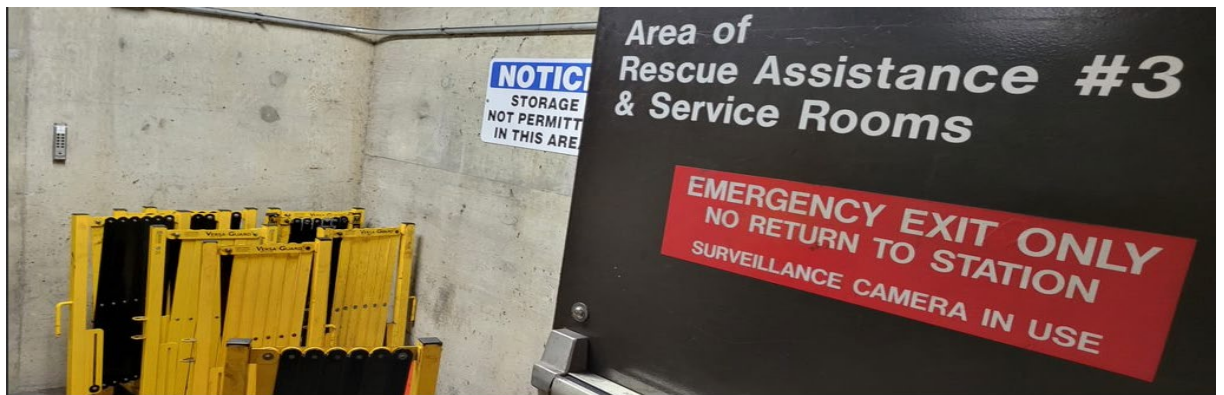
Defect 5

Georgia Ave-Petworth (E05), Area of Rescue #3 has a sign stating that storage is not permitted, but gates are stored that require immediate removal.

Hazard Rating: 2D

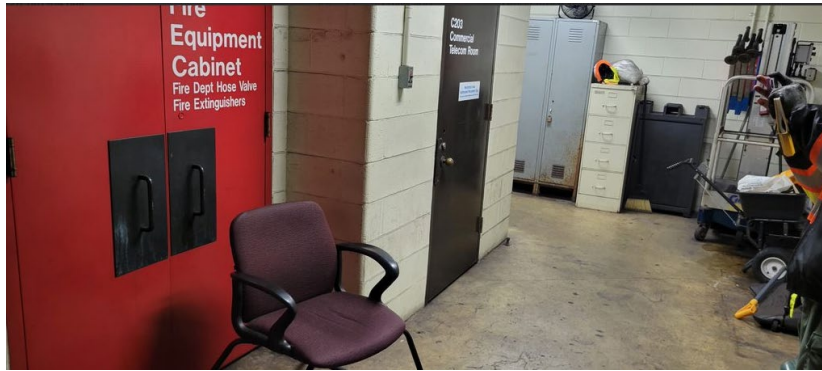
Defect 6

Georgia Ave-Petworth (E05), fire equipment cabinet C201 has chair obstructing door. Chair removed by WMSC inspectors. Other Items still require immediate removal by Metrorail.

Hazard Rating: 3D

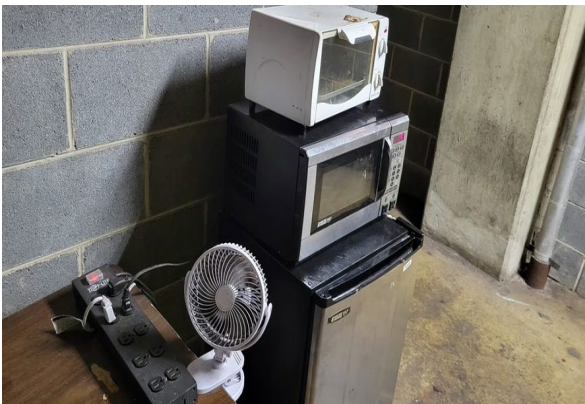
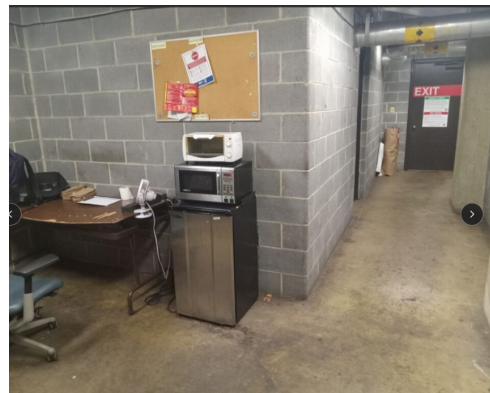
Defect 7

At George Ave-Petworth (E05), toaster oven and microwave plugged into a power strip and not directly plugged into an outlet.

Hazard: 2D

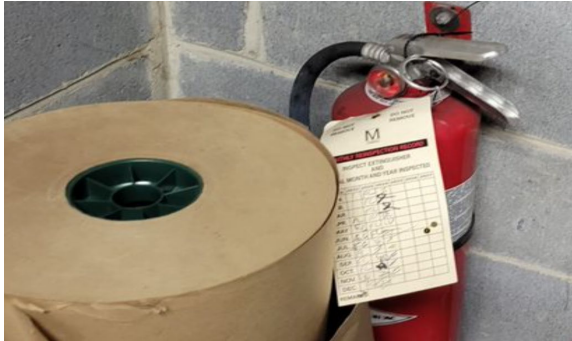
Defect 8

At Georgia Ave-Petworth (E05), the fire extinguisher in the room with the toaster oven is past due for inspection and was last inspected in November 2024. Items are stored in front of and block access to this fire extinguisher.

Hazard Rating: 2D

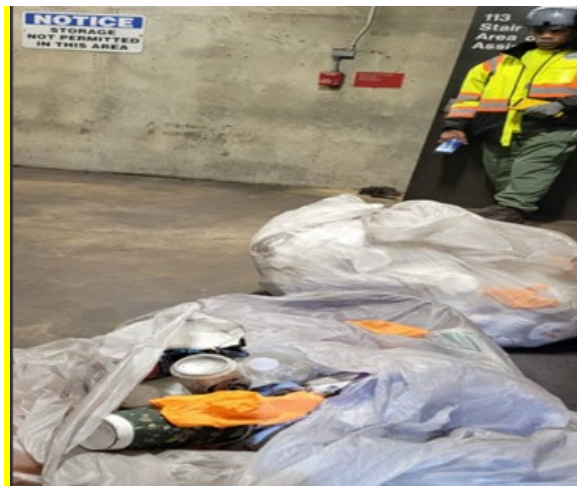
Defect 9

At Georgia Ave-Petworth (E05), area of assistance room 113 has trash bags stored. Room 113 is labeled with a sign stating, "storage not permitted in this area".

Hazard Rating: 2D

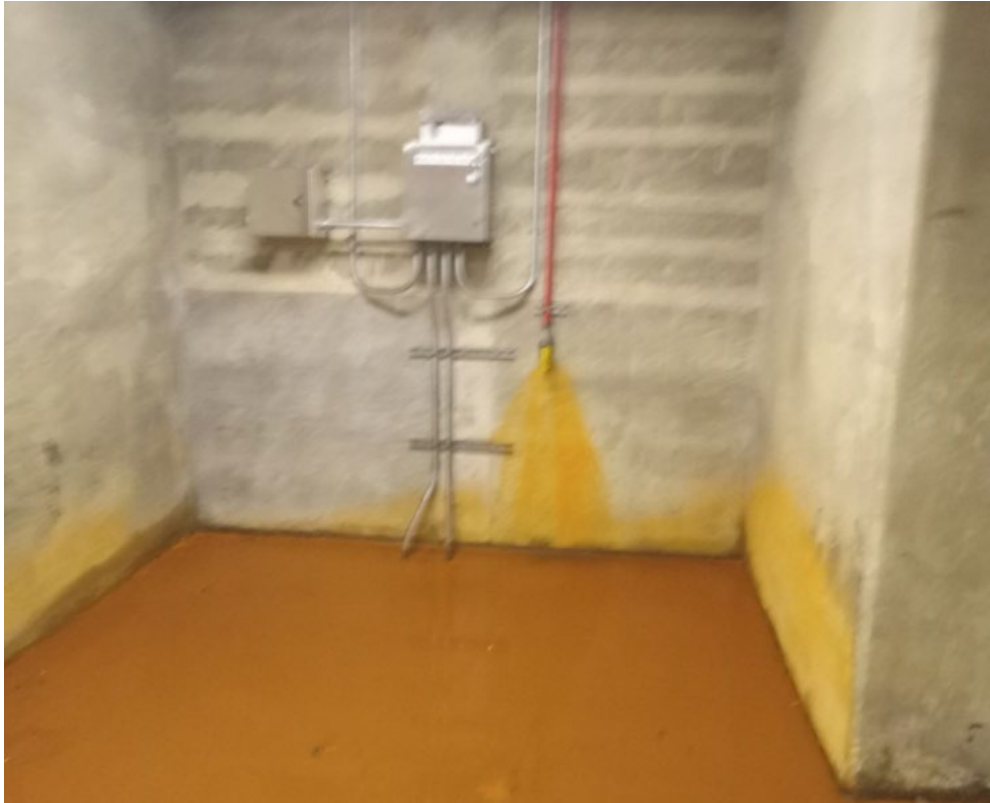
Defect 10

At Georgia Ave-Petworth (E05), Track 2 outbound area of rescue #2 has water and mud intrusion problems. The slippery mud and water create hazardous conditions in the event of an emergency

Hazard Rating: 1E

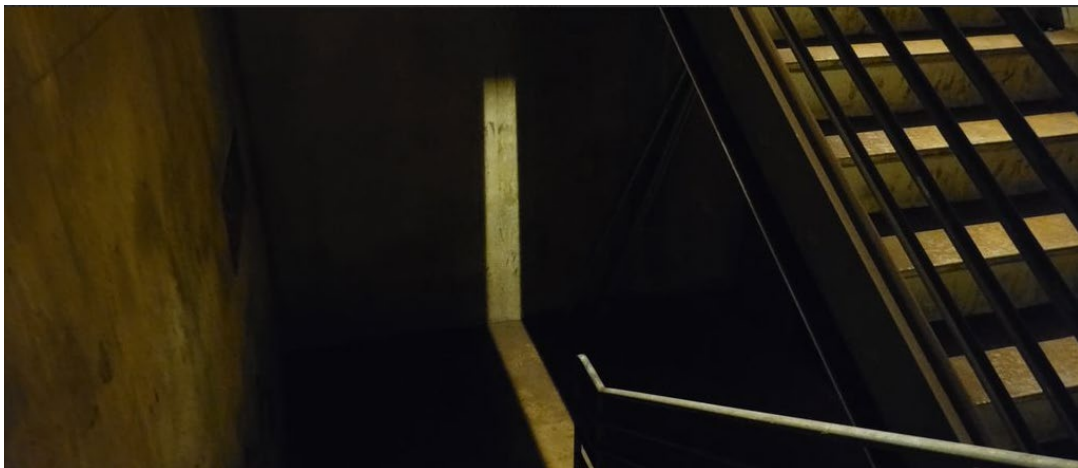
Defect 11

At Georgia Ave-Petworth (E05), exit stairs with lights not functioning (five of the first eight lights).

Hazard Rating: 1E
