# WMSC Inspection Report 20250314

Title: Train Control Room (TCR) Inspection

Location: A01, B01, B02, B03, B35, B04, B05, B07, B10

Date of Inspection: 3/14/2025

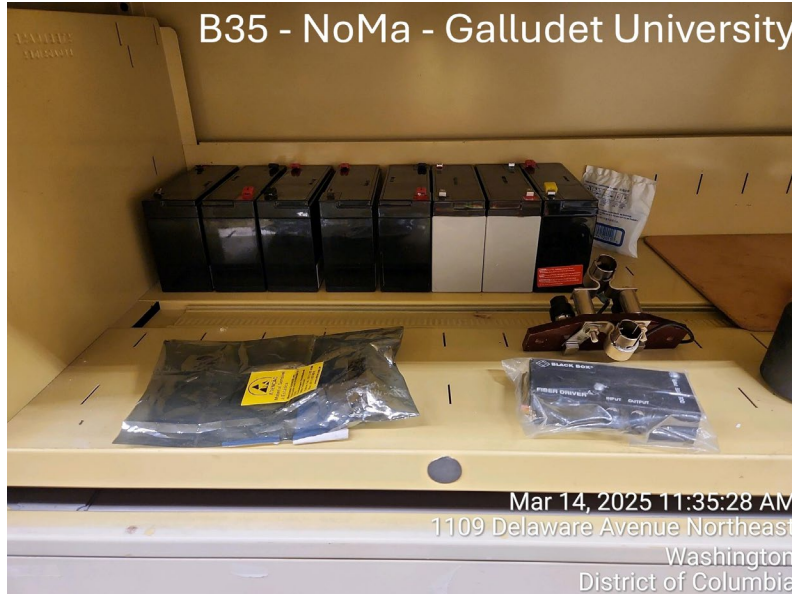
During inspection, lead acid batteries were found that did not have their metallic leads guarded and that were stored within metal lockers often neighboring accelerants such as paper and chemicals. Such batteries encountering other metals can cause sparks which could lead to a fire. This condition was observed at B35 NoMa-Gallaudet U Station and immediately reported to the present Assistant Director, Automatic Train Control Maintenance (ATCM), who was on site during the inspection and who contacted the local area supervisor for mitigation. At the time of discovery, the batteries were removed from their metal cabinet to an open-air space, their leads taped and removed for proper disposal from the TCR.

During the inspection, this potentially hazardous condition was identified as an Immediate Safety Concern that was immediately conveyed to ATCM Assistant Director and as noted above, was mitigated on-site during the inspection.

**Hazard Rating: 3B**

Additionally, WMSC notified WMATA of the Immediate Safety Concern again via email on Monday, March 17, 2025, in accordance with Program Standard Section 6.F.2.a. In response to the WMSC's emailed Immediate Safety Concern, Automatic Train Control Maintenance advised that the batteries had been relocated to the Car Maintenance shop at Brentwood Yard for proper disposal.

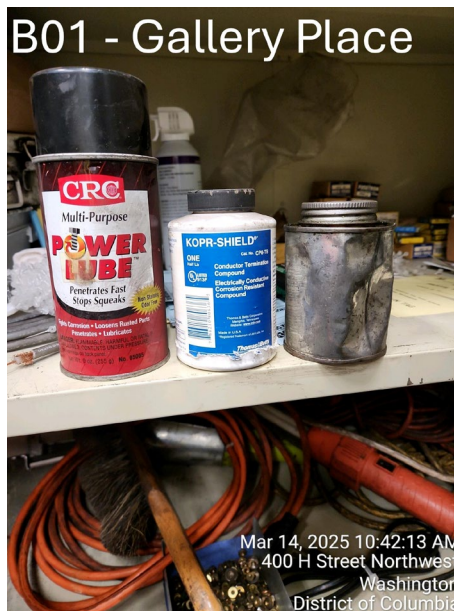
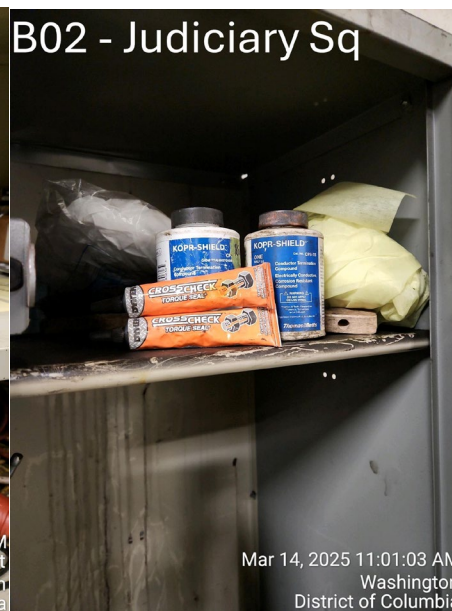
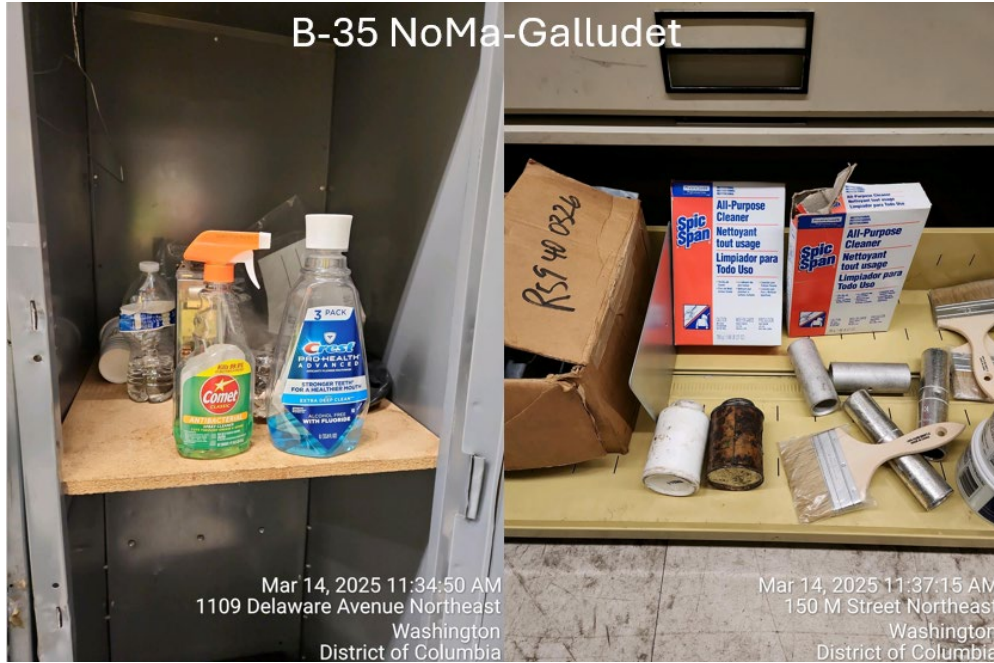
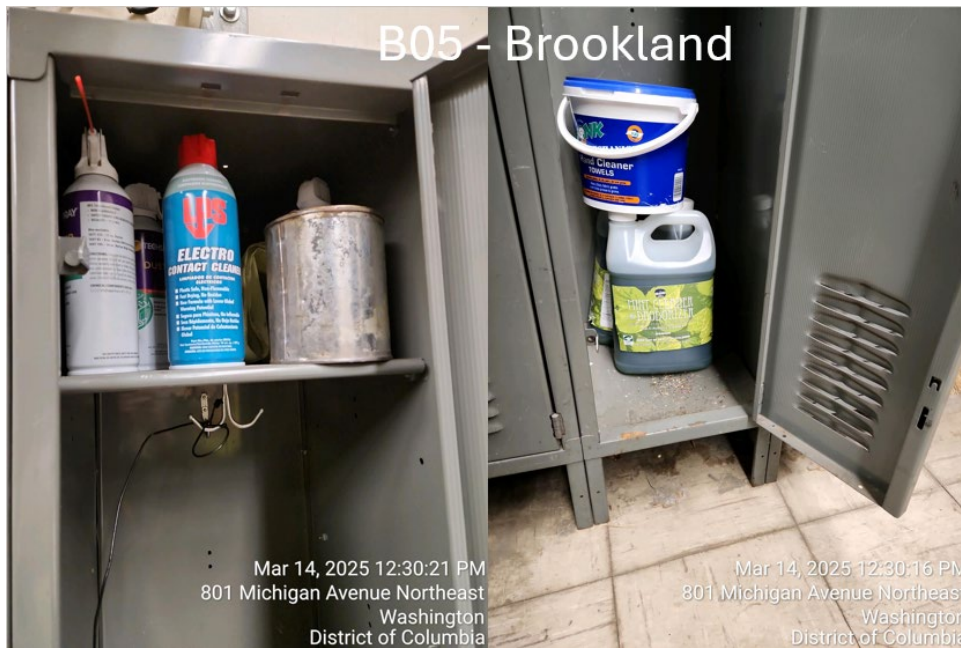
In 4 of the 9 TCRs (B01, B02, B35, and B05) hazardous material or chemicals were observed in the room that included combustibles, flammables, and corrosives (see photos below).

**Hazard Rating: 3B**

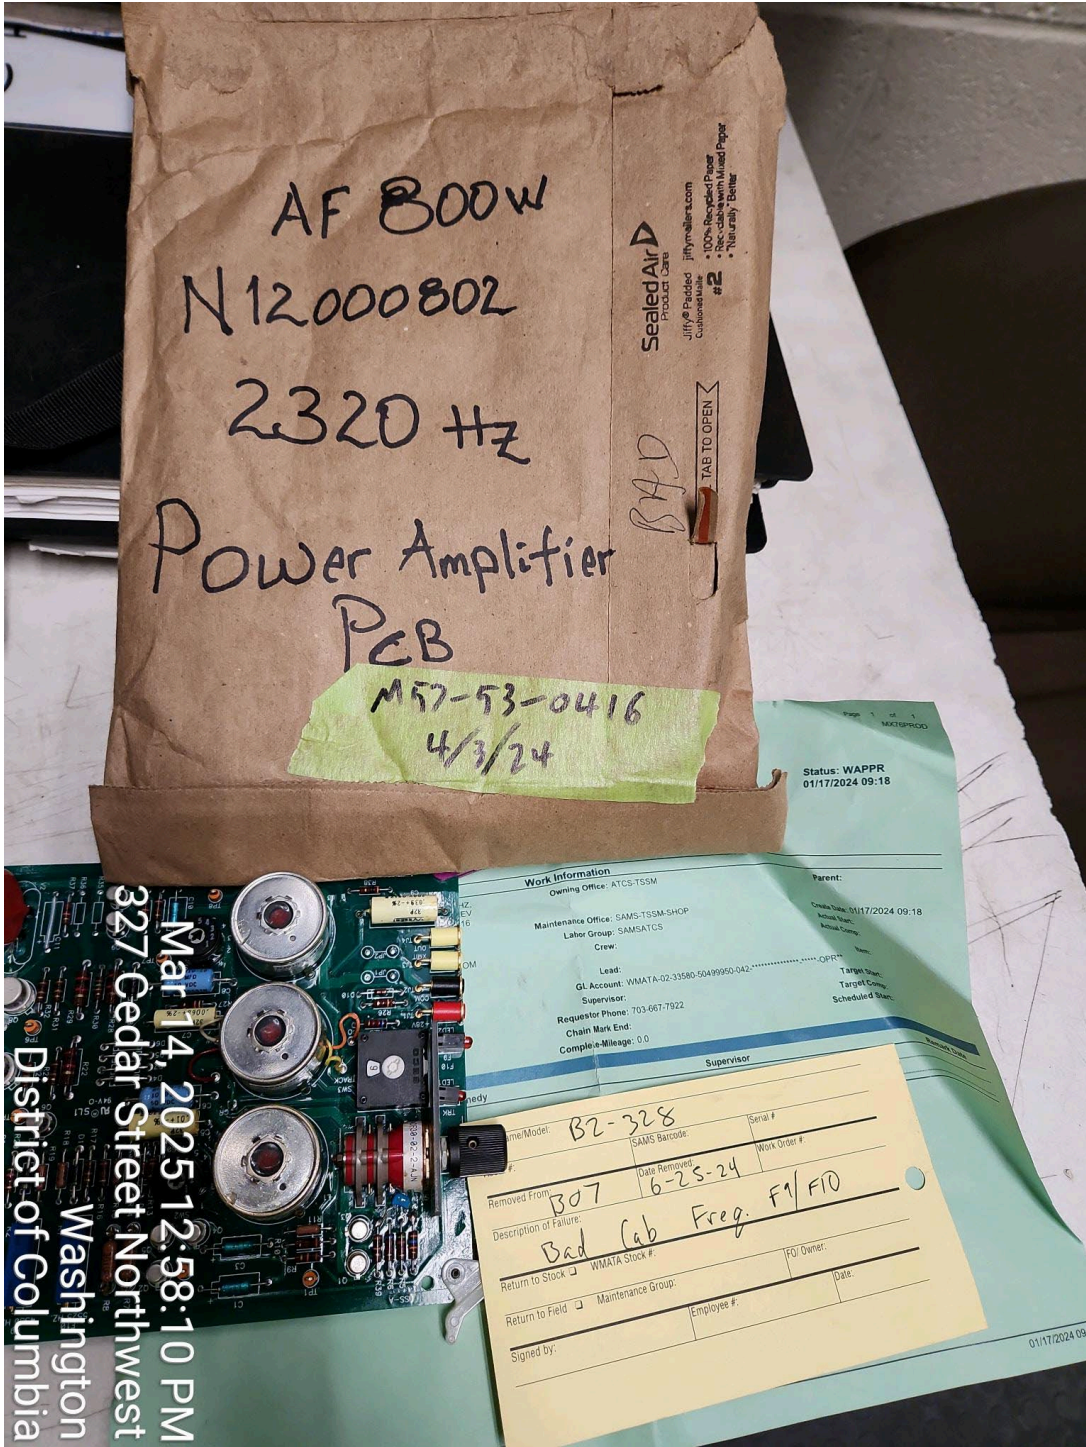
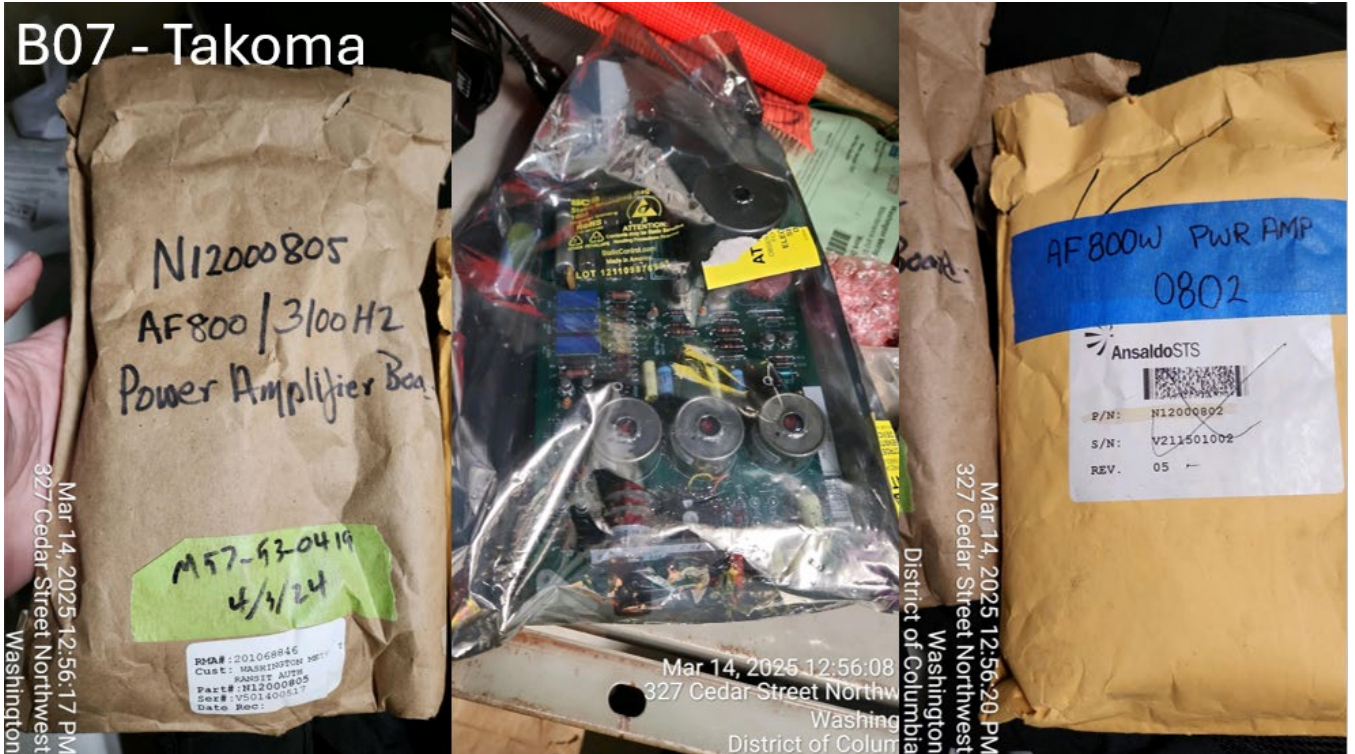
Four AF800 Power Amplifier boards were found at the B07 Takoma Train Control Room sitting inside a cabinet. These power amplifiers are a vital piece of equipment that is used during testing and verification to take measurements when conducting train (cab level) testing. It is unclear as to when these boards were brought into the room as they were not present during the inspection that occurred December 5, 2024. The concern is that some of these boards were marked defective as of June 25, 2024, but were still being stored out in the field. The yellow tag indicating defective

was not attached to the board and instead had to be retrieved out of the bottom of the containing sleeve the board was stored in. The integrity of this group of boards is unknown. The boards found during this inspection were removed by WMATA personnel.

**Hazard Rating: 1D**

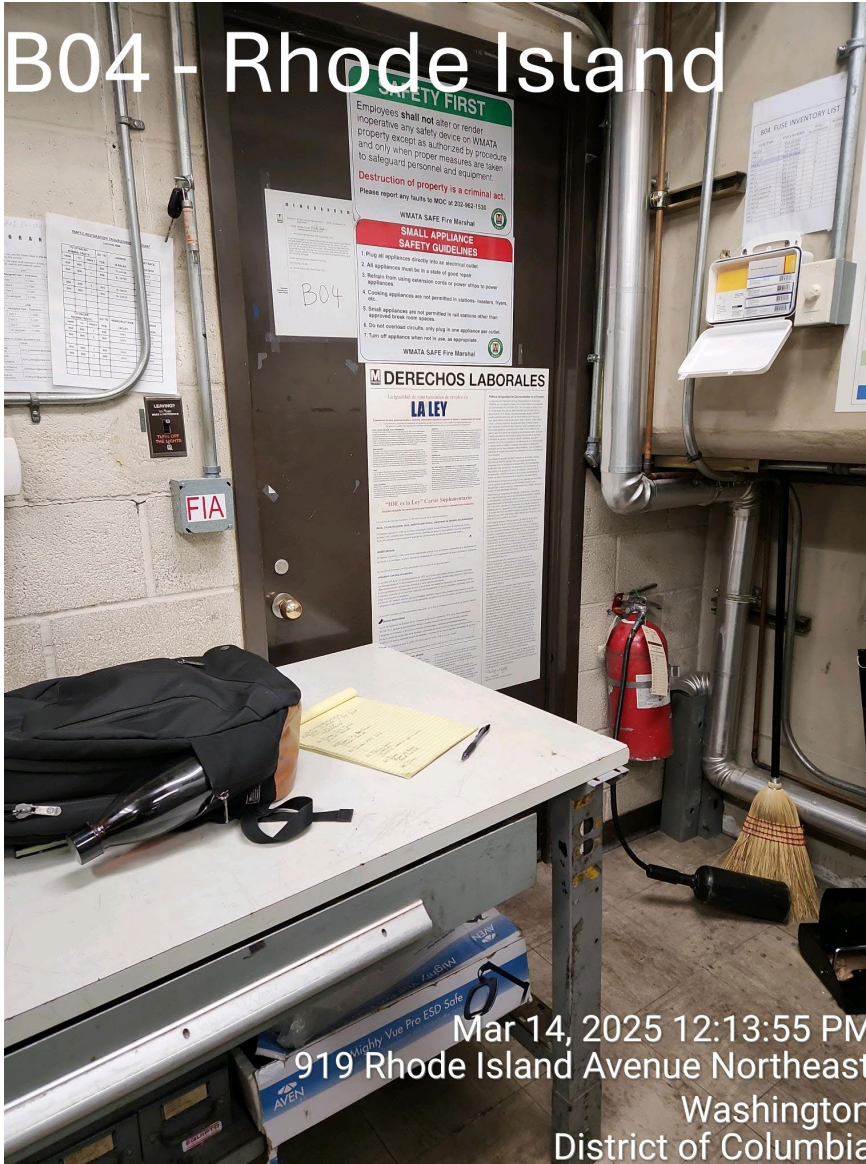
# B04 - Rhode Island

The egress from the TCR at B04 Rhode Island Ave Station is blocked by a table. This creates hazardous conditions in the event an evacuation from the TCR is necessary.

**Hazard Rating: 2D**

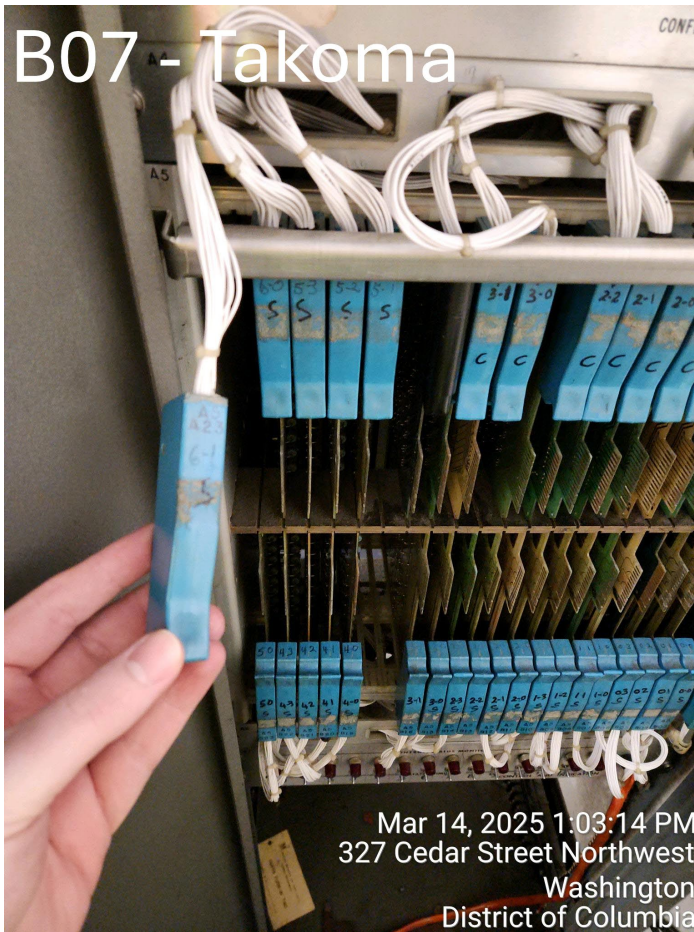
There were unsecured connections located in the RTU at B07 Takoma for reasons that could not be identified or determined while on site and no blue tag was found.

**Hazard Rating: 3B**
