W-0360 – Derailment – near Naylor Road Station – May 17, 2024

Washington Metropolitan Area Transit Authority
Department of Safety (SAFE)
Office of Safety Investigations (OSI)
FINAL REPORT OF INVESTIGATION A&I E24385

Naylor Road Station – Derailment

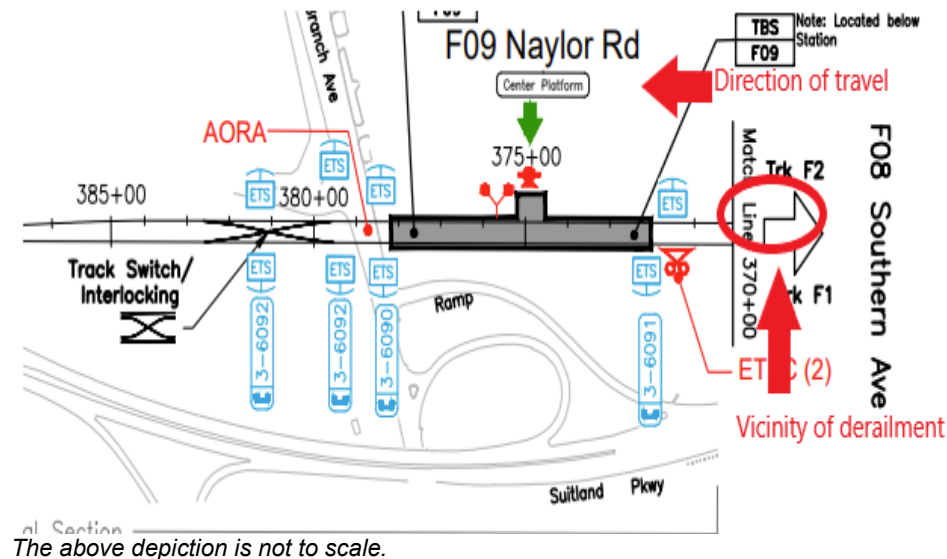
Field Sketch/Schematics

Naylor Road Station, track 2, CM F2 369+00.

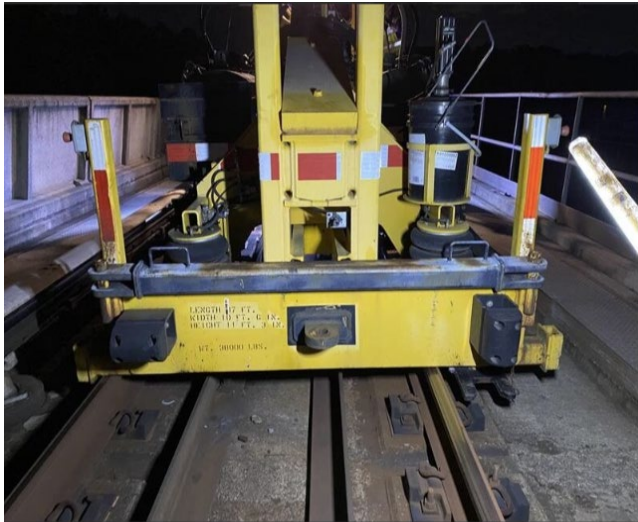
Image 1: Depicts the front of TR05.

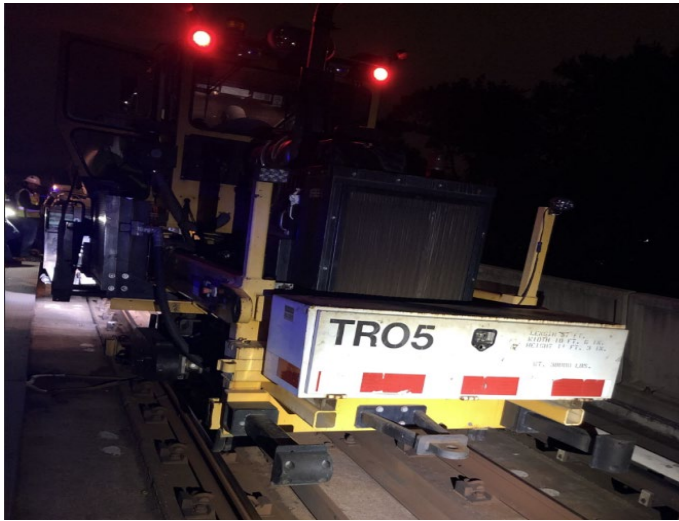
Image 2: Depicts the rear of TR05.

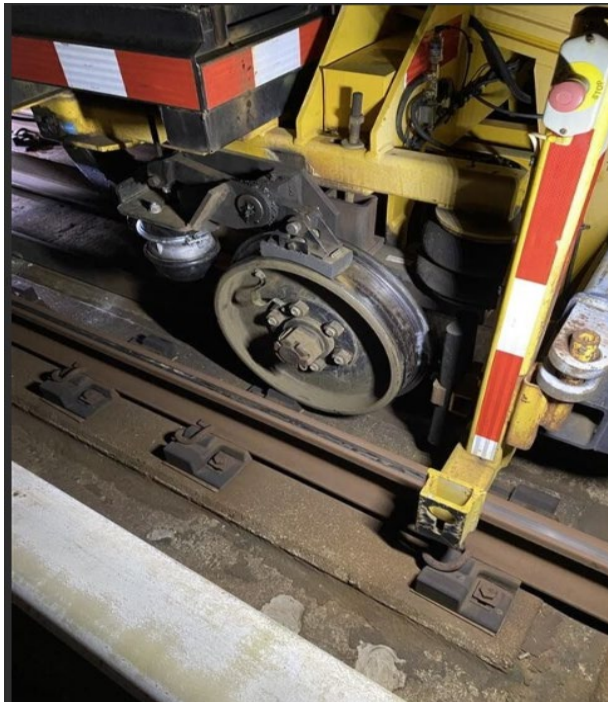
At 01:23 hours, a Track and Structure (TRST) Supervisor contacted the Button RTC via landline and advised that TR05 derailed while ascending on track 2, at chain marker (CM) F2 369+00, traveling at 2 MPH.¹ outside the platform limits of Naylor Road Station.

Image 3: Shows TR05 right front wheel that derailed.

¹ According to the CENV Incident and Derailment Report TR-05 was traveling at 7mph prior to the derailment.

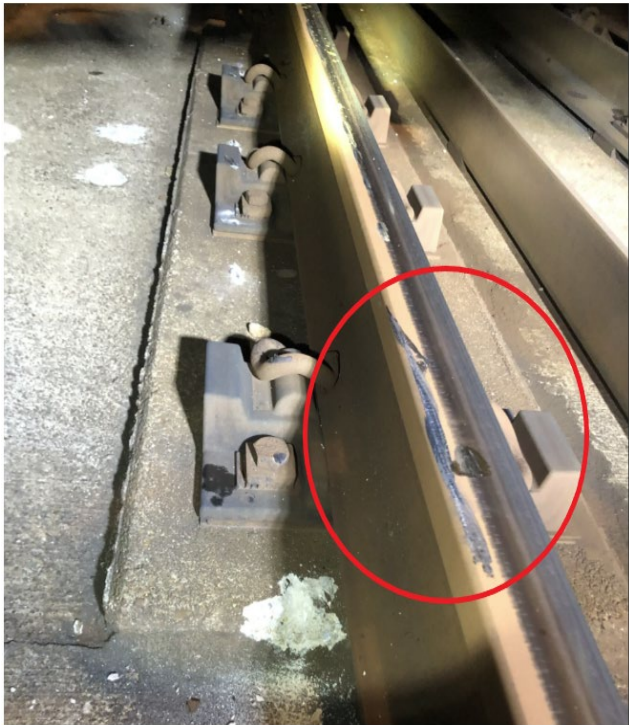
Image 4: Shows the Point of Derailment.

The probable cause of the Derailment event on May 17, 2024, at Naylor Road Station resulted from a wheel climb initiated by TR05 traveling at an excessive speed (more than 5mph) in work mode in a spiral transition curve. A contributing factor is that TR05 does not have enough wheel torque to negotiate an incline radius while operating in travel mode, which prompted the equipment operator to place TR05 in work mode, causing uneven wheel loading.

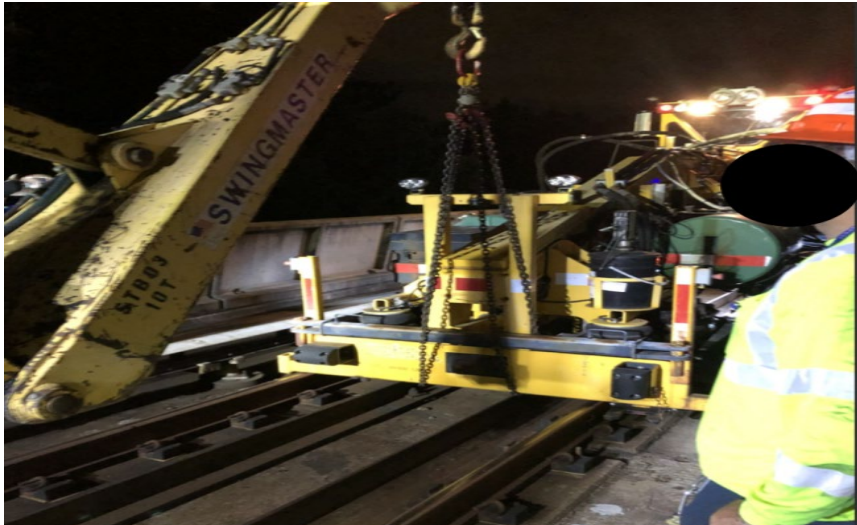
At 02:54 hours, the TRST Supervisor advised the Radio RTC that TR05 was re-railed and awaiting the convoy to Branch Avenue Yard.

Image 5: Shows SM03 assisting with the re-railing of TR05.

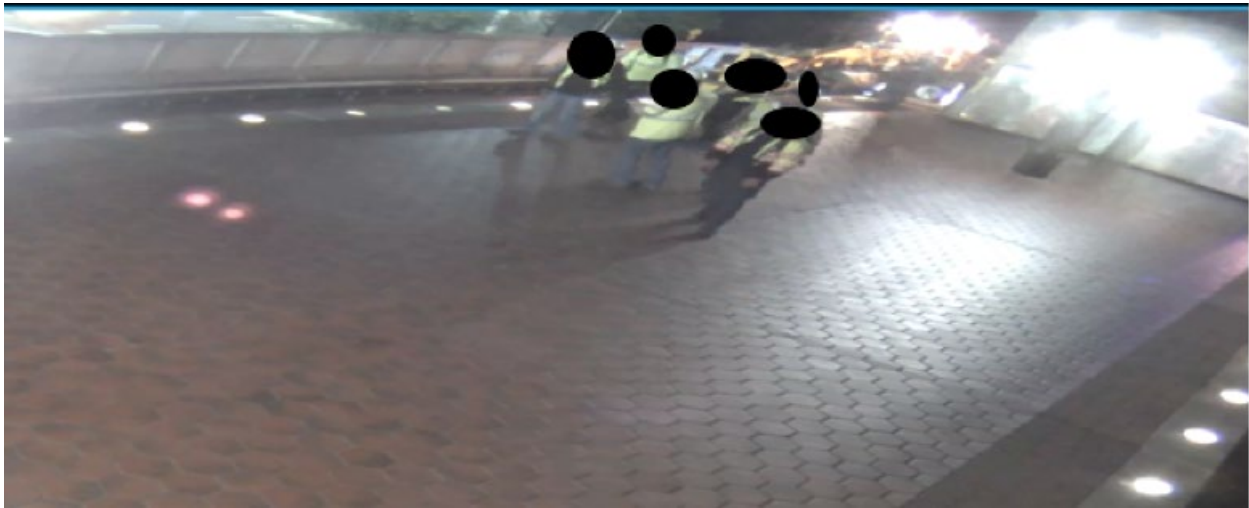
Image 6: Shows TRST personnel cleared the roadway at 03:01 hours.

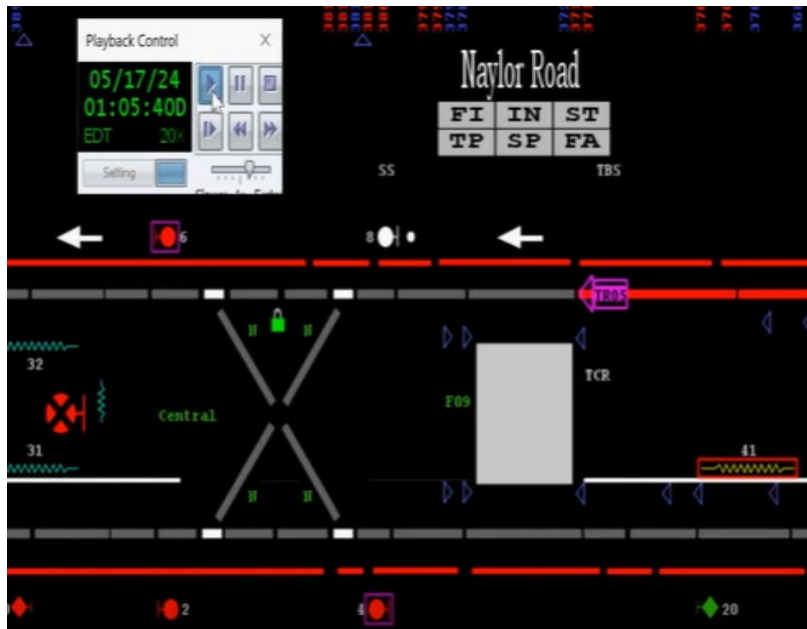
Figure 1: Shows TR05 arriving at Naylor Road Station.

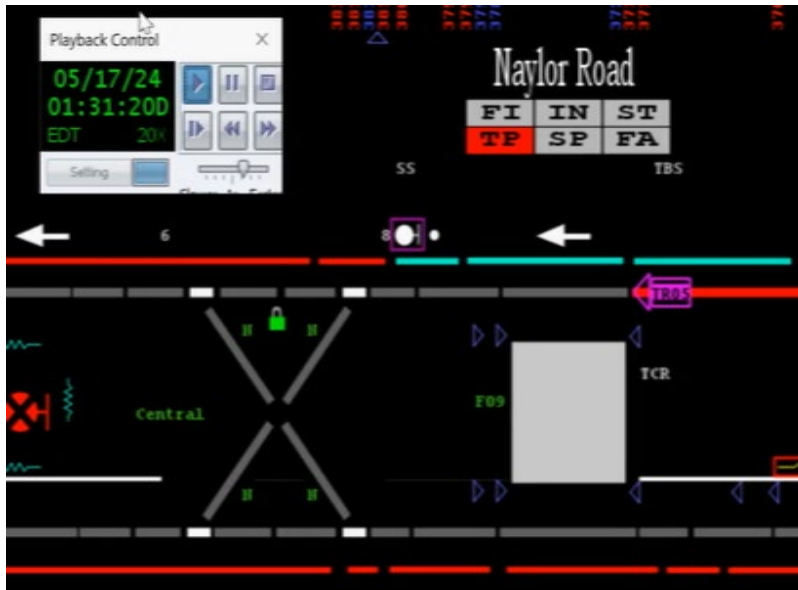
Figure 2: Shows 3rd power de-energized at 01:31 hours.

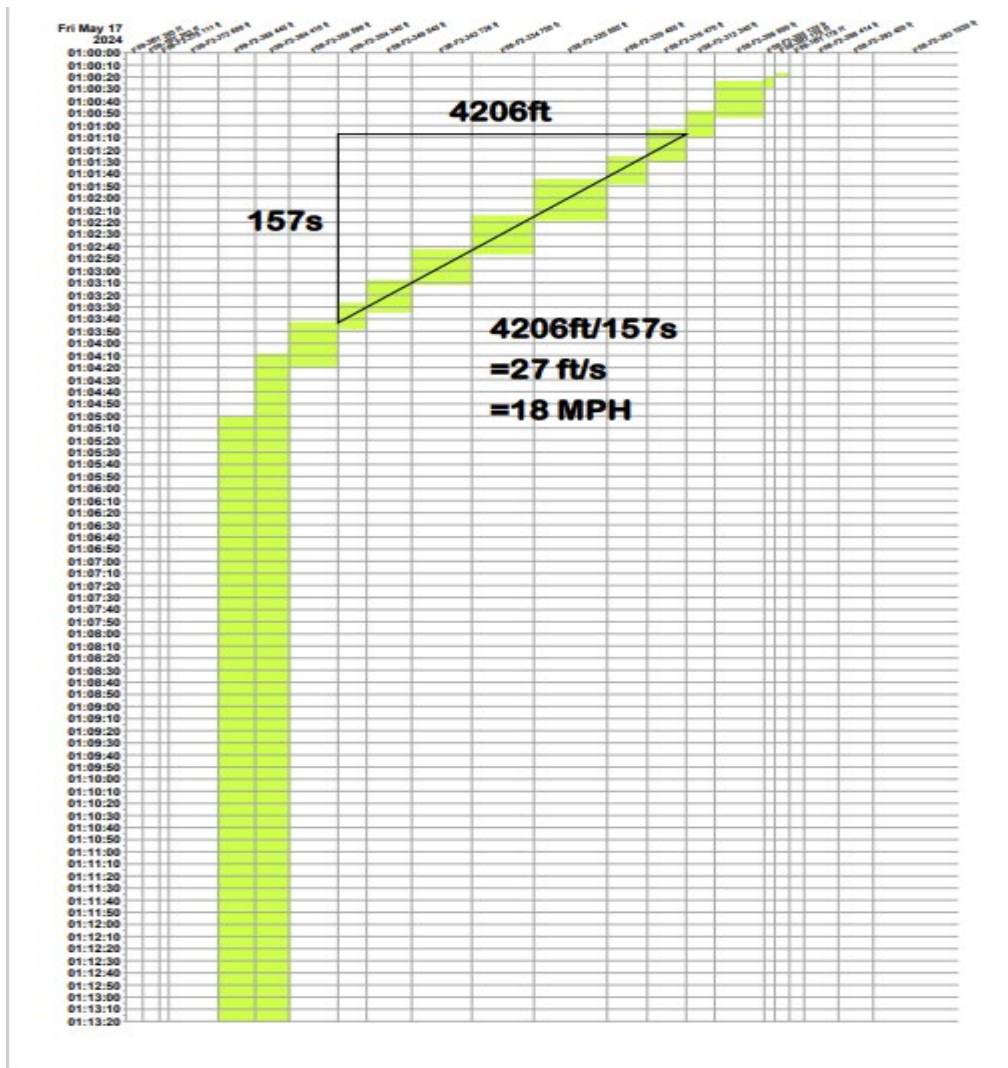
The IBOP IT performed occupancy data analysis for TR05 on track 2 from F08 to F09 right after 01:00 hours on Friday, May 17, 2024. In the several minutes preceding the derailment, TR05 was moving at 18MPH near CM F2-358 at 1:03:40 hours, it began slowing down, and it stopped occupying blocks F2-364 and F2-368 right around 01:05 hours.

Chart 1: IBOP IT Speed calculation chart.

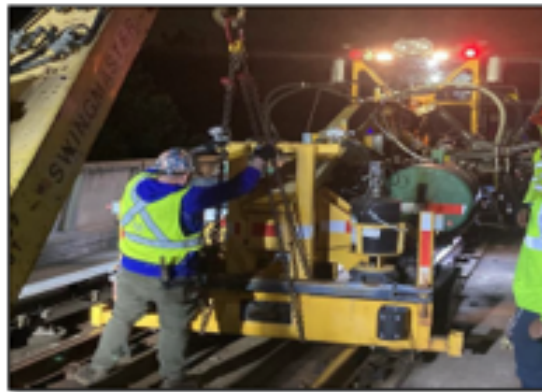
Following a transition from Travel mode into Work mode, the vehicle traveled approximately 125 feet before the derailment occurred. At the time of the incident, the vehicle was moving forward at approximately 7 mph with forward propel engaged.

Figure 1 - TR05 Derailment

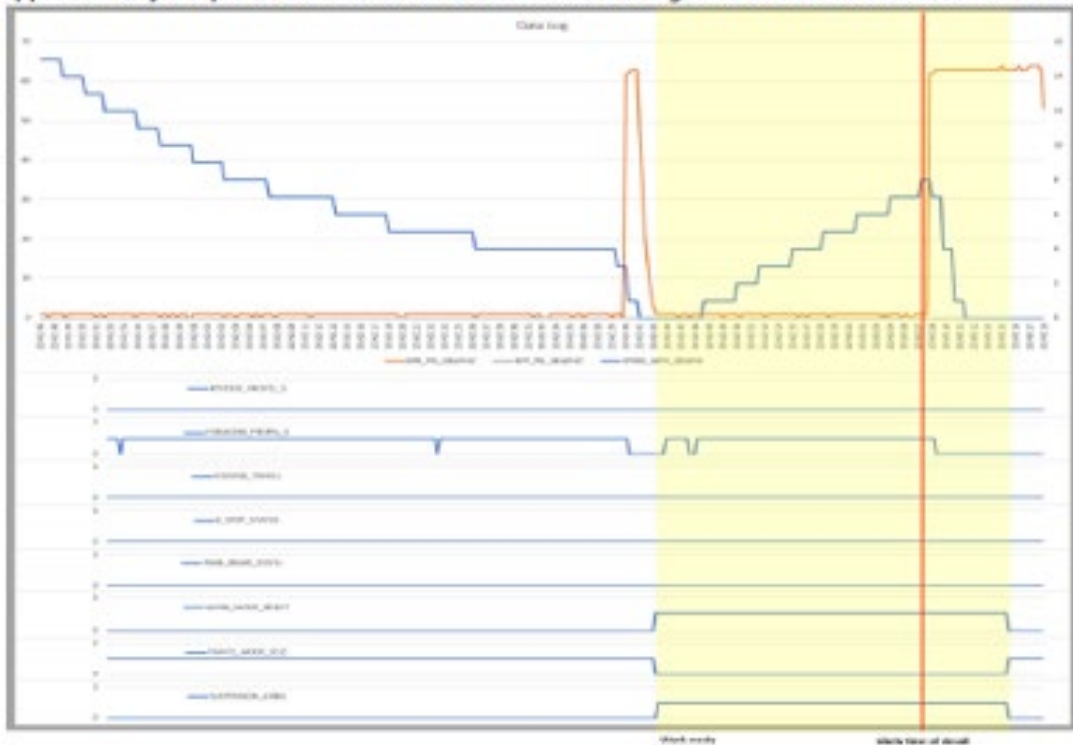
Once TR05 reached Branch Avenue yard. CTEM conducted a post-incident inspection of the vehicle and found no issues. Vehicle Program Services Engineering (CENV) gathered data from TR05's data logger and digital video recorder to analyze. According to the recorded data, the vehicle was traveling at approximately 7 mph at the time of the incident. Refer to Figure 2 to review the recorded data.

Figure 2 - TR05 Derailment Incident Data Graph

NOTICE: The Data Recorder's time lags 1 hour and 20 minutes behind the local time. The Digital Video Recorder time lags 58 minutes behind the local time.

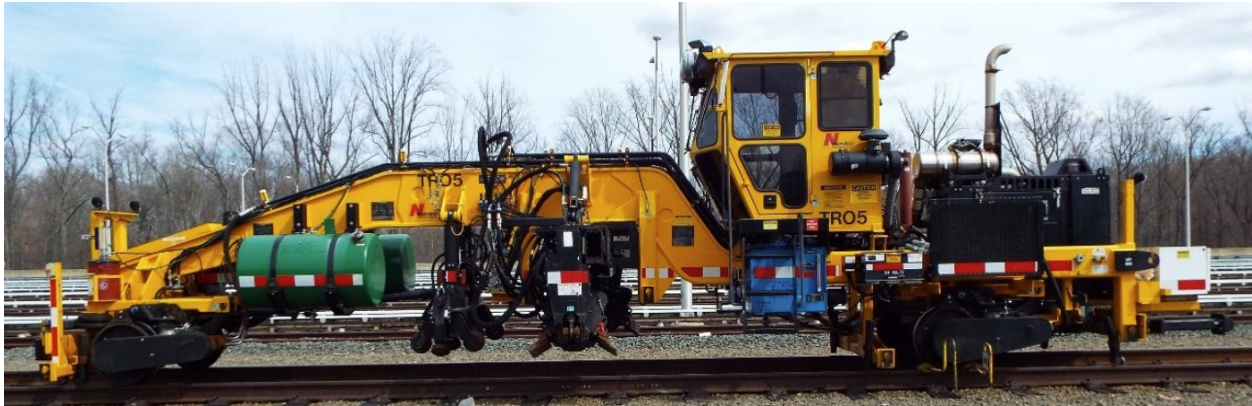
Photograph 1: Shows the left side of TR05.
