Evacuation for Life Safety Reasons

**At or Near L'Enfant Plaza Station, Foggy Bottom Station,
Eisenhower Avenue Headquarters and Benning Road Station
April 1, 2024, May 18, 2024, July 2, 2024 and July 22, 2024**

Document Purpose

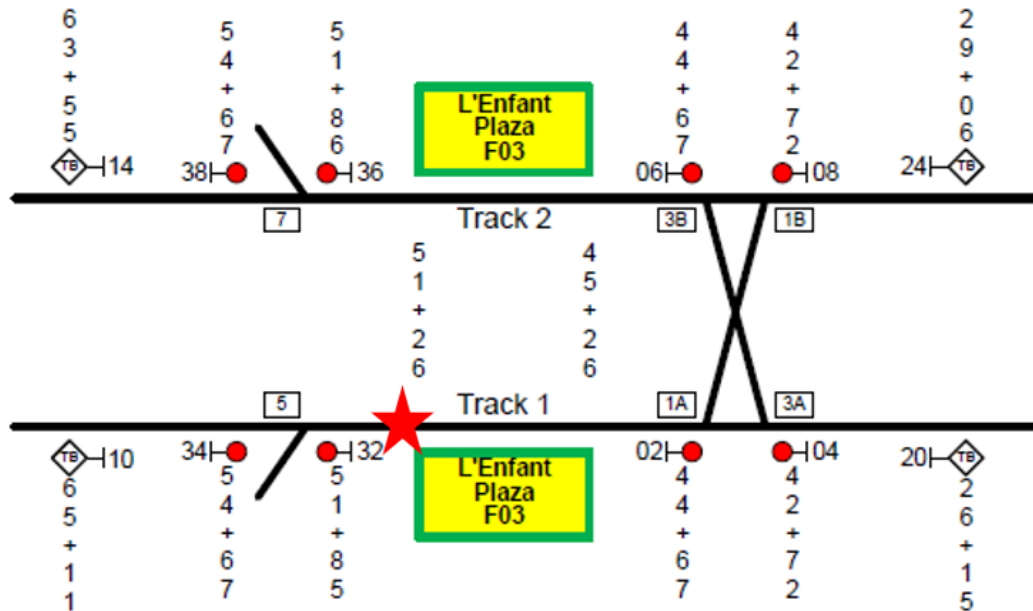
Field Sketch/Schematics

The above depiction is not to scale. The red star indicates the approximate location of the arcing stud bolt.

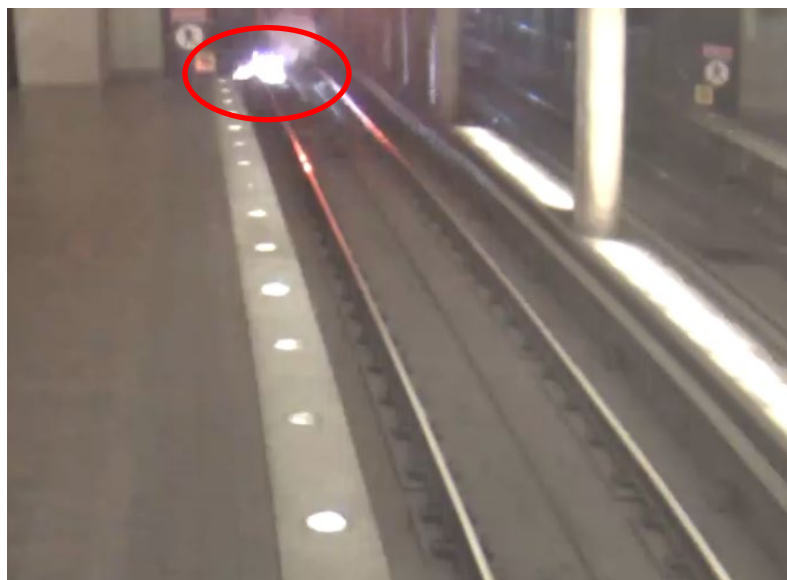
Figure 1 Arcing Stud Bolt at F03 Track 1

The probable cause of the Evacuation for Life Safety Reasons event on Wednesday, April 17, 2024, at L'Enfant Plaza Station was a stud bolt coming into contact with rebar in the concrete due to an old method of installation. This caused arcing and smoke as a stray current was introduced through the running rails as the train departed the station

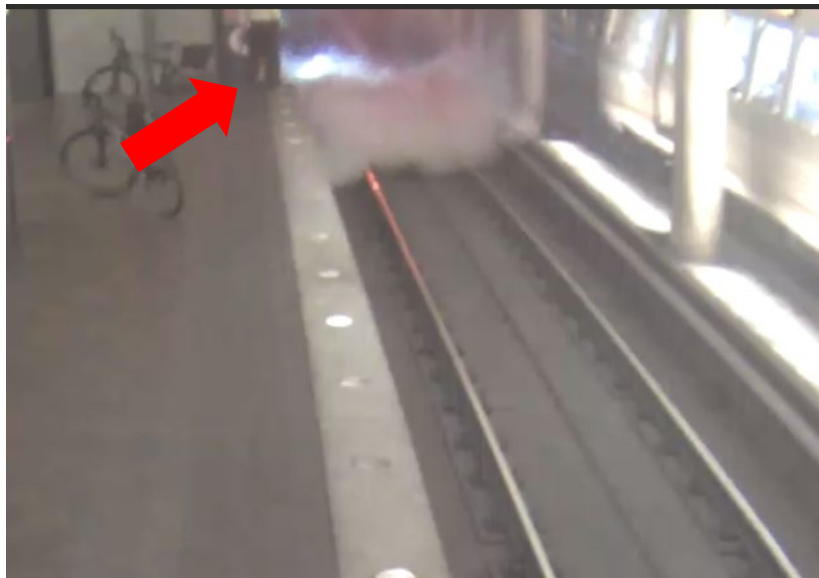
Figure 3 MTPD Personnel attempting to extinguish Arcing Stud Bolt at F03

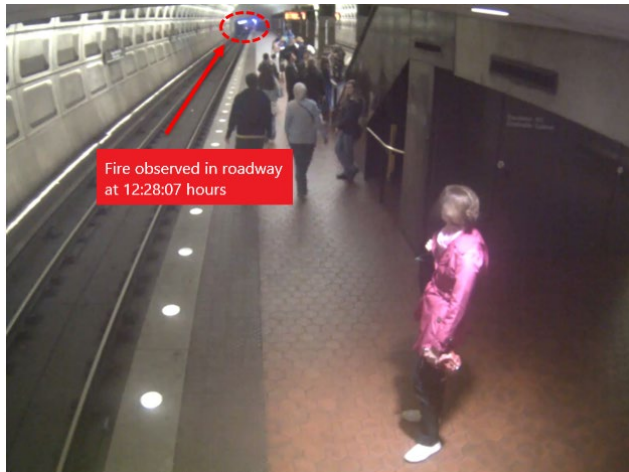
Figure 2 - depicts flames emanating from inside of the tunnel on track 2 towards Farragut West Station.

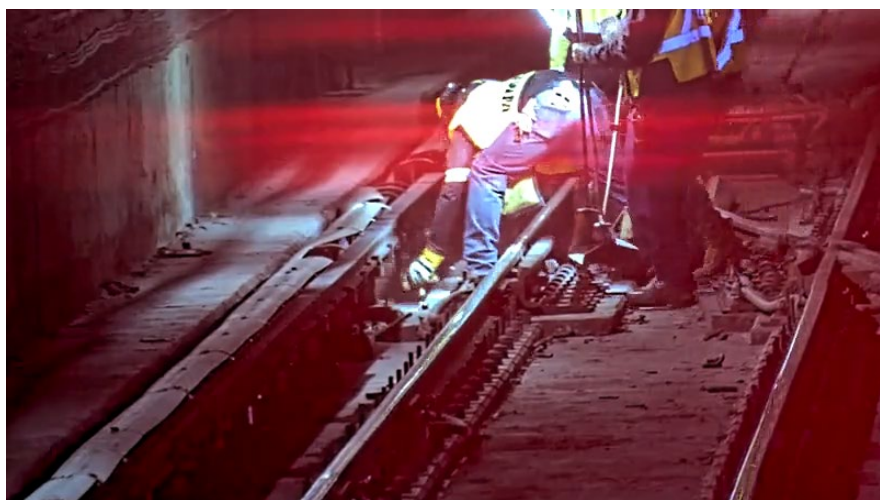
ERT personnel determined the cause of the fire was debris that made contact with energized third rail that was located near the interlocking. ERT conducted initial removal of the debris and returned to the platform at 1:08 p.m. During an investigative interview the ERT Supervisor stated they placed a Warning Strobes and Alarm Device (WASAD), but did not use a hot stick to confirm power was de-energized.

Figure 7 - depicts ERT clearing the debris underneath the third rail from the roadway

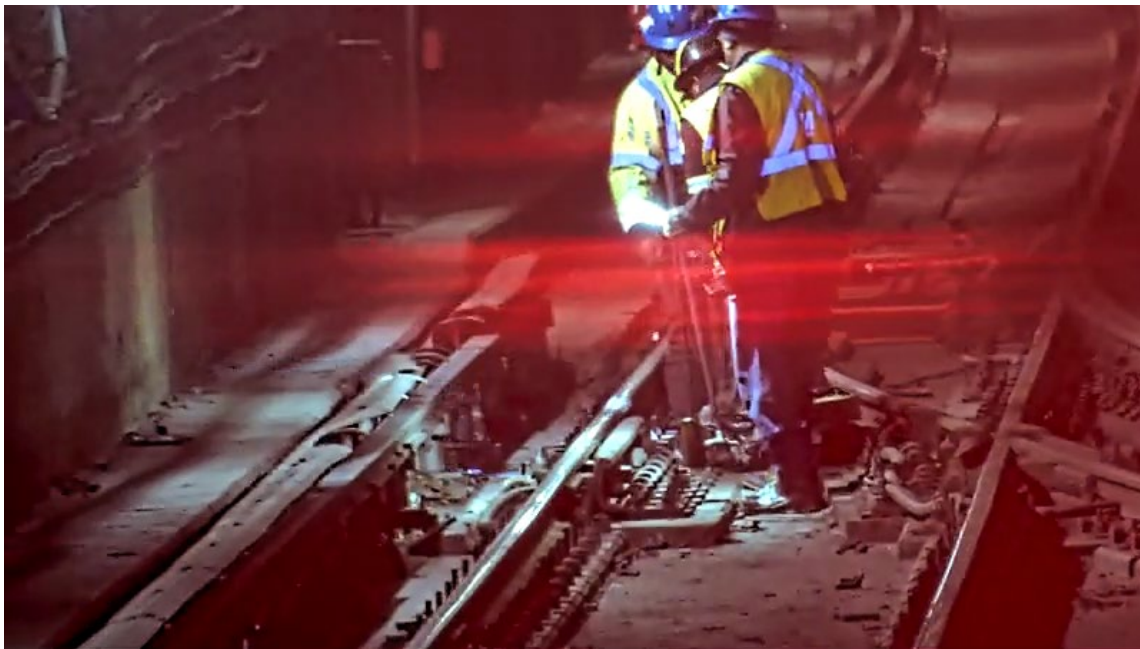
Figure 18 - depicts ERT personnel clearing the debris near the third rail on track 2

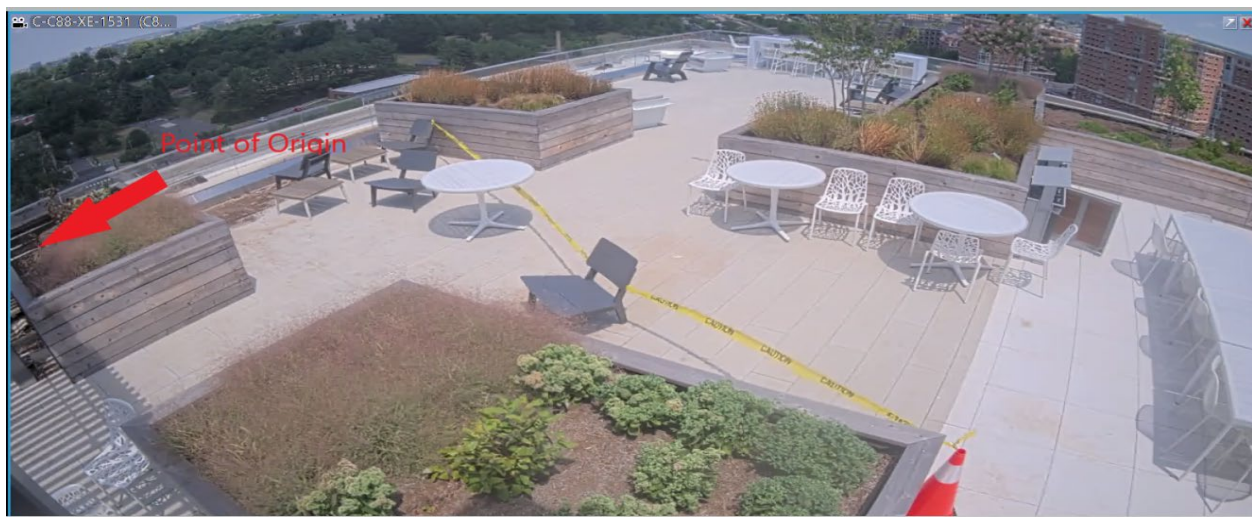
The investigation determined that the fire started due to embers from smoking materials that were improperly discarded in a flower box on the patio. During an investigative interview both employees stated that they placed their cigars in a cup and then discarded them in a bathroom toilet.

Image 1 – Image of the area where the fire occurred.

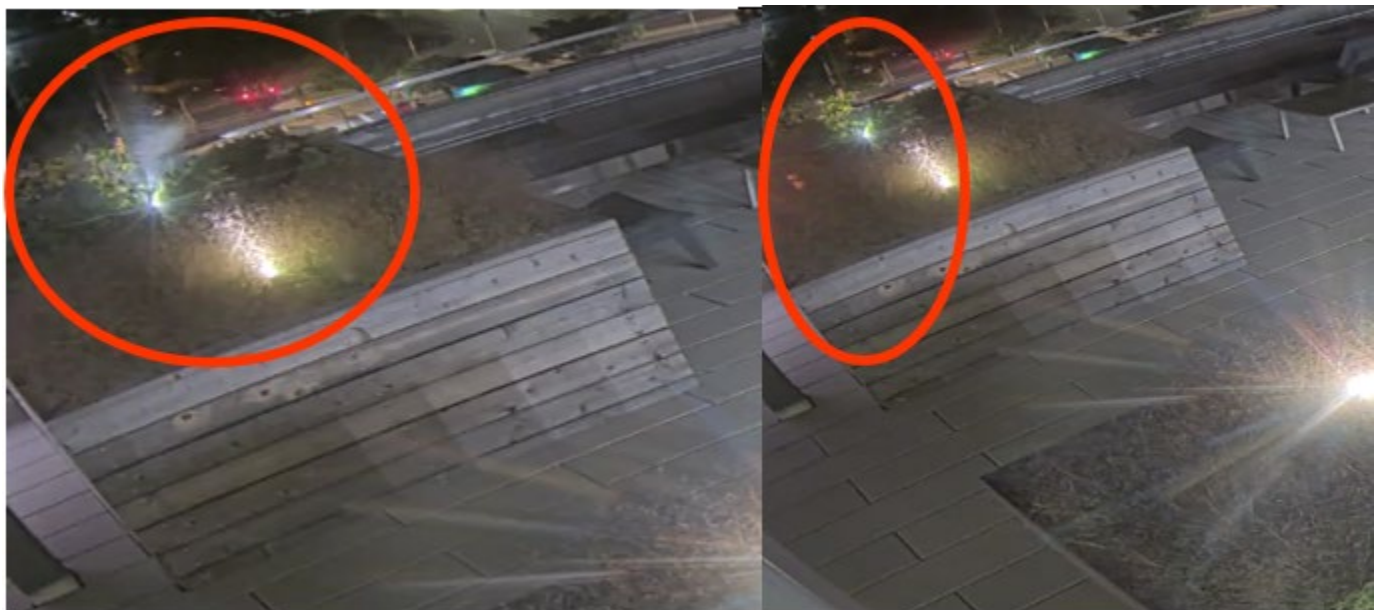
Image 5 – Images of smoke and then fire beginning to burn within the wooden flower planter.

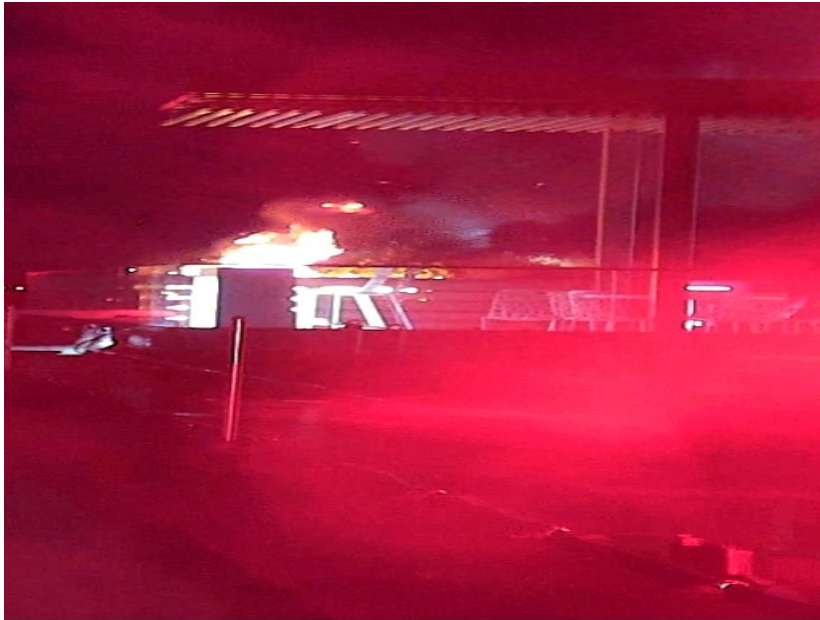
Image 6 - Image of the fire within the wooden flower planter.

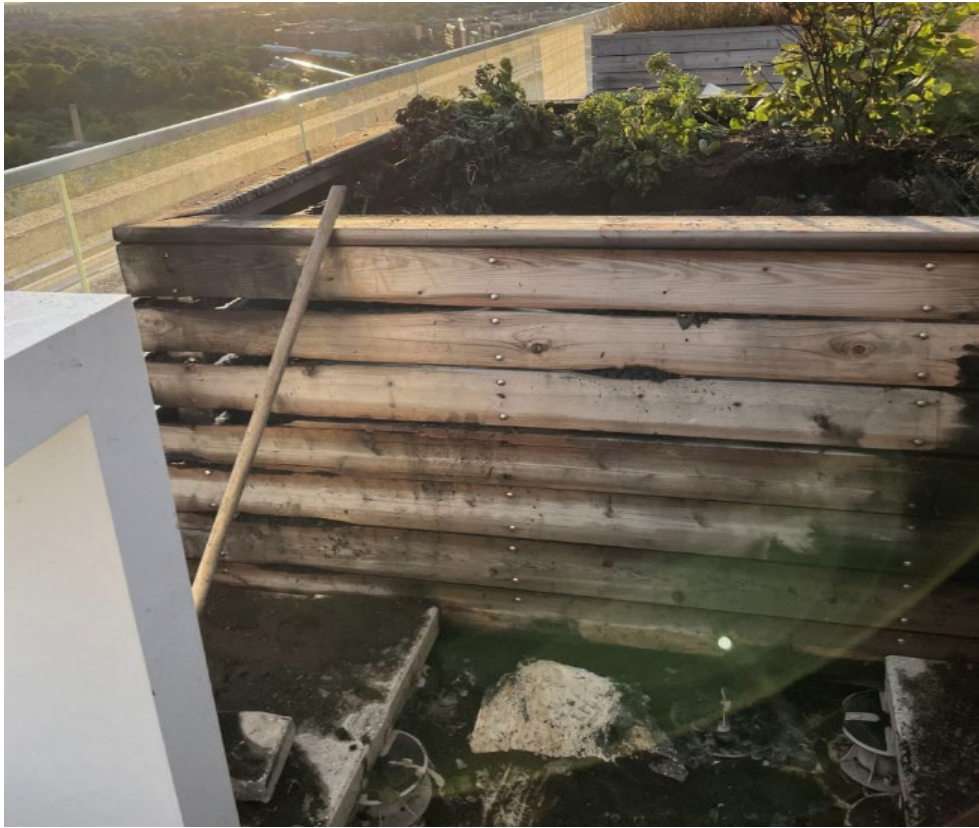
A wooden flower planter box was damaged by fire, but no injuries were reported.

Image 8 – Image of the damaged wooden flower planter.

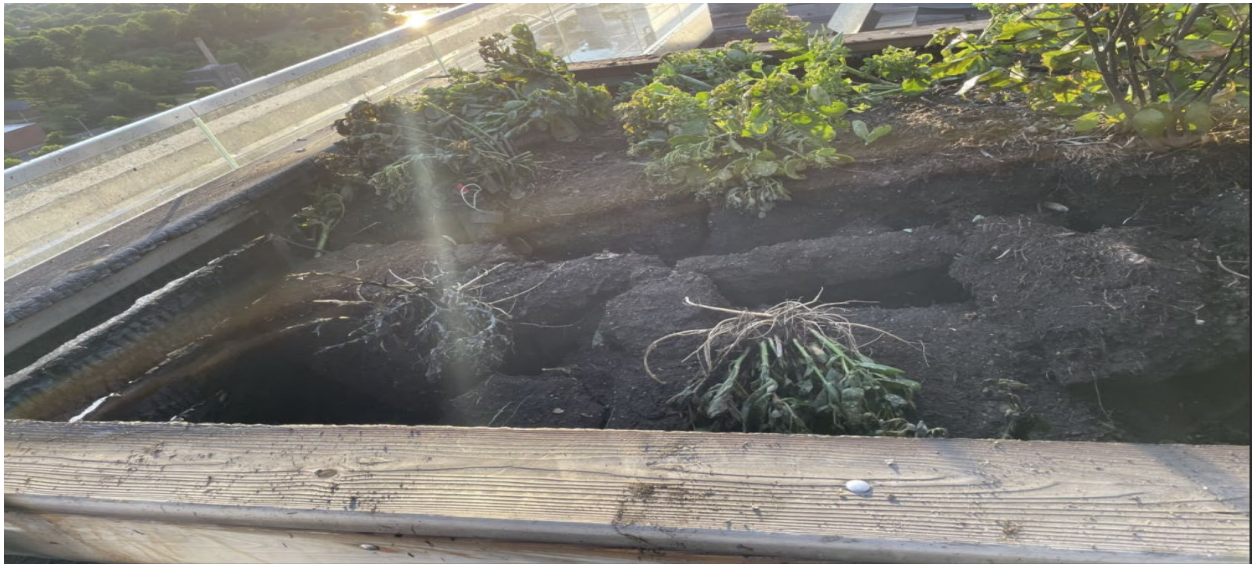
Image 9: Wooden flower planter (post-fire).

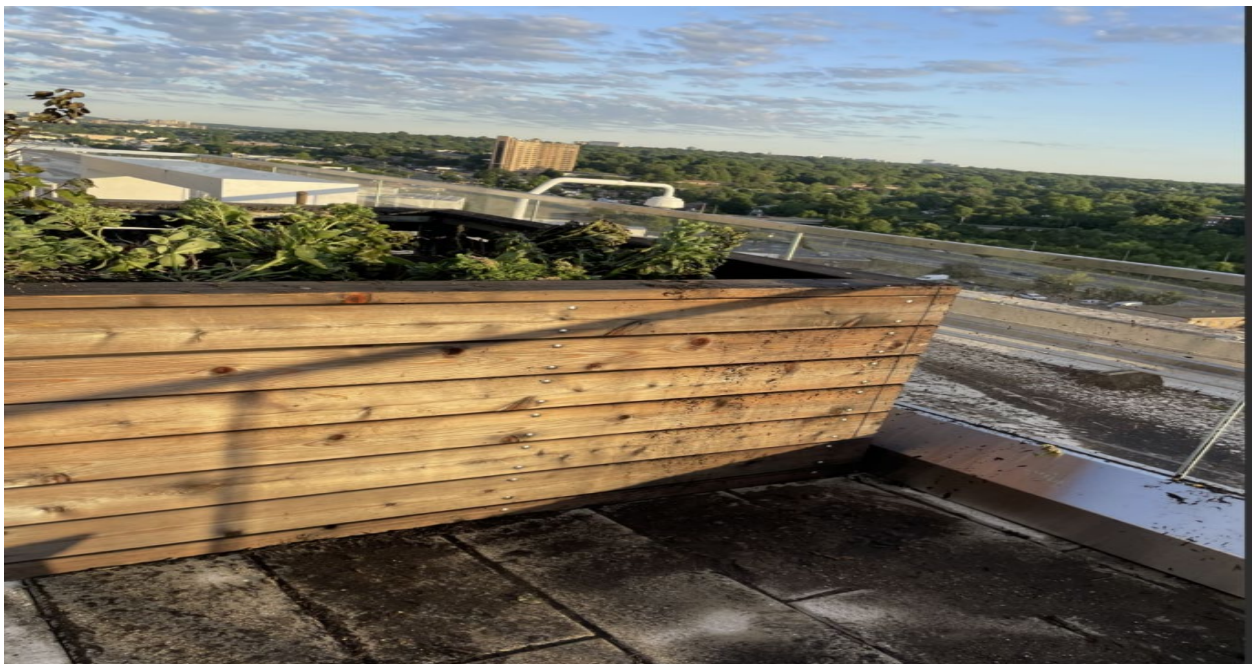
Image 10: Wooden flower planter (post-fire).

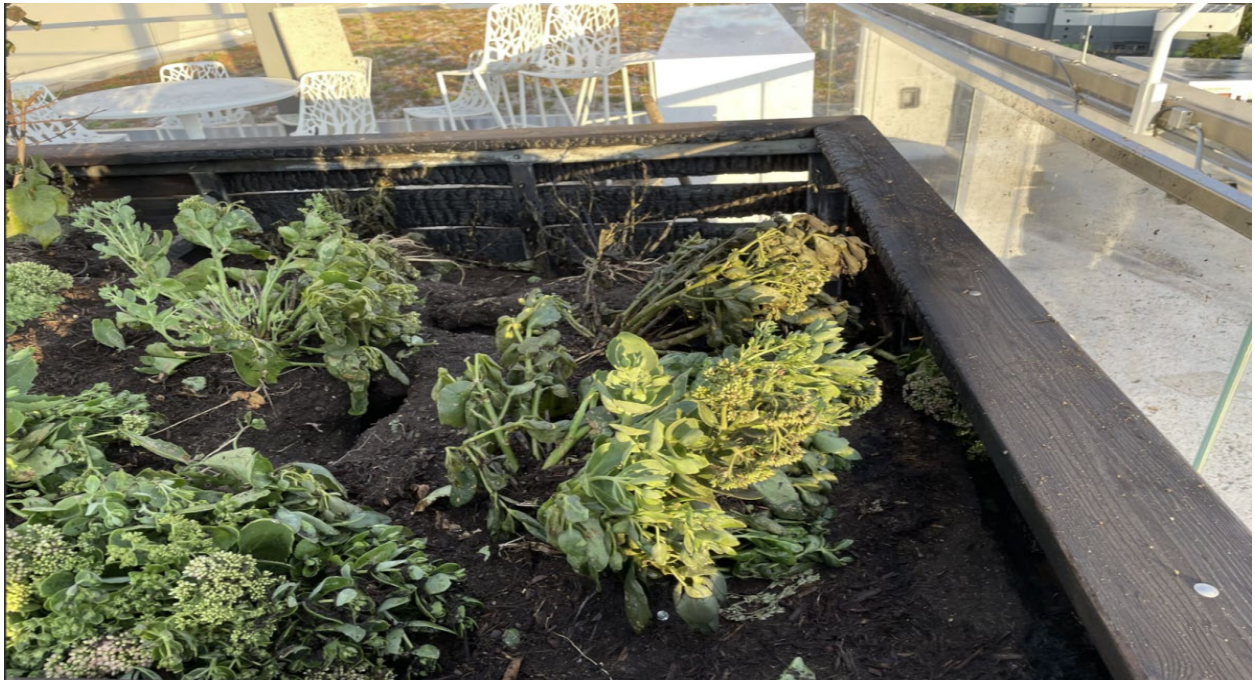
Image 11: Wooden flower planter (post-fire).

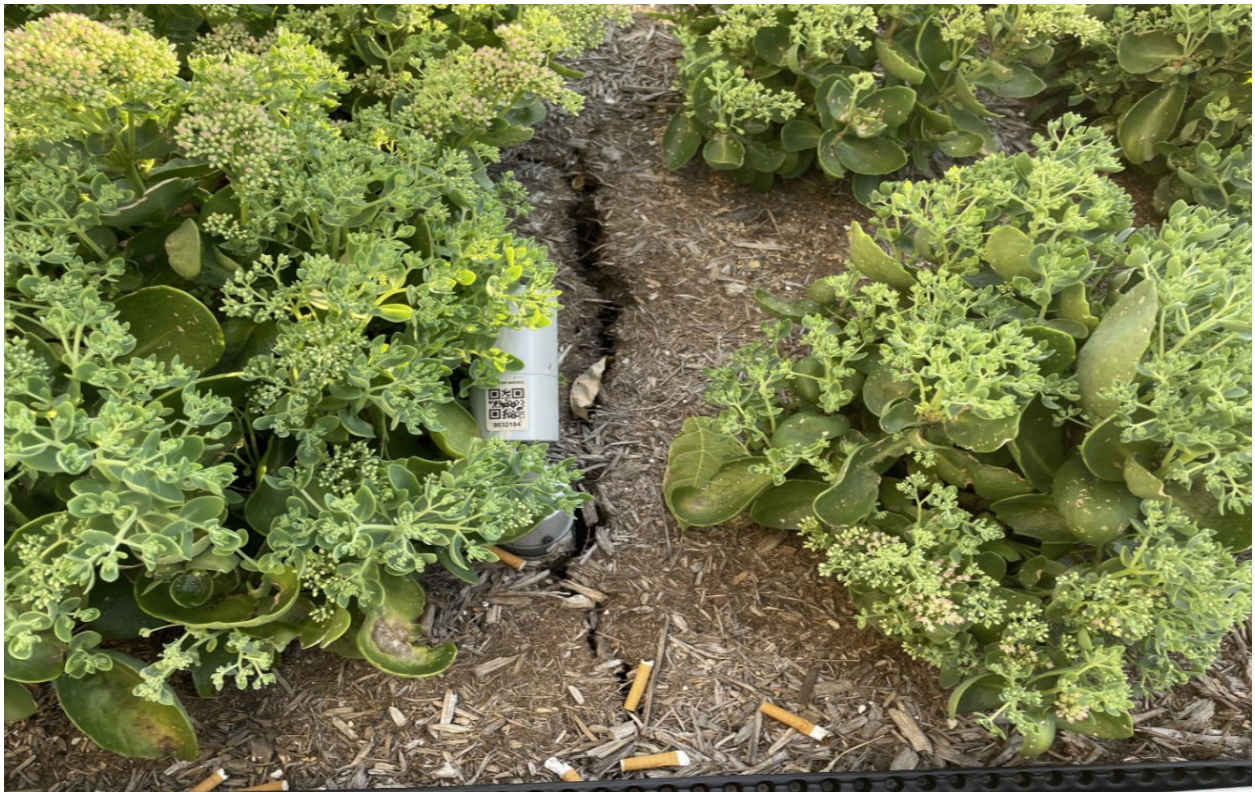
Image 12: Wooden flower planter (post-fire).

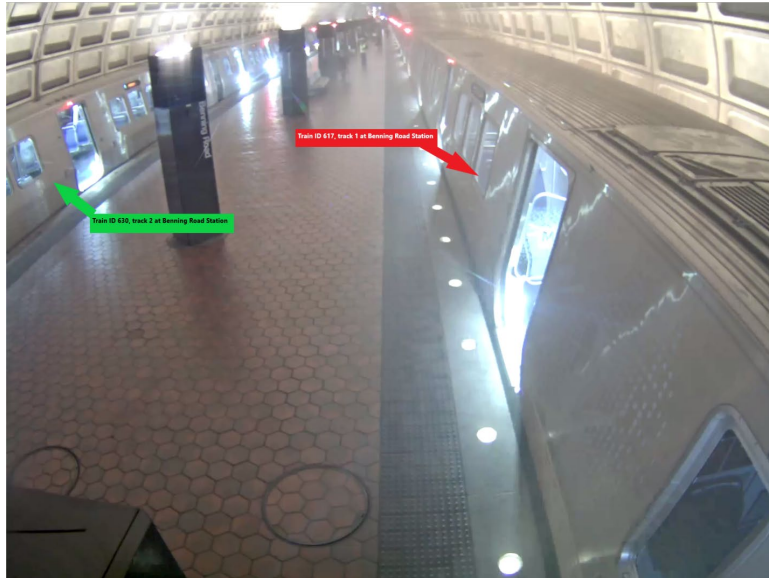
Figure 2 - CCTV footage of smokey haze entering the station platform behind Train ID 617.

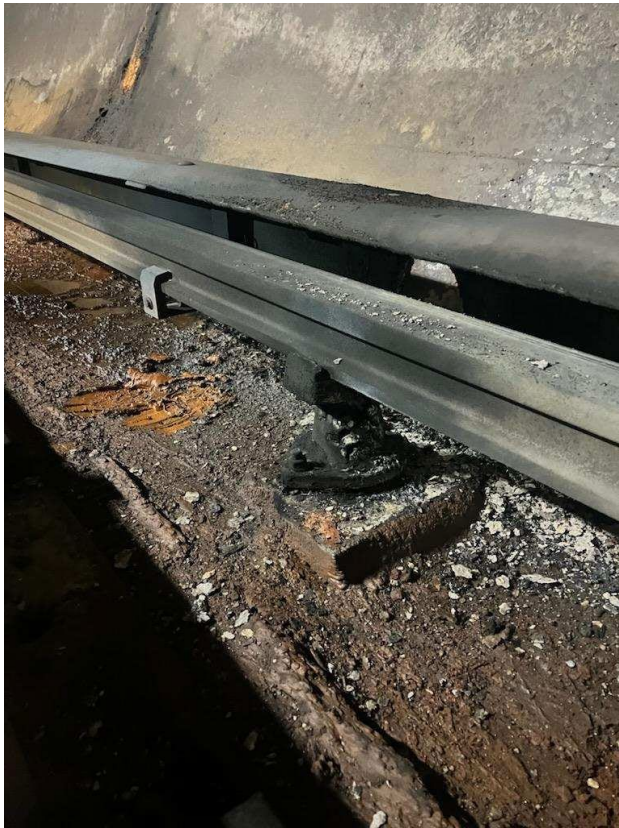
The track inspection identified an arcing insulator, a maintenance issue, as the cause of the smoke and incident command was transferred from DCFEMS to MTPD. The arcing insulator was removed. Power was restored improperly without the required announcements or authorization. A test train confirmed track 1 was safe for passenger service, however ERT reported that no test train was necessary for track 2.

Figure 7 - Depicts the insulator found near CM G1 307+00.
