# WMSC Inspection Report 20250317

Title: Greenbelt Service and Inspection Shop, Digital Dial Gauge Availability

Location: Greenbelt Yard (E99)

Date of Inspection: 3/17/2025

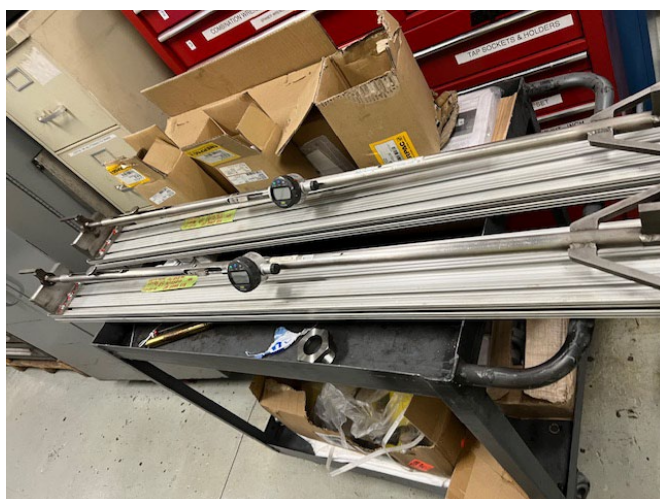
The WMSC identified one defect (see below) while at the Greenbelt Service and Inspection Shop. Regarding the digital dial gauges, the WMSC observed two gauges in the Greenbelt tool room that were in calibration and ready for use. Eight additional gauges were in the machine shop awaiting calibration. No back-to-back wheelset or journal bearing gap measurements were underway while at Greenbelt.

Photo 1. Digital dial gauges ready for use.

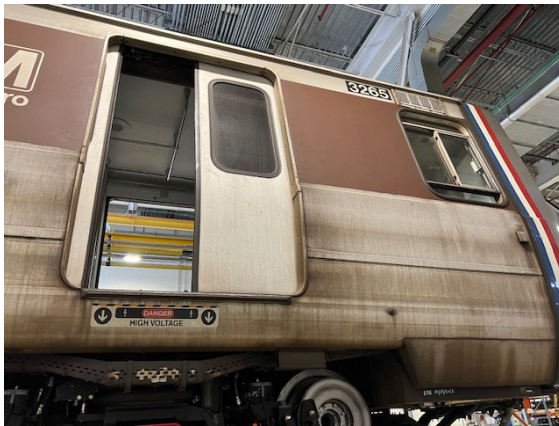
Rail vehicle door barriers (fall protection) were not in place on four railcars (two married pairs). This was reported to WMATA personnel on site and then subsequently via email on March 18, 2025 as well. Photos 3 and 4 show railcars without any fall protection in place. Photo 5 shows the proper fall protection (rail vehicle door barriers) in place.

Car Maintenance (CMNT) memorandum with the subject “Door Barriers on Elevated Railcars” (dated March 10, 2022) states that “[w]hen a rail car is elevated on a lift or pit, the side doors must be kept closed, **with the following exceptions:**

**Hazard Rating: 3D**

Photo 3. Railcar on lift without fall protection in place.

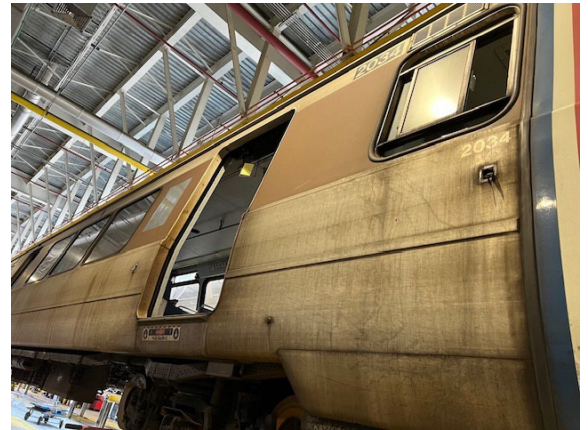
Photo 4. Railcar on lift without fall protection in place.

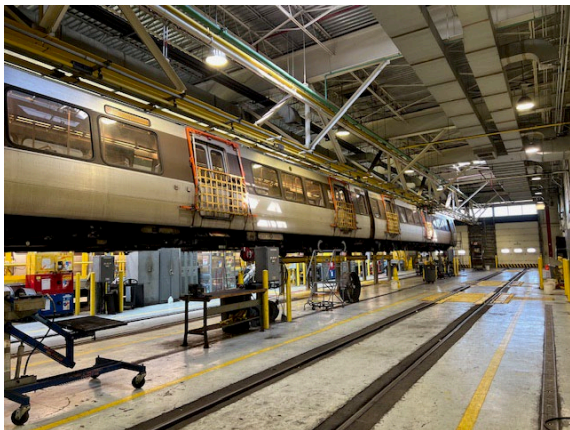
Photo 5. Railcar on lift with appropriate fall protection in place.
